Proceedings of International Conference : Issues, Management And Engineering In The Sustainable Development On Delta Areas Semarang, Indonesia – February 20th, 2015 Paper No. XXX (The number assigned by the OpenConf System)

The Impact of Alluvial Land Subsidence Towards Extension of Inundation and Infrastructure Damage At Settlements Around Harbor Area of Tanjung Mas – Semarang

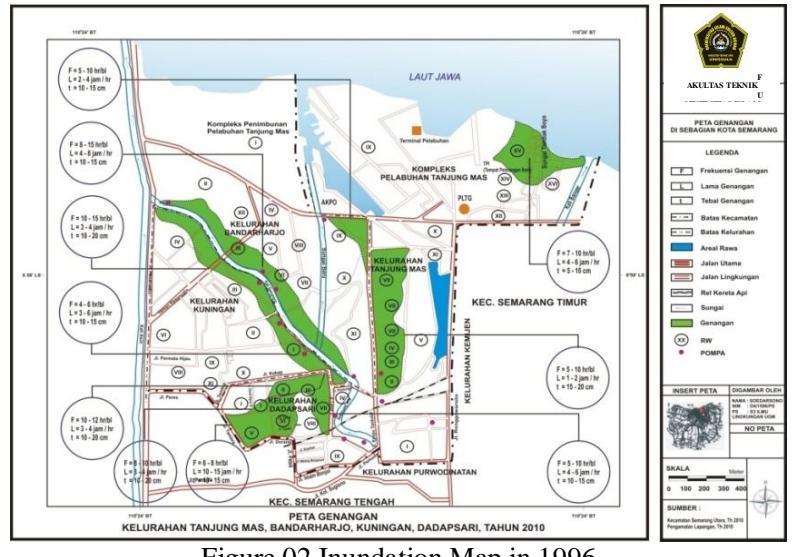
Figure 02 Inundation Map in 1996

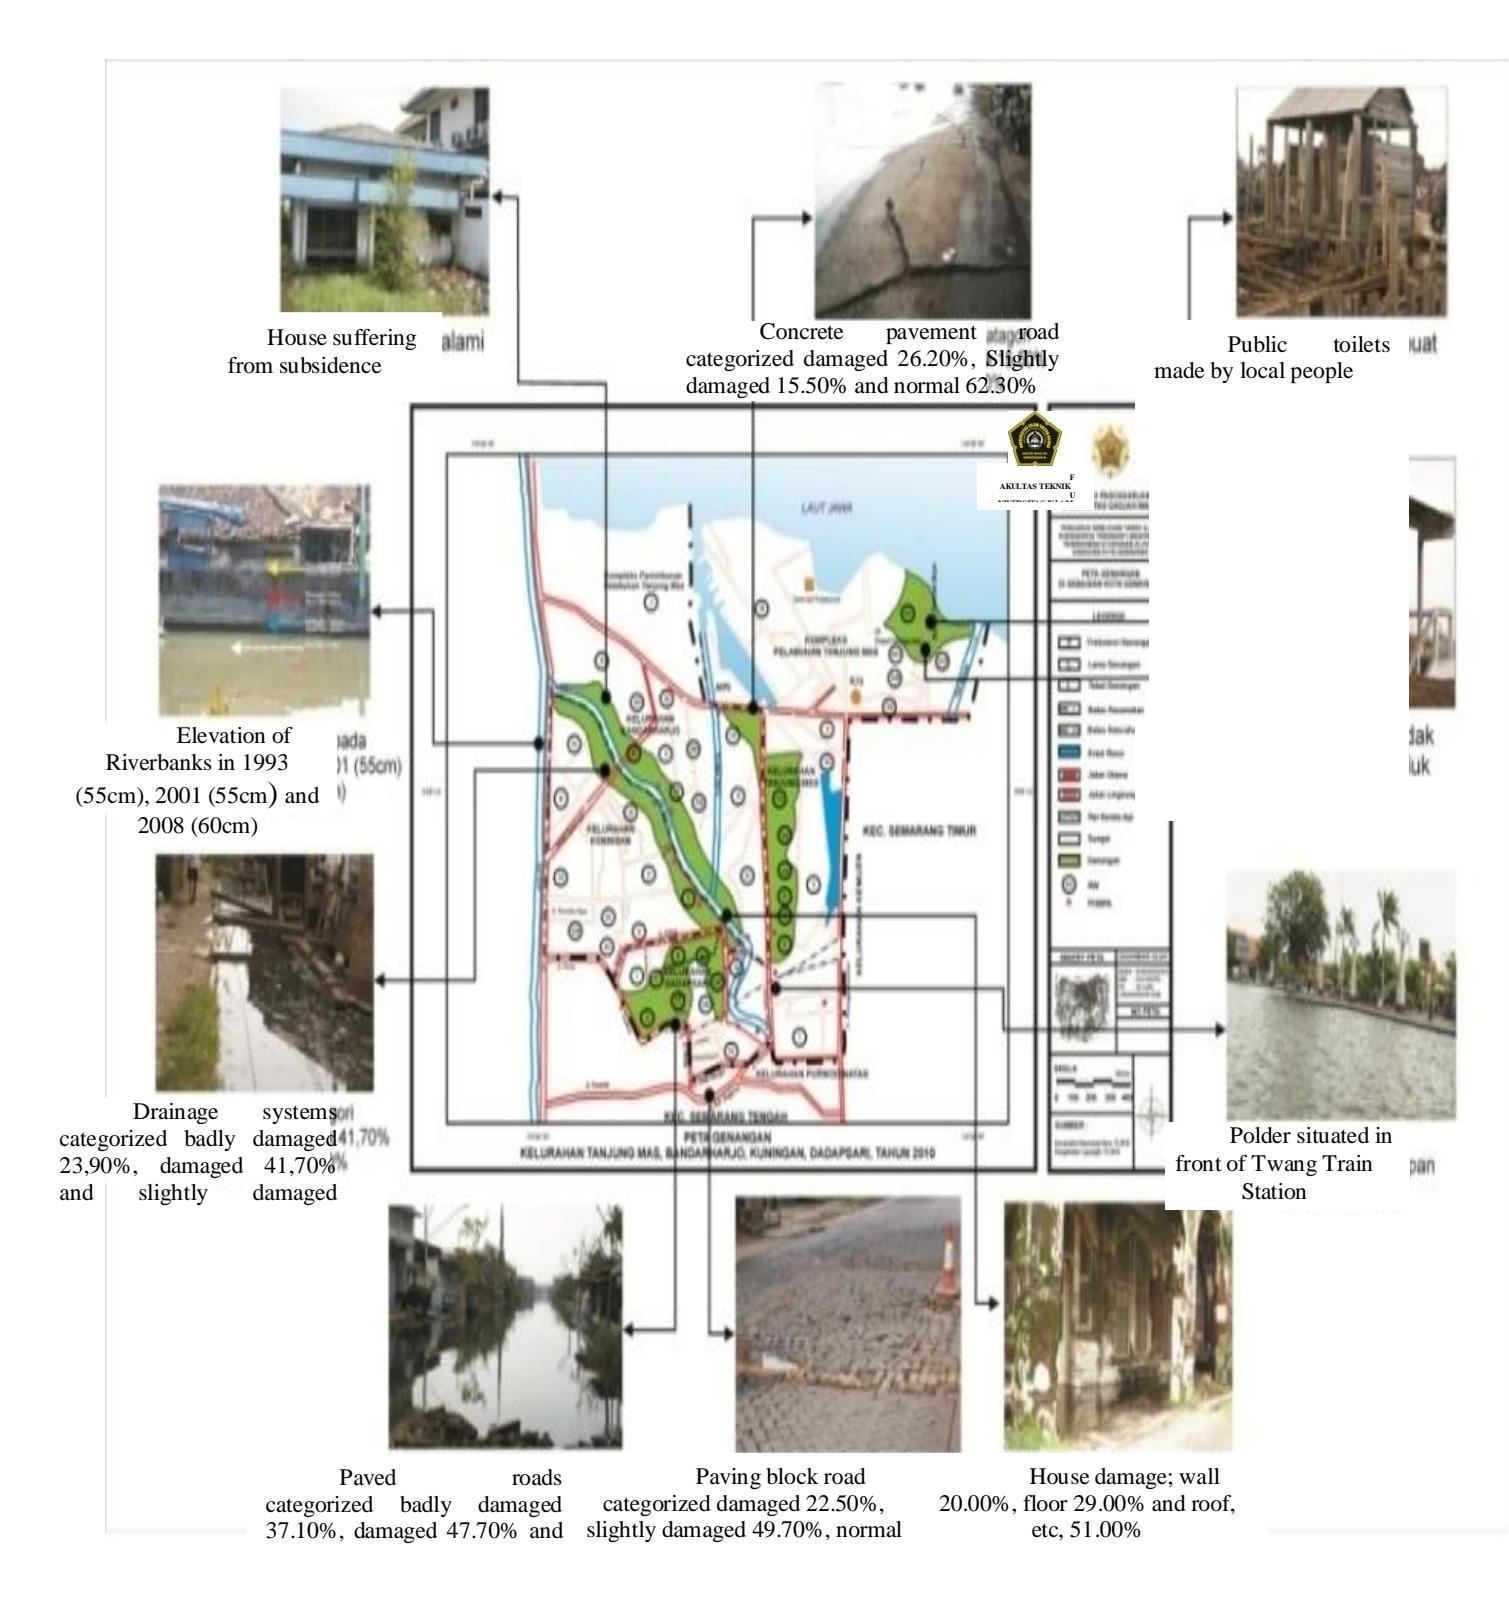
Figure 4. condition, house location and infrastructure suffering from damage due to inundation at the settlement in 2010

The impact of sea water frequently flooding the settlement areas could be seen from the damage of the building and infrastructure. Sea water would soon damage the building in the area frequently flooded especially to the building made of mortar consisting of porland cement (PC) and sand, chemically, sea water was able to release compound within the cement, as a consequence, the building was easily fragile (Kusnandar, 2009). Infrastructures suffering from damage were roads with pavement of asphalt, concrete and paving blocks.

Prabowo (2009) conducted research using mixed design of thin layer of asphalt concrete of worn-out layers, explained the higher acidity of the water and the longer being submerged in sea water, the faster it would be peeling the asphalt mixture. Road damage with asphalt pavement happening in Jl. Dorang, Jl. Tombo and Jl. Empu Tantular were much caused by sea water immersion.

Damage of road construction with concrete layer in Jl. Usman Janatin was the impact of structure damage, such as cracks on the pavement layers (upper layer), but did not happen to the basic of *slab* concrete. Road damage with concrete pavement layer in Jl. Usman Janatin in the area of Tanjung Mas was mostly caused tender basic soil layer due to being submerged by water and the road itself was frequently passed by heavy leaden vehicle. Road damage with pavement layer *paving block* was caused by discharge of the lower sand layer *paving* *block* because of the water submerging, displacement of sand under the pavement (*bedding sand*) caused instable road layers (Hatta et.al, 2003). Road damage in Jl. Layr and Jl. Kolonel Sugiono using paving block, besides it was frequently submerged, this was also because of heavy leaden vehicle passing by.

The condition of drainage system in the research location was party broken in the left and right side of the channel, most of which were full of sediment and household waste, existing drainage systems were turning following condition of the settlement with the slope (i) lesser than 2%, as a resut while raining and high tide, the water would flood the settlement.

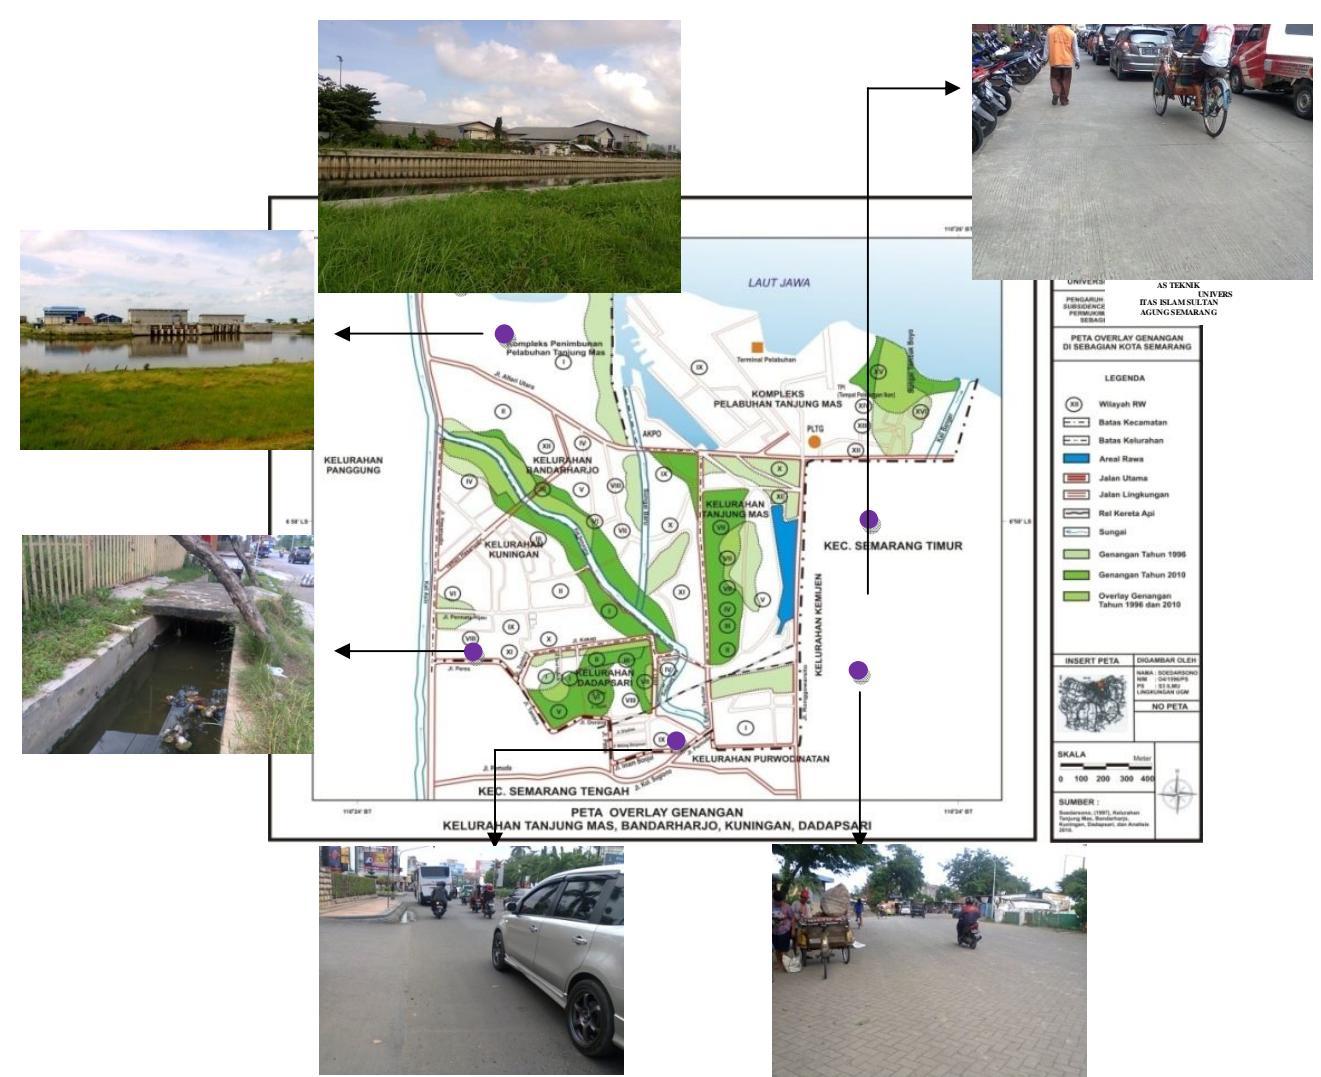
Figure 05 Condition, house location, and infrastructure sufferin from damage due to inunation at the settlement in 2015

In 2015, there were two kinds of events happened, first was the inundation decreased of 68.44 hectare and second, the decrease of infrastructure damage of the settlement due to normalisation happening to Semarang and Asin River, by sediment dredging to those two rivers as well as improvement of the estuary the water could flow well, besides, this was the first time for Semarang River restensive pool to be operated, as a result, when high tide was happening the door of restensive pool was closed to which this was able to partly block the sea water coming to the River.
