Sewers as a Source and Sink of Chlorinated-Solvent Groundwater Contamination, Marine Corps Recruit Depot, Parris Island, South Carolina

Don A. Vroblesky, Matthew D. Petkewich, Mark A. Lowery, and James E. Landmeyer

REFERENCE: Proceedings of the 2010 South Carolina Water Resources Conference, held October 13-14, 2010, at the Columbia Metropolitan Convention Center

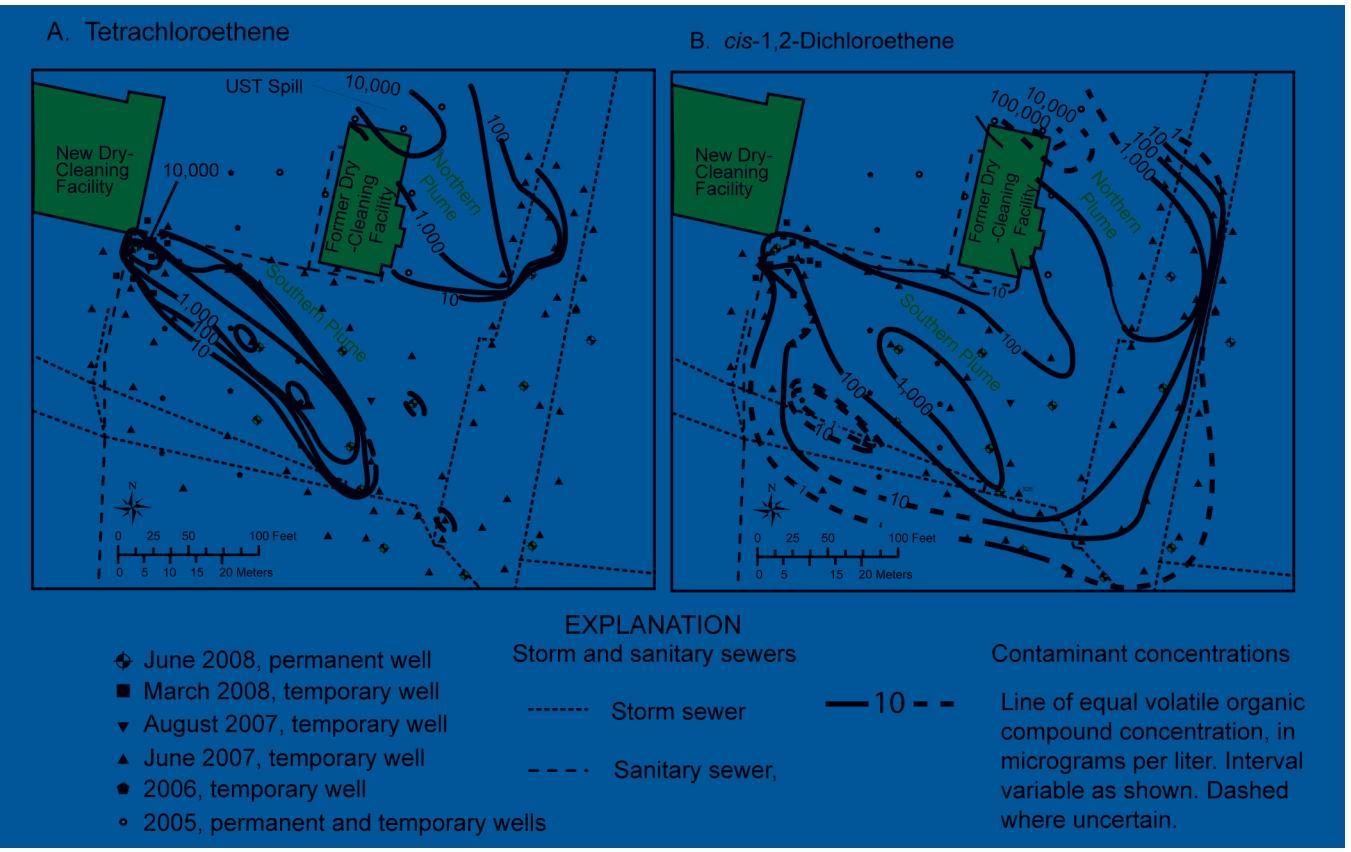
Figure 1. Tetrachloroethene and *cis*-1,2-dichloroethene in groundwater and locations of storm and sanitary sewers, Site 45, Marine Corps Recruit Depot, Parris Island, South Carolina, 2005-2008.

The aquifer at the southeastern corner of the new drycleaning facility, where the section of the sanitary sewer was removed, contained the greatest PCE concentrations (Fig. 1), the greatest PCE/daughter-product ratios, and the lightest PCE carbon compound-specific stable isotope values in the southern plume. The direction of groundwater flow is to the southeast and the chemical data indicate that the area where the sanitary sewer was removed contains the most concentrated and least degraded parent compound in the southern plume. The southeastern corner of the new dry cleaning facility is, therefore, the likely source area for the southern plume.

Data indicate that storm sewers also intercept contamination in the southern plume. Chlorinated solvents were detected in water from STS05 (30 μ g/L of PCE, 100 μ g/L of TCE, 70 μ g/L of *c*DCE, and 7 μ g/L VC of in June 2007). Thus, it appears that the storm drain below the water table in the down-gradient parts of the plume is a discharge zone for groundwater contamination (Fig. 1).

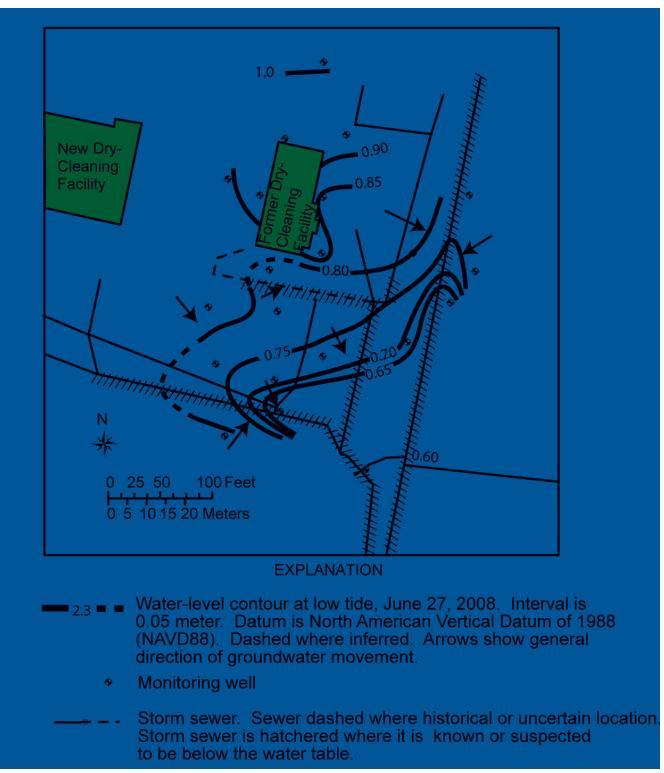
Storm sewers underlay Site 45 (Fig. 2) and appear to be an important influence on groundwater flow directions. The inverts of some sections of the storm sewer system at Site 45 are below the high-tide level and below the groundwater levels. The groundwater contours in the surficial aquifer show strong curvature toward some of the storm sewers where the inverts of the sewers are deeper than the water table (Fig. 2). These data show that groundwater discharges to the storm-sewer system in those areas. Once in the storm sewer, water discharges to Ballast Creek, about 463 m from Site 45.

Figure 2. Water table, Site 45, Marine Corps recruit Depot, Parris Island, South Carolina.

VOC detections in the storm sewer indicate that groundwater contamination in the northern plume discharges sections of the storm sewer below the water table. In addition, the curvature of water-table contours around parts of the storm sewer below the water table indicates movement of groundwater to the storm drain from both sides (Fig. 2).
