Forster, Alan Mark; Medero, Gabriela M

Published in:
Building Surveying Journal

Material evidence

Simulations have helped understanding of the performance of cob walls during flooding, as **Alan Foster**, **Gabriella Medero** and **Tom Morton** explain

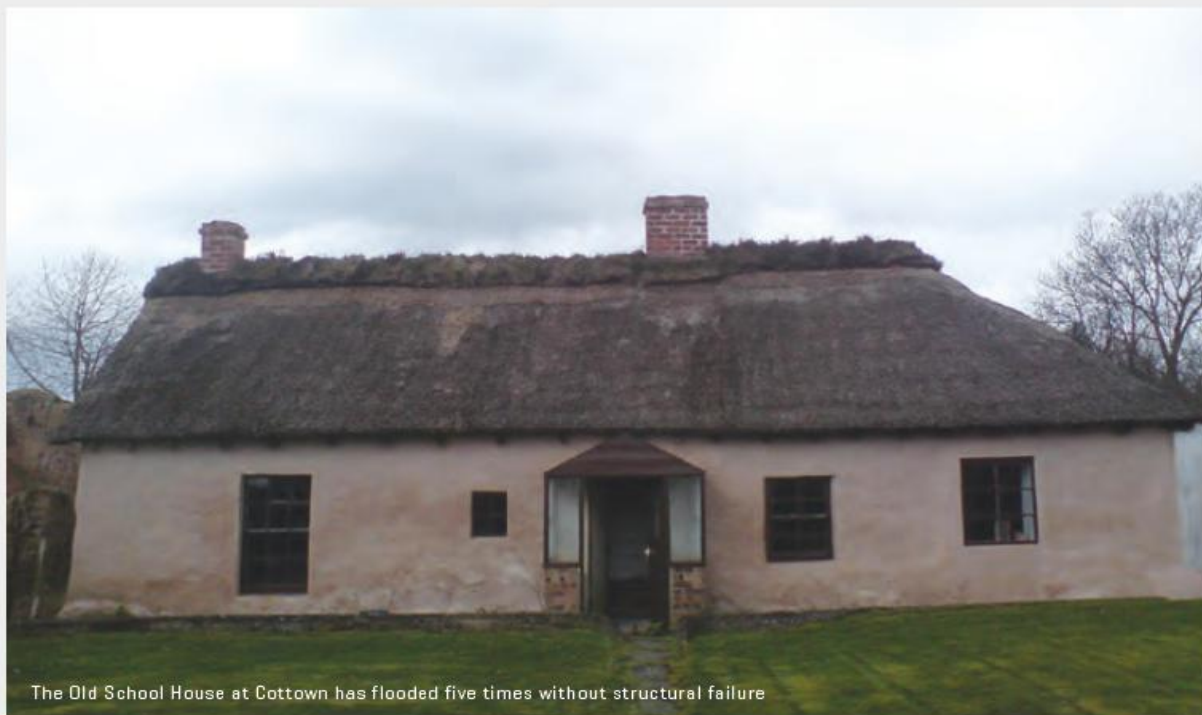
Take the example of the Old School House at Cottown, Perthshire, built around 1760 of cob – one of the most frequently occurring types of earth construction. The building had been flooded five times in recent years, but while the submerged regions exhibited undercutting and loss of earth materials from the wall faces, there was no structural failure. In a bid to gather data, a study was carried out at Heriot-Watt University that

The Old School House at Cottown has flooded five times without structural failure

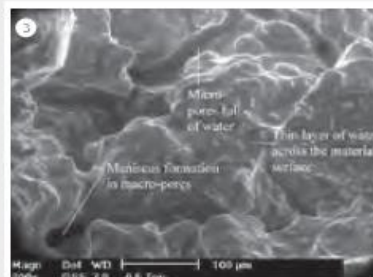
[Photo 3](#) illustrates a thin layer of water that has coated the sample. The development of menisci between the clay/aggregate particles can be seen in several locations. The micro-pore structure is apparently full of water, while the macro-pores are still unsaturated. The clay particles and siliceous aggregates are hydrophilic in nature.
