# Visual recovery of desert pavement surfaces following impacts from vehicle and foot traffic in the Ross Sea region of Antarctica

**Abstract:** Sites of past human activity were investigated to assess the visual recovery of the desert pavement following impacts from human trampling and vehicle traffic. Visually disturbed and nearby control sites were assessed using comparative photographic records, a field-based Visual Site Assessment, and Desert Pavement Recovery Assessment. Sites included: vehicle and walking tracks at Marble Point and Taylor Valley; a campsite, experimental treading trial site, and vehicle tracks in Wright Valley; and vehicle and walking tracks at Cape Roberts. The time since last disturbance ranged from three months to over 50 years. This investigation also attempted to determine what has the greatest lasting visual impact on soil surfaces in the Ross Sea region: dispersed trafficking or track formation? Walking tracks remained visible in the landscape (due to larger clasts concentrating along track margins) long after the desert pavement surface had recovered. However, randomly dispersed footprints were undetectable within five years. For many sites, allowin

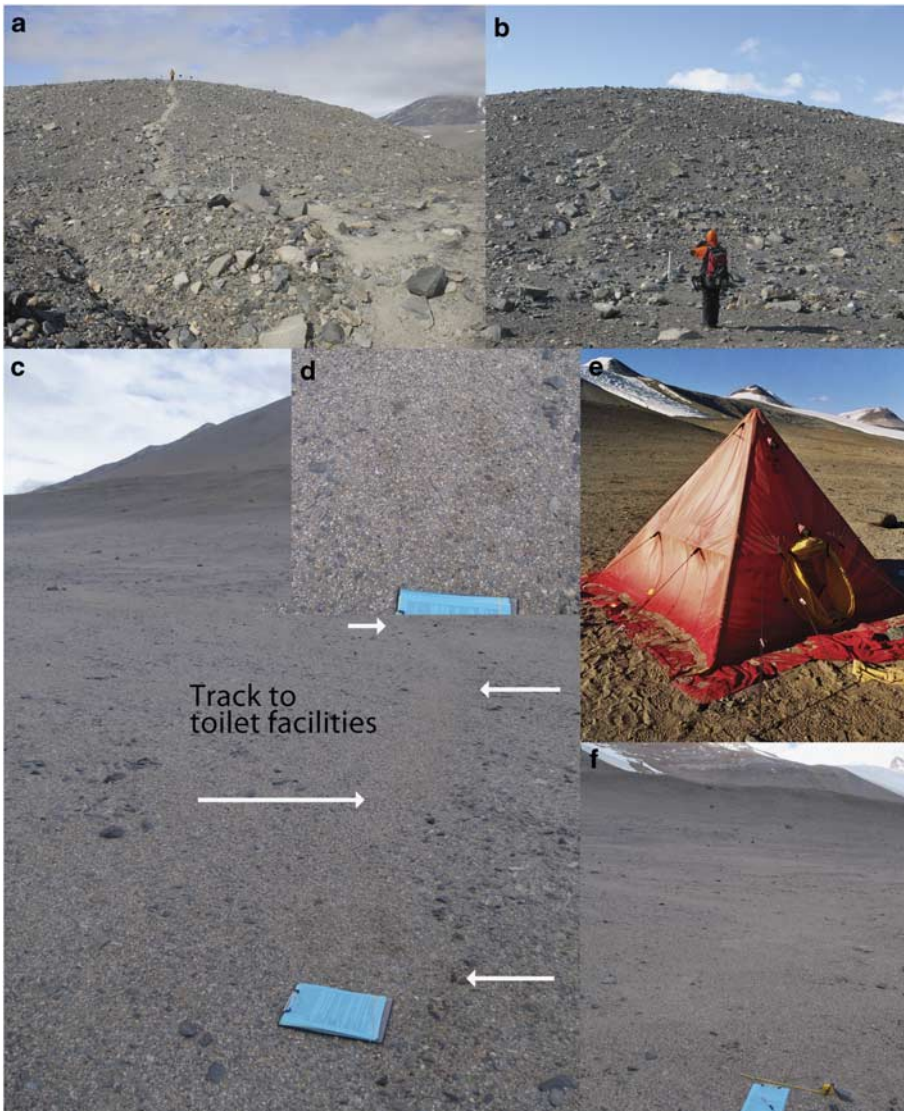
**Fig. 2.** Taylor Valley Visitor Zone and Loop moraine sites. **a.** Taylor Valley Visitor Zone, walking track from the helicopter landing site to the hilltop lookout, 2006/07 season, after 96 tourist visitors. Picture: Jana Newman. **b.** Walking track from the helicopter landing site to the hilltop lookout, December 2009, before first tourist group of the season. **c.** Loop moraine 2004/05 walking track to toilet, track margin visible (white arrows), after five years recovery, December 2009. **d.** Recovery of the desert pavement on the track surface, after five years. **e.** Loop moraine tent site, December 2004. Picture: Fiona Shanhun. **f.** Loop moraine tent site, five years later, December 2009.

At the Loop moraine campsite, the 2004/05 walking track between the tents and toilet facilities had abundant disturbed surface stones, and distinct surface texture change (Table IV). The ground surface had an indentation effect, the result of sorting of rock material and compaction of the inner part of the track (Fig. 2c & d). The walking track had a moderate colour contrast between the track and the adjacent undisturbed material, which is probably the result of the larger, and darker, dolerite rocks having moved to the outer margins of the track due to foot traffic (Fig. 2c). The visibly disturbed area was about 450 m<sup>2</sup> (300 m long x 1.5 m wide), and the foot track was clearly evident five years after the disturbance.

In contrast, at the Loop moraine campsite, the impacts around the tent site, caused by widespread random trampling (Fig. 2e), were undetectable (Fig. 2f). There were no visibly disturbed stones, no impressions of rocks removed, no boot imprints and no visible surface colour difference. In less than five years the desert pavement at the tent site showed visual recovery to pre-disturbance condition (Fig. 2e & f) and was visually indistinguishable

from the tent site to the toilet) would enhance the visual aesthetics by eliminating unnatural surface irregularities, and facilitate the visible recovery of previously disturbed desert pavement. Larger stones, such as those used to pin down tents at the Loop moraine campsite, must however, be replaced in original orientations with salt coated surfaces down and polished or weathered surfaces up, preferably in the indentations from which they were removed. The redistribution of disturbed rocks from vehicle and walking track margins was an effective means of remediation at the former Vanda station site (MRI of 90%), but needs to be undertaken with an understanding of the rock material's natural position in the environment.

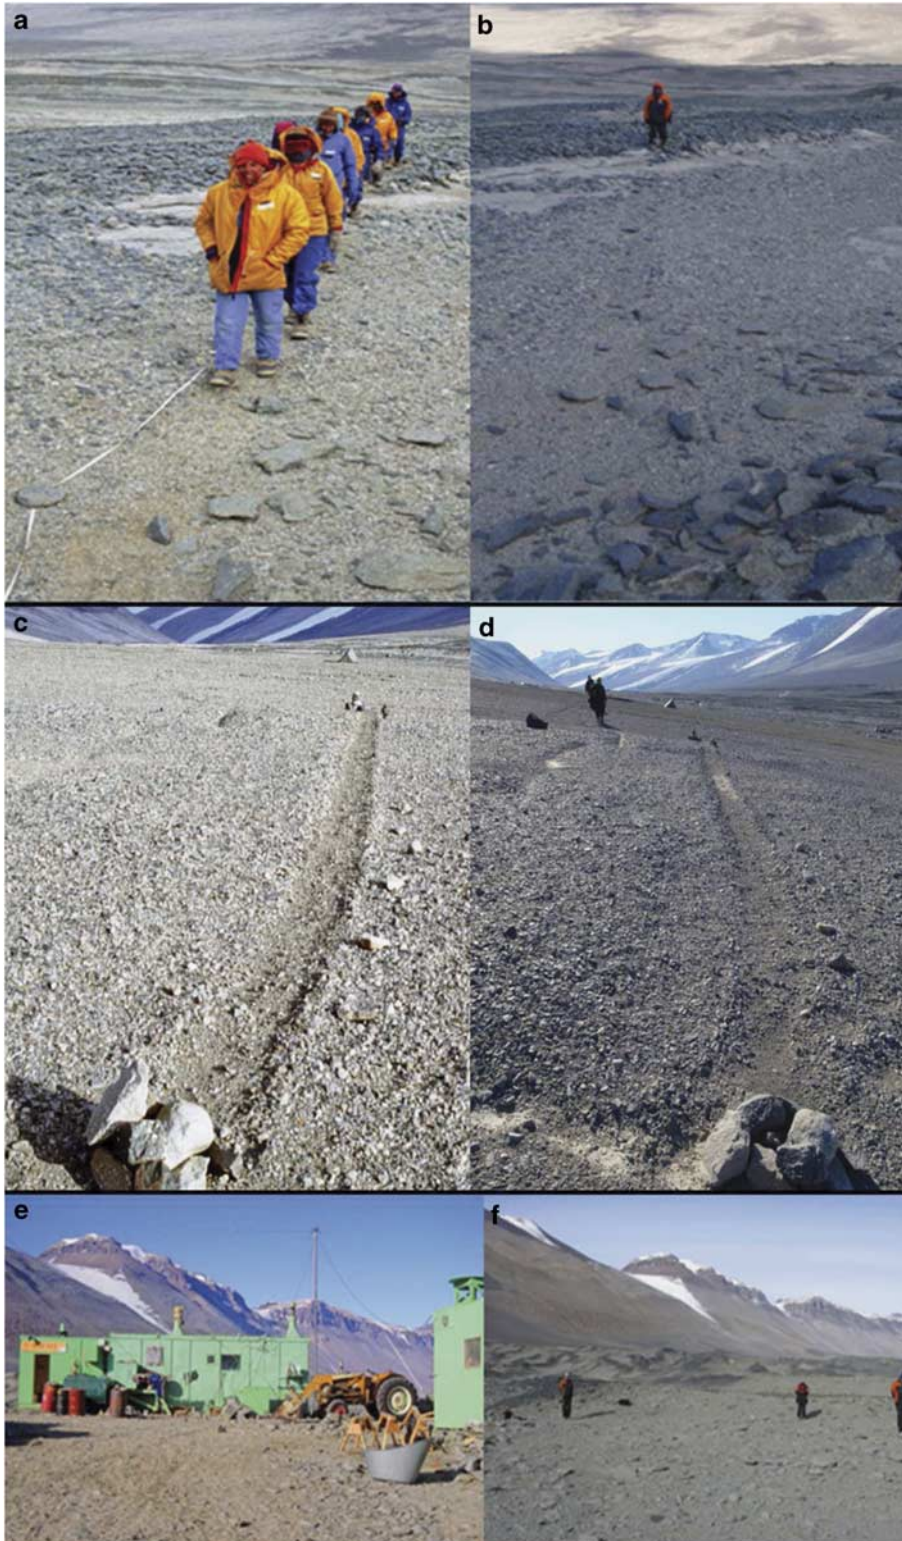
**Fig. 3.** Vanda experimental treading trial and former Vanda station sites. **a.** “Vanda Rocky” site, 192 passes, December 1993. **b.** “Vanda Rocky” site, after 17 years of recovery, December 2009. Note the “out of place” stones that were used to secure the measuring tape in December 1993. **c.** “Vanda Fan” site, immediately after 200 passes, December 1993. **d.** “Vanda Fan” site, after 17 years of recovery, December 2009. **e.** Vanda station, January 1992, immediately prior to removal. **f.** Site of the former Vanda station mess hut, December 2009. The three people are marking the corners of the former buildings.

Most impacts at the “Vanda Rocky” experimental treading site were minimal or non-existent (Fig. 3a & b). Only the “softer” mixed till sections, between the slabs of coarser granodiorite bedrock, showed traces of the track (Fig. 3b). There were some unnaturally positioned bedrock slabs lining the middle of the track which had been placed there to hold the measuring tape during the experiment. There were no impressions of removed rocks, no boot imprints, or salt deposits on the surface of the “Vanda Fan” and “Vanda Rocky” treading trial sites (Table IV). In contrast, the experimental walking track on the “Vanda Fan” site, formed on an alluvial fan comprising soft mixed till materials, remained an obvious feature in the landscape 17 years after the treading trial experiment (Fig. 3c & d). The “Vanda Fan” site had an abundance of disturbed surface stones, obvious stratigraphic disturbance, and a moderate surface colour contrast (Table IV). Whilst the desert pavement of the inner part of the track had partially recovered, the larger clasts which were once scattered

across the entire ground surface were concentrated along the margins of the walking track and the associated indentations persisted in the landscape (Fig. 3d). The “Vanda Fan” site was in an intermediate stage of visual desert pavement recovery (MRI of 62%), whilst the “Vanda Rocky” site, which had higher cobble to sand fraction and greater resistance to the original trampling impacts, was in an advanced stage of desert pavement recovery (MRI of 96%) (Table V). The visibly disturbed area of the “Vanda Fan” site was 20 m<sup>2</sup>, with 6 m<sup>2</sup> at the “Vanda Rocky” site.

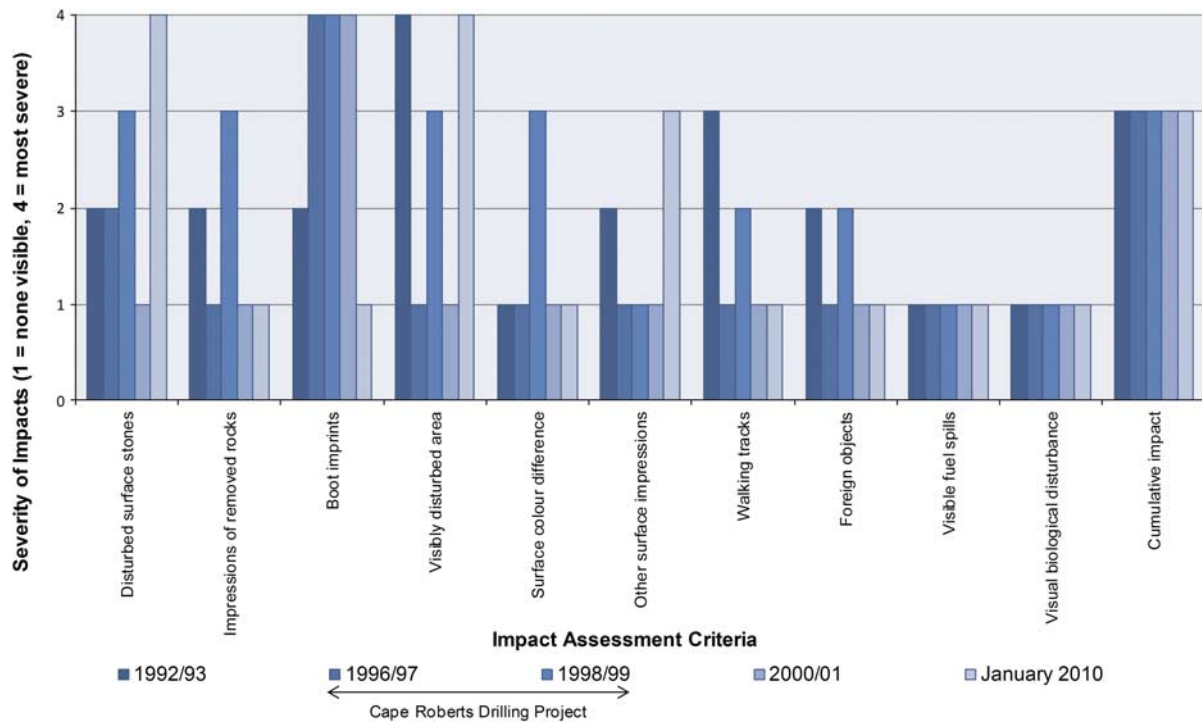
**Fig. 4.** Visual Site Assessment of Cape Roberts Project (CRP) “Northern Plot” monitoring site, pre-CRP (1992/93, after Campbell & Keys 1993), during CRP (1996/97 and 1998/99, after Waterhouse 2001), after remediation (2000/01, after Cowie 2001), and ten years after remediation (January 2010). Note: January 2010 control scores are not shown, however, each impact assessment criteria scored a one.

At the “Northern Plot” VSAs showed the site was overall in better condition in 2010 than in the pre-CRP baseline assessment in 1992/93 (Fig. 4). This probably reflects effective site cleanup and restoration in 1999/2000 and 2000/01. The Cape Roberts sites had been disturbed on numerous occasions prior to the commencement of the Cape Roberts Drilling Project. In 2010 there was an improvement in four impact assessment criteria, including, a decrease in impressions of removed rocks, boot imprints, presence of foreign objects, and evidence of formed walking tracks. Four criteria remained the same, and the evidence of cumulative impact remained consistent at  $> 100 \text{ m}^2$ . Mid-project 1996/97 and 1998/99 VSAs showed an increase in impressions of removed rocks, evidence of walking tracks, and foreign objects over the duration of the drilling project. The abundance of disturbed surface stones, and other surface impressions, shows only partial recovery to baseline 1992/93 condition (Fig. 4), with rehabilitation probably an ongoing process. The “Northern Plot” had an MRI of 88% (Table V).

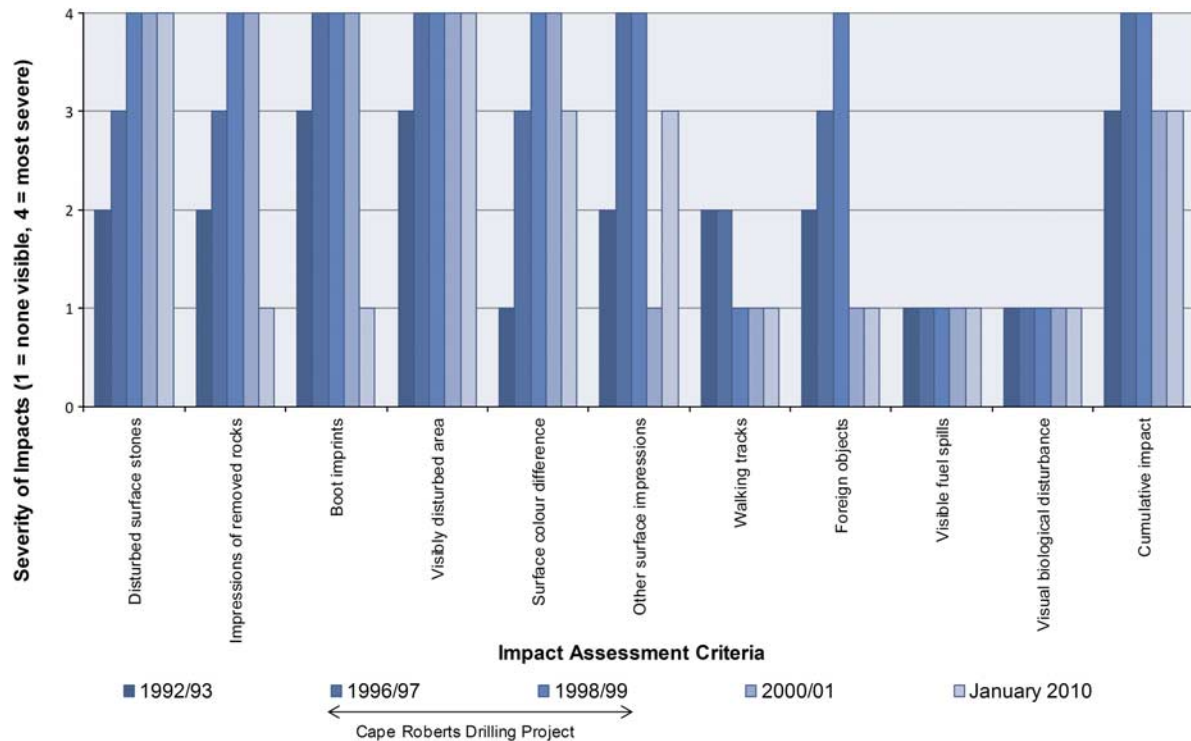
**Fig. 5.** Visual Site Assessment of Cape Roberts Project (CRP) “Southern Plot” monitoring site, pre-CRP (1992/93, after Campbell & Keys 1993), during CRP (1996/97 and 1998/99, after Waterhouse 2001), after remediation (2000/01, after Cowie 2001), and ten years after remediation (January 2010). Note: January 2010 control scores are not shown, however, each impact assessment criteria scored a one.

Visual impacts were consistently greater at the “Southern Plot” as it was the site where most vehicle and walking tracks were concentrated, and the location of the fuel rack and huts. The “Southern Plot” showed deterioration in some of the criteria re-assessed in 2010. There was a decline in four impact assessment criteria, including an increase in abundance of disturbed surface stones, and visibly disturbed areas, and evidence of other surface impressions, such as Hagglund vehicles tracks and helicopter skid marks (Fig. 5). Three impact assessment criteria remained the same, such as the extent of cumulative impact which remained consistent at  $> 100 \text{ m}^2$ , and four showed an improvement beyond the 1992/93 baseline assessment (impressions of removed rocks, boot imprints, evidence of walking tracks, and foreign objects). The surface colour contrast between the impacted site and the surrounding undisturbed material showed the greatest increase in the first few years of the project. Both the visibly disturbed area and cumulative impacts increased rapidly at the beginning of the CRP (see 1996/97 and 1998/99 VSAs, Fig. 5), and remained “severe” over the duration of the project. The 2010 assessment showed no obvious evidence of post-CRP environmental monitoring soil sampling pits, nor visible evidence of the removal of contaminated sand and gravel that was taken during remediation (Waterhouse 2001).
