SAFETY PERFORMANCE EVALUATION OF MICHIGAN'S 4X5 PORTABLE SIGN SUPPORT

MIDWEST ROADSIDE SAFETY FACILITY

MwRSF Research Report No. TRP-03-135-03

June 20, 2003

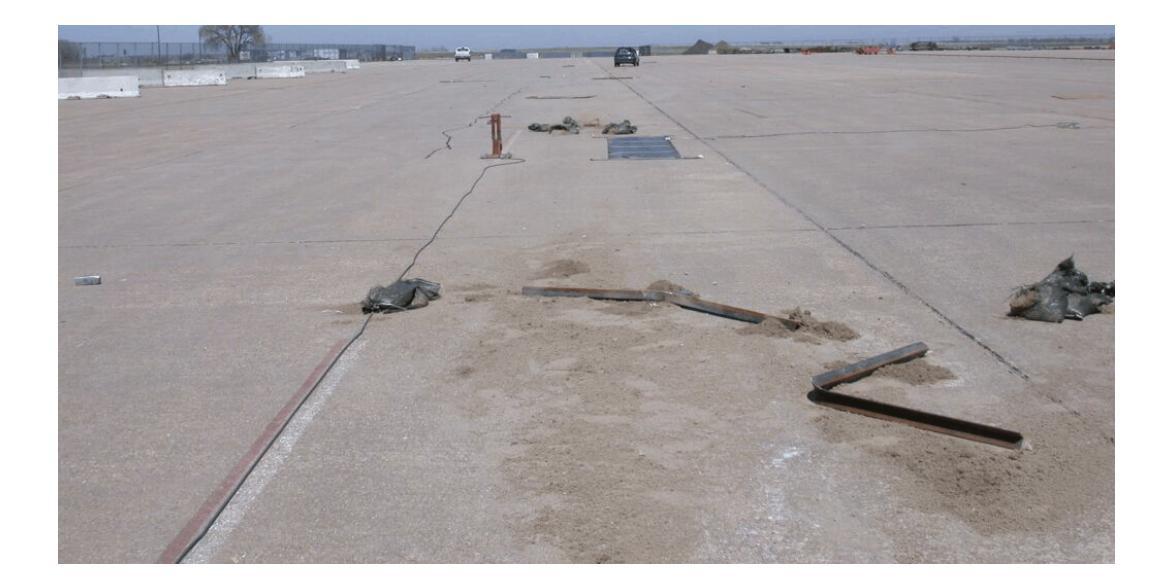
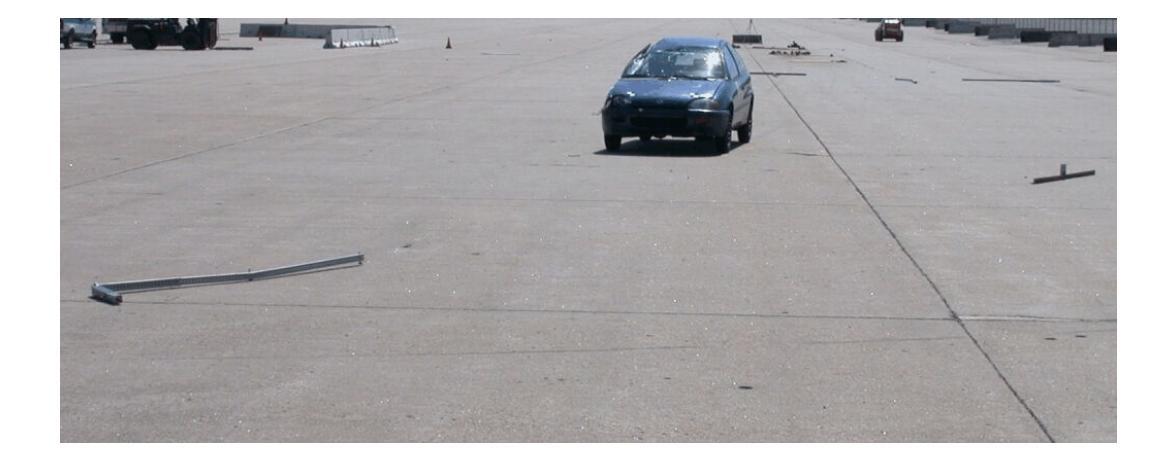
Figure 17. Overall Damage and Final Positions, Test MI-4

Damage to System Nos. 7 and 8 is shown in Figures 17 through 22. System No. 7 encountered moderate damage. Both legs disengaged from the masts. The impacted leg's vertical upright tube disengaged from the angle portion due to fracture of the welds. The disengaged vertical upright tube was deformed on the non-impacted side. Both legs' angles were deformed near their center points. The impacted outer tube and mast were deformed at bumper height and near the lower panel bolts and also fractured near bumper height. The non-impacted outer tube and mast were deformed near the lower panel bolts. The sign panel disengaged from both masts and the panel bolts.

System No. 8 encountered moderate damage. The right mast, outer tube, and leg remained attached, and the mast and outer tube encountered minor deformations. The left leg disengaged from the mast and was undamaged. The left mast and outer tube were deformed near the center of the outer tube. The sign panel disengaged from both masts and the panel bolts remained attached to the masts. The sign panel encountered moderate deformations on all edges. The sign panel also deformed at each of the four panel bolt holes and was slightly torn at the bottom right hole. All eight of the sandbags were torn open with the sand scattered along the path of the vehicle, starting at the initial position of the second sign support.

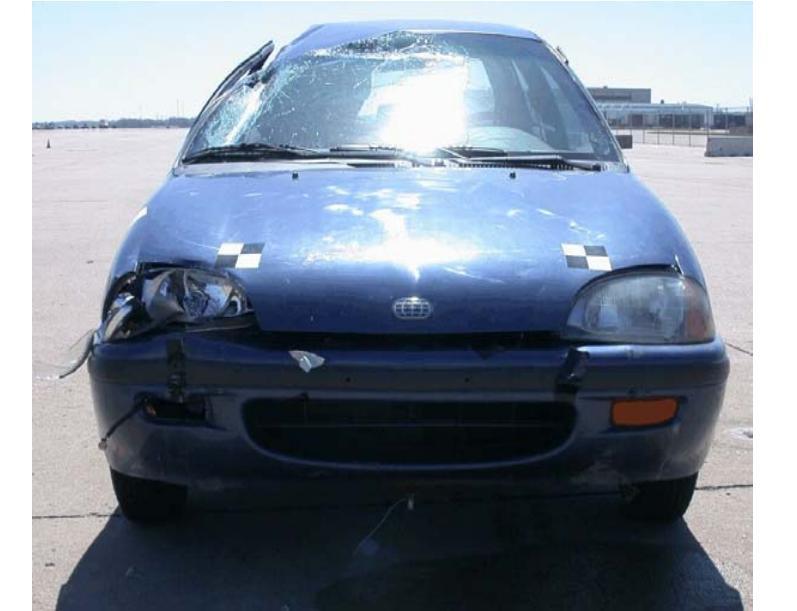
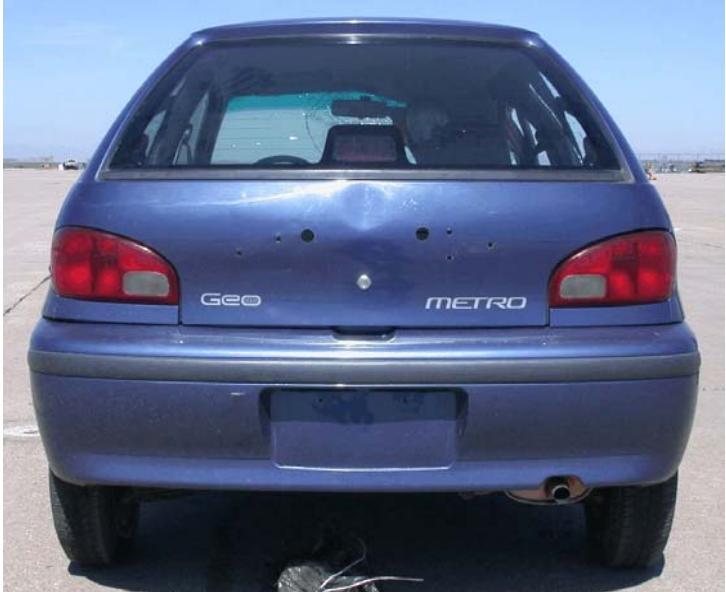
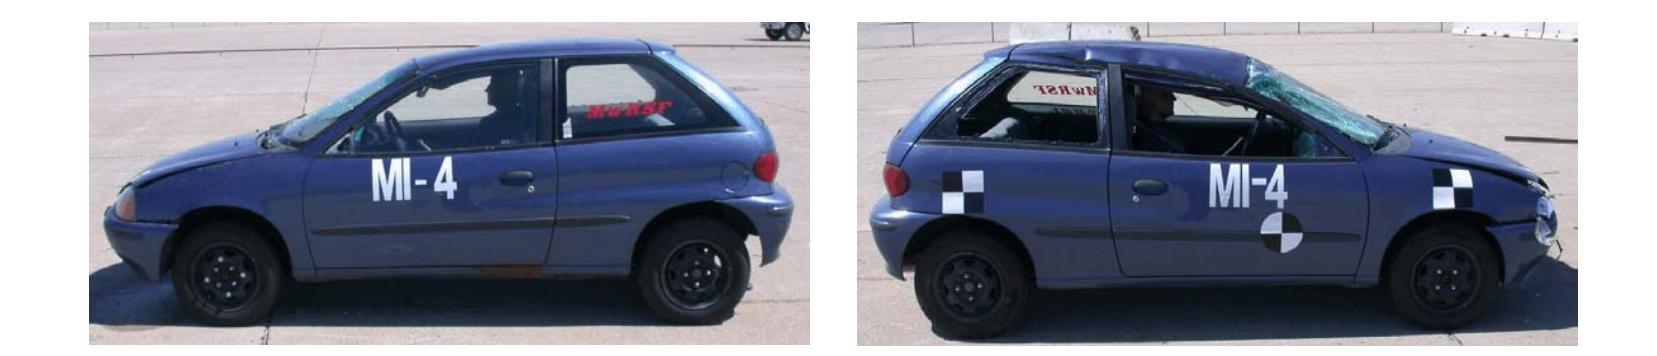
Figure 23. Vehicle Damage, Test MI-4

Exterior vehicle damage is shown in Figures 23 through 25. The front bumper and lower plastic shield encountered minor dents and contact marks. The hood encountered minor scuff and scrape marks. The right side of the roof encountered major indentation (maximum of 133 mm) and subsequent penetration. The right-side A-pillar was crushed extensively in toward the occupant compartment. The roof also sustained scuff and scrape marks. The right-side headlight and park light broke, while the left-side park light was cracked. The right-side door and right-rear windows were shattered. The windshield sustained major "spider web" cracking throughout, with both layers of the right-side and upper-middle regions of the windshield being cracked. Most of the structural

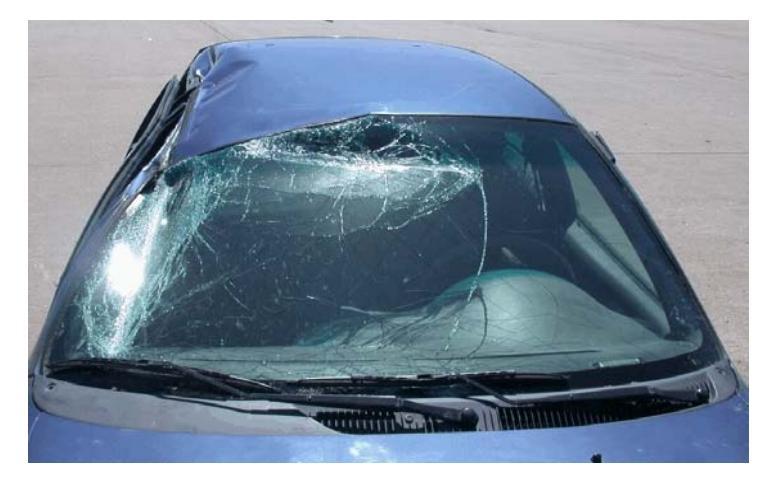
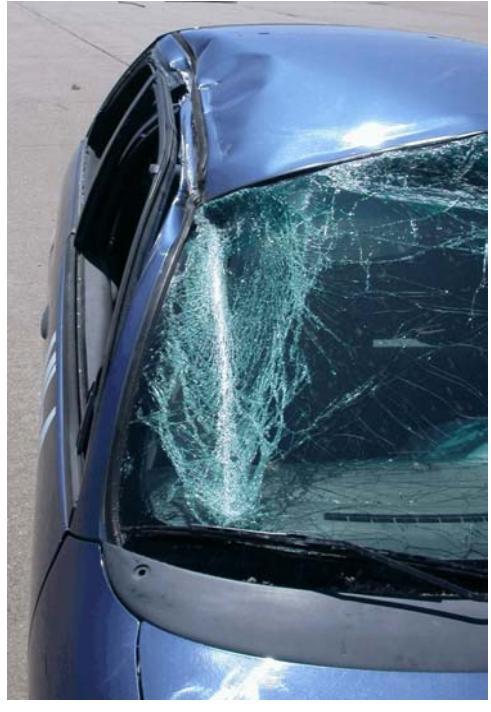
Figure 25. Windshield and Roof Damage, Test MI-4

integrity of the windshield on the right side and upper middle was lost and the windshield indented inward toward the occupant compartment. A large hole (slice) through the windshield was located near the center region of the right side. No damage was found to have occurred to the left side, rear end, left-side headlight, nor parking lights.
