REVISTA DE METALURGIA, 44 (5) SEPTIEMBRE-OCTUBRE, 398-405, 2008 ISSN: 0034-8570 eISSN: 1988-4222 doi: 10.3989/revmetalm.0734

Antifouling effect of two saturated copper coatings applied on carbon steel structures^(•)

P. S. Guiamet*,** y S. G. Gómez de Saravia*,***

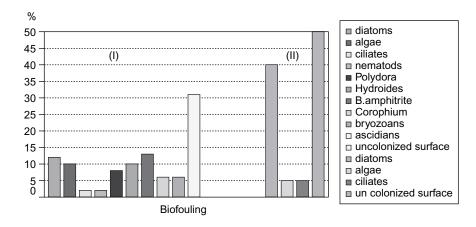
In the case of panels covered by the copper coating, only high levels of aerobic heterotrophic bacteria biofilm were detected for both monthly and accumulative six month exposure (Tables II and III). The presence of this biofilm could favor the adhesion of macofouling organisms in a period longer than six month. Neither fungi nor yeast were detected in either cases. After the six-month immersion, numerous macrofouling and microfouling species were observed in the control panel. This panel was dominated by solitary ascidians, which in turn provided suitable substrate for the settlement of other organisms such as algae (Enteromorpha sp. and Ectocarpus sp.), bryozoans, and tubeworms, as well as facilitating sediment deposition. Some barnacles, other bryozoans, and sand tube building worms were also recorded on the surface of the panel (Fig. 5).

Figure 5. Cover percentage on control panel (I) and panel covered by saturated copper coating (B) (II) (6 months of immersion).

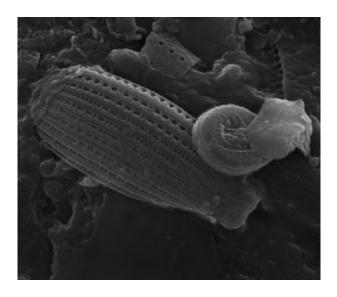
including different species of diatoms, as corroborated by SEM (Fig. 6).

Figure 6. SEM micrograph showing diatoms corresponding to a panel with copper layer (B). (third month of immersion) X 3500. Image wide 18.08 µm.

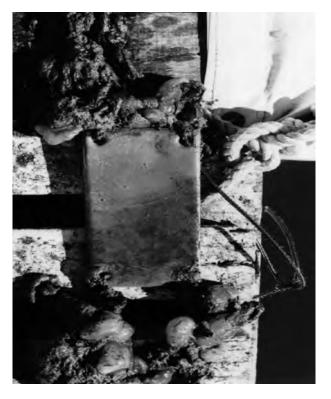
The panel covered with copper coating (B) did not show macrofouling. Microscopic examination showed only a thin film dominated by a few diatom species on the lower half of the panel (Figs. 5 and 7). Although this cover is similar to (A), its good performance was due to the fact that it was handexpread and no copper leaching was observed.

Figure 7. Panel covered by saturated copper coating (B) after six month of immersion.

The panel covered with saturated copper coating (B) showed good antifouling performance after six months of immersion. This is evidenced by comparing the heavy fouling registered on the control panel vs. the thin film of microfouling organisms registered on this copper-coated panel. Nevertheless, both the samples with saturated copper coating (B) and the control showed important adherence of heterotrophic aerobic bacteria. This could favor the adhesion of macrofouling organisms in a period superior to the 6 months of this study. Future investigations will assess the progress of colonization during longer periods.
