Željko Domazet<sup>1</sup>, Francisko Lukša<sup>1</sup>, Lovre Krstulović-Opara<sup>1</sup>

# Failure analysis of the rolls with grooves

<sup>1</sup>Faculty of Electrical Engineering, Mechanical Engineering and Naval Architecture; University of Split; Split, Croatia

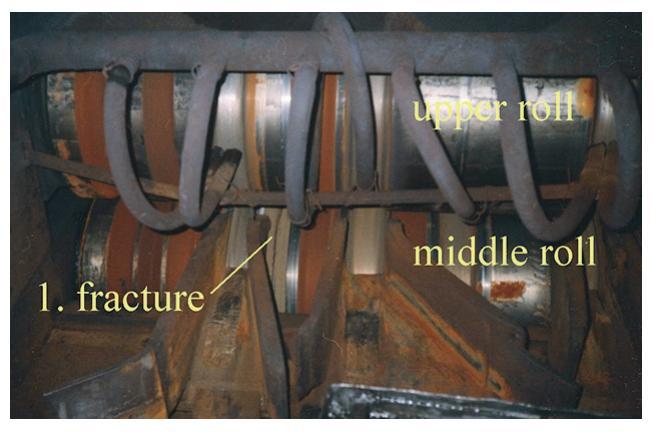
Fig. 3. Position of 1<sup>st</sup> fracture (back side of the stand)

The first roll (middle roll) broke after 13 hours of operation. Figure 3 shows the position of the 1<sup>st</sup> fracture.

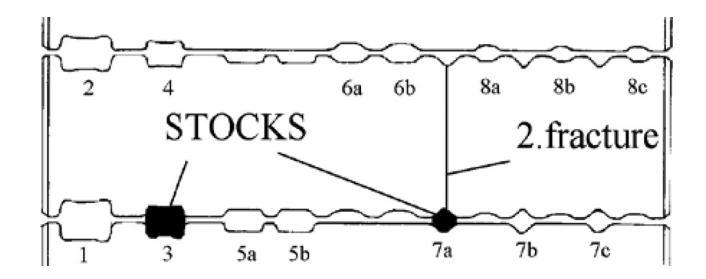
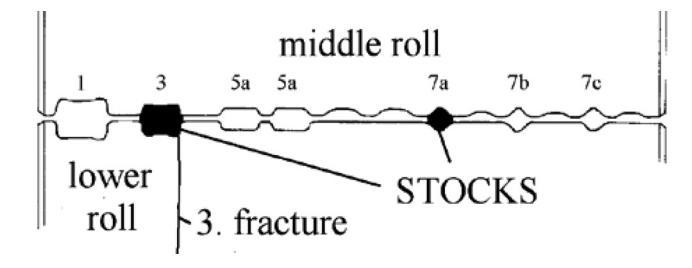
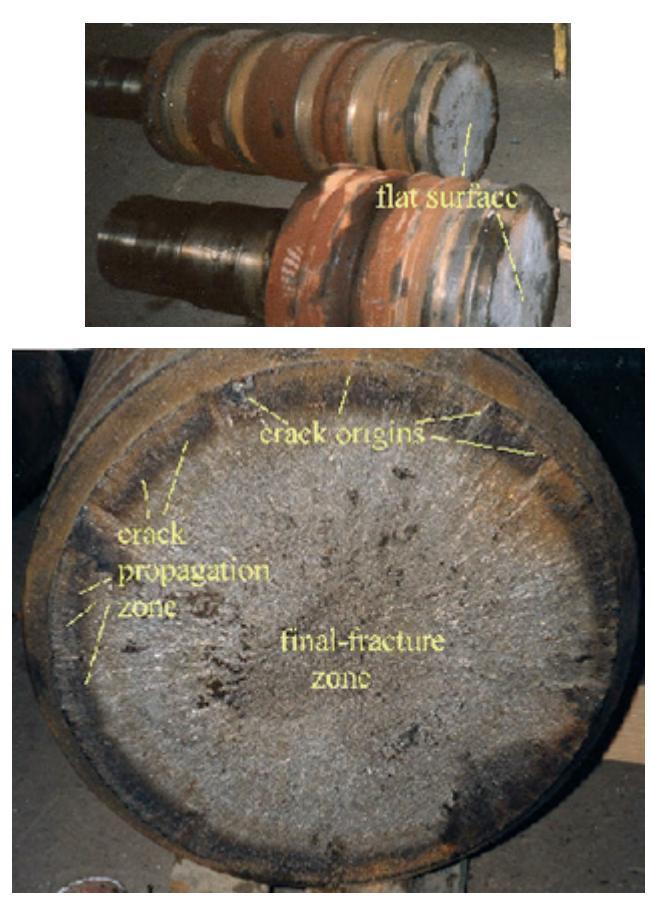
Fig. 5. Fracture surfaces of the  $2^{nd}$  broken roll and the position of the stocks at the time of the fracture

dressing. Figure 5 shows the fracture surfaces of the  $2^{nd}$  broken roll with the position of the stocks at the time of the fracture.

Visual examination of the fracture surfaces of the 1<sup>st</sup>, 2<sup>nd</sup> and 4<sup>th</sup> broken roll revealed three fracture regions as shown in Fig. 4, Fig. 5 and Fig. 7: crack origin zone on the periphery, crack propagation zone and final fracture zone. The fracture surfaces of the 2<sup>nd</sup> and 4<sup>th</sup> broken roll were flat while the fracture surface of the 1<sup>st</sup> broken roll was curved. No surface irregularities and no fire cracks were present in the fracture surfaces and around the fracture surfaces on the surface of the grooves. The appearance of the fracture surfaces and around a lobending from rotation-al-bending loading with a high stress concentration.

- Change of the roll designs and groove distributions according to the pass schedule.
- To install the devices for the control of the rolling temperature during the whole rolling process.
- Change of the safety parts design.

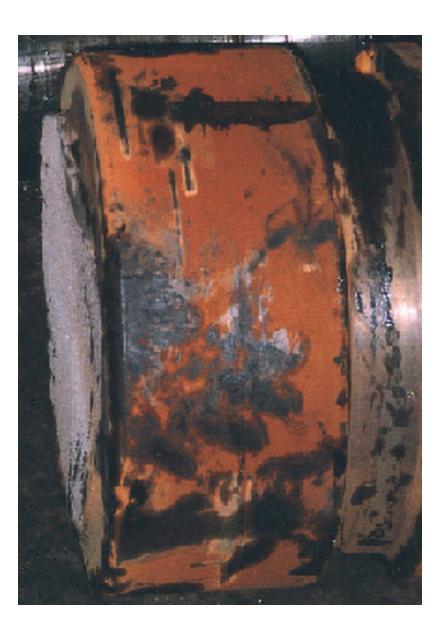
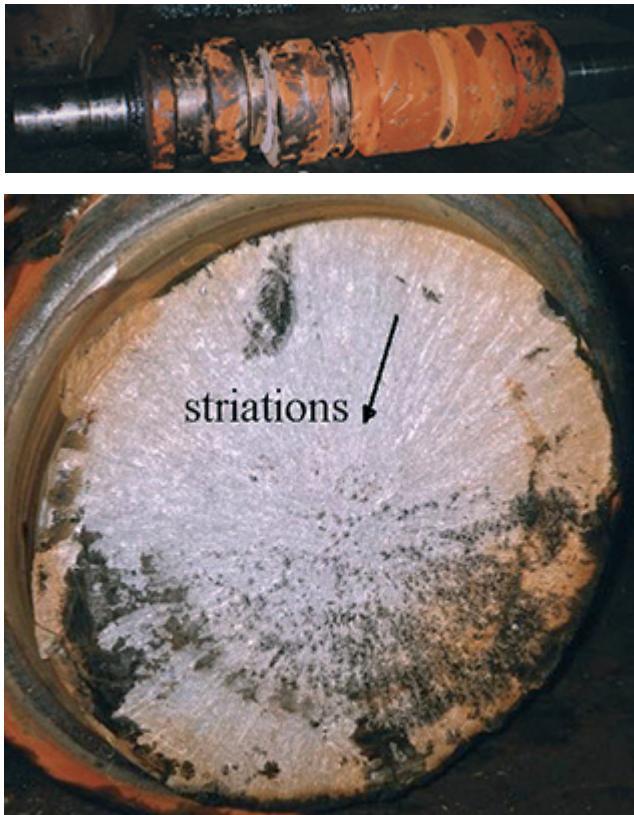
**Fig. 6.** Fracture surfaces of the 3<sup>rd</sup> broken roll and the position of the stocks at the time of the fracture

The third roll (lower roll) was dressed two times, after 4000 rolling tons and then after 8000 rolling tons. This roll broke after a short time of operation after the second dressing. Figure 6 shows the third broken roll and the fracture surface with the position of the stocks at the time of fracture.

Visual examination of the fracture surface of the 3<sup>rd</sup> broken roll revealed only one fracture region with rough striations from the surface to the centre of the roll. The appearance of the fracture surface of this roll suggested that the fracture occurred rapidly due to overload by dynamic impact.

The bending overload was the result of the decreasing rolling temperature due to technological stops.

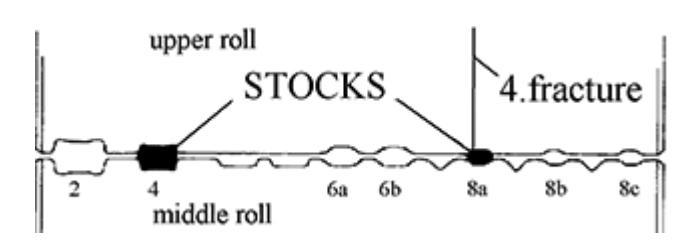
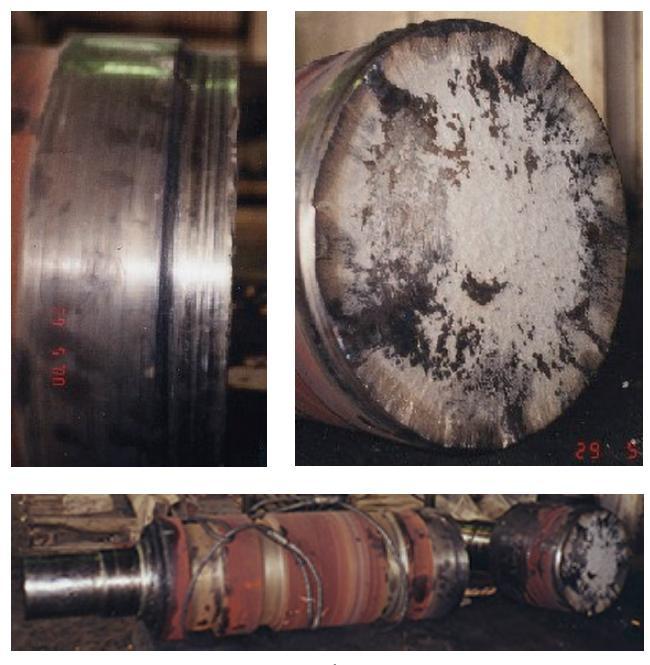
Fig. 7. Fracture surfaces of the 4<sup>th</sup> broken roll and the position of the stocks at time of the fracture

The fourth roll (upper roll) was dressed after 4500 rolling tons and broke after 568 rolling tons after dressing. Figure 7 shows the fourth broken roll and the fracture surface with the position of the stocks at the time of the fracture.

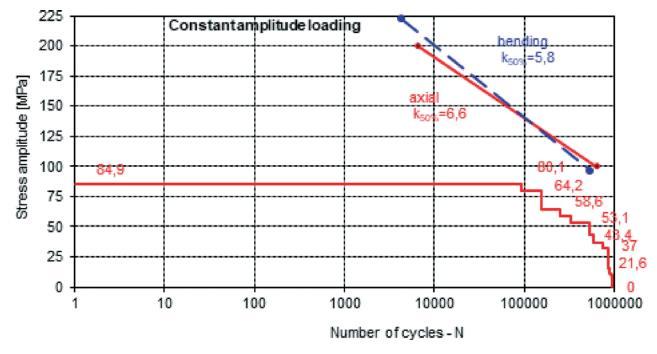
Fig. 13. Fatigue strength of the roll material and stress spectrum in the critical area for 4000 rolling tons

This diagram reveals that failures should be avoided in normal service without overloads.

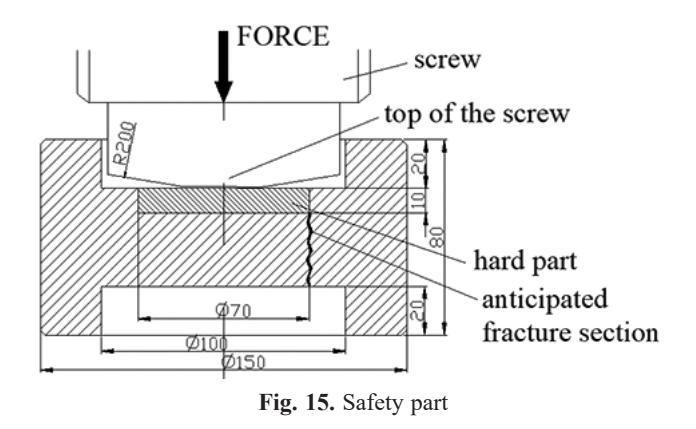
The rolls are protected from bending overload with the safety parts (Fig. 8). In case of the bending overload, one (or both) safety part has to fail before the failure of the roll. The material used for safety parts was flake graphite iron GG20 according to DIN. Figure 15 shows the safety parts design.

Analysis of safety parts design showed that the safety parts have to fail if the rolling temperature is 900°C.

In all cases of the roll failures, the failure of safety parts did not occur.

Safety parts, designed to prevent failure of the rolls, did not perform their function.
