PROCESS TESTING AND IMPROVEMENT OF TAPPING MACHINERY
AT LISI AEROSPACE

A Senior Project submitted
As part of the Requirements for the Degree
Of Bachelor of Science in Industrial Engineering

By:
Michael James Hester
March 2015

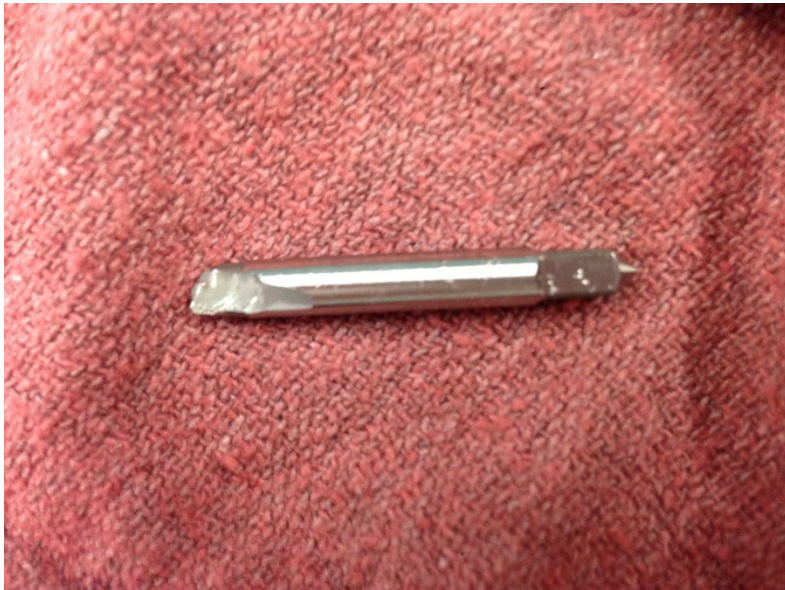
Figure 1: A broken tap due to incorrect tap replacement

The photo above in Figure 1 is one of the end results of the experiment; both pictures and an explanation of what went wrong. This data will be compiled so that management can decide if extending tap life is feasible.

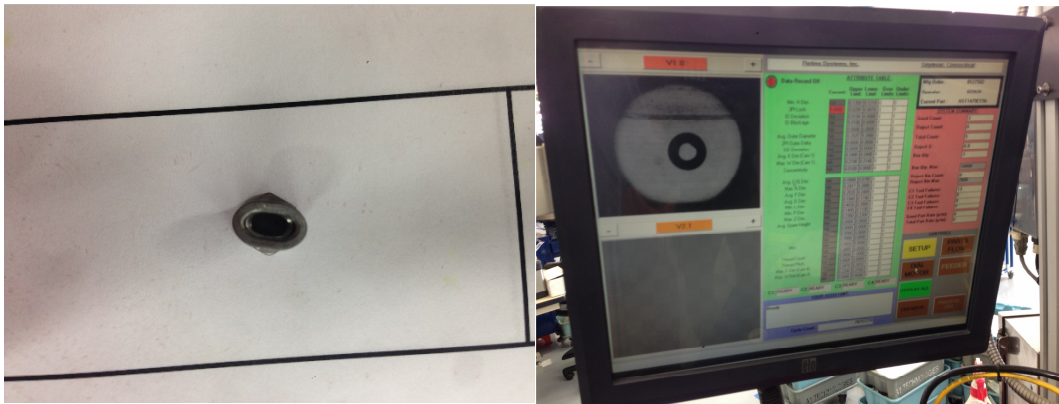
Figure 4: Broken part

Figure 5: Visual inspection machine display

100% visual inspection would have caught this error and insured that only good parts are coming into the tapping area to be processed.
