## Chen, Meng-Yi; Chu, Jyh-Cheng Scour Monitoring Around the Breakwater Head at Mailiao Harbor

## SCOUR MONITORING AROUND THE BREAKWATER HEAD AT MAILIAO HARBOR

Key Words : breakwater, field measurement, bed topography, Mailiao harbor, equilibrium scour depth

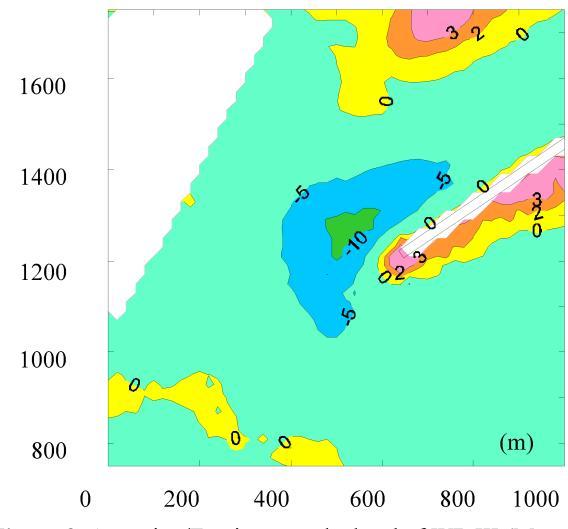
Figure 3 Accretion/Erosion near the head of WB III (May 2001-March.1996)

Figure 3 shows that in May 2001 just after the construction of WB III was completed a scour hole with maximum scour depth to 12m was formed at about 125m away from the head of the breakwater, 45° from the extended centerline of the breakwater when measured clockwise. Figure 4 shows that in April 2004 the scour extent enlarged both in the northern and southern direction with the maximum scour depth of 25m and the center of scour is about 215m away from the head, 75° from the centerline.

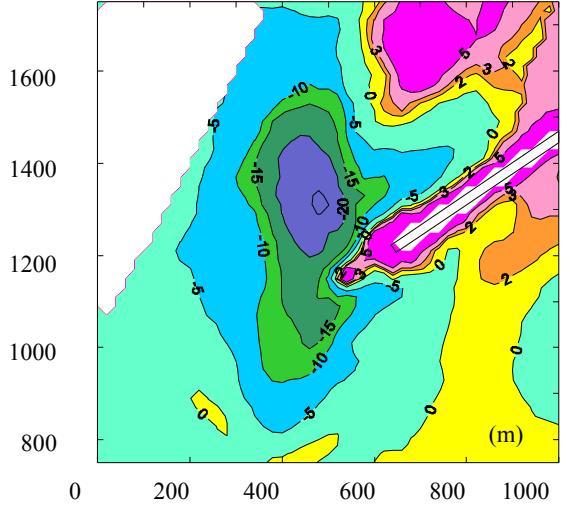
Figure 5 Accretion/Erosion near the head of WB III (April 2005-March.1996)

compared with March 1996. It can be seen from figure 5 the appearance of the submerged breakwater. The reason why a boulder like topography appears at the location of the submerged breakwater is due to bad construction conditions. Figure 6 shows that in May 2006 the extent of the sour hole is reduced significantly. The maximum scour depth was reduced about 4m and the location was moved southward along the submerged breakwater.

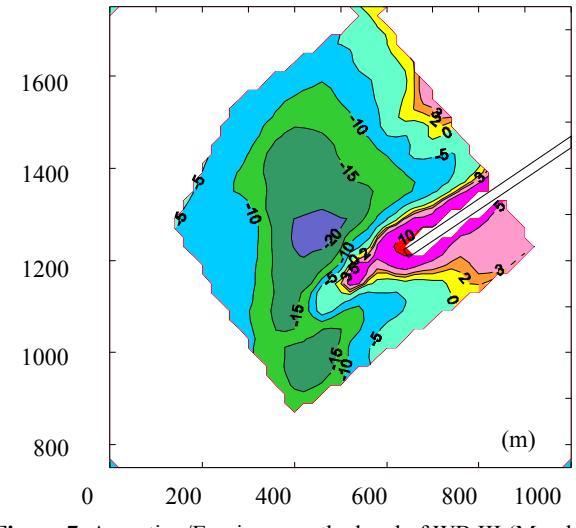
Figure 7 Accretion/Erosion near the head of WB III (March 2007-March.1996)

Figure 7 and figure 8 show that in March 2007 and in August 2007, after the completion of submerged breakwater, the scour hole is gradually

increasing its extent with the width of the region where scour depth is greater than 20m widened from about 100m to 250m, and maximum scour depth of 25m is approximately equal to the maximum scour depth in April 2004.
