# Two mid-19th-century Chinese lacquered folding screens still in use – Research and conservation

## JOHANNE BORNEMANN MOGENSEN\*

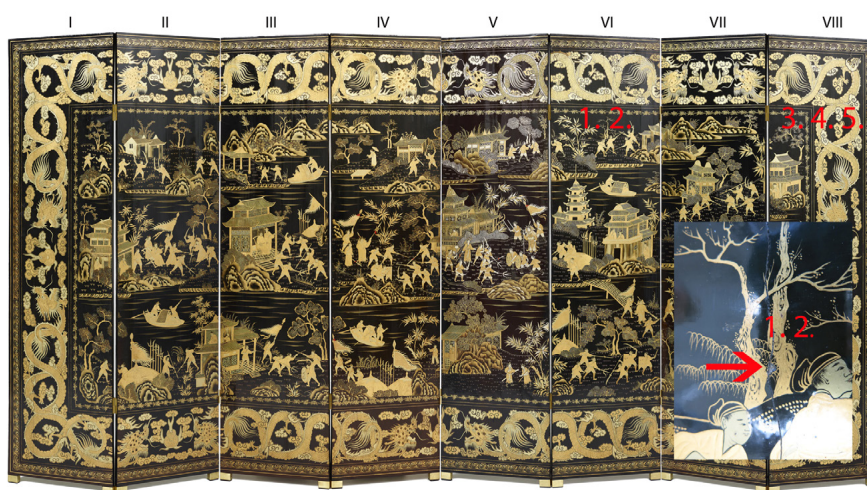
**Figure 1.** The front of screen A before conservation. The lacquer and decoration on section V is a later reconstruction and therefore has a marked colour difference. The red numbers and likewise in Figures 2 and 3 designate sample areas (Table 1)

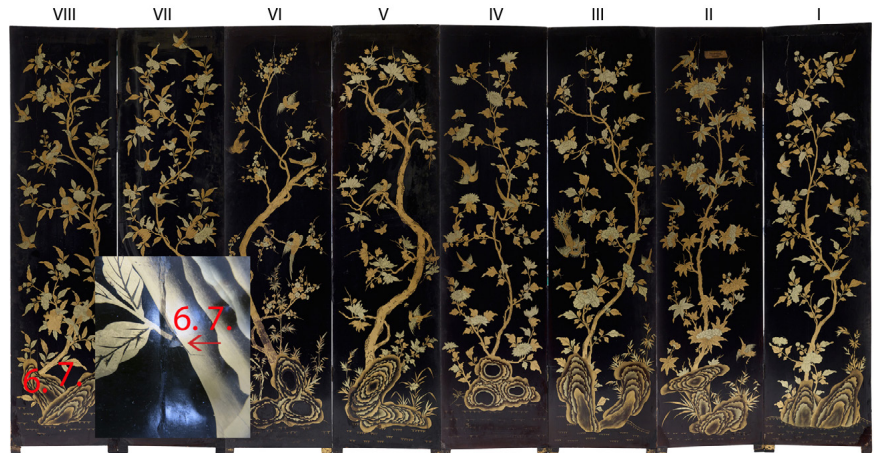
**Figure 2.** The reverse of screen A with the highly decomposed lacquer surface before conservation

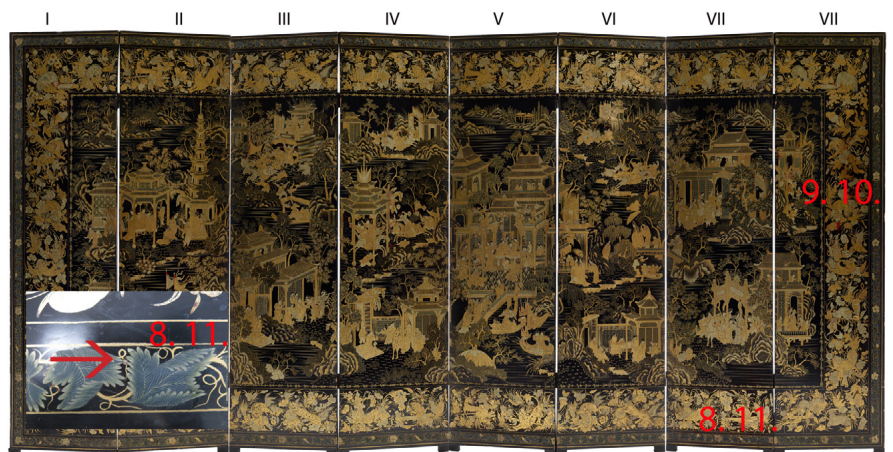
**Figure 3.** The front of screen B

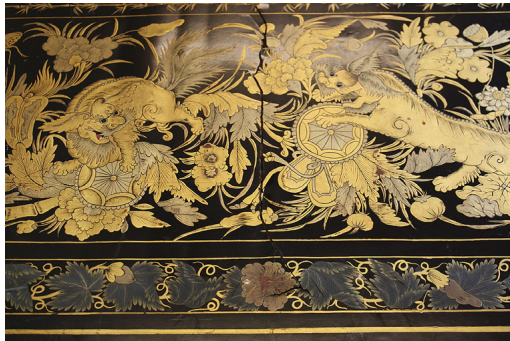
**Figure 4.** Example of a crack in the lacquer layers on screen B caused by shrinkage of the wooden core and separation of the joints

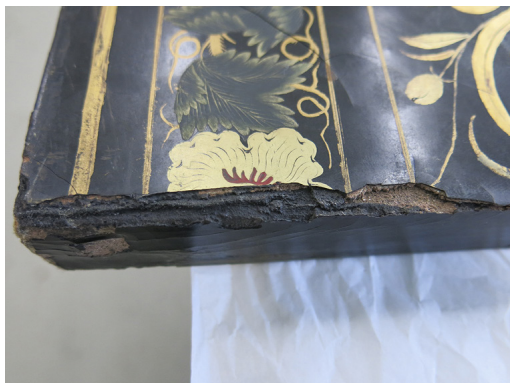
**Figure 5.** Screen B: loss caused by deformation in the wooden section frames and following repeated collisions with the neighbouring section

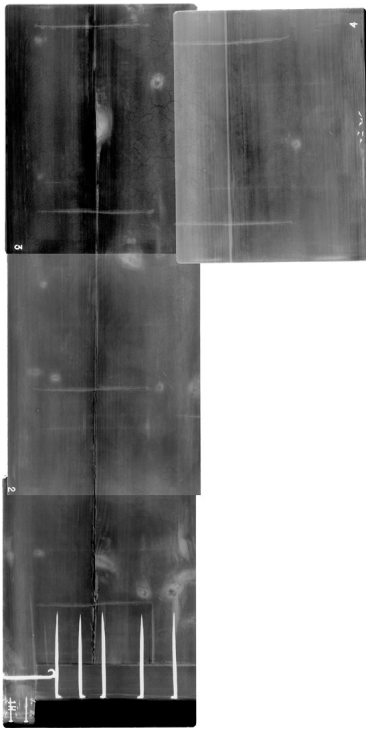
**Figure 6.** Composite x-radiograph of the lower left corner of screen A, section VIII, seen from the front

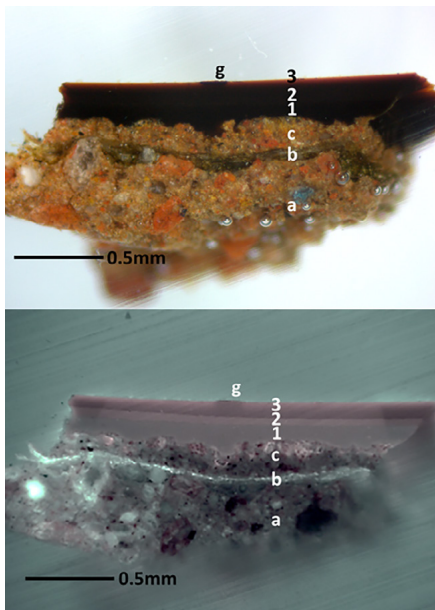
**Figure 7.** Cross section from screen B seen in darkfield (top) and UV-fluorescence (bottom): a, c = ground layers; b = intermediate paper layer; 1, 2, 3 = lacquer layers; g = gold decoration. The structural organisation on the two screens is similar
