## Analysis Of Trees Damaged From Flooding And Ice In Columbus, Nebraska

AN UNDERGRADUATE THESIS

With the Emphasis of: Urban Forestry

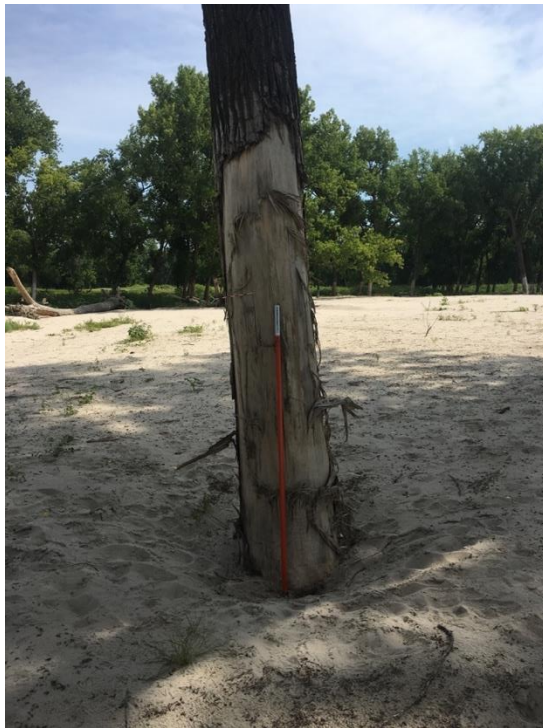
The flow of the water was moving northeast, and therefore the damage on the trees was seen on the south and west sides of the trunks. Figure 1 shows the kind of damage that was created due to ice rubbing against the bark and sand being displaced from the river.

*Figure 1. Ice damage on the southwest side of a cottonwood.*

deficiency; these trees should be watched in the years to come to determine if treatment is necessary. All of the trees that have scarring from the ice in the flood should be monitored for signs of declining health. This can be determined by examining the new growth on the twigs to see if it has grown less than previous years. Foliage is also a good way to determine the health of a tree. If the leaves are abnormally small or discolored, this could be a symptom of declining health.

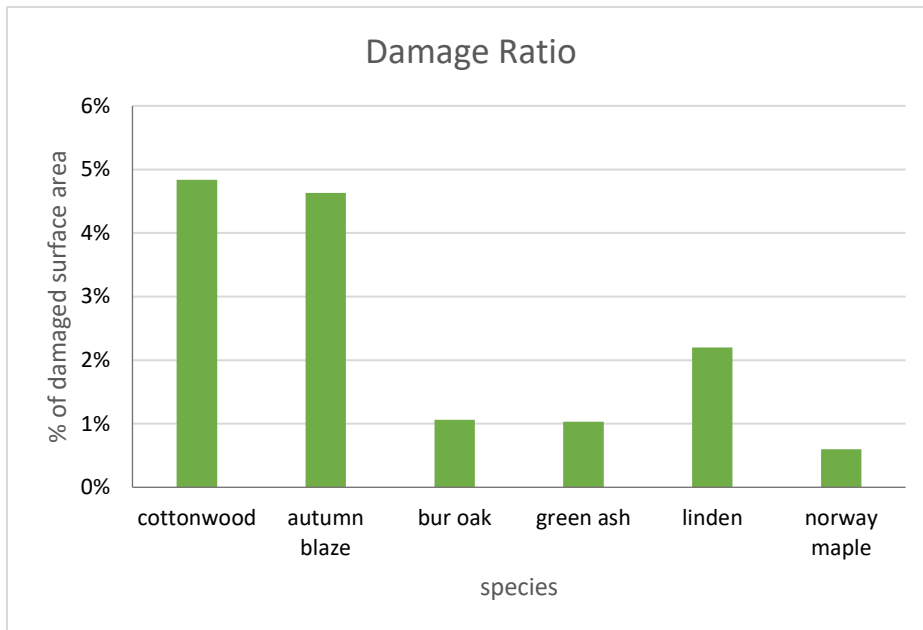
*Chart 1. Damage ratio by species*

To calculate the percentage of the tree that had damage, the surface area of the tree was estimated using the height and circumference at breast height. Although circumference changes with height of the tree, this consistent calculation allowed an estimation of trunk damage. The average damage ratio is broken down by species in Chart 1.

The amount of damage seen on each species is consistent with Justin Evertson's list of trees susceptible to ice damage in Nebraska. The cottonwoods endured the most amount of ice damage. This could be due to their high susceptibility to storm damage or the fact that these trees were closest to the river bed. Autumn blaze maples, which are a hybrid between red and silver maples, experienced quite a lot of damage, whereas the Norway maples resisted most of the damage. This observation lines up with Evertson's list, as well. The green ash trees resisted damage unusually well, but this could be due to the location and distance from the river bed and protection from surrounding trees.
