EEA Conference & Exhibition 2008

An investigation of excessive corona on a new 275kV line

Dr. Stewart Hardie, Dr. Alan Wood and Prof. Pat Bodger Electric Power Engineering Centre (EPECentre), University of Canterbury, Christchurch, New Zealand

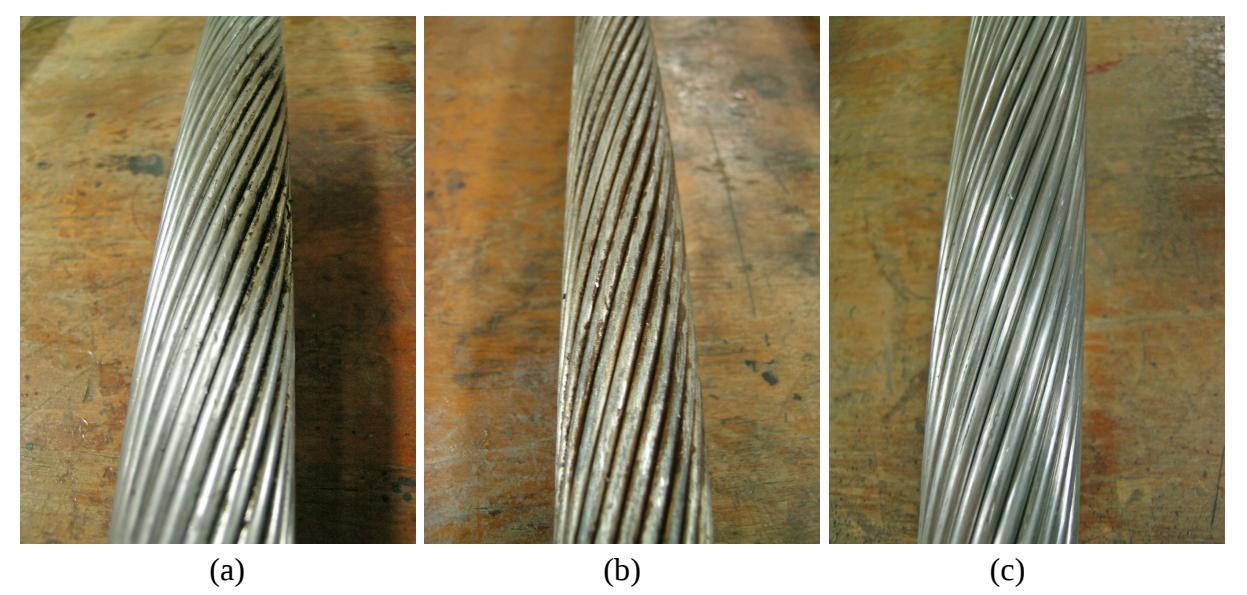
Figure 2 – (a) 'New Olex', (b) 'Used Midal Bungama' and (c) 'New Midal other project'.

The 'New Olex' surface had an oily feel. One side of the conductor had patches of black, dirty grease between the strands. The strands were otherwise clean, smooth and shiny. There were a few minor scratches and nicks on the outer strands. Internally, clean grease appears to be present on all conductors except the outer layer. This conductor is shown in Figure 2(a).

The 'Used Midal Bungama' had an oily feel, but dryer than the 'New Olex' conductor. There were a lot of dirty greasy patches that generally felt dry, and were mostly between the outer strands, but also right around the strands in places. There were a reasonable number of minor scratches on the outside of the outer strands, removing the shiny look. There were no lumps present, as seen on the live conductor at Bungama by EPECentre staff (described later in this paper). Unfortunately, it also appeared handling and packaging had removed some of the dirt and grease from the outside of the conductor. Internally, clean grease appeared to be present on all conductors except the outer layer. This conductor is shown in Figure 2(b).

The 'New Midal other project' conductor was generally clean, non-greasy and shiny all around. There was no dirty grease seen between strands. There were some minor scratches and nicks. Internally, clean grease appeared to be present on all conductors except the outer layer. This conductor is shown in Figure 2(c).

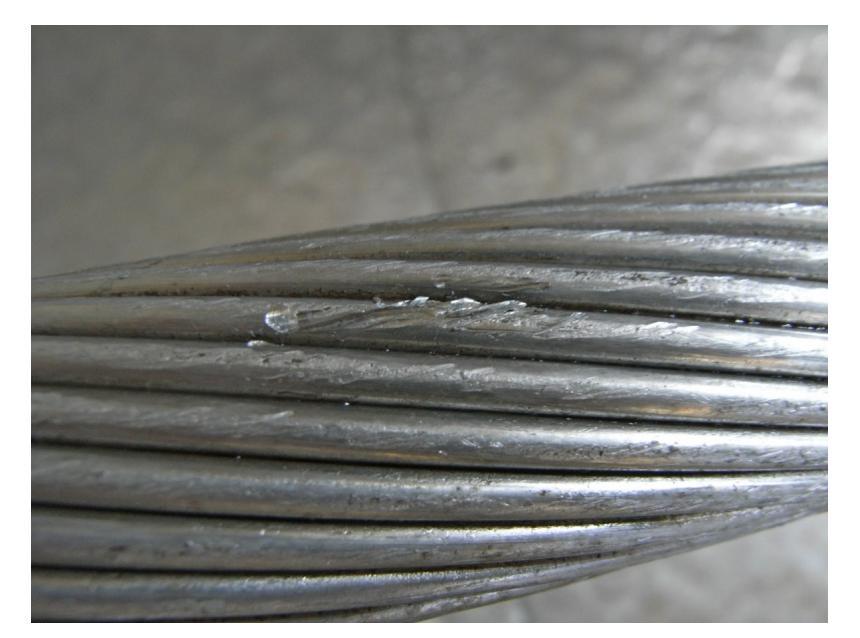
Table 5 shows the results of the HV tests on the three conductors. In addition, corona flares were particularly apparent from scratches such as the one in Figure 4.

Figure 4 - 'Used Midal Bungama' conductor with a jagged scratch which corona flared from.

The used conductor supplied showed evidence of rough handling, with significant surface scratches. It is unknown if this was a result of the line stringing process, or from the decommissioning of a span for sample testing. However, scratches and scrapes on the conductor surface are a very significant source of corona, and should be minimised when the line design results in high surface voltage gradients.

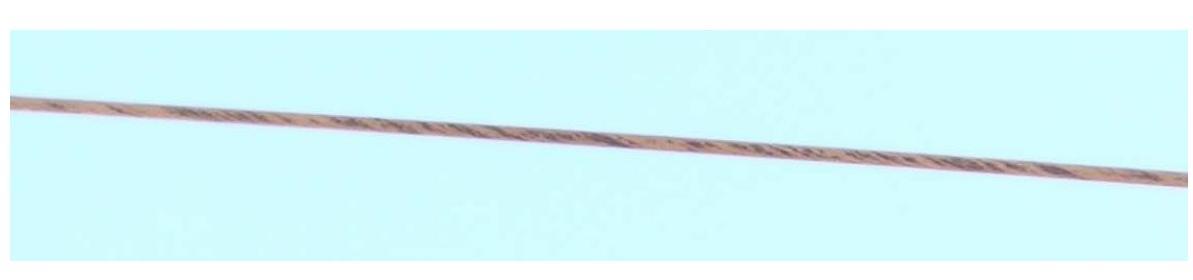
Standing under the HV lines of the new Bungama line, a loud coronal buzzing noise could be heard coming from the transmission line. It was far higher than any level of coronal audible noise that the authors have heard from any HV power line, especially considering the dry, warm conditions. A black surface layer appeared to cover up to 50% of the conductor, in a patchy fashion. The coronal noise appeared to come from all sections of the transmission line. Figure 8 shows the black substance diagonally aligned with the strands of the conductor, suggesting that it has been sourced from within the conductor rather than being applied from an external source.

Figure 8 – Bungama transmission line conductor with a black substance apparently being emitted between strands.

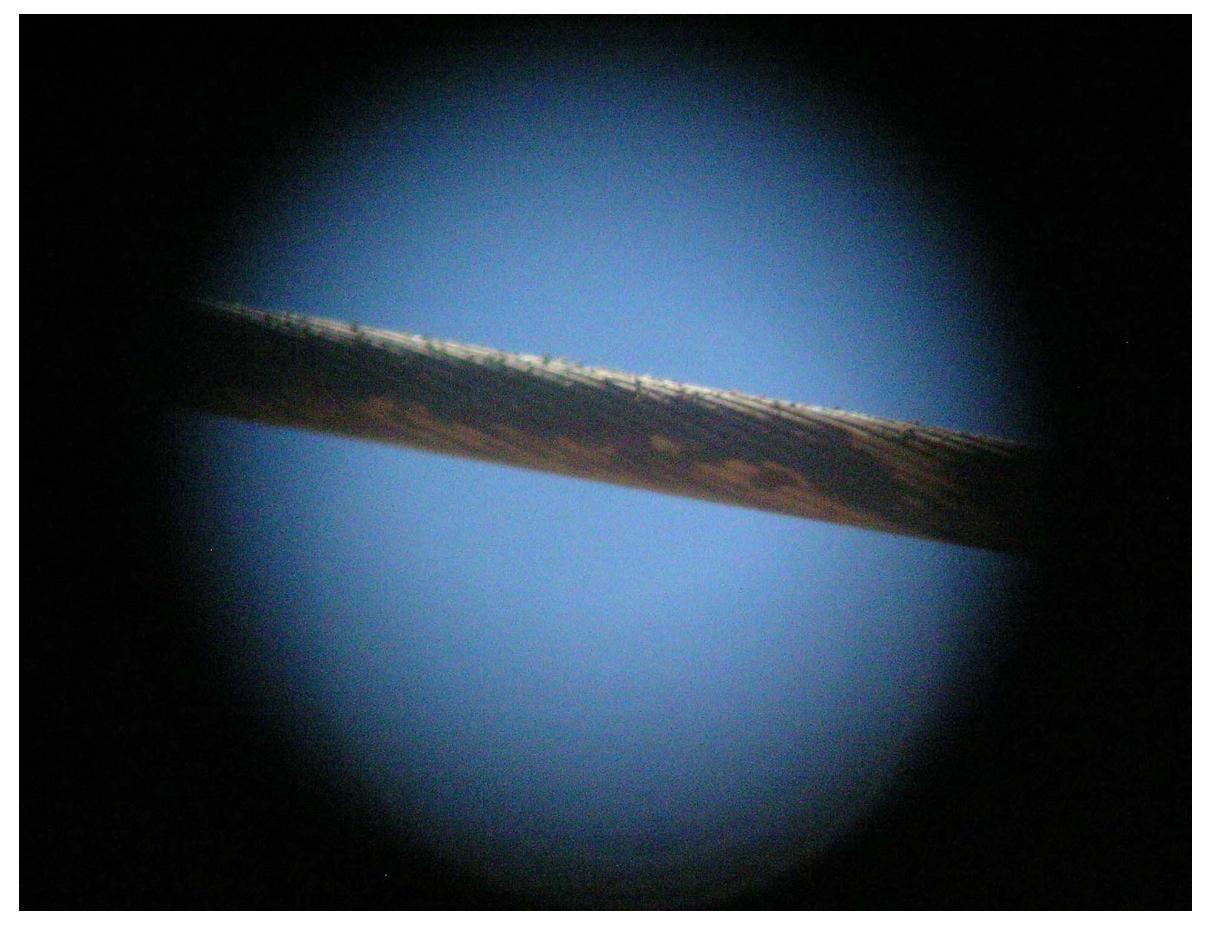
Black lumps were also observed with binoculars along all sections of the Bungama conductors, as shown in Figure 9. The lumps ranged in size up to approximately 3 mm, with dozens to hundreds of lumps per metre of conductor. They appeared to be present on all of the conductors. The nature of the lumps could not be determined, but had the same colour as the substance covering the conductor. Considering the size of the black lumps and how much they protruded from the conductor surface, it is highly likely that they are a major contributing factor towards corona generation. It is possible the substance is grease leaking from the conductor, and allowing small objects such as dirt or flies to stick to the conductor. The surrounding countryside is dry and dusty. Also, a small wind twister was observed sucking dust up to heights above the Bungama transmission towers.

Figure 9 – Unknown black lumps present on the surface of one of the conductors on the Bungama transmission line.

The dirt on the conductors may have been from conductor handling during line construction, or from electrostatic attraction of contamination during line operation. As excessive corona was reported during line commissioning, the former may be the dominant source. Either way, the presence of surface grease had allowed the dirt to stick to the conductors. Both the Midal and Olex cable samples supplied to the EPECentre had surface grease. Observation of the Bungama line while in service indicated excessive levels of surface dirt, with lumps up to 3 mm diameter being clearly visible.
