**HALIFAX PUBLIC GARDENS:  
ARCHAEOLOGICAL RESOURCE IMPACT ASSESSMENT**

**Heritage Research Permit A2006NS10**

**August 2006**

Submitted by:  
Davis Archaeological Consultants Limited  
6519 Oak Street  
Halifax, Nova Scotia  
B3L 1H6

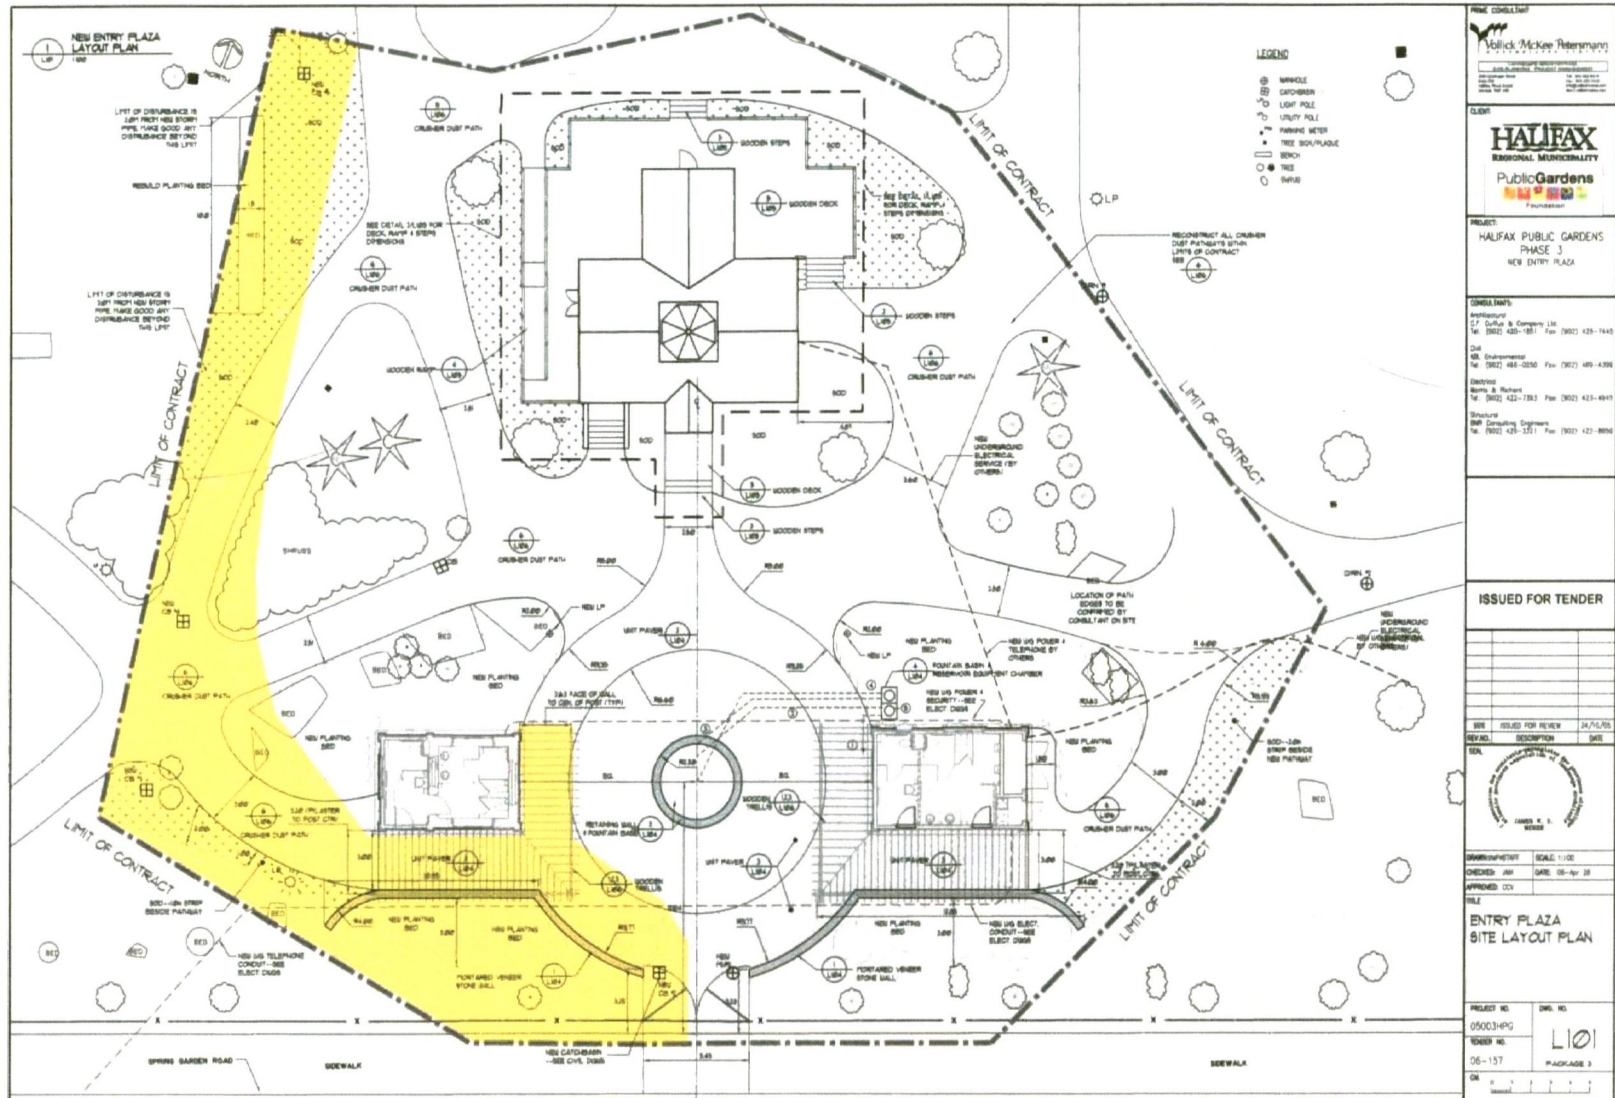
Figure 2.0-1: Site layout plan (courtesy Vollick McKee Petersmann & Associates Limited) showing the approximate area of archaeologically monitored excavation in yellow (yellow shaded area by DAC Ltd.).

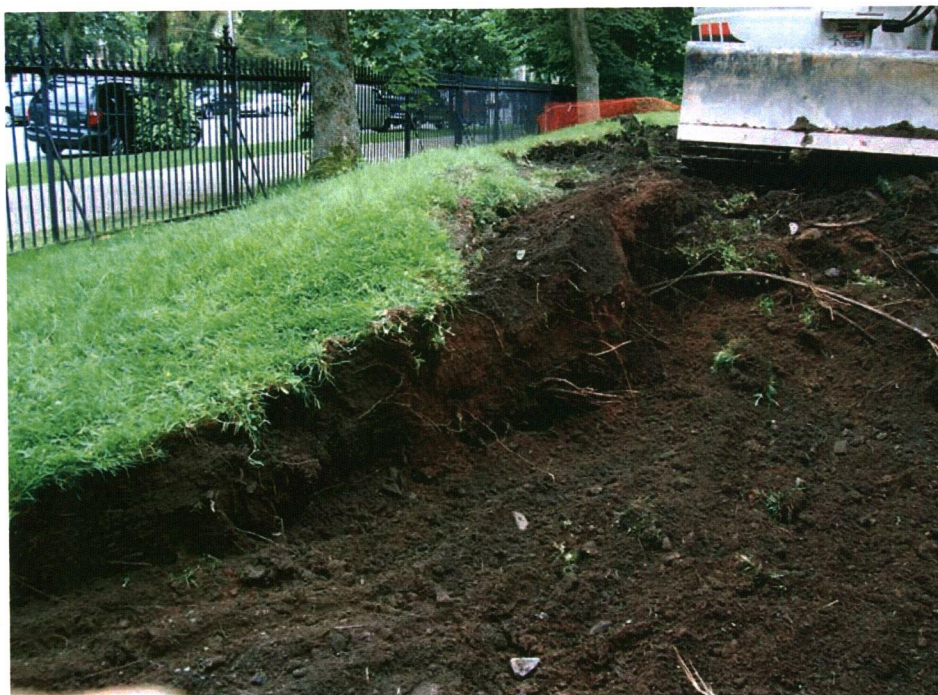
Plate 1: Excavation of artificial berm to west of park entrance on Spring Garden Road, looking southwest.

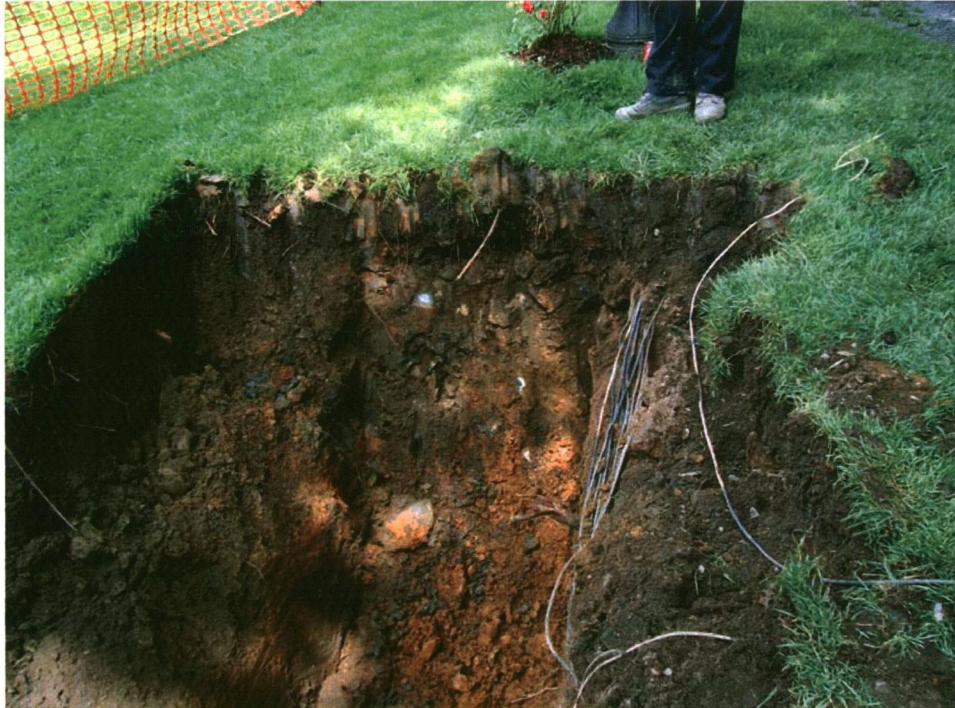
and the surrounding matrix was comprised of medium brown/grey sandy loam fill with gravel to a depth of 0.61 metres below the surface. Beyond this was natural till (Plate 2). At the north end of the trench 0.35 metres below the surface was a layer of ironstone (rock) in a mottled orange and brown disturbance lot (Plate 3). Several scattered fragments of broken brick were observed in this trench and the ironstone did not appear to be structural. This may be associated with demolition of a nineteenth century building, possibly the lodge or root house constructed in 1848. A complete stoneware ink well was recovered from this trench and catalogued.

Plate 3: North edge of catch basin trench showing ironstone 0.35 metres below surface, looking north.

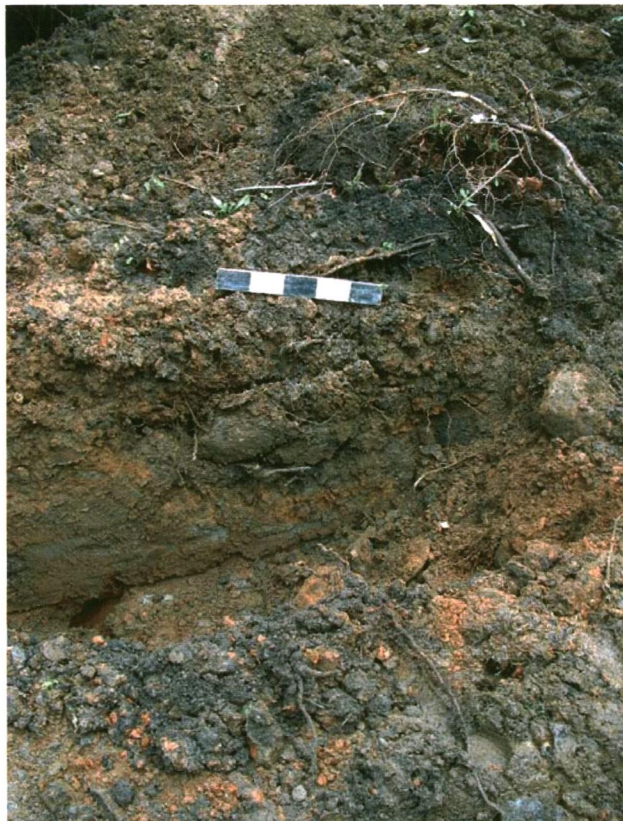
Monitoring of the southern extension of this trench by Heather MacLeod-Leslie revealed a single feature which was breached. This appeared to be a drainage feature, apparently late 19<sup>th</sup> century in origin, which resulted from infilling with soils and cultural materials (fragmentary artifacts) and rocks, to reify and drain a swampy depression. A site visit by Steve Powell ensured that a decision to continue trenching through the feature, with proper recording of its location and the breach of it, would be an acceptable course of action. The feature began at approximately 18 metres south of the northernmost catch basin and continued for approximately 3 to 4 metres south at 0.35 metres below the surface (Plate 4).

Plate 4: Drainage feature in catch basin trench, looking east. Cultural stratum (organic) & yellow stratum below it define depression that was filled (below rocks).

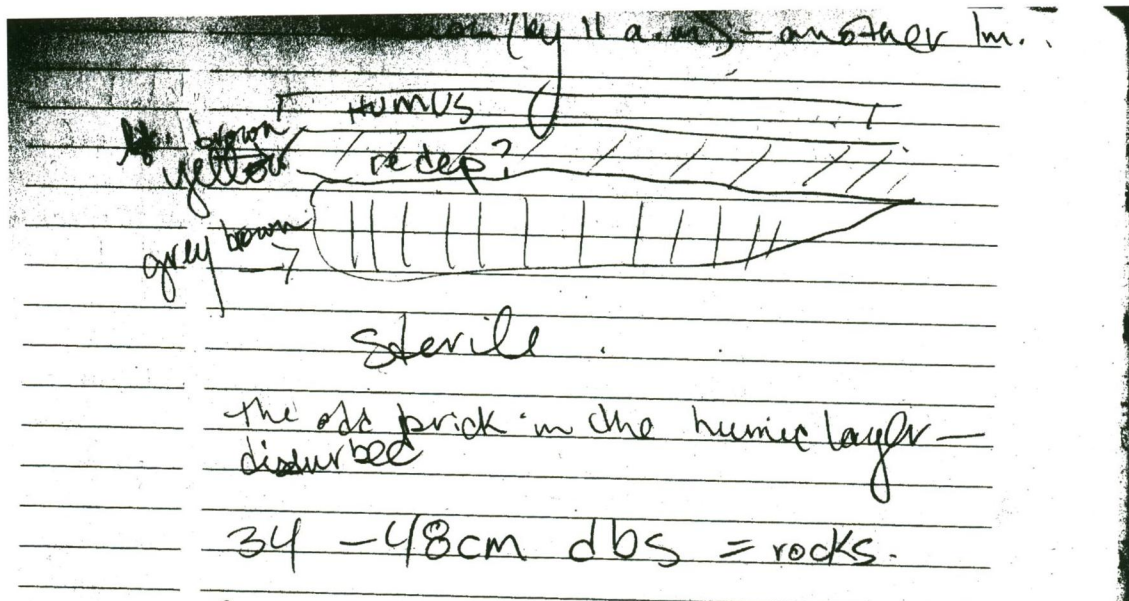
Strata sketch #1 (c. -17 m N from catch basin #1)

The odd brick in the humic layer, noted earlier, is disturbance.

34 – 48 cm dbs – rocks

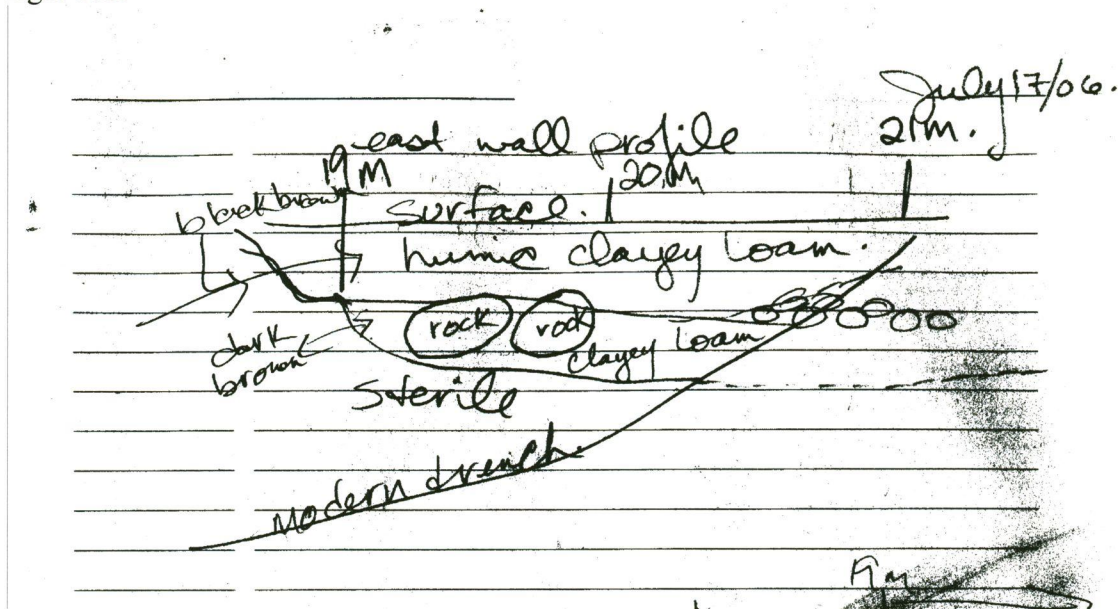
**Strata sketch #2 (c. -19 to -21m N from catch basin #1)**

Linear rock stratum is c. 30 cm dbs at top of deposit and c. 45 cm dbs at bottom (15 cm thick).

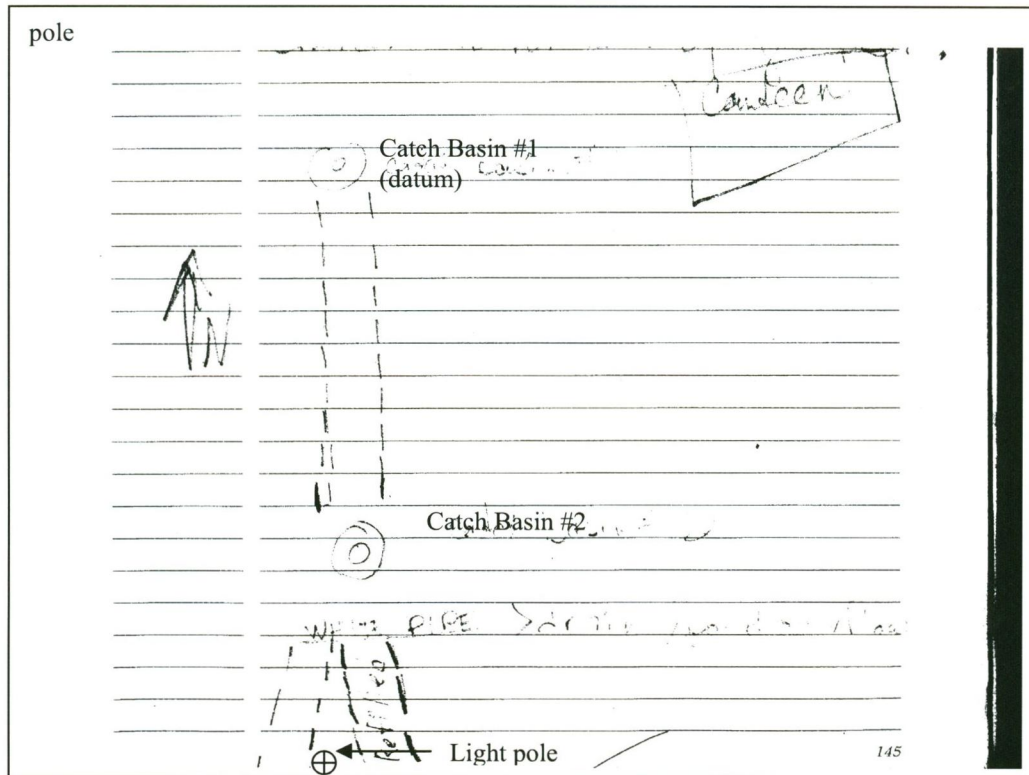
**Public Gardens: sketch map #2**

Drain appears to extend c 1.5 – 2 m. south of white bog drain pipe. Water is clearly flowing freely just south of white pipe. The trench for this pipe impacted the older (rock & fill) drainage feature, which continues for another 1 – 1.5 m south of the white pipe trench.
