UNITED STATES DEPARTMENT OF THE INTERIOR
GEOLOGICAL SURVEY

RESULTS AND INTERPRETATION OF EXPLORATORY DRILLING
NEAR THE PICACHO FAULT, SOUTH-CENTRAL ARIZONA

Thomas L. Holzer

Open-File Report 78-1016

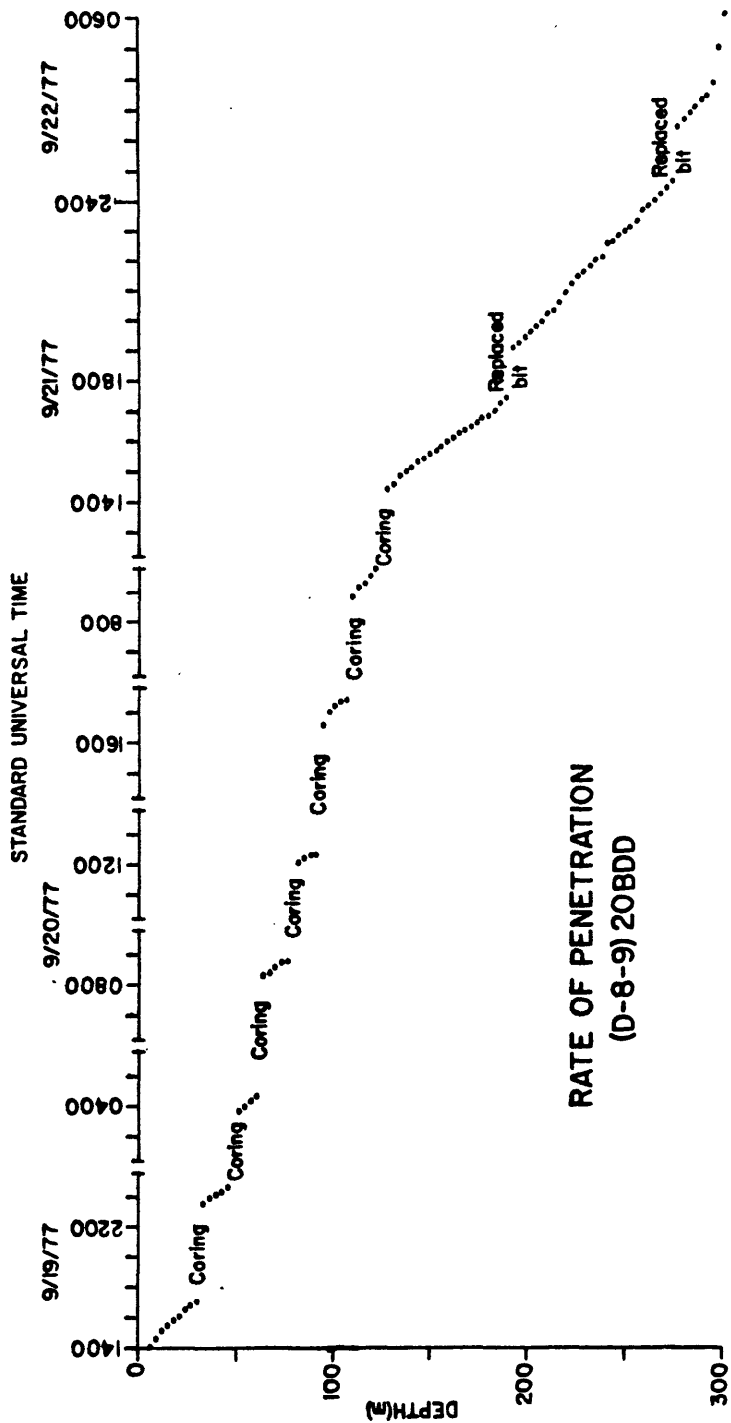
FIGURE 2.---Drilling penetration versus time, (D-8-9) 20BDD.

Within the depth interval 292.6 to 295.7 m the rate of penetration decreased significantly and remained low to the bottom of the hole (fig. 2). Cuttings from below 295.7 m consisted of coarse angular grains of predominantly gneiss, quartz, and feldspar. Inspection of the drill bit after its recovery indicated a very abrasive formation in the deeper part of the hole. The characters of the resistivity and the neutron logs change at a depth of approximately 294 m, indicating a resistive material with relatively low porosity below this depth. The gamma-gamma log indicates that the material with the lower porosity also has a slightly higher bulk density relative to the shallower material. The

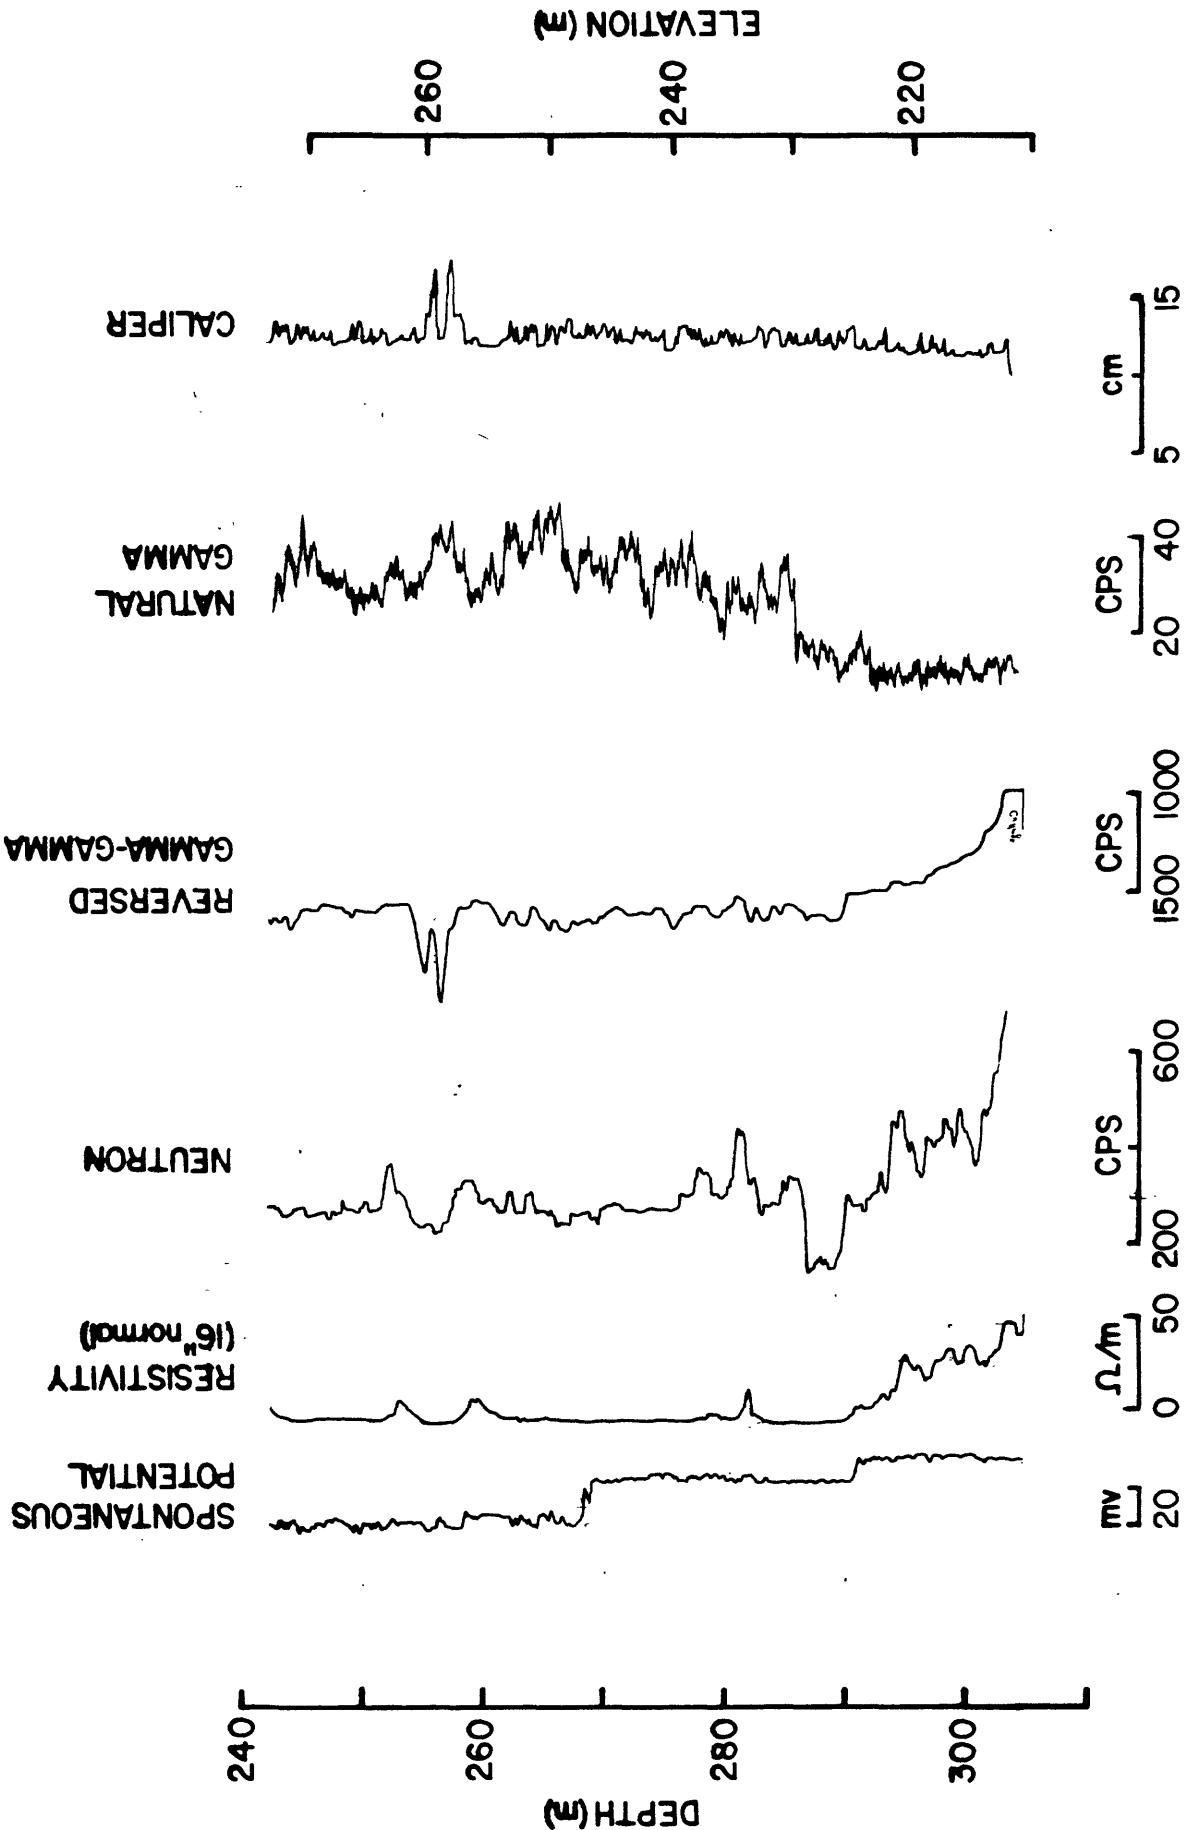
FIGURE 4.---Geophysical logs of lower part of (D-8-9) 20BDD.

The neutron and gamma-gamma logs indicate that very dense material with a porosity of nearly zero was penetrated for approximately 2.9 m below a depth of 301.6 m. The resistivity and spontaneous potential logs also suggest material with different physical characteristics was penetrated in this interval. The natural gamma radiation of this material is similar to that of the material immediately overlying it.

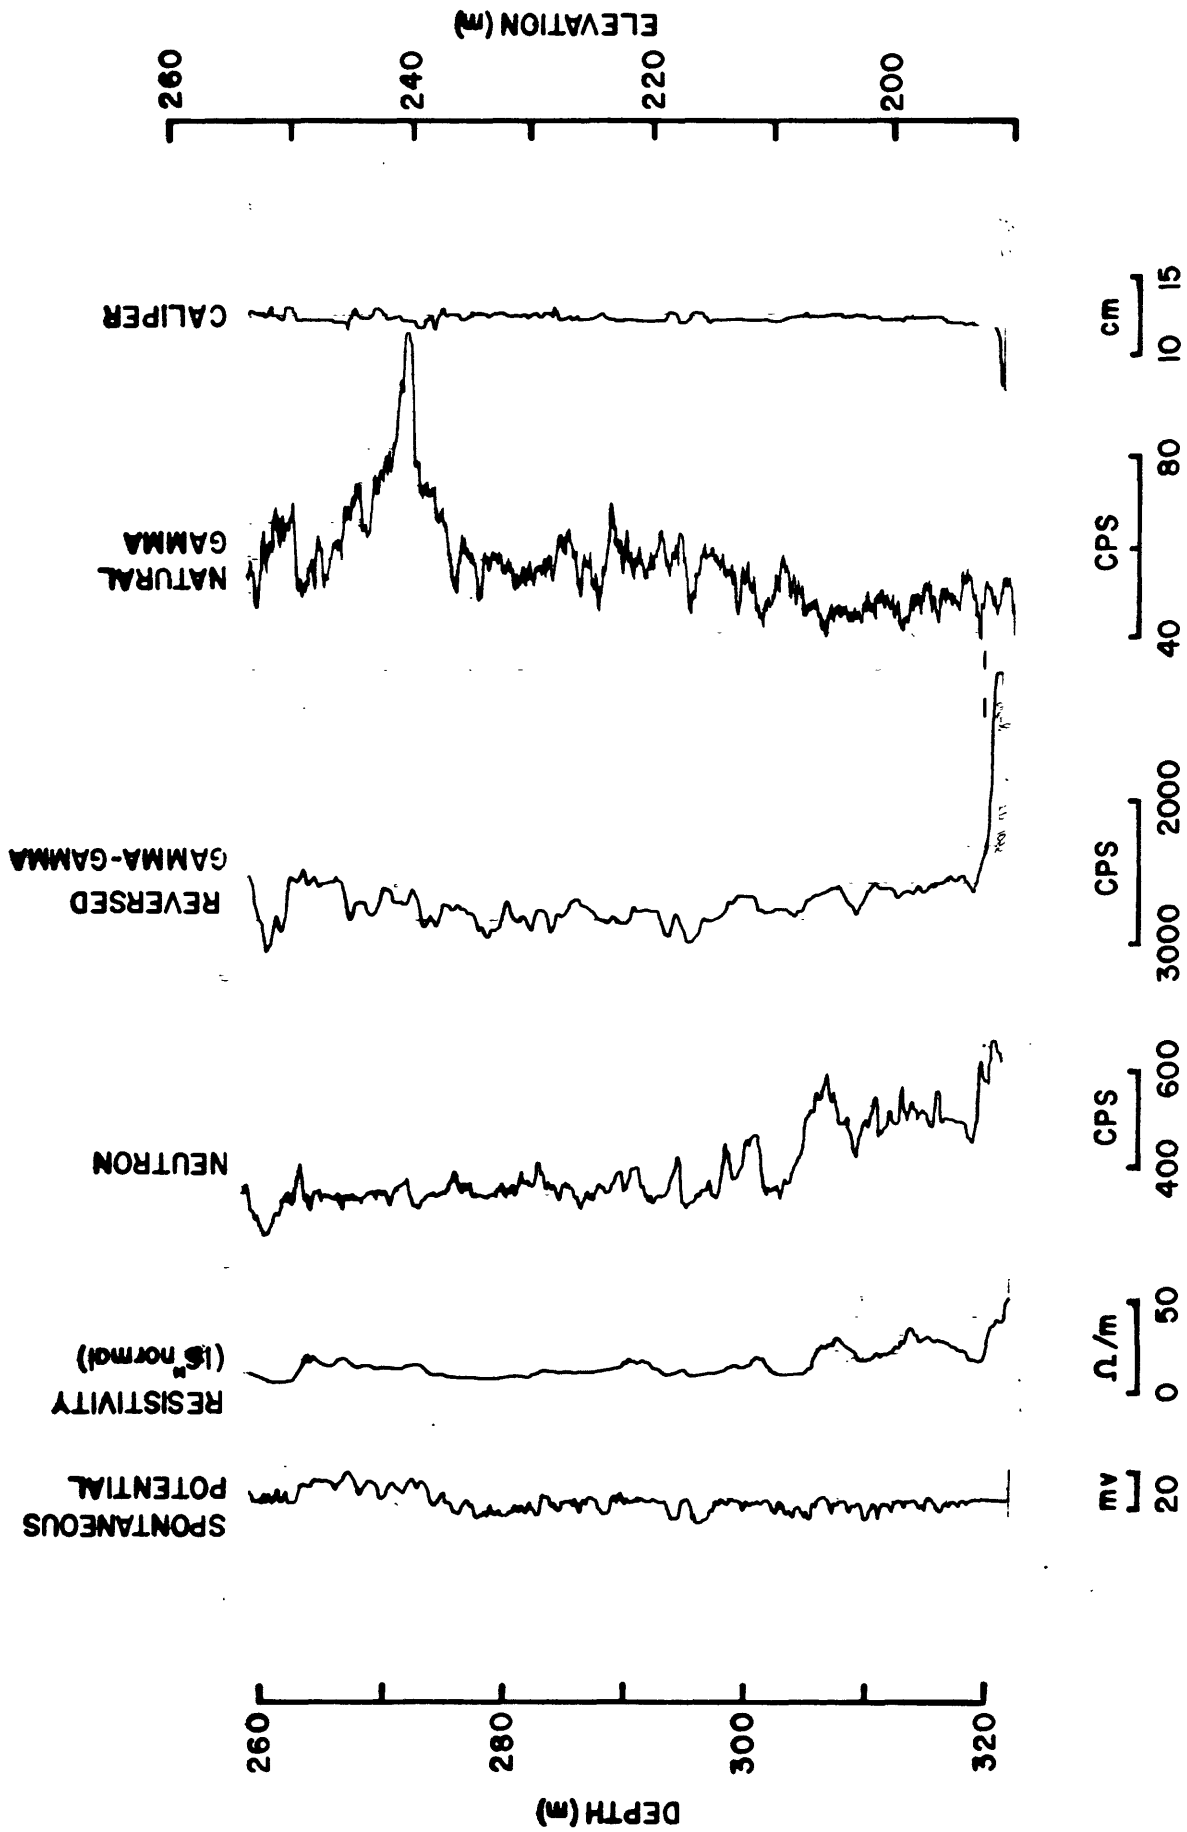
FIGURE 7.--Geophysical logs of lower part of (D-8-9) 20BDA.

Above a depth of 306 m, cuttings and geophysical logs (pl. 2) indicate that a sedimentary deposit similar to that in the upper part of test hole (D-8-9) 20BDD was encountered. An increase in the percentage of fine-grained material in the cuttings from 119 to 213 m (fig. 6) may be due to the increase in drilling mud density that was done to reduce circulation loss. The precise depth of the base of the unconsolidated alluvial deposit is indicated by the neutron and resistivity logs, which show an abrupt change at a depth of 305.2 m to a more resistive material with a relatively lower porosity (fig. 7). The decrease in porosity is accompanied by an increase in bulk density according to the gamma-gamma log and a slight decrease of natural gamma radiation

from the formation (fig. 7). The cuttings also are compatible with a contact at 305.2 m. Below this depth, particles were predominantly coarse-grained and were very angular as contrasted with more rounded particles in the shallower material.

Both the neutron and gamma-gamma logs indicate that below a depth of 319.4 m approximately 3.7 m of very dense material with very low porosity was penetrated. The material seems to be the same as encountered at the bottom of (D-8-9) 20BDD because the characteristics of the resistivity and spontaneous potential logs are similar between the two holes. The natural gamma radiation of the deep material in (D-8-9) 20BDA is similar to that of the overlying dense, low-porosity material. The bottom of the test hole was cored, and approximately 0.3 m of broken gneissic crystalline rock fragments filled the bottom of the core barrel. The fragments ranged from 20 to 60 mm in diameter. Thin sections were made of the five fragments that appeared to be the most dissimilar. All five thin sections revealed that the cored material was biotite quartz monzonite with thin layers of annealed polycrystalline quartz, indicating that the rock had been subjected to tectonic shearing.

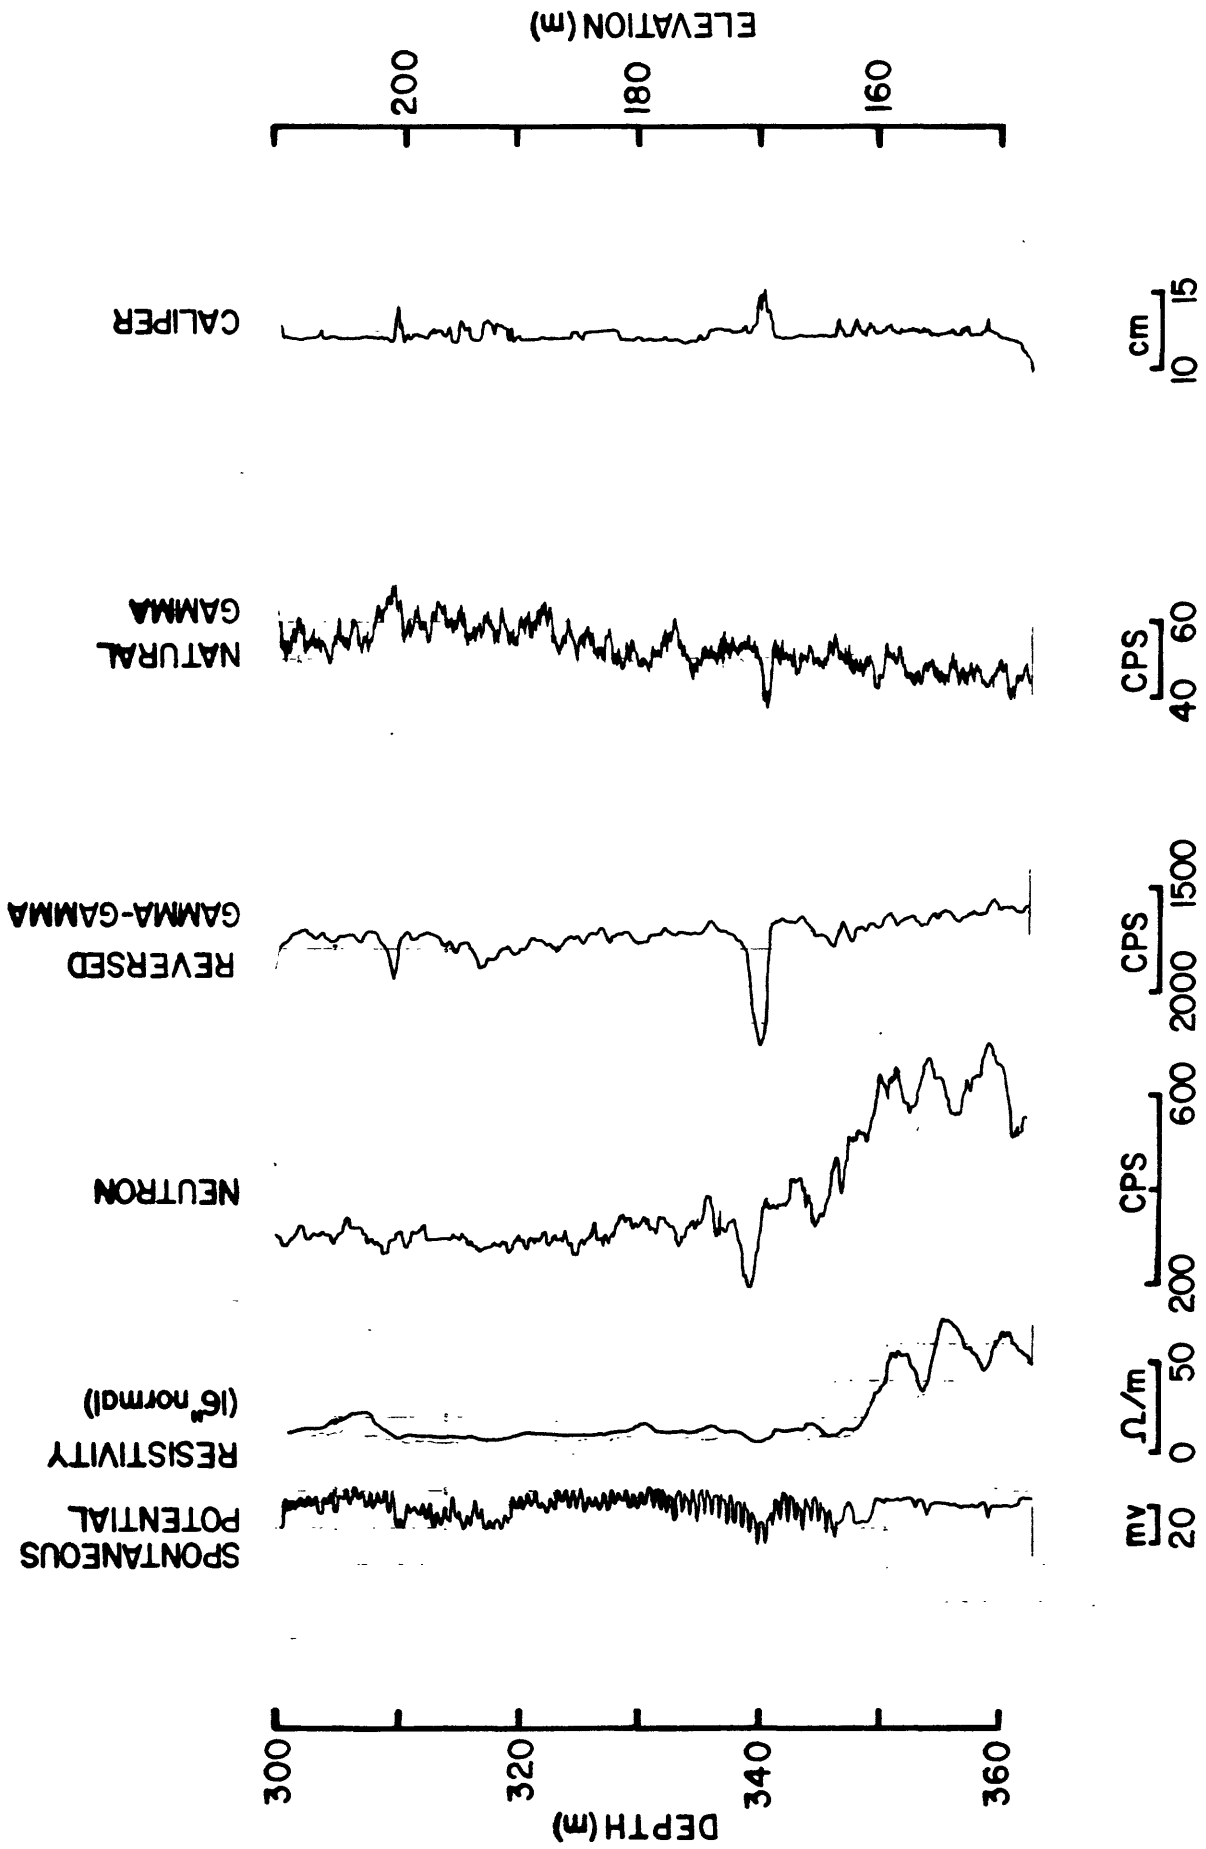
FIGURE 10.--Geophysical Logs of lower part of (D-8-9) 20BAC.

The geophysical logs (fig. 10) correlate quite well with the drilling behavior. The resistivity and neutron logs indicate a contact between the overlying alluvium and a more resistive, low-porosity material at 349.6 m. The contact is somewhat gradational on the neutron log with the gradation beginning at 340.2. As in the two other holes, the deeper material has a higher bulk density and lower natural gamma activity relative to the overlying material.

The low-density and high-porosity material above the contact indicated by the gamma-gamma and neutron logs is probably due to a localized increase in the diameter of the bore hole and probably does not reflect actual material properties.

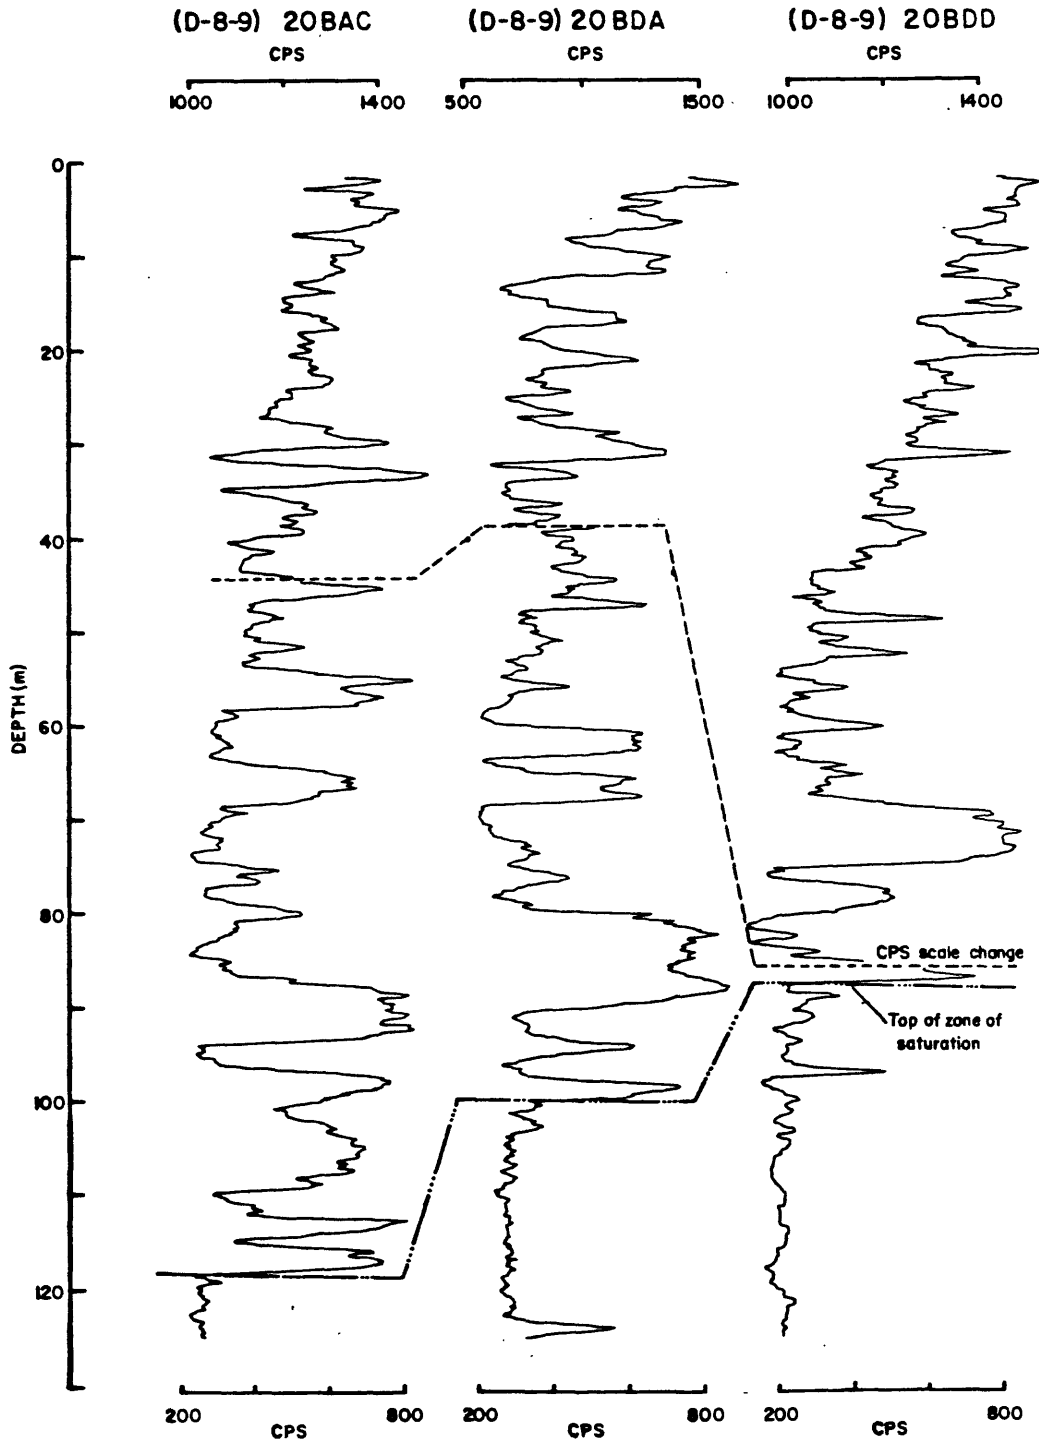
FIGURE 11.--Neutron logs of unsaturated portions of test holes.
(CPS = counts per second.)

The neutron logs revealed a well-defined top to the zone of saturation in each of the test holes (fig. 11). The logs also indicated that a considerable amount of soil moisture has been retained in the part of the deposit dewatered by ground-water withdrawal.

Results from the neutron logs are compatible with the interpretation of a partial ground-water barrier within the alluvium. If the preexisting fault plane intersects test hole (D-8-9) 20BDA where circulation was lost, then the saturation of the material beneath this depth could be attributed to the fault behaving as a ground-water barrier. Attributing the saturation to penetration of drilling fluid does not appear to be satisfactory because there is no indication based on the neutron log of unsaturated material beneath this zone and it would seem to be fortuitous that the drilling fluid would have completely saturated material down to the top of the zone of saturation. In addition, the seismic refraction survey by Pankratz and others (1978) supports the former interpretation of the neutron logs. They found that a layer with a velocity ranging from 1.9 to 2.0 km/s dropped 28 m in elevation to the west beneath the fault at a depth of approximately 90 m. The velocity of the material overlying this layer ranges from 0.98 to 1.1 km/s. These velocities suggest that the upper surface of the 1.9 to 2.0 km/s layer is the contact between unsaturated and saturated alluvium.

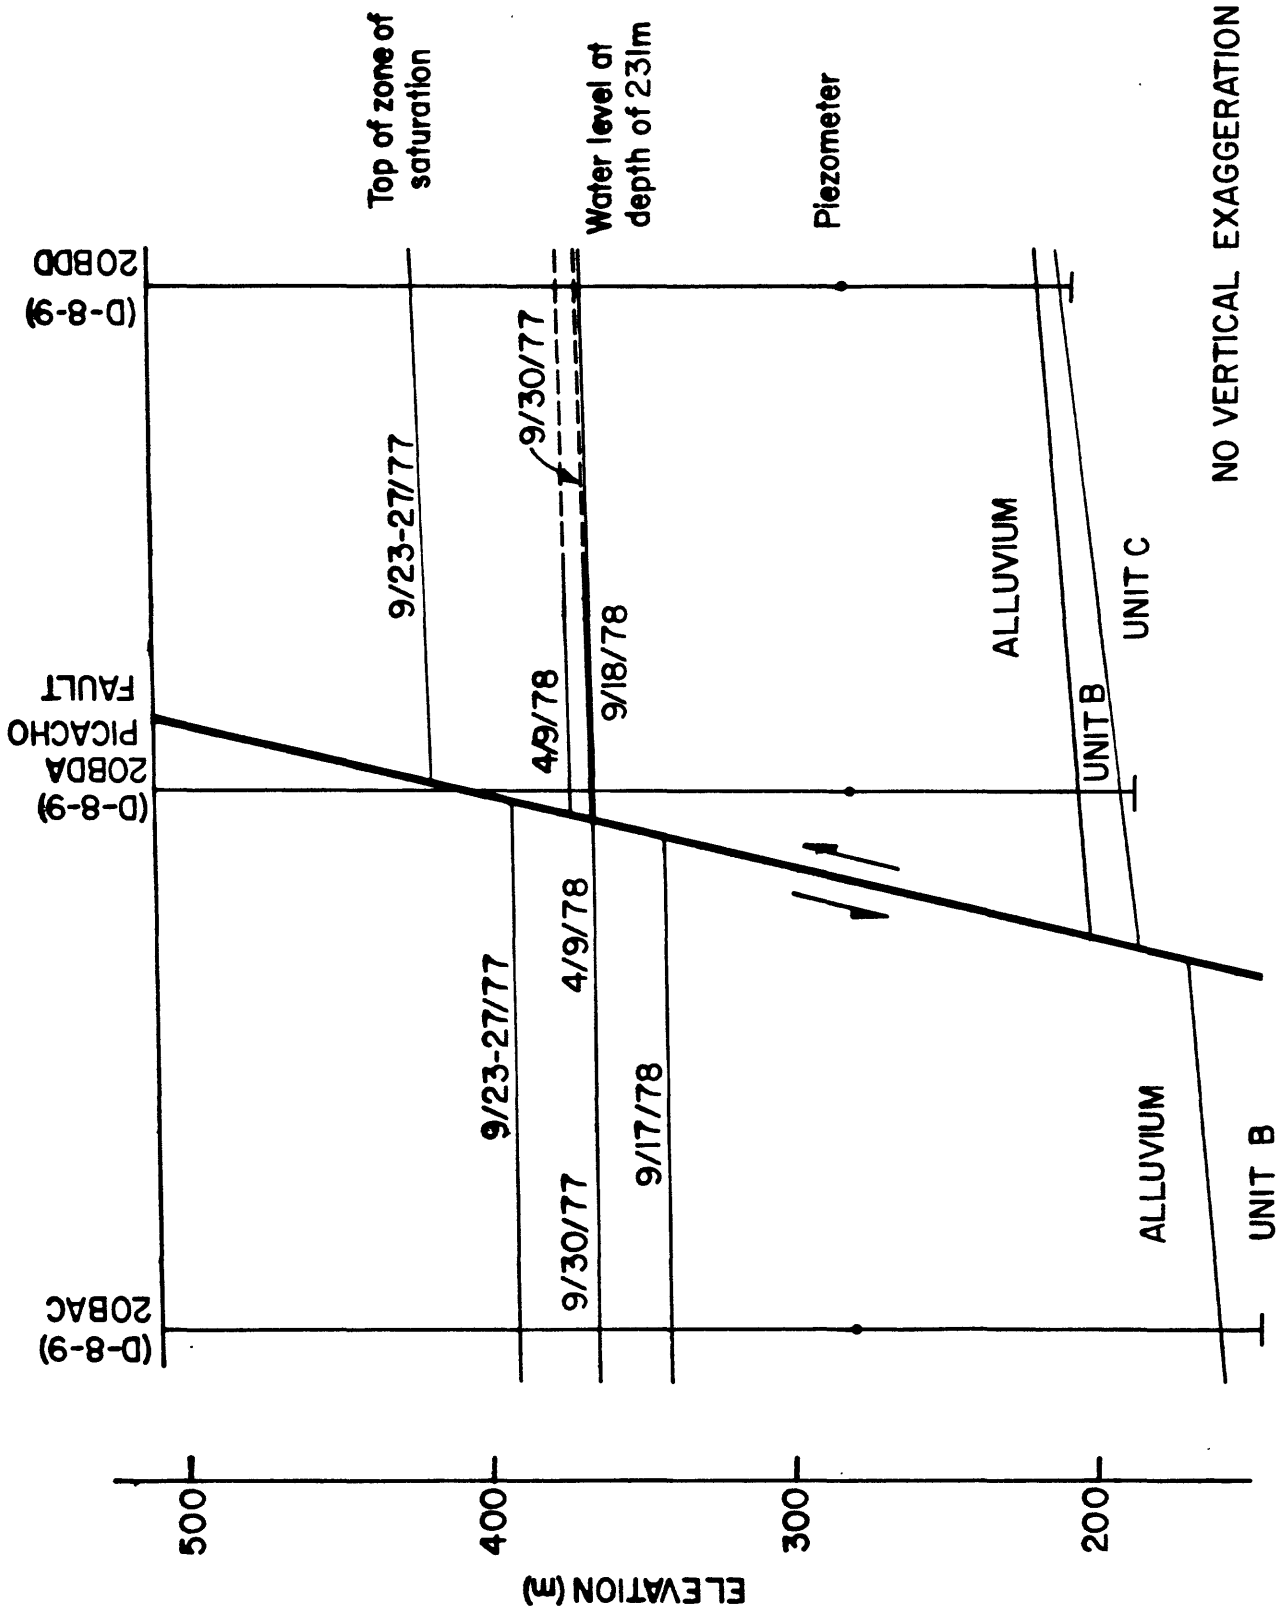
The preferred interpretation of the drilling and hydrologic data is shown in cross section in figure 12. The cross section is a projection passing through (D-8-9) 20BDA normal to the strike of the fault. The contact between the alluvium and unit B in figure 12 is based on the resistivity and neutron logs, which indicated a marked increase in resistivity accompanied by a decrease in porosity near the bottom of each test hole. Unit C in test holes (D-8-9) 20BDA and 20BDD is the very dense, nonporous material encountered beneath unit B at the bottom of each of these two test holes. The upper surface of unit B presumably is the base of the compacting alluvial material causing land subsidence near the fault, since the properties of units B and C inferred from the geophysical logs and their drilling resistance indicate material which is relatively incompressible. Unit B and material beneath it will henceforth be referred to as "hydrologic bedrock". A pre-existing, high-angle, normal fault offsetting alluvium and underlying hydrologic bedrock and behaving as a partial ground-water barrier is interpreted to connect to the modern surface fault. The magnitude of fault offset at the base of the alluvium, estimated to be approximately 30 m in the cross section, is based on assuming the bedrock surface has the same slope on both sides of the fault. Hence, the estimate of the amount of offset is somewhat arbitrary. The dip of the fault in the cross section is based on connecting the surface fault with the point in (D-8-9) 20BDA at which circulation loss began. Interpretation of a preexisting fault is based principally on geophysical and hydrologic data since no stratigraphic correlations within the alluvium were made. Although the tectonic shearing of the rock cored at the base of (D-8-9) 20BDA suggests at least the possibility of a preexisting fault zone within the hydrologic bedrock.

FIGURE 12.--Interpretive hydrogeologic cross section across Picacho fault. Water levels shown in cross section were measured in piezometers. Top of zone of saturation is from neutron logs.

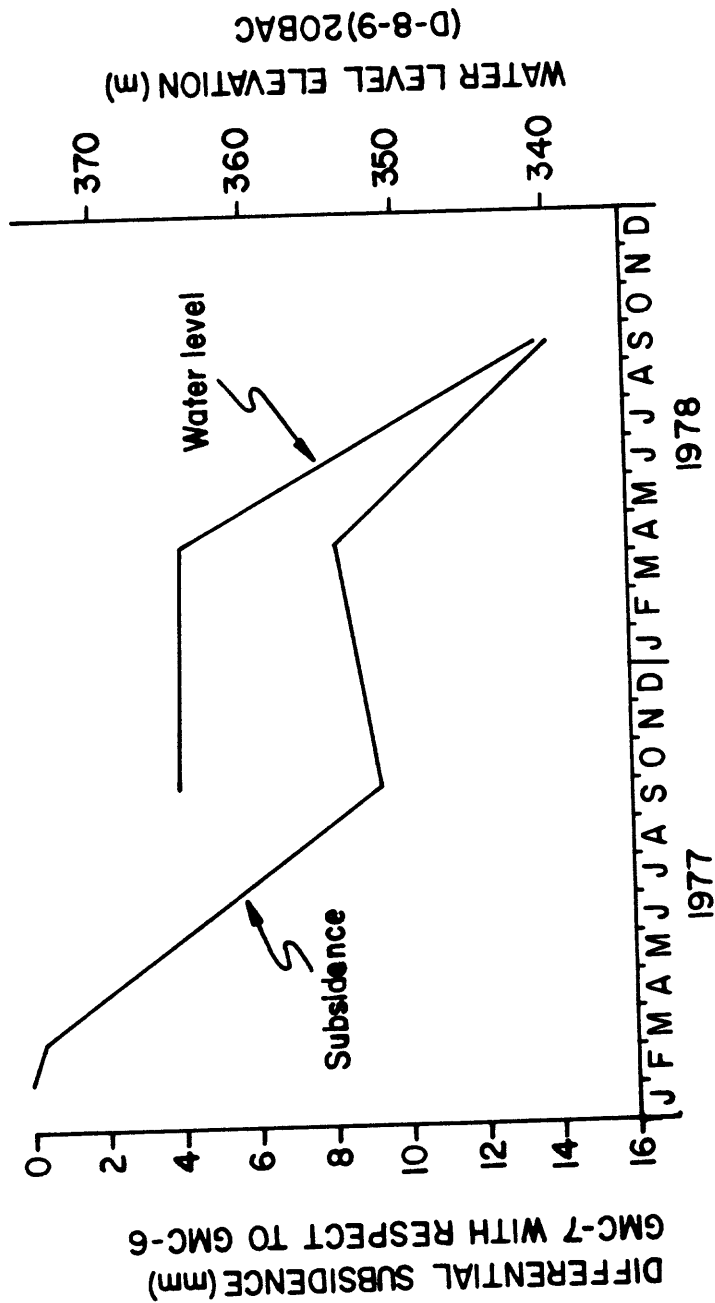
beginning in September 1977 along with the monitoring of water levels confirms that seasonal movement of the fault is still occurring (fig. 13). Fault movement, as recorded by surveys of bench marks GMC-6 and 7 which span the fault and are 14.5 m apart, corresponds to the fluctuation of water-level in piezometer (D-8-9) 20BAC on the downthrown side of the fault. This result provides additional support for a relation between modern surface faulting and ground-water withdrawal.

FIGURE 13.--Differential subsidence of bench marks 14.5 m apart on opposite sides of Picacho fault and elevation of water level in (D-8-9) 20BAC versus time. (See figure 1 for location of bench marks.)
