## **Scanning Microscopy**

# Micrographic Fracture Characterization of Gallium Arsenide Wafers

## MICROGRAPHIC FRACTURE CHARACTERIZATION OF GALLIUM ARSENIDE WAFERS

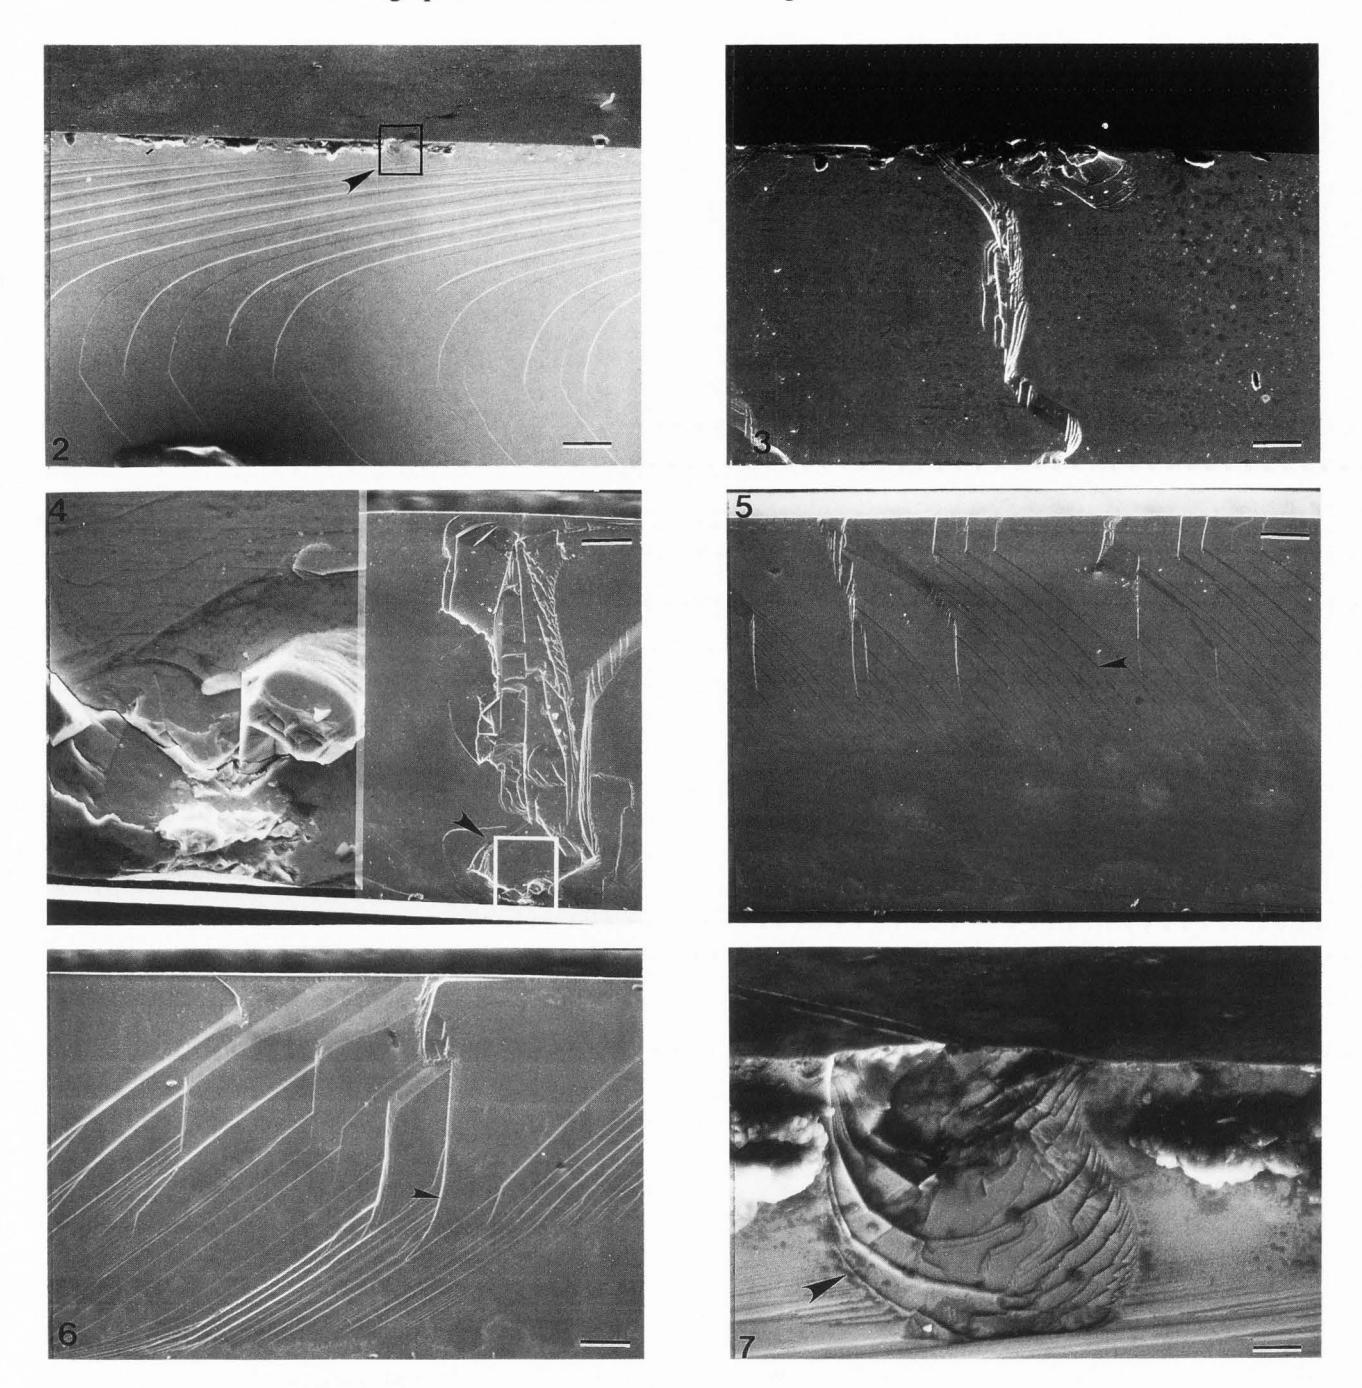
To better identify the initiation site, three randomly selected control specimens were intentionally damaged with a pointed scalpel and then placed in bending such that fracture initiated at the damage site. Figure 4 shows the fracture surface of the control specimen, with steps that occurred in a vertical band. A surface flaw intersects many {110} failure planes, and thus the crack initiates on several {110} planes. As the crack "seeks" its ultimate propagating plane, it creates the observed steps. On either side of this band, the fracture surface was flat until Wallner lines appear (Figs. 5 and 6). The region without Wallner lines was most likely the distance that the crack traveled before the stress waves reached the specimen boundary and reflected back to interact with the propagating crack. The Wallner lines are symmetric about the flaw (Fig. 4), suggesting that this flaw

Figure 3 shows a naturally occurring initiation site, which was identified by the vertical band of steps, as above. The center of the micrograph shows this band, emanating from the flaw at the top center, is similar to that in the control specimen. Again, there was a flat region on either side of the vertical band of steps, followed by Wallner lines that were symmetric about the flaw (left side shown in Fig. 2).

In general, many flaws exist in any material, but only one becomes critical under load and leads to failure. It is important to note that although it was clear that the cracks initiated at existing defects along the edges of the specimens, the cause of this initiation site cannot be determined and was not within the scope of this study. In many cases, there were other flaws present on the tensile side of the fracture surface. Figure 7 shows an enlargement of a defect on the fracture surface circled in Figure 2. There was no band of vertical steps emanating from this flaw and the Wallner lines seem unaffected by its presence, indicating that this flaw did not initiate fracture.

Figure 2. Fracture surface showing Wallner lines on an otherwise flat surface. Surface flaw (boxed) is on the tension side of the specimen. The area indicated by the arrow is shown enlarged in Figure 7. Bar =  $100 \ \mu m$ .

Figure 3. Another area of the same fracture surface of Figure 2. The vertical band of steps originating from the flaw at the top (tension side) of the specimen, indicating that this was the initiation site. Bar =  $100 \mu m$ .

Figure 4. A control specimen, intentionally damaged to help recognize fracture initiation sites. The vertical band of steps originated from the flaw is shown ten times enlarged on the left side of the micrograph. Bar =  $100 \ \mu m$ .

Figures 5 and 6. Areas to the left (Fig. 5) and right (Fig. 6) of the initiation site (Fig. 4), showing Wallner lines in opposite directions. Bars =  $100 \ \mu m$ .

Figure 7. Enlargement of flaw indicated by arrow in Figure 2. The Wallner lines seem unaffected by the presence of this flaw. Bar = 10  $\mu$ m.

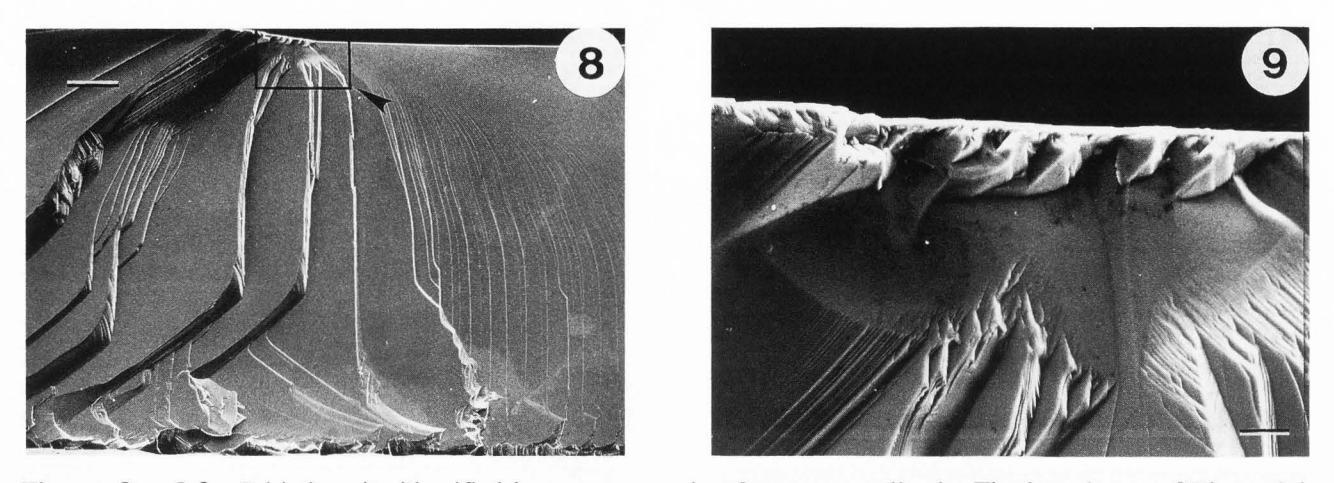
Figures 8 and 9. Initiation site identified by steps emanating from area outlined. The boxed area of Figure 8 is enlarged in Figure 9. Bars = 100  $\mu$ m (Fig. 8) and 10  $\mu$ m (Fig. 9).

specimen loaded by a combined tensile and shear stresses. The steps emanating from the initiation site (enlarged in Fig. 9), were not in a clear vertical band. This was probably due to the shear loading on the failure plane, which caused the maximum tensile stress to occur on a plane oriented at  $30^{\circ}$  to the (110) failure plane. The stresses within the specimen prevented the crack from settling on a {110} plane as rapidly as in the tension-only cases of the previous specimens. The Wallner lines were again symmetric about the initiation site.

After identifying the flaws that initiated fracture, the size of the initial flaw was measured in randomly selected specimens and compared to the theoretical model and previously published values for the fracture strength of GaAs [1]. As an example, the flaw in Figure 9 was modeled as a semi-elliptical surface crack in a thin elastic plate subjected to bending using the model of Newman and Raju [5]. The details of this calculation are presented elsewhere [1], but the results predict a flaw size of approximately 32  $\mu$ m deep and 91  $\mu$ m wide to cause failure at the measured bending stress of this specimen. The flaw geometry in Figure 9 is consistent with this prediction, which indicates that the theoretical model not only fits the experimental data, but also incorporates the observed physical phenomenon that causes fracture in GaAs.
