Arenosa Creek Surface Water Quality Monitoring Report

Texas Water Resources Institute TR-482
October 2015

Segment: 2453C

Texas Water Resources Institute Technical Report 482

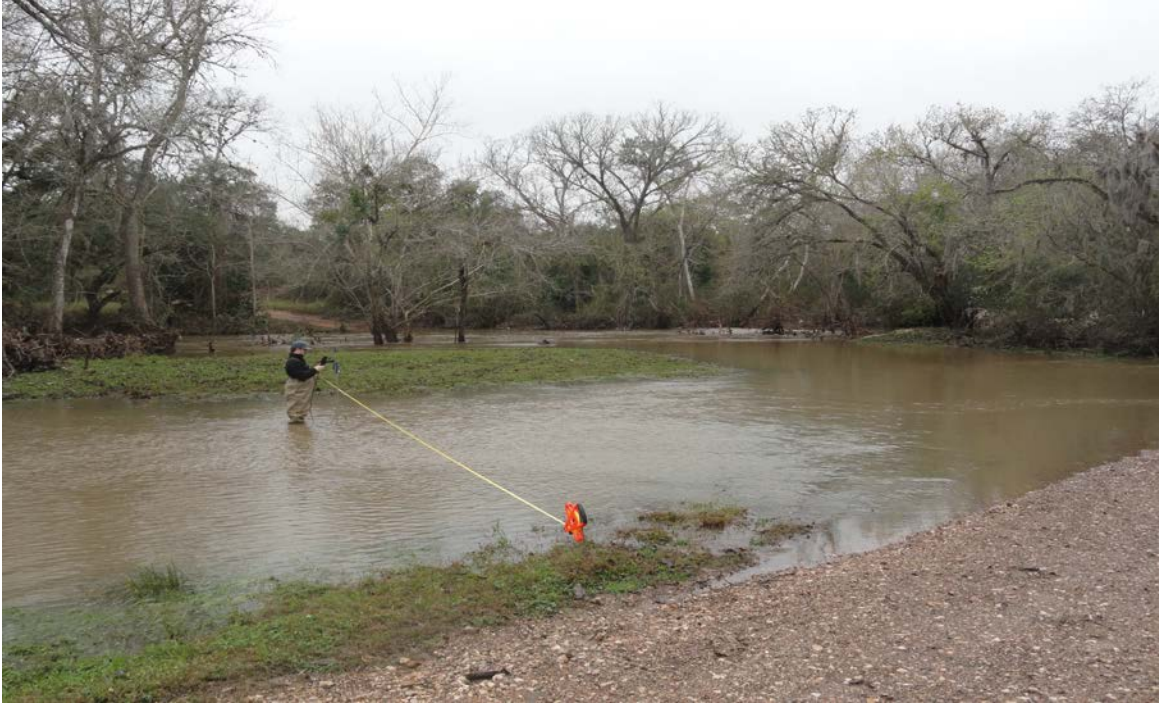
Arenosa Creek during the March monitoring event.

Flow ranged from 0 to 647.4 cubic feet per second (cfs) during the sampling period. The highest flow was recorded in March as a result of 4.17 inches of rain falling across the watershed during the 7 days prior to the sampling event. During January, no flow measurements were taken due to unsafe conditions. However, this flow was estimated using the Velocity-Area method. The stream was assumed to be an ellipsoid shape, with an area calculated using the equation-

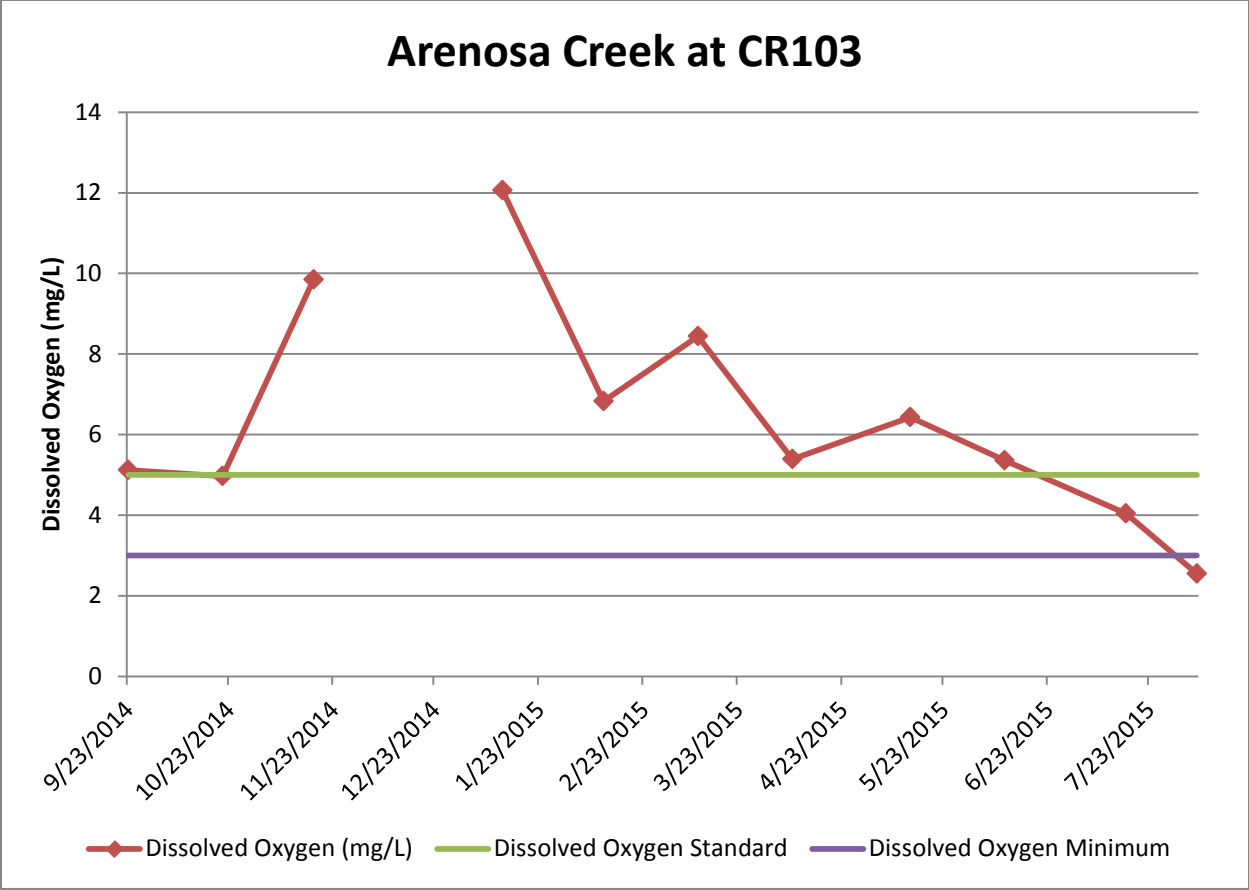
Figure 3. Arenosa Creek DO distribution.

The average DO recording was 6.5 mg/L with a maximum value of 12.0 mg/L and a minimum recording of 2.6 mg/L (Figure 3). The minimum value fell below the TCEQ minimum value standard. This reading occurred during a monitoring trip with no flow. There were no statistically significant correlations between streamflow and DO readings ($r= 0.56$; $p=0.07$), or *E. coli* concentrations ($r=0.52$; $p=0.10$). No DO reading was taken during the December 17, 2014 monitoring trip due to incorrect calibration of the YSI EXO1 multiprobe.

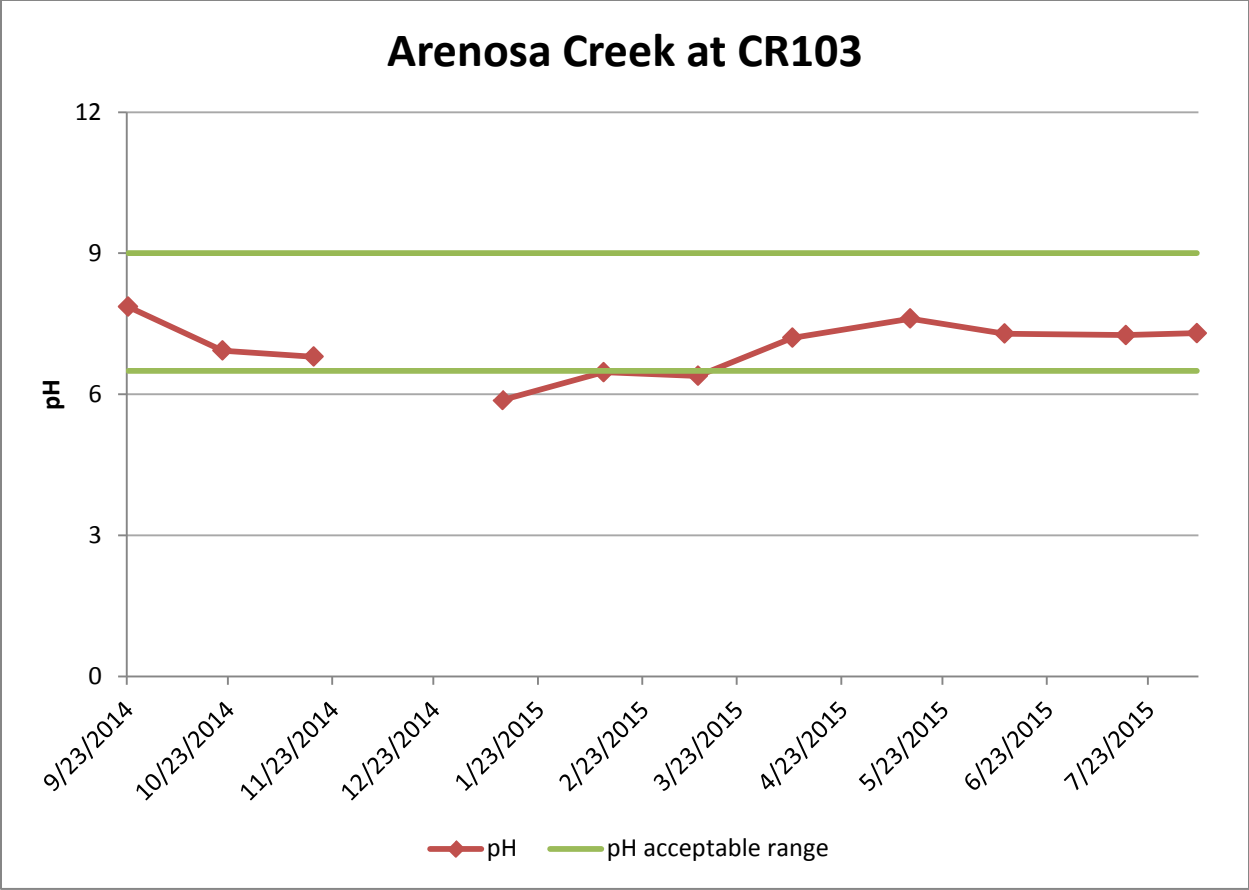
Figure 5. pH distribution for Arenosa Creek.

Three pH measurements fell below the acceptable pH range of 6.5 to 9.0 between January and March 2015 (Figure 5). pH measurements ranged between 5.9 and 7.9 with a mean of 7.0. There was a statistically significant correlation between pH and streamflow ($r=0.63$, $p=0.03$), but no statistically significant correlation between pH and *E. coli* ($r=0.31$, $p=0.36$). The low pH measurements that were below the TCEQ minimum standard for pH were collected after significant rainfall events. These events could lower the pH of Arenosa Creek due to rainwater having a pH of around 5-6, thus being the likely cause of this minor exceedance. No pH reading was taken during the December 17, 2014 monitoring trip due to incorrect calibration of the YSI EXO1 multiprobe.

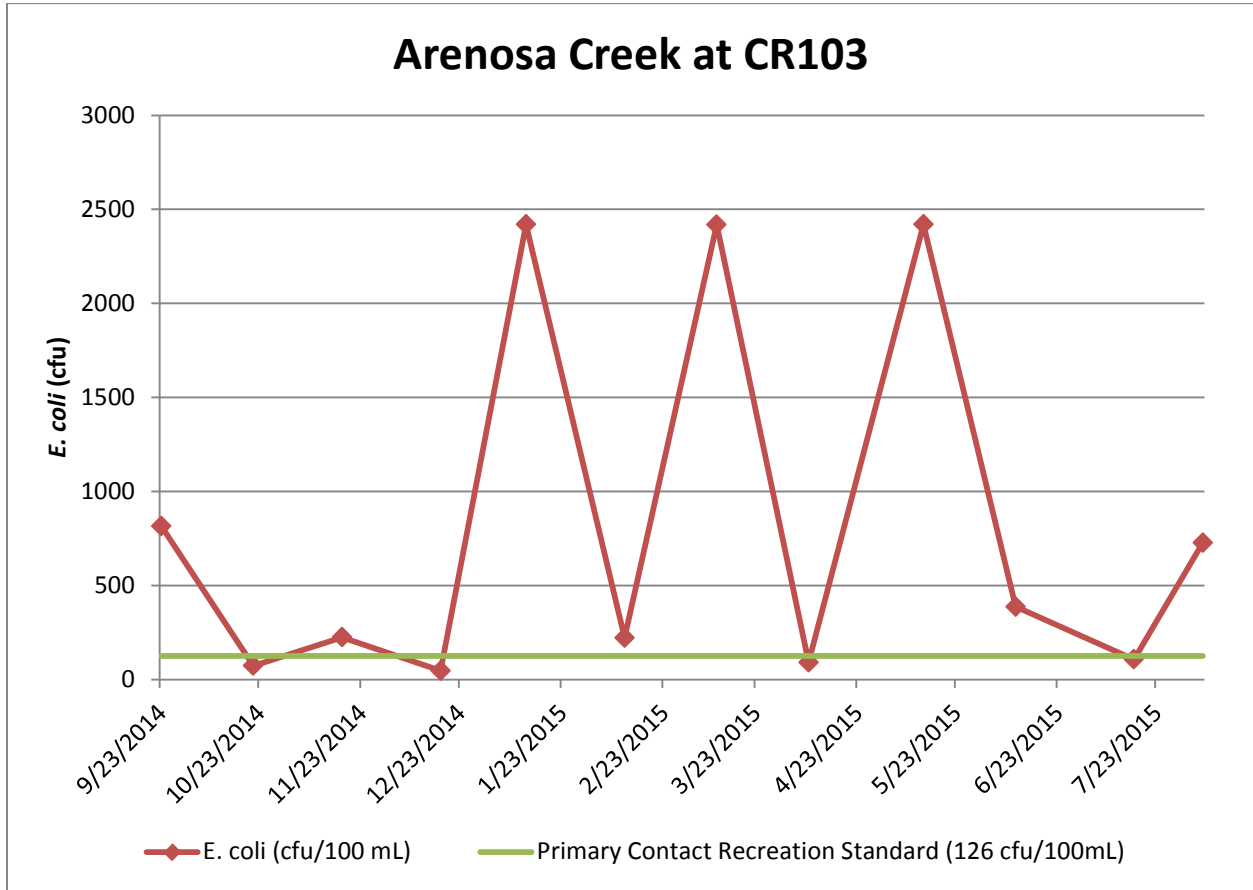
Figure 11. Arenosa Creek *E. coli* distribution with the TCEQ primary contact recreation standard (126 cfu/100mL).

The geomean for *E. coli* of 364 cfu/100 mL continued to exceed the state water quality standard established by TCEQ to protect primary contact recreation (126 cfu/100mL); however, it was well within the secondary contact recreation standards (Figure 11).

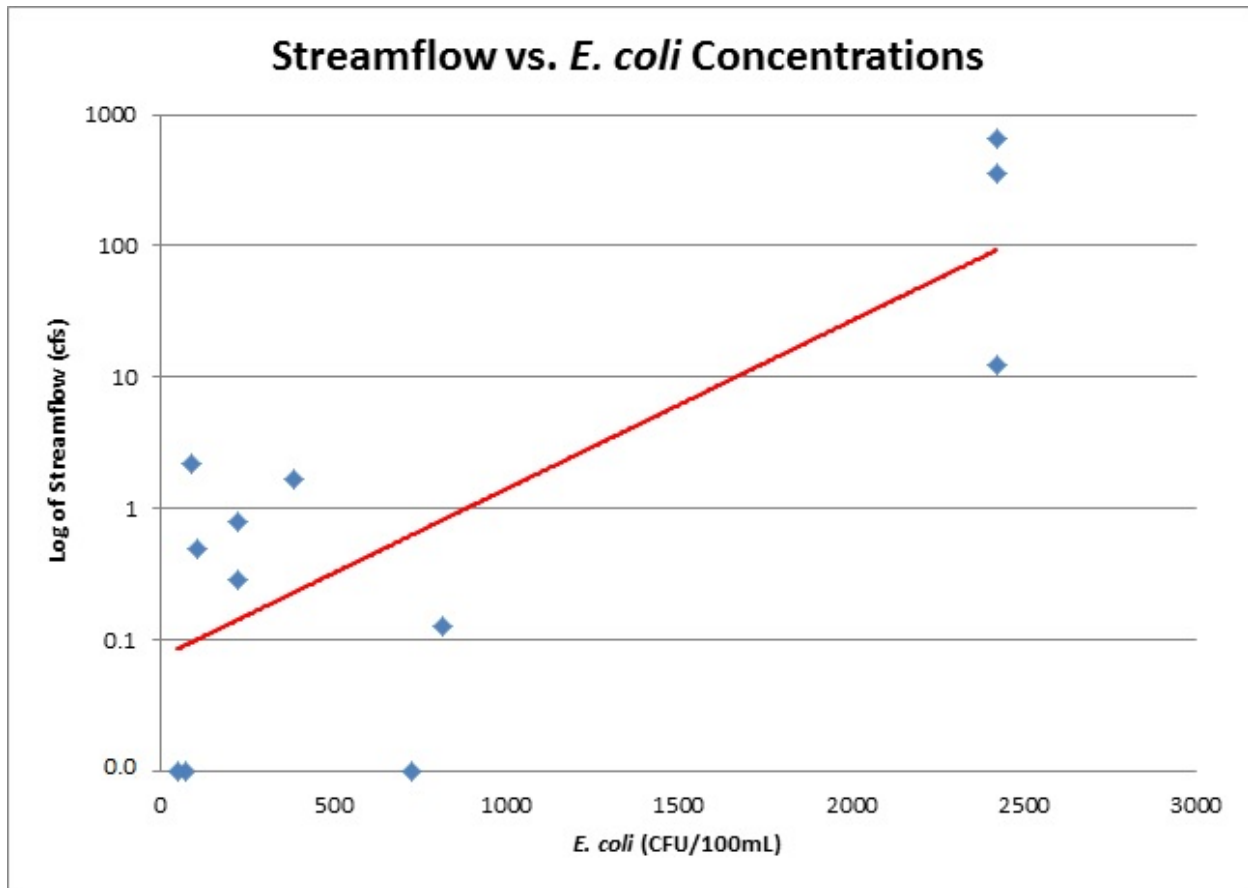
Figure 13. Streamflow vs. *E. coli* concentrations of Arenosa Creek.

There was a strong correlation observed between *E. coli* concentrations and streamflow, with an r value of 0.72 (Figure 13). This correlation was statistically significant with a p-value of 0.007. However, it should be noted that the inclusion of the three high flow events and their corresponding *E. coli* values creates the significance of the observed correlation, with a weak correlation when these values are removed (r=0.22).

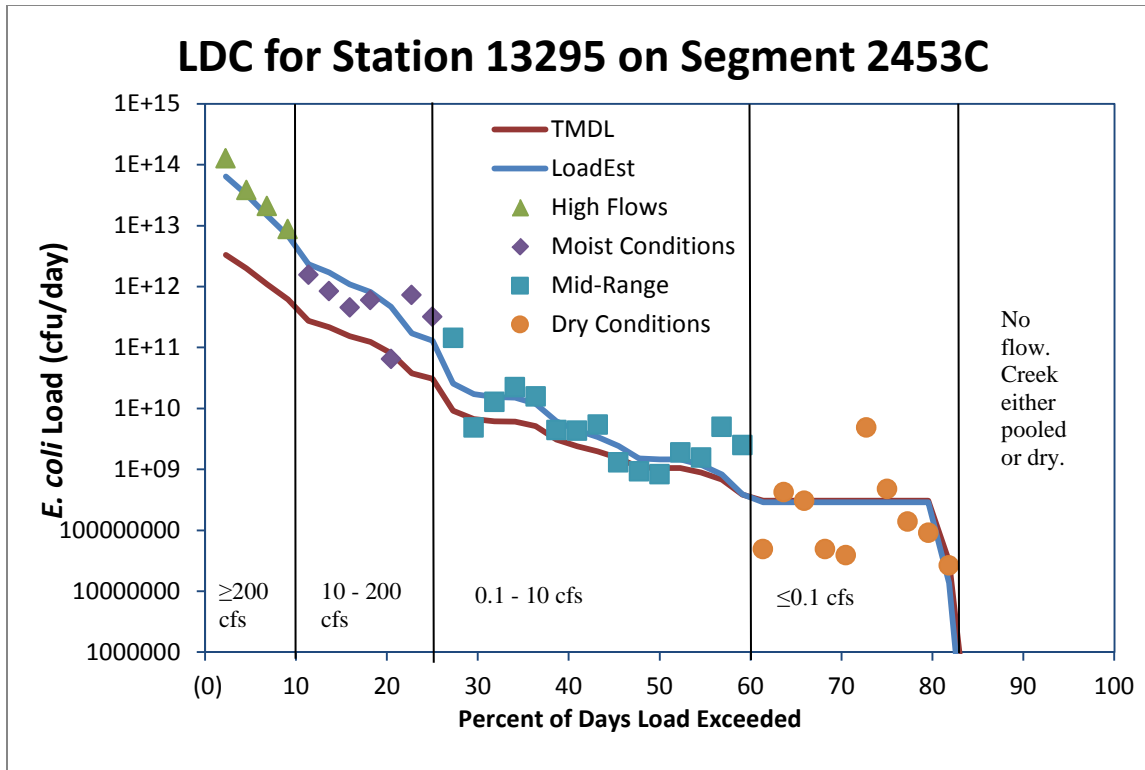
Figure 14. Load Duration Curve for Arenosa Creek at County Road 103

The FDC is then multiplied by the water quality standard and the appropriate unit conversion to establish the Total Maximum Daily Load (TMDL) line or the maximum allowable pollutant load. The monitored loading is approximated by plotting paired pollutant concentration (*E. coli*) data with recorded stream flow levels. Once plotted, the majority of *E. coli* data should be below the TMDL line, which indicates that the water body supports the applicable water quality standard. As seen in Figure 14, the majority of *E. coli* loading does not fall below this TMDL line.

Data collected by the GBRA and TWRI were used in this LDC analysis. There were sufficient paired data points (44 paired streamflow and *E. coli* concentrations) to create a LDC that provided evidence of nonpoint sources of *E. coli* loading within Arenosa Creek. Reductions in *E. coli* loads are needed under high flows, moist conditions and mid-range flows to meet the primary contact recreation standard (Table 5). In several instances, *E. coli* samples were collected when the stream only maintained pools of water that were not flowing. These data are not reflected in the LDC as no *E. coli* load exists if flow is not present.

This LDC assessment suggests that that non-point sources and resuspension of *E. coli* in stream bed sediment are the main drivers of the bacterial impairment in Arenosa Creek.
