Failure of Zr₅₀Ti_{16.5}Cu₁₅Ni_{18.5} Amorphous Metallic Ribbon

J. Miškuf,^{1,a} K. Csach,^{1,b} A. Juríková,^{1,c} V. Ocelík,^{2,d} V. Bengus,^{3,e} and E. Tabachnikova^{3,f}

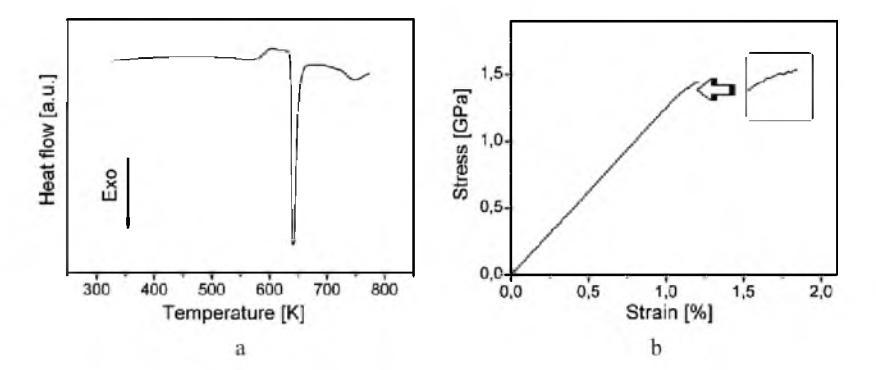
Results and Discussion. A wide temperature region of undercooled liquid state above the glass transition temperature T_g (592 K) up to the crystallization temperature T_x (629 K) is typical for the amorphous alloy $Zr_{50}Ti_{16.5}Cu_{15}Ni_{18.5}$ as demonstrated by the DSC thermogram in Fig. 1. The ribbon samples were loaded under uniaxial tension. The measured fracture stress was 1.53 ± 0.15 GPa which is similar to that reported in [4, 5]. The stress–strain curve for $Zr_{50}Ti_{16.5}Cu_{15}Ni_{18.5}$ at a strain rate of $2.6 \cdot 10^{-3}$ s⁻¹ at 300 K under uniaxial tension is shown in Fig. 1 on the right side. Multiple seriations were

Fig. 1. DSC trace of $Zr_{50}Ti_{16.5}Cu_{15}Ni_{18.5}$ at a heating rate of 20 K/min (a). Stress–strain curve at strain rate of $2.6 \cdot 10^{-3} \text{ s}^{-1}$ under uniaxial tension at temperature 300 K (b).

The observed macroscopic plastic deformation was just about 0.5%. The fracture is localized in a major shear band and the fracture angle between the tensile stress axis and the fracture plane is close to 45° – the failure in the maximum shear stress plane. The reduced free volume results in the deviation of the shear banding direction from the maximum shear stress [7].

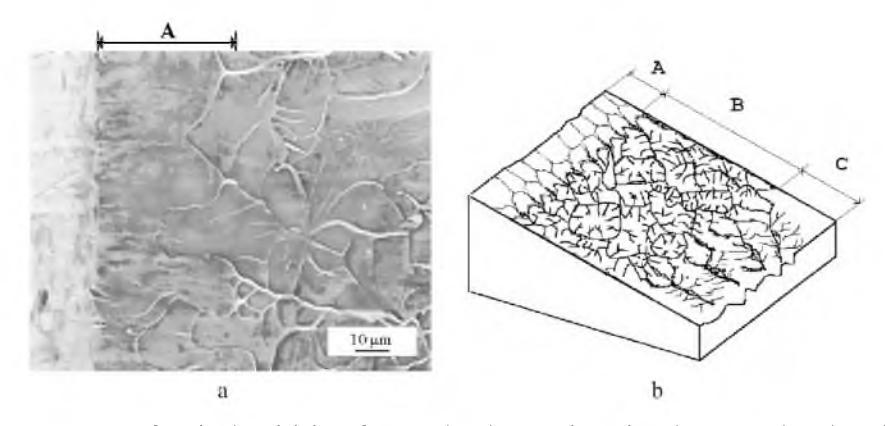
The left side of the fracture surface presented in Fig. 2a shows a vein free area formed during an initial stage of the local shear at the wheel side of the ribbon. This area corresponds to zone A of the scheme shown on the right side of Fig. 2. The scheme summarizes all typical features observed on the fracture surface of 300 μ m thick amorphous ribbons with a wide undercooled liquid state region and fractured by ductile shear failure.

Fig. 2. Fracture surface in the vicinity of a sample edge. An intensive shear near the edge of the fracture surface (a) and the scheme of areas with three characteristic morphologies observed on the fracture surface of a 300 μ m thick amorphous ribbon (b).

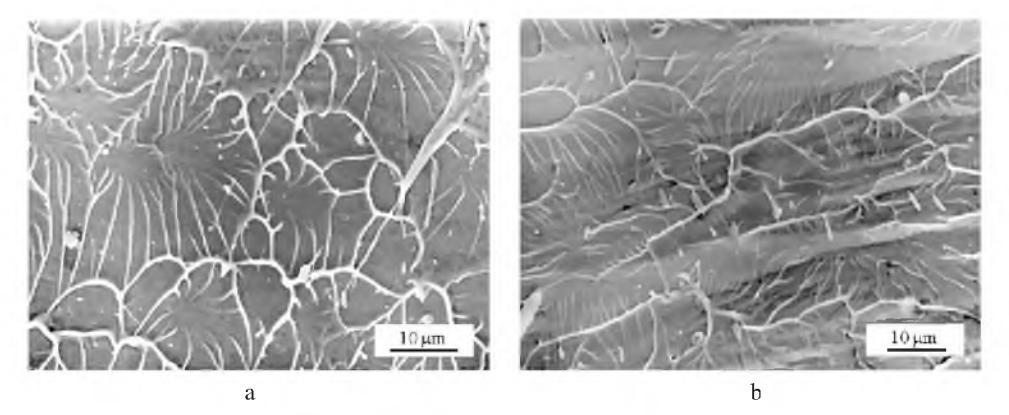
For standard amorphous metallic alloys in the form of ribbons the failure is initiated mostly at surfaces and only occasionally at extraneous particles or intersections of shear bands [9]. On the fracture surface of a 300 μ m thick ribbon we observed the areas with radial veins. These radial veins come out from the central flat area as Fig. 3a clearly shows.

Similar morphology of radial veins was observed on $Zr_{59}Cu_{20}Al_{10}Ni_8Ti_3$ bulk amorphous alloy failed in tensile mode [10]. The fracture nucleates at the central flat part as a consequence of two processes: (i) the nucleation and (ii) the propagation of cores. A subsequent cavity growth proceeds through the formation of radial veins which become finally linked to the main vein around the whole cell – Fig. 3a. The cell contains a flat and radial parts enclosed with secondary vein rings of a cellular unit. No extraneous particles or visible defects are present at flat centers.

Fig. 3. Cellular vein-like morphology together with areas of radial primary veins – zone B (a). "River morphology of fracture surface" corresponding to zone C of the scheme in Fig. 2b.

A complex stress field at the final fracture stage forms distinct relief structures on the fracture surface with a number of aligned veins. The relief fracture surface contains ridges with the main vein at their tops and ditches between them – Fig. 3b. Aligned primary veins propagate from the rivers to the ridges and link into the main one. This type of the vein organization observed on the fracture surface of $Pd_{40}Cu_{30}Ni_{10}P_{20}$ bulk amorphous alloy is called the river morphology of fracture surface [11]. Similar fracture surface morphology of Zr-based bulk metallic glass matrix composites and Cu-based bulk glass after compression testing was observed in [12]. However, the round cores with radial veins were also observed in compression at elevated temperatures [13].
