University of Vermont

ScholarWorks @ UVM

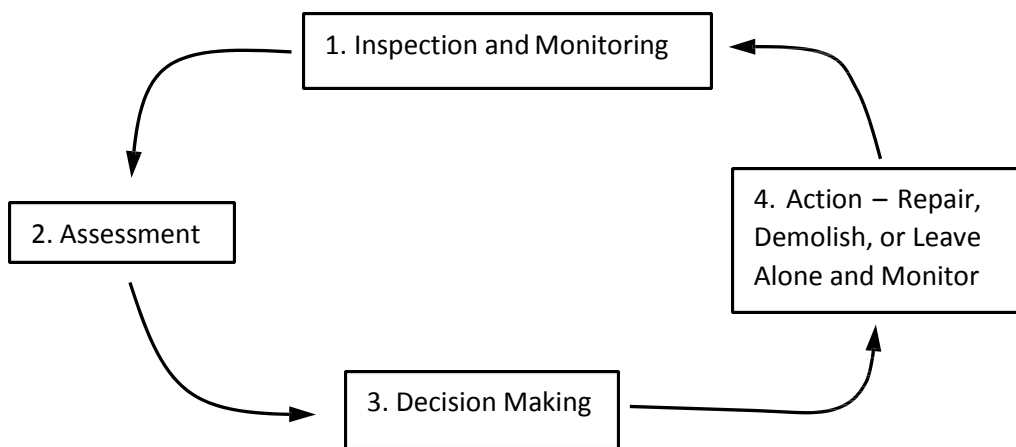
Figure 1.2 Cyclic nature of structural maintenance and repair

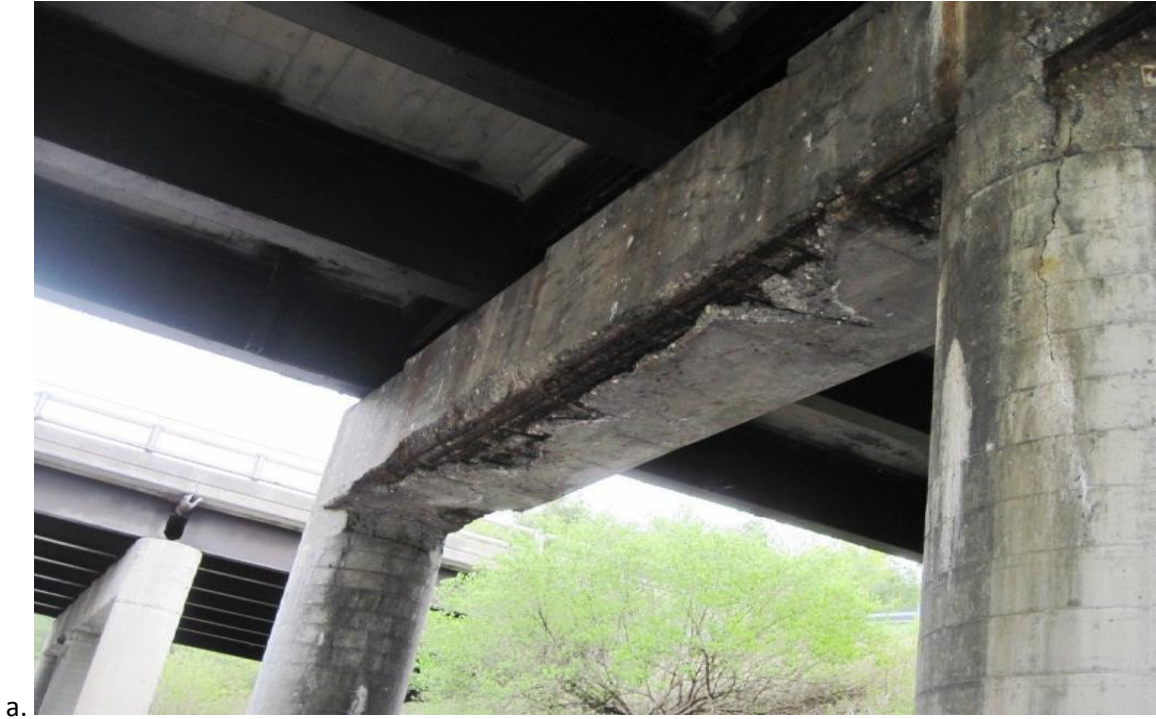
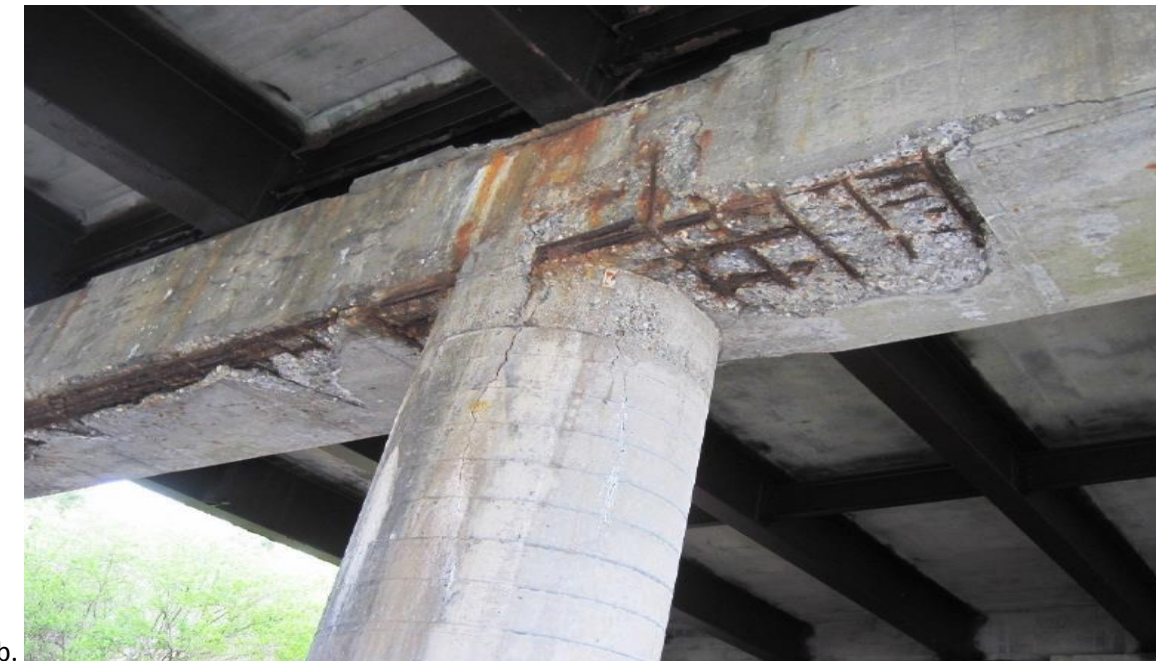
Figure 4.1 I-89 Middlesex Br.#45 S

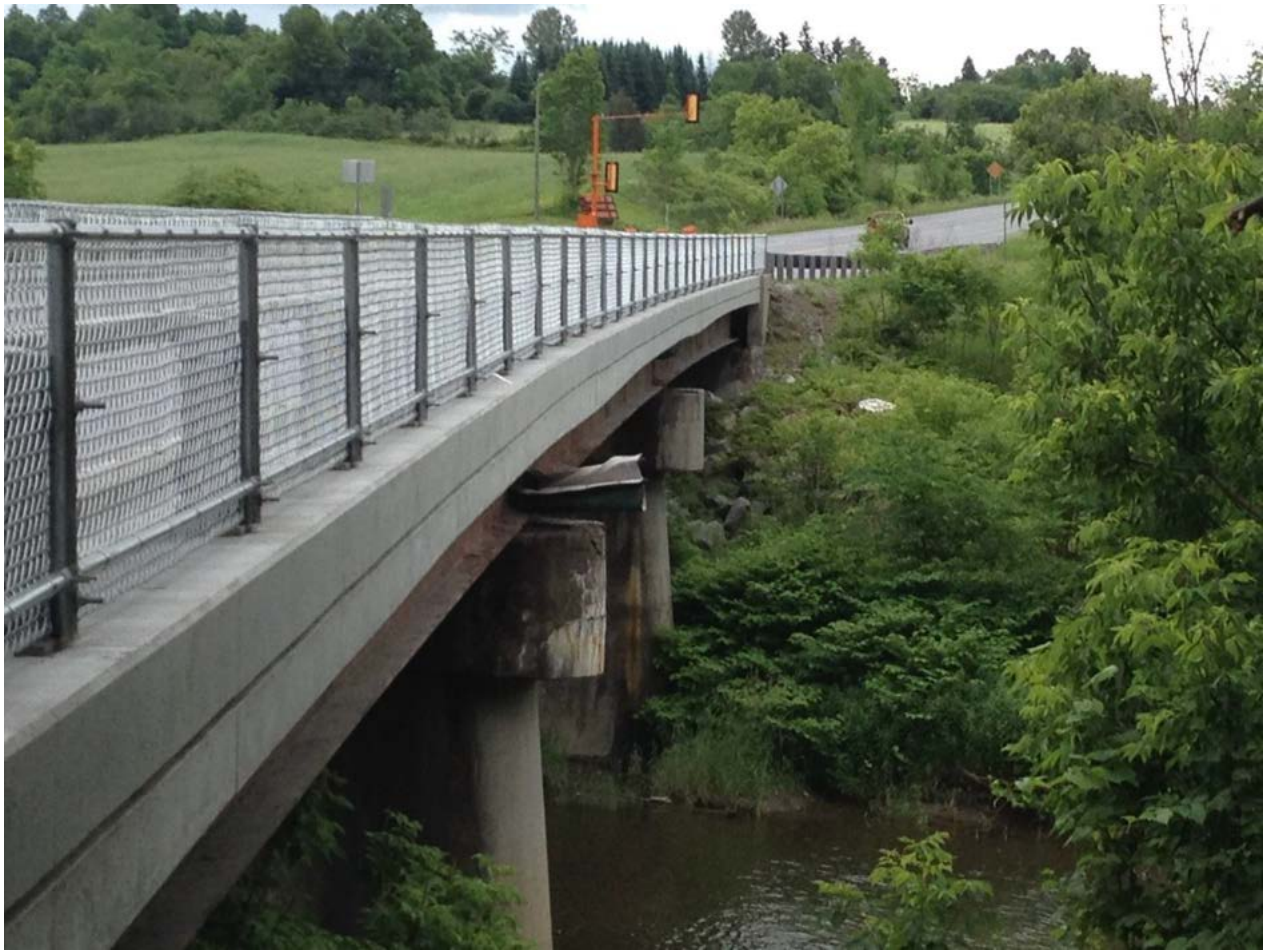
Figure 4.6 US 7 New Haven Br. #129 – REPAIRED Fascia/Curb Reconstruction, \$350,000

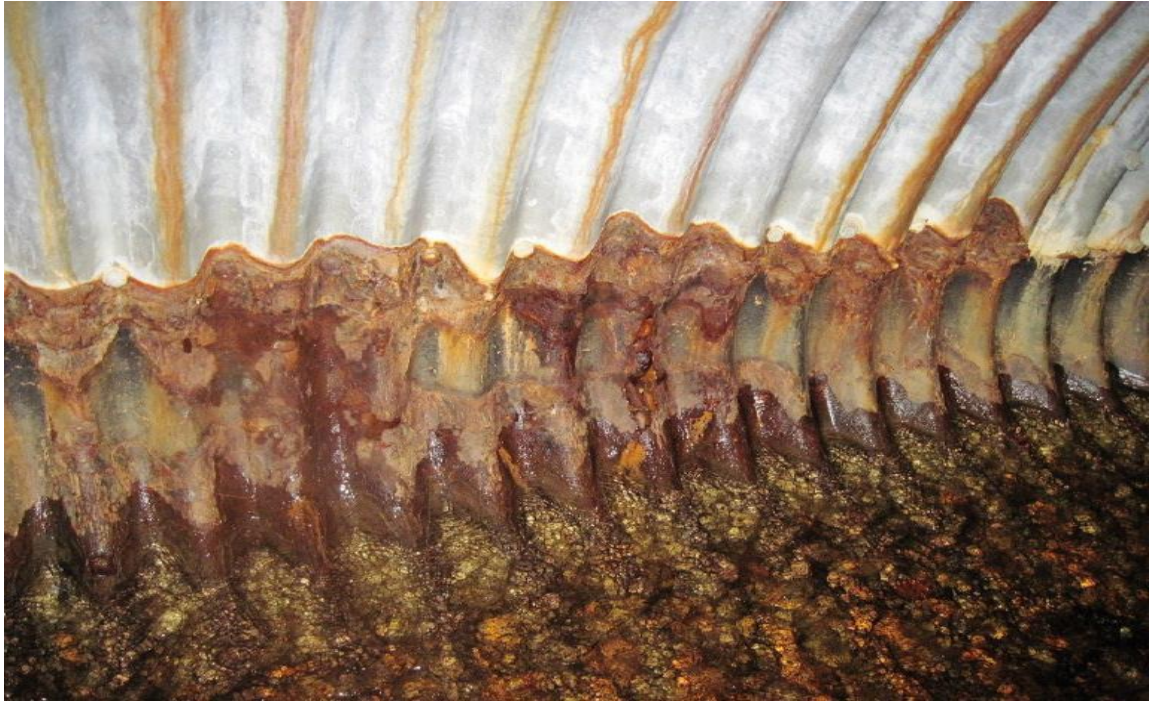
Bridges with integrated water flow structures, such as corrugated steel arches, can suffer damage at the water flow line due to corrosion and erosion. Figure 4.7 shows the Vt. Rte. 30 Winhall Br. #45 with a severely damaged corrugated steel flow line. Figure 4.8 shows a repair that replaced the flow line with concrete.

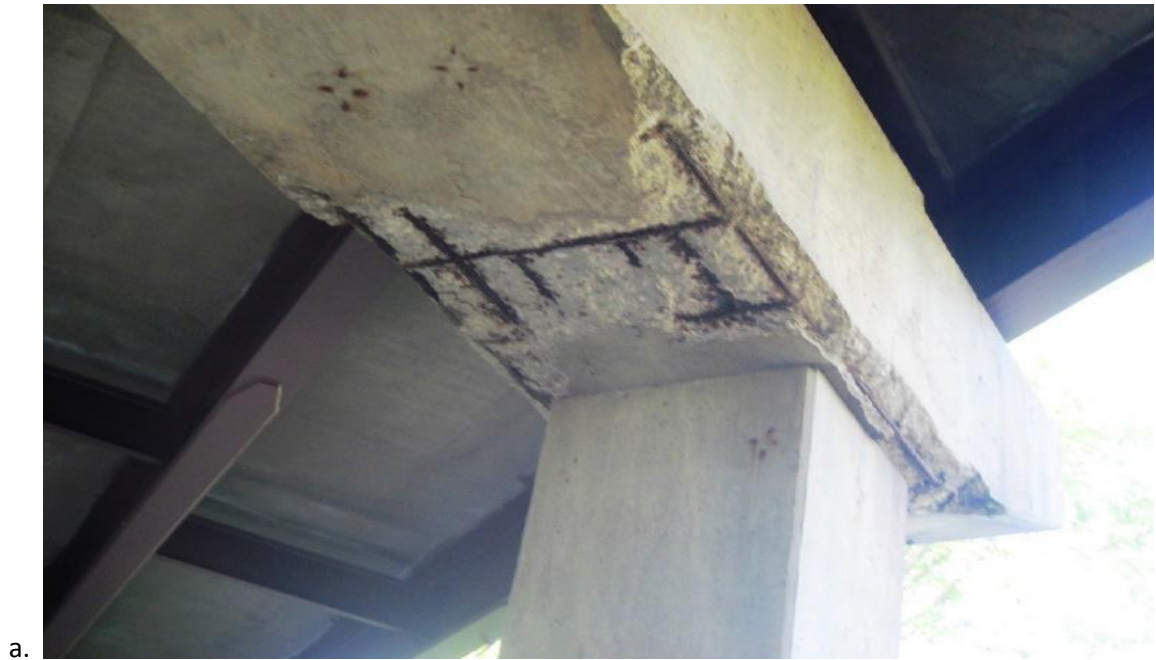
Figure 4.14 Vt. Rte. 11 Londonderry Br. #27 – REPAIRED Pier Repairs, \$120,000

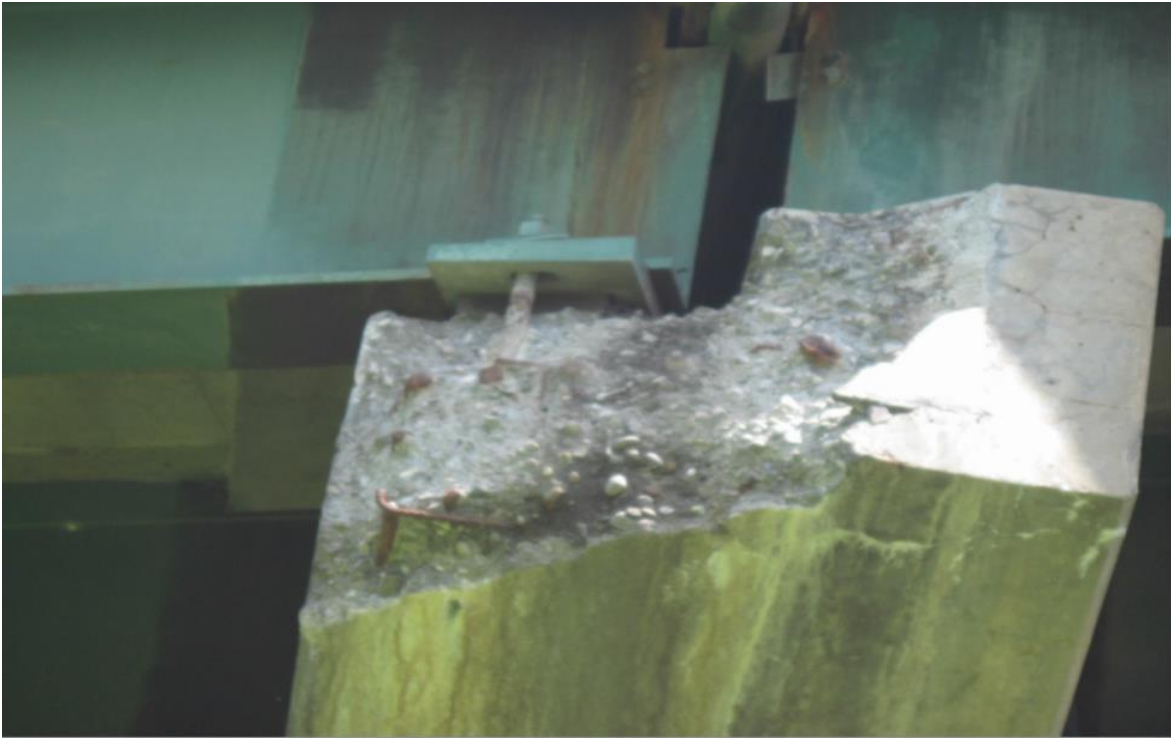
Figure 4.18 River Street Rutland City Br. #27 – REPAIRED

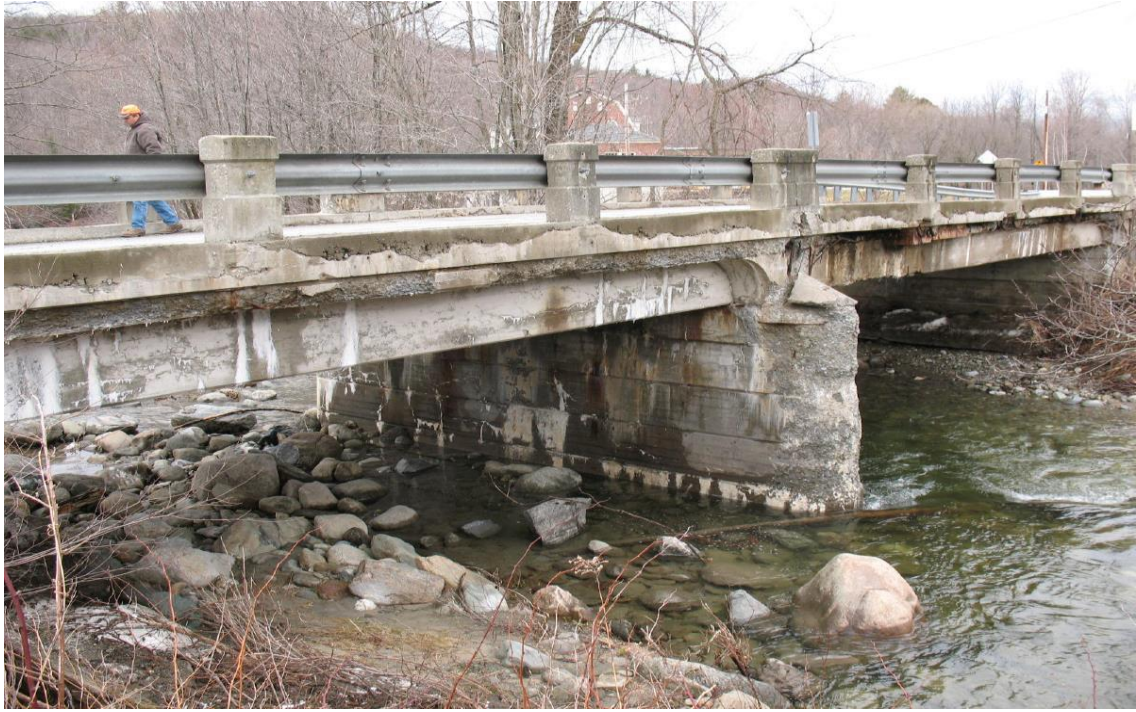
Many short span bridges in Vermont use combinations of integrated concrete beams and decks, with T-beam/deck combinations as common variants. The integration of concrete beams and decks produces an efficient structural form, but can result in combined damage to both the deck and beams, which leads to combined repairs. Figure 4.23 shows damage to both the deck and beams in Vt. Rte. 105A Richford Br. #2. Figure 4.24 shows a reconstruction repair. Figure 4.25 shows Vt. Rte. 12 Woodstock Br. #19 with considerable spalling from both the deck and the beam. Figure 4.26 shows the repaired bridge.

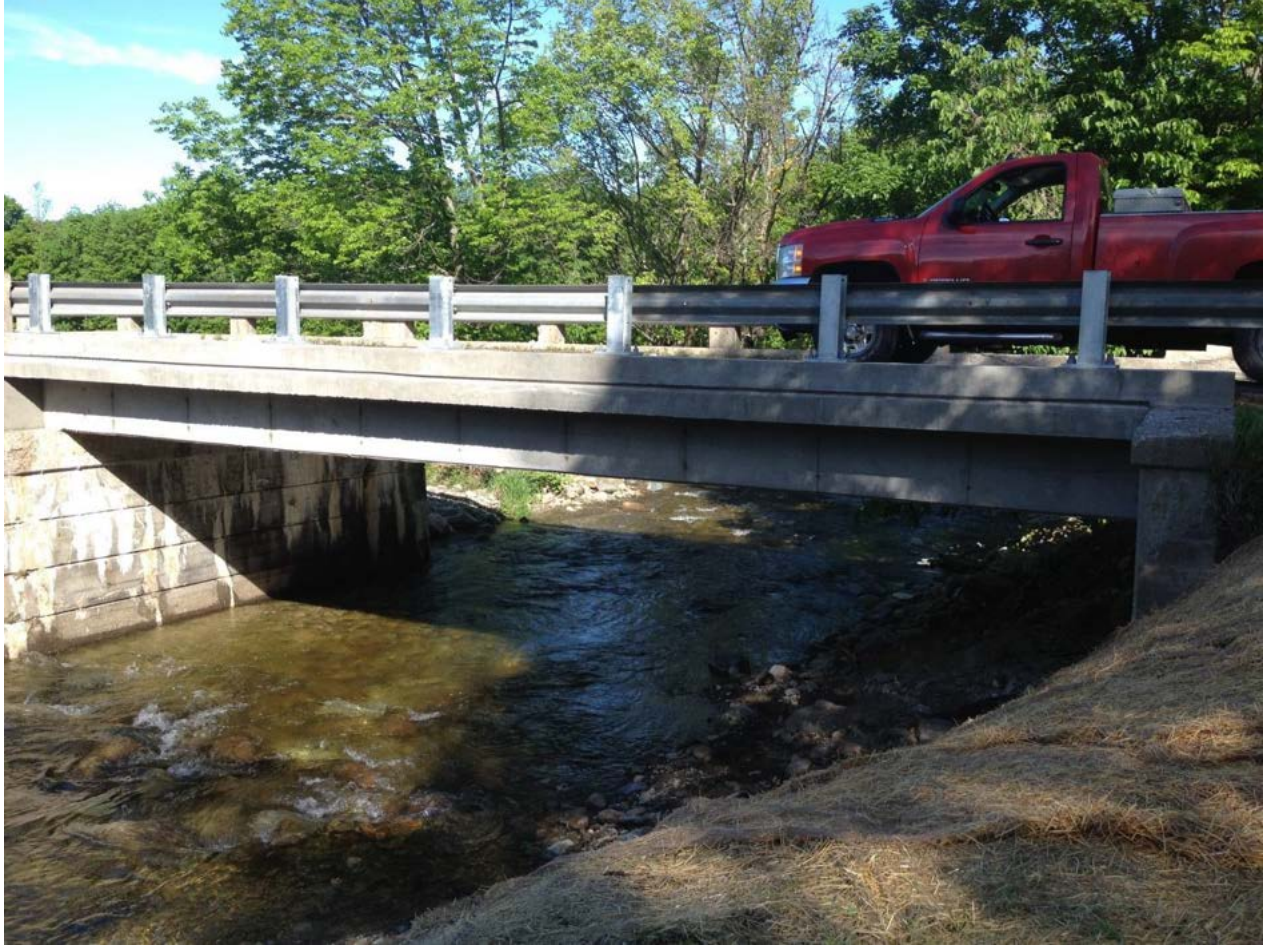
Figure 4.24 Vt. Rte. 105A Richford Br. #2 –REPAIRED T Beam/Deck Reconstruction \$150,000

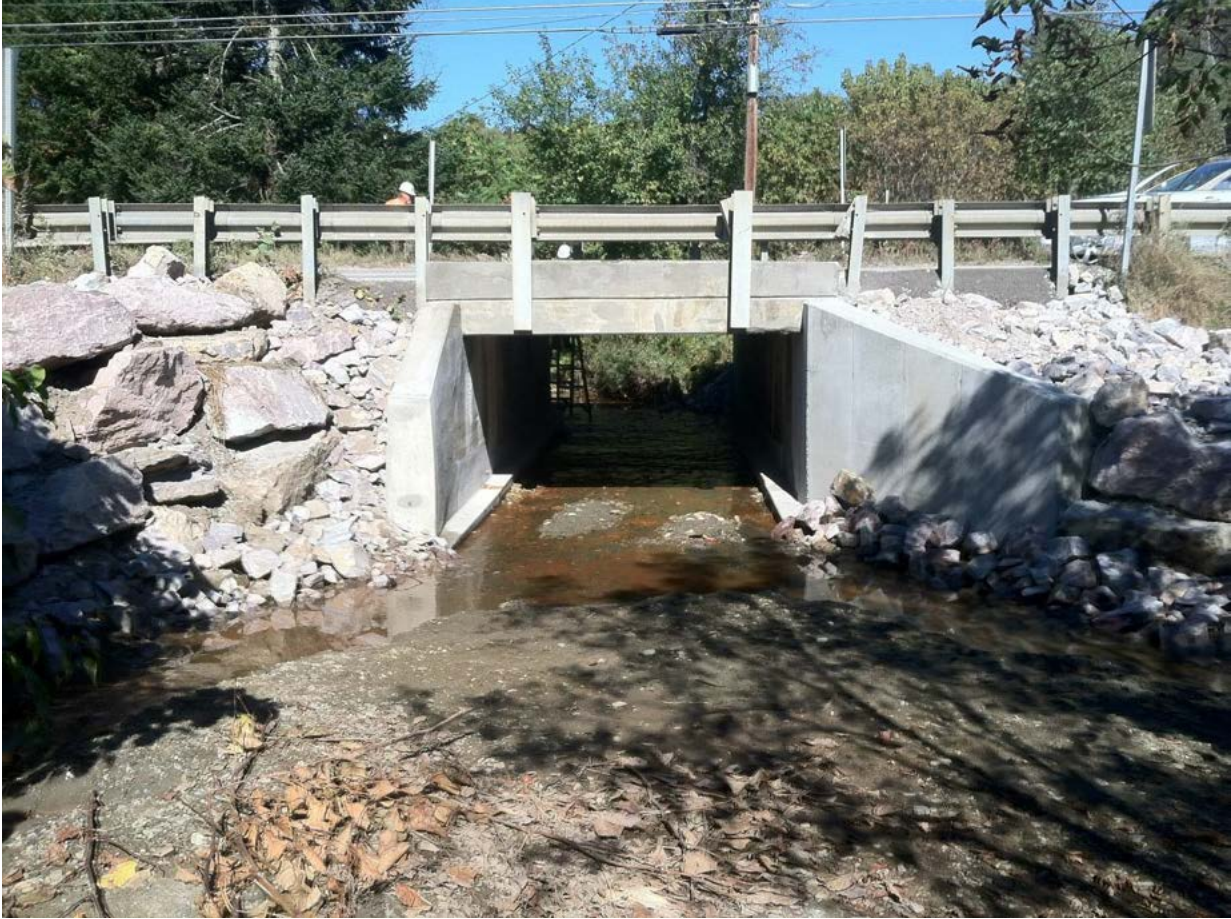
Figure 4.28 Vt. Rte. 12 Berlin Br. #70 - REPAIRED Head Wall/Wing Wall Reconstruction, \$150,000

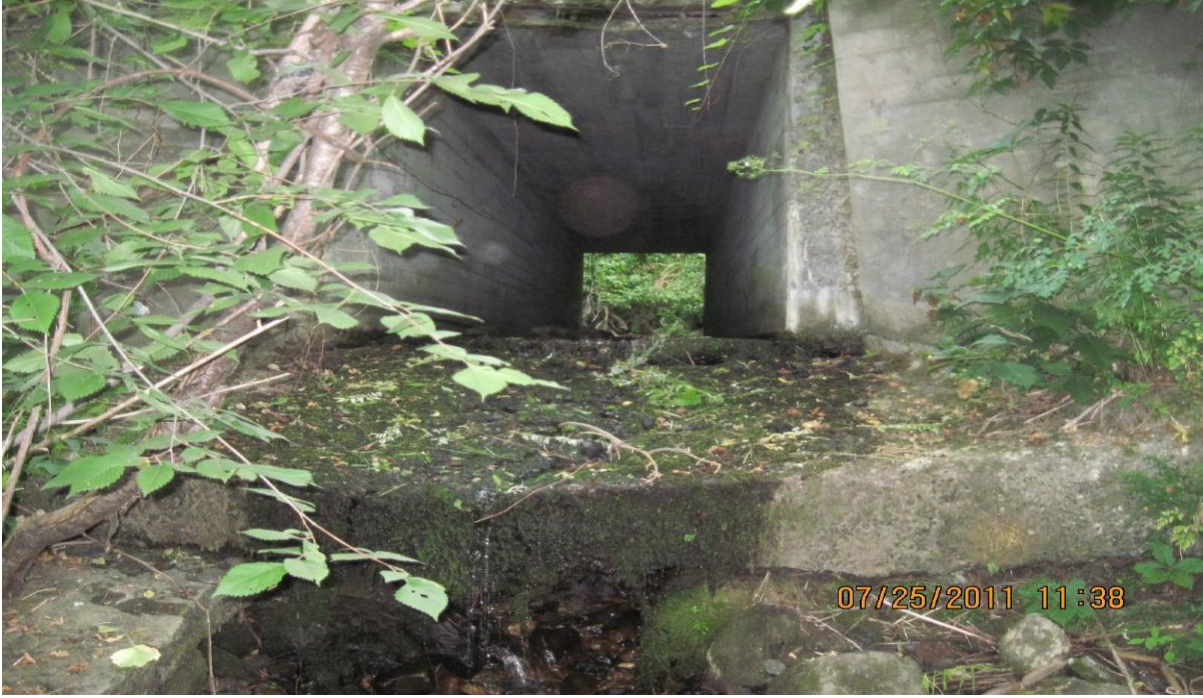
Figure 4.30 Vt. Rte. 12 Elmore Br. #95 - REPAIRED Wing Wall Encasement, \$100,000

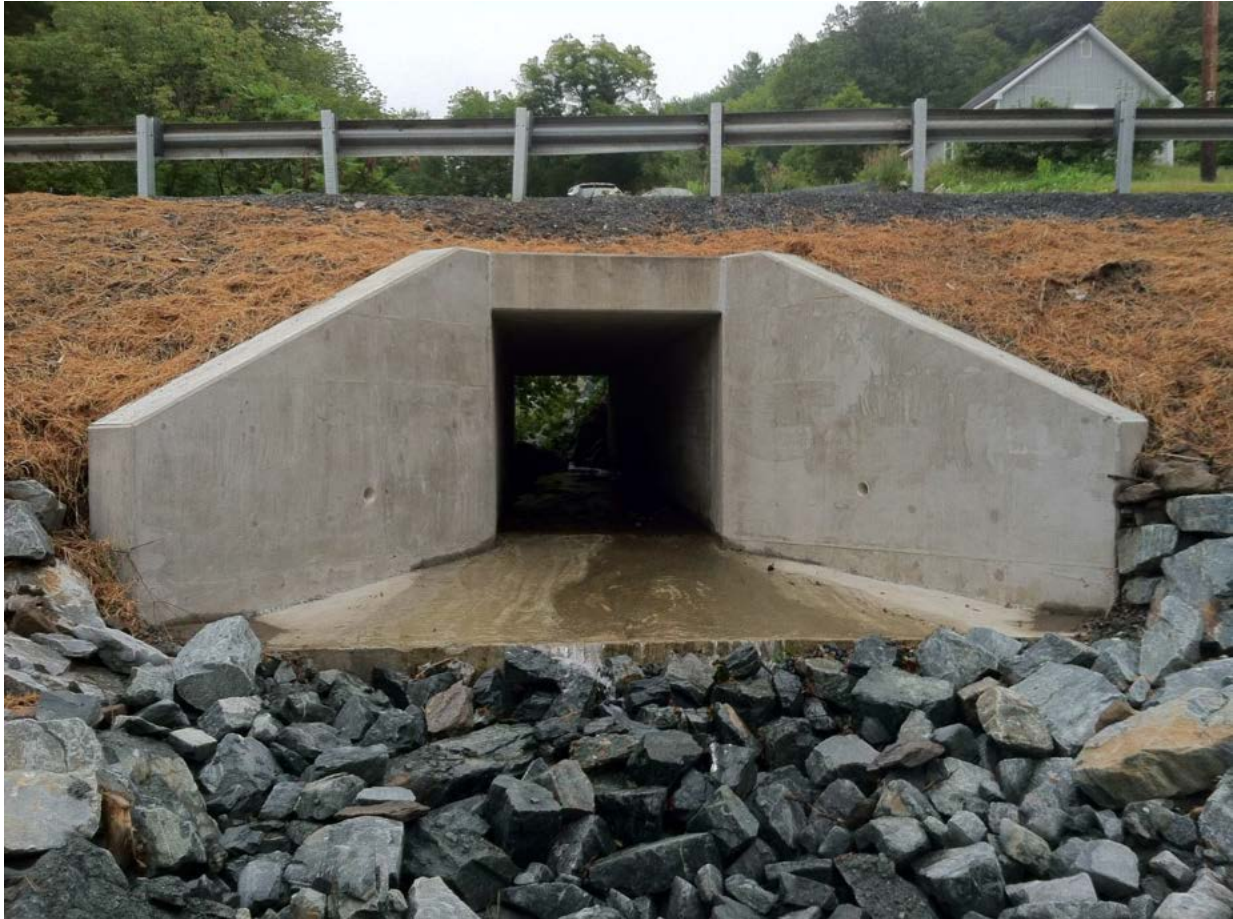
Figure 4.32 Vt.Rte.14 Hartford Br.#7 - REPAIRED Wing Wall/ Cut-off Wall Reconstruction \$180,000

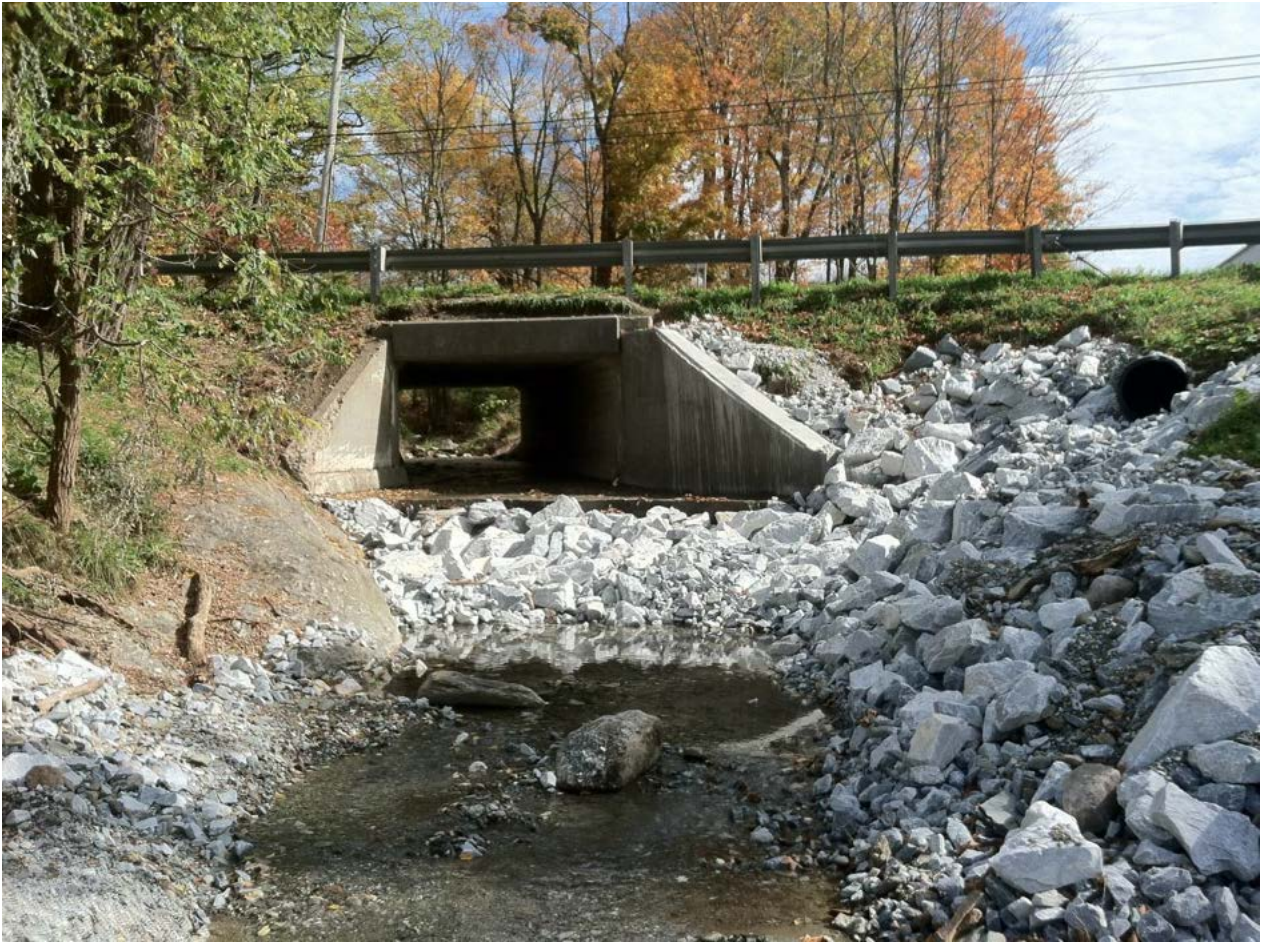
Figure 4.34 Vt. Rte. 30 Pawlet Br. #78 - REPAIRED Wing Wall reconstruction, \$80,000

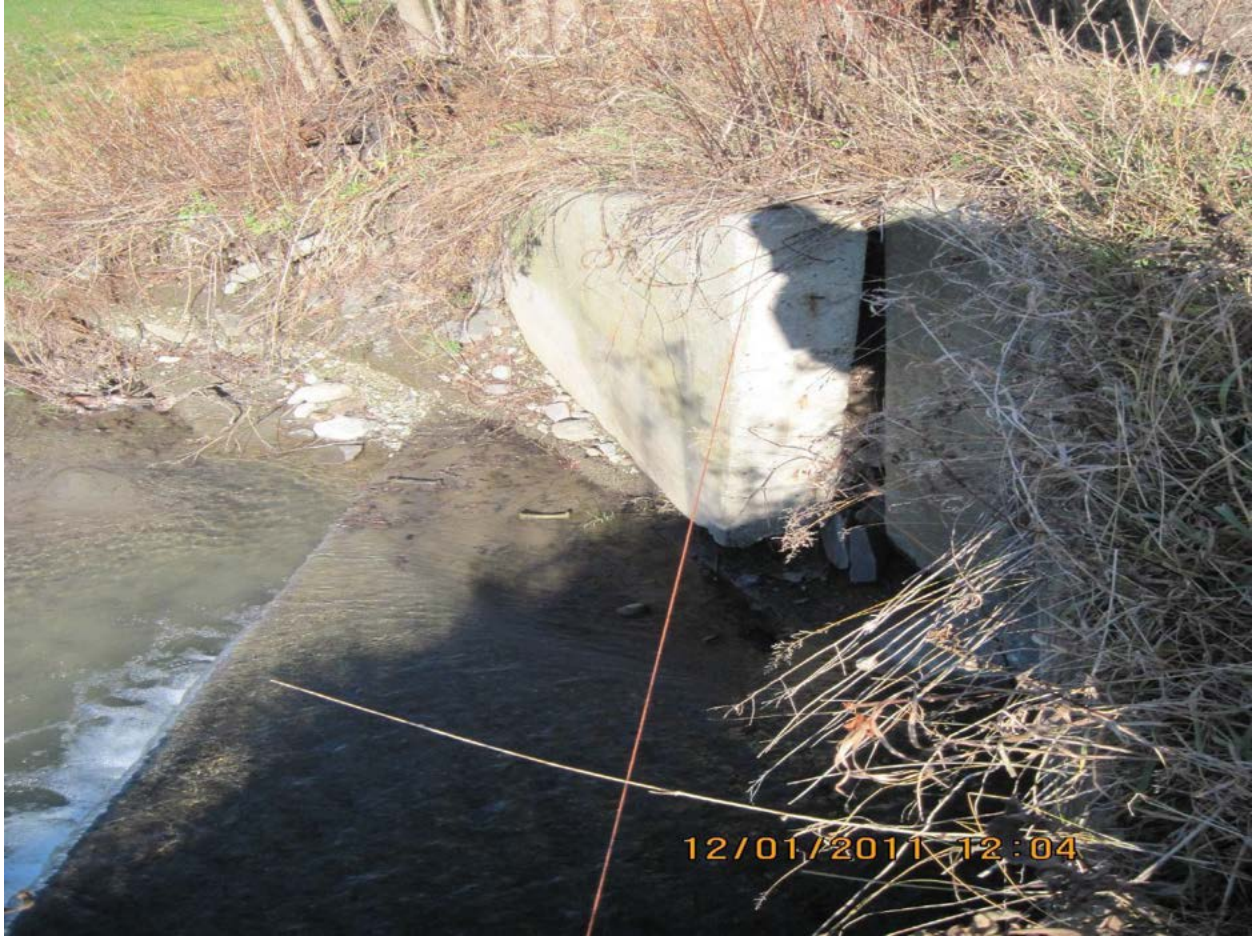
Figure 4.35 Vt. Rte. 30 Pawlet Br. #77

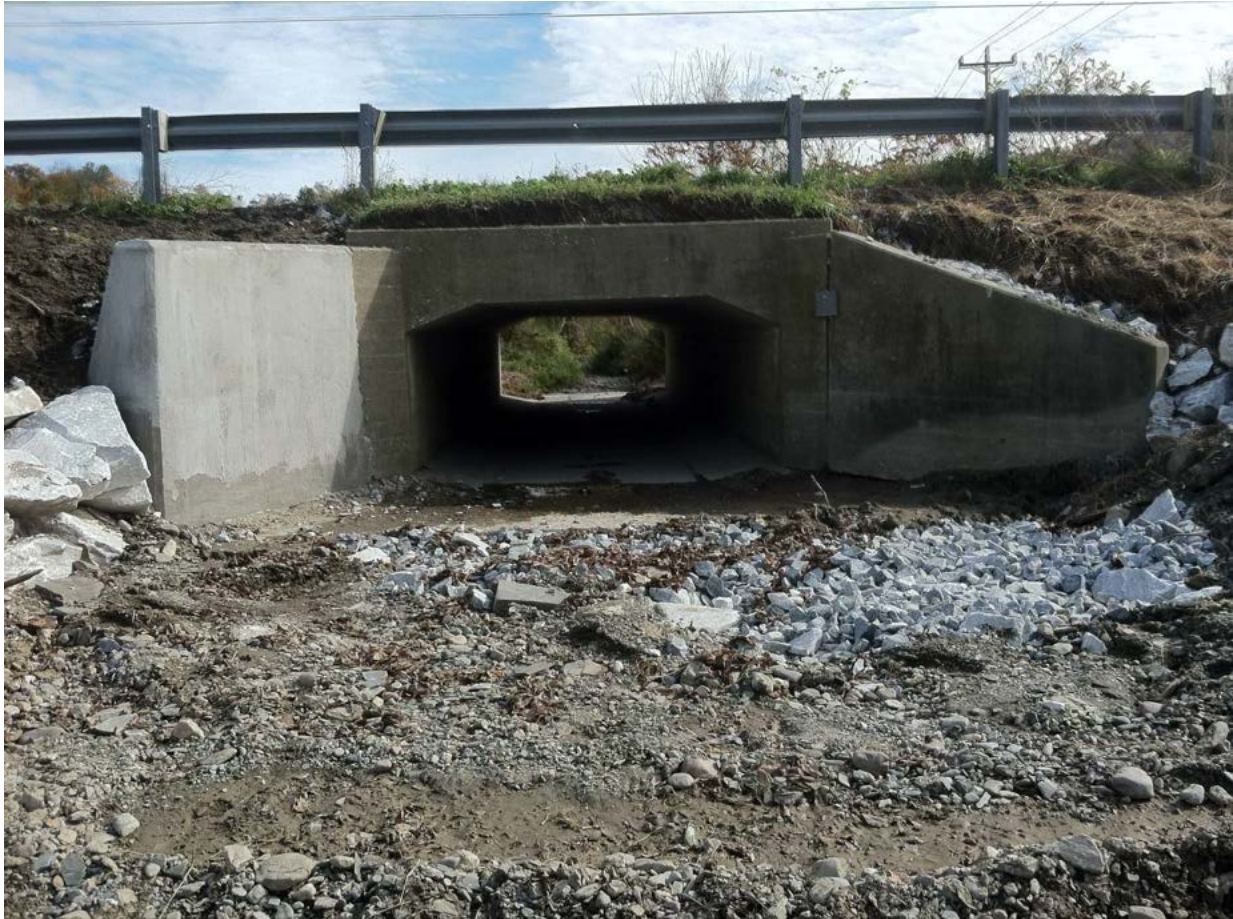
Figure 4.36 Vt. Rte. 30 Pawlet Br.#77 - REPAIRED Wing Wall/ Cut-off Wall Reconstruction \$100,000

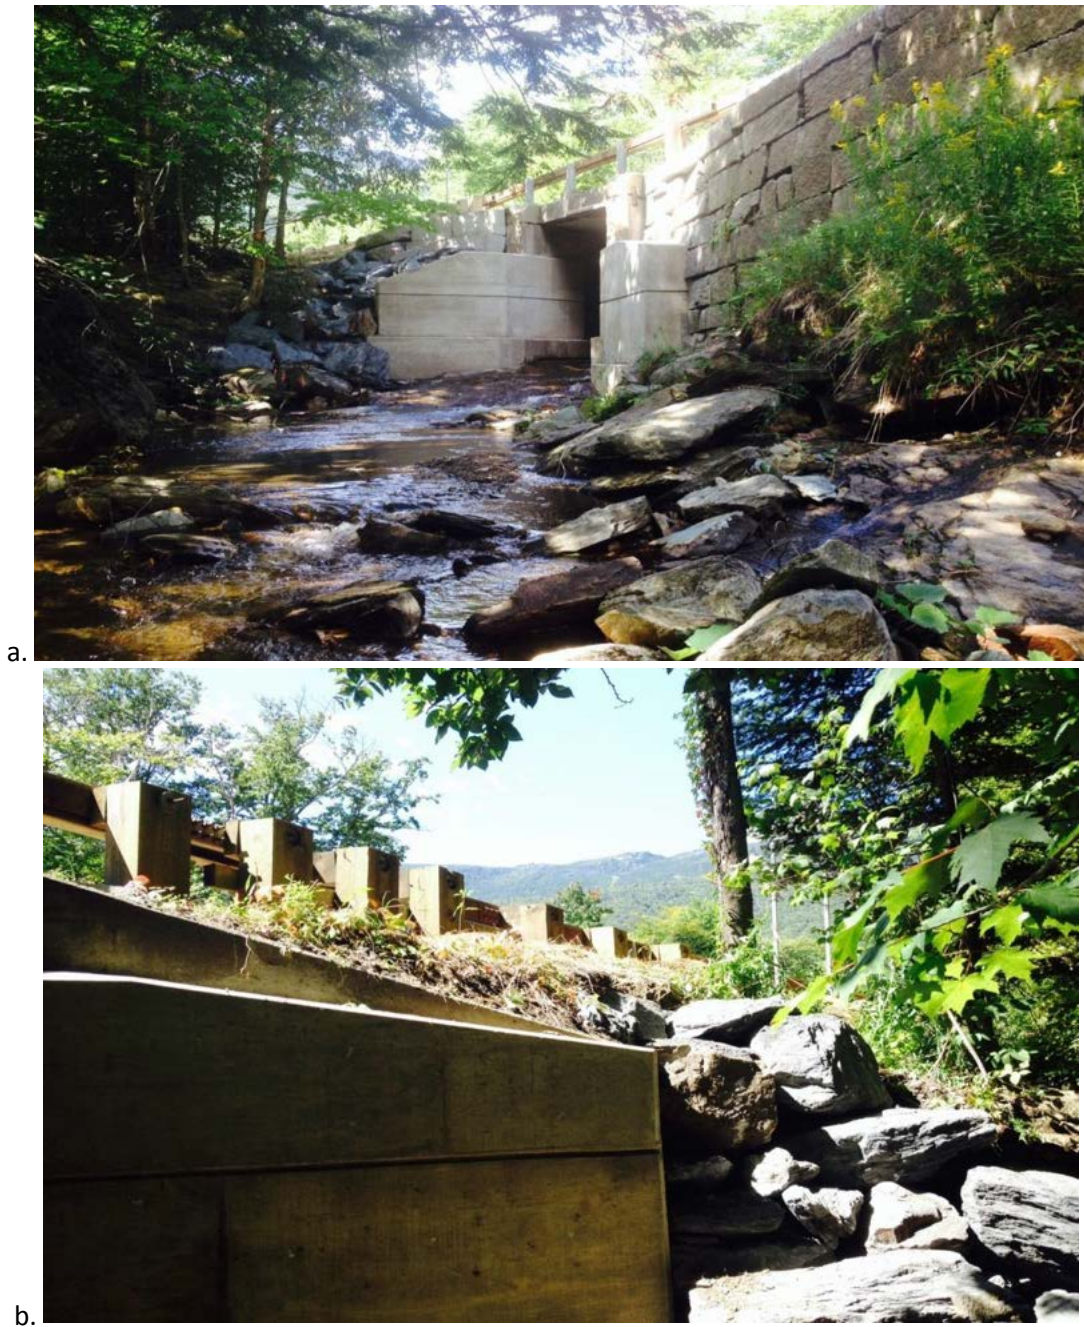
Figure 4.38 Vt. Rte. 108 Stowe Br. #10 – Repaired Wing Wall Encasement/ Other Repairs, \$200,000

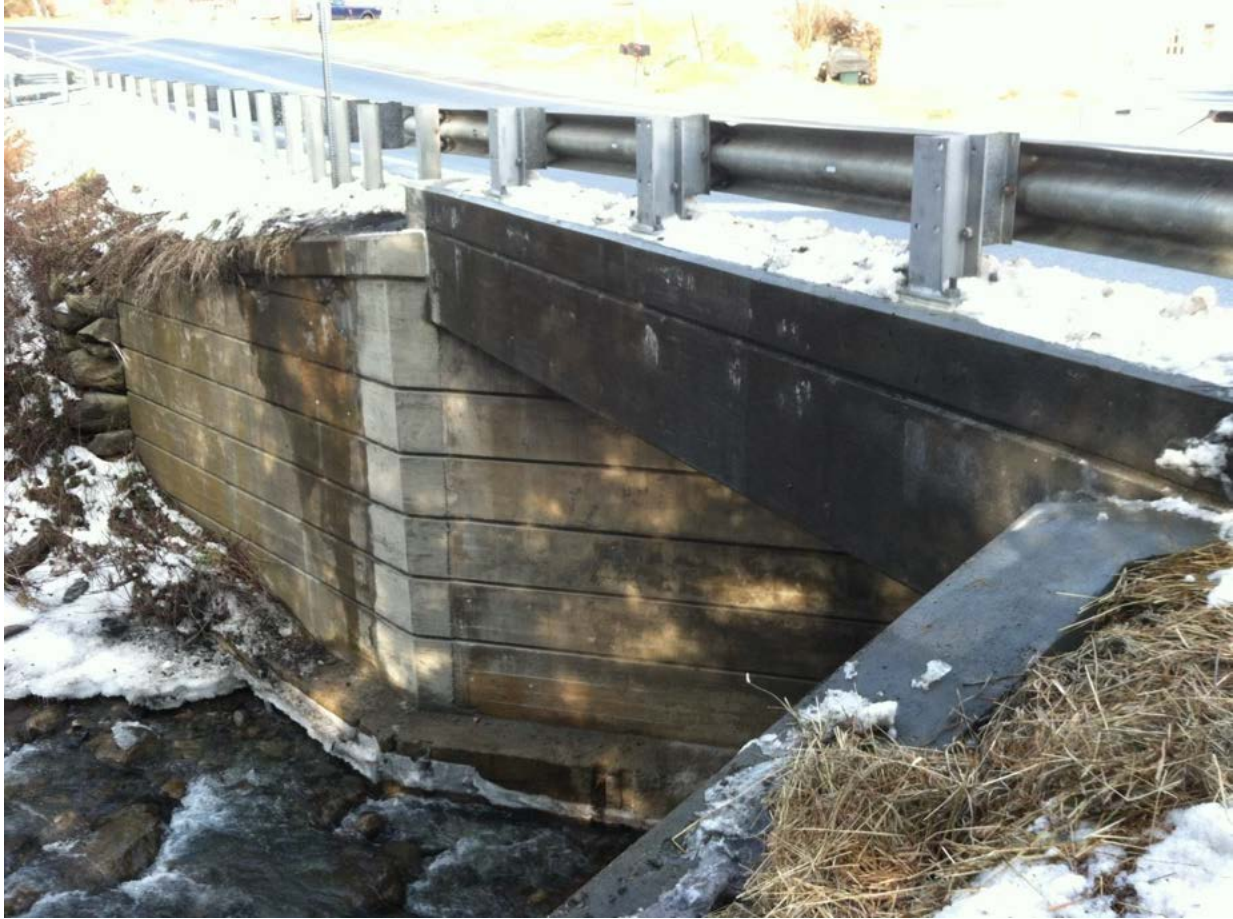
Figure 4.42 Vt. Rte. 113 Vershire Br. #11 - REPAIRED Deck/Wing Wall Repairs, \$150,000

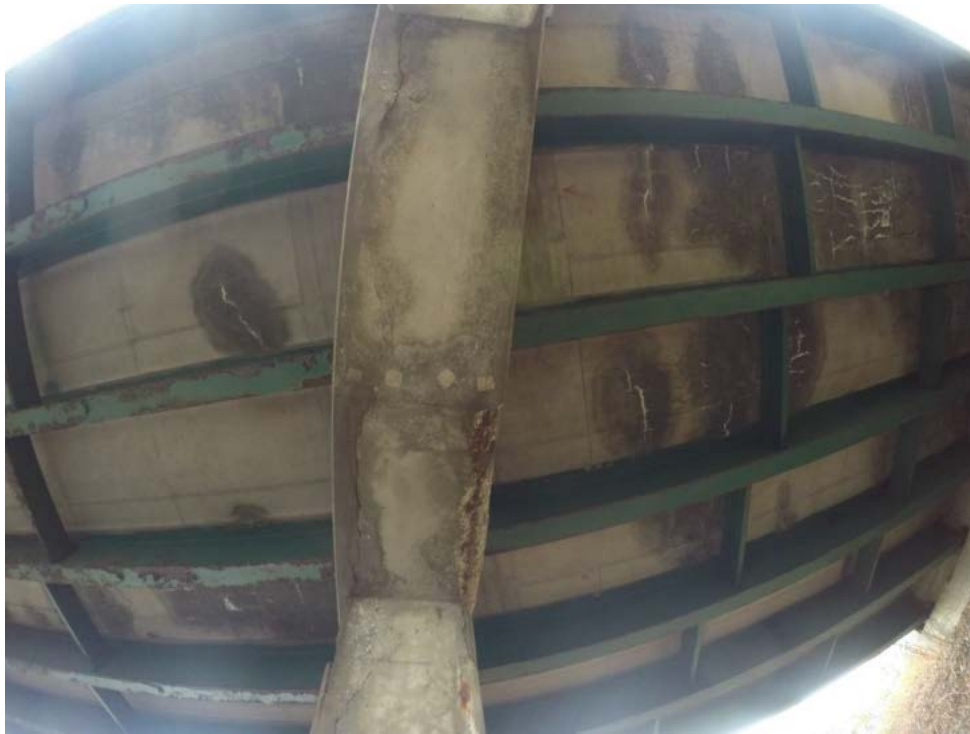
Figure 5.10 Spalling on underside of pier on Colchester/Milton I-95 Bridge. The deck is also showing some distress.

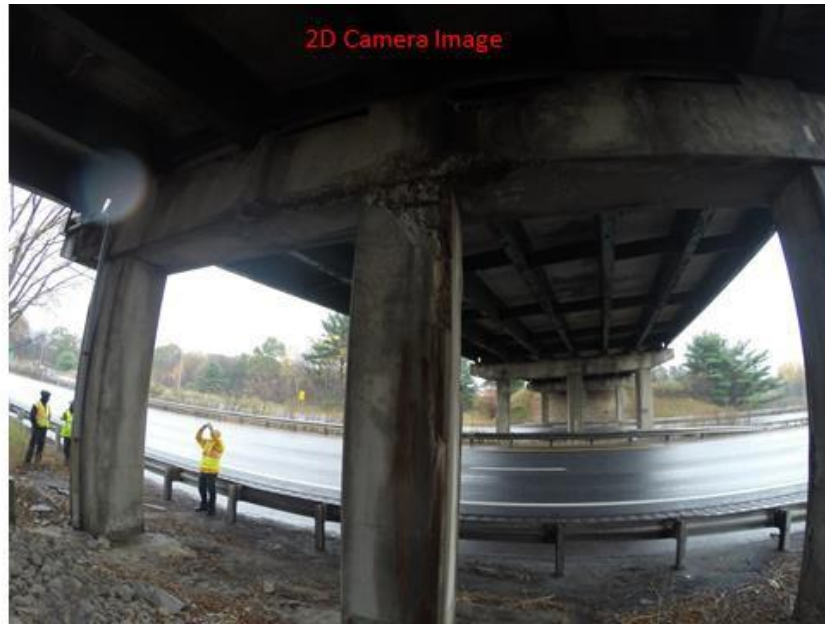
Figure 5.12 Spalling on column of Colchester/Milton I-89 Bridge

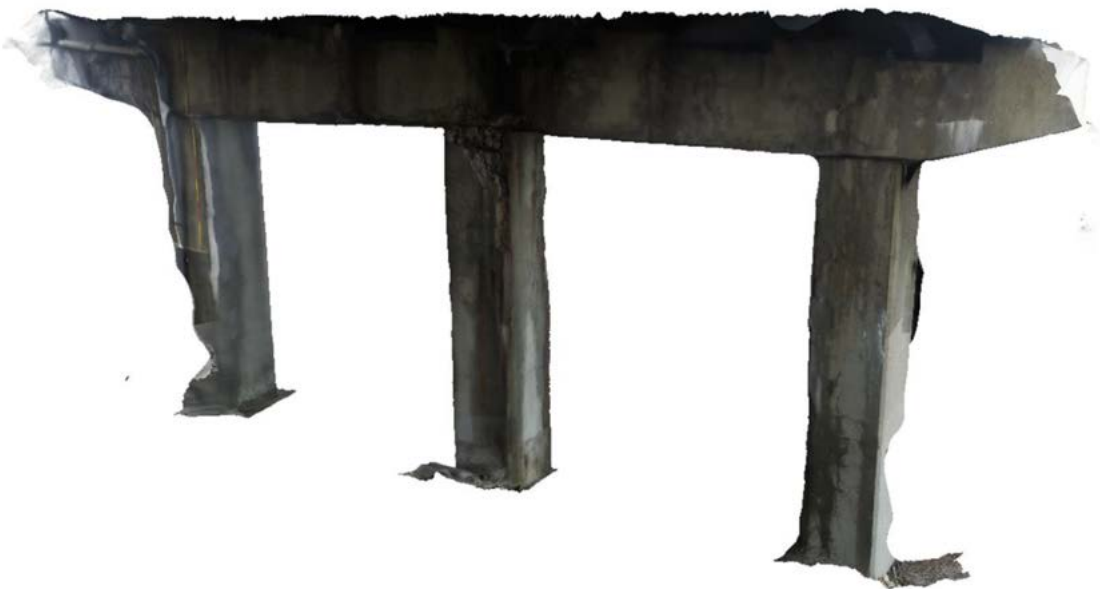
Figure 5.13 3-D photogrammetric point cloud rendering of Colchester/Milton I-89 Bridge

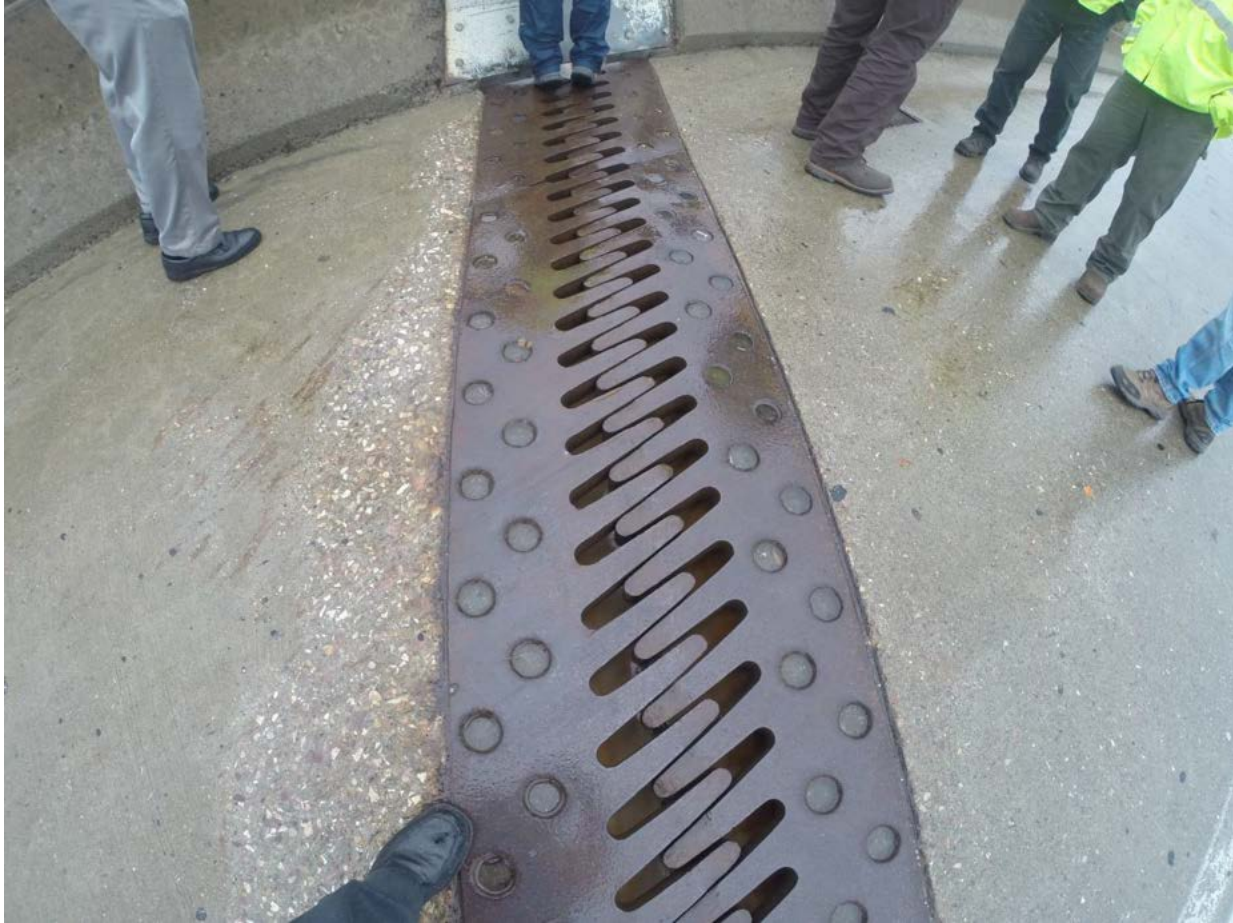
Figure 5.17 Finger expansion joint on US 2 Lamoille River Crossing Bridge

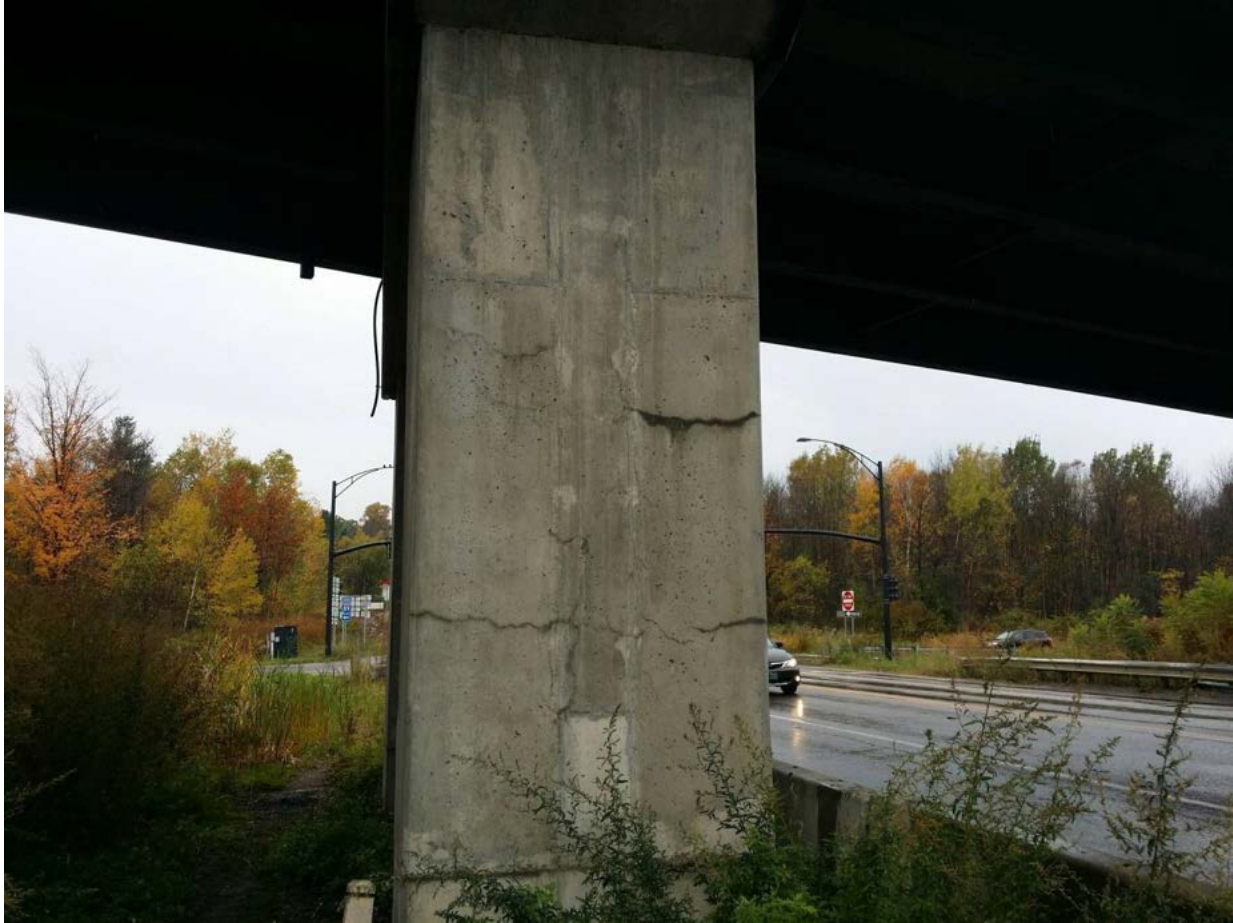
Figure 5.19 Encasement repaired column on Williston I-89 Overpass Tafts Corner, with visible cracking

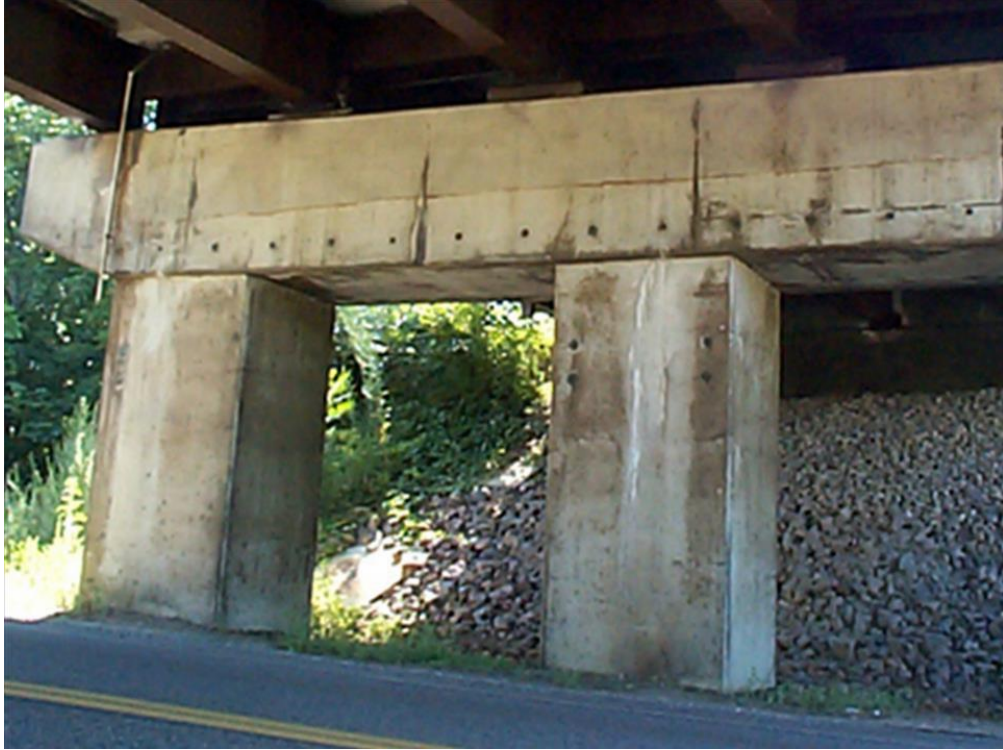
Figure 5.20 Spear St. I 189 Overpass Bridge pier in 2000 recently encased, with cracks

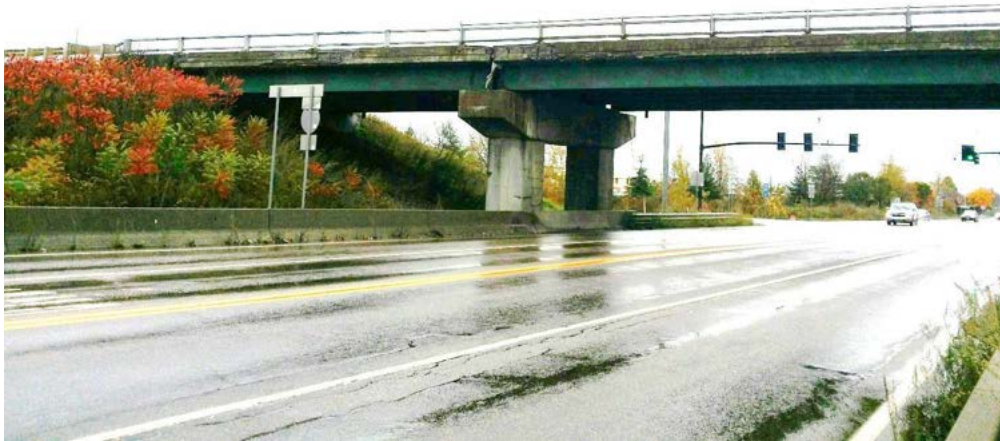
Figure 5.21 Williston I-89 Overpass Tafts Corner with encasement repair of the pier, failed expansion joint gutter and distressed fascia
