University of Vermont

ScholarWorks @ UVM

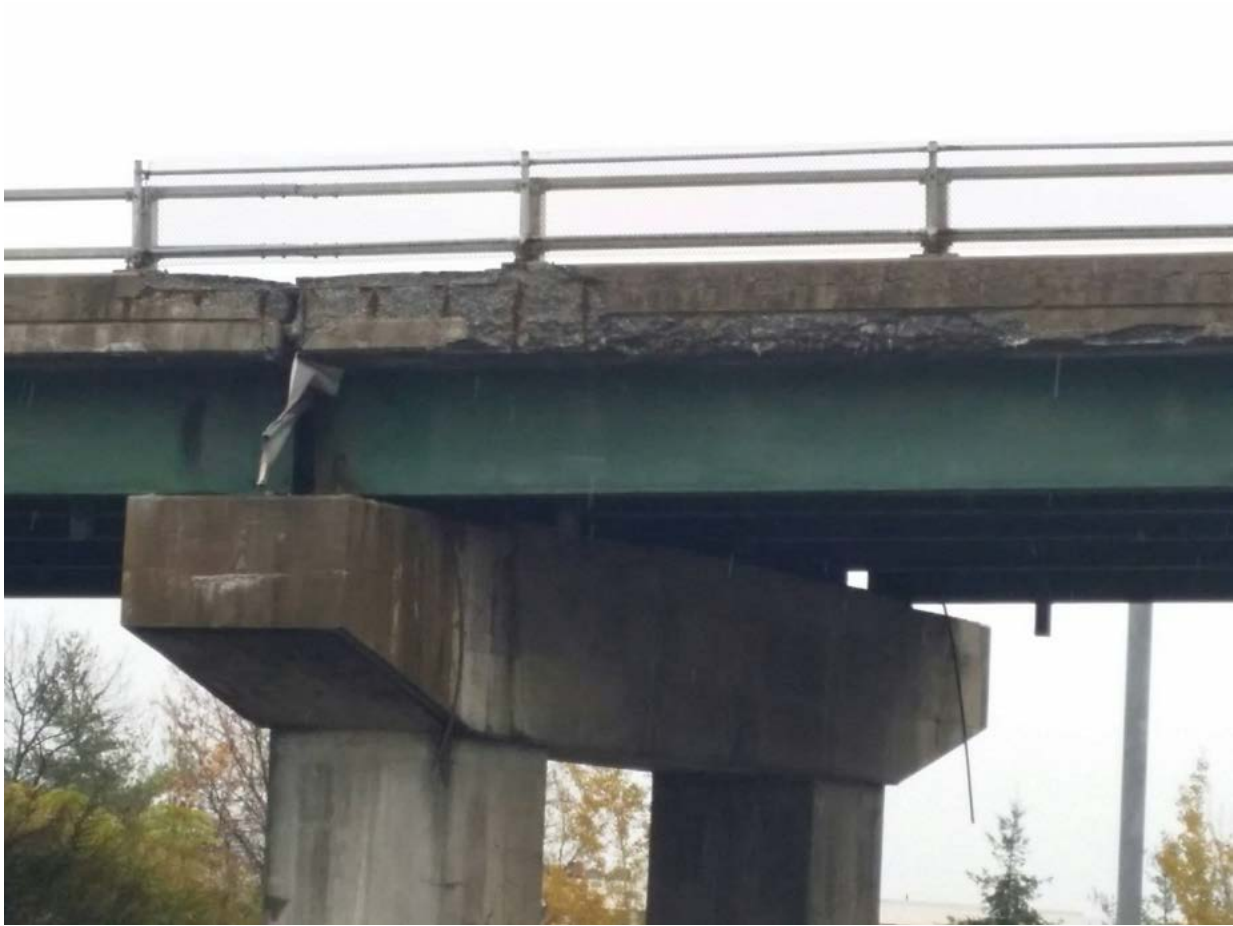
Figure 5.22 Closeup of Williston I-89 Overpass Tafts Corner with encasement repair of the pier, failed expansion joint gutter and distressed fascia

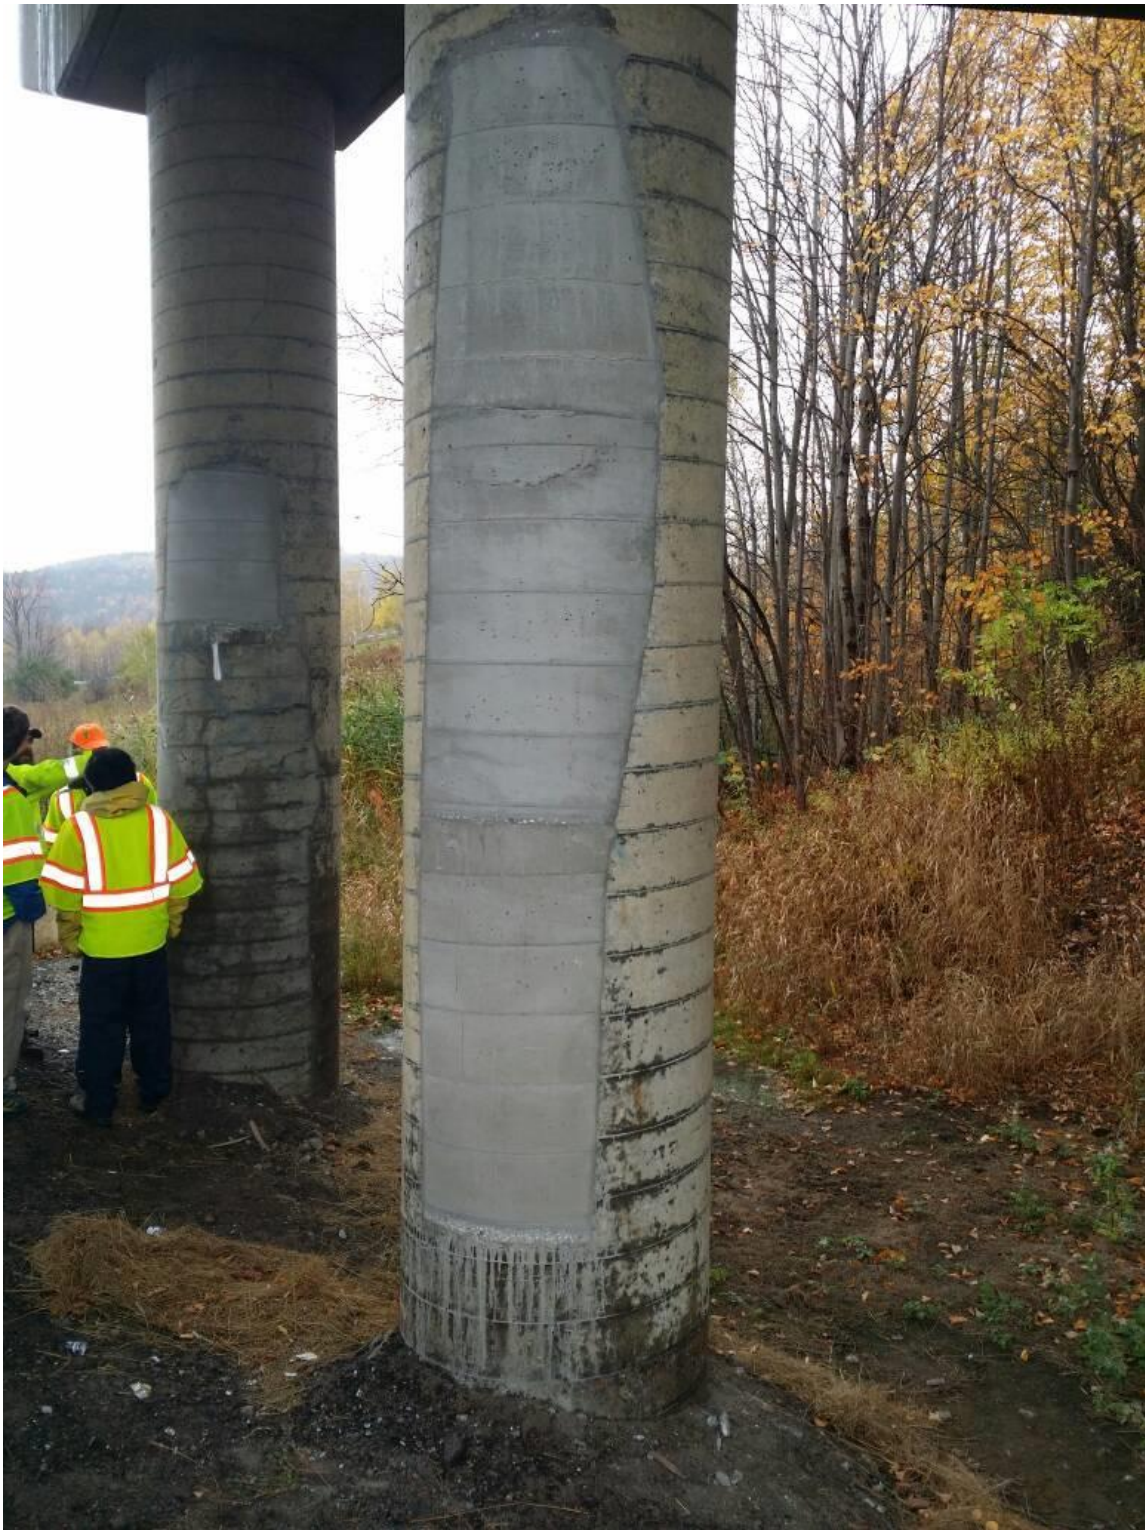
Figure 5.25 Large column patch repair #1 on Williston I-89 Oak Hill Rd Underpass Bridge

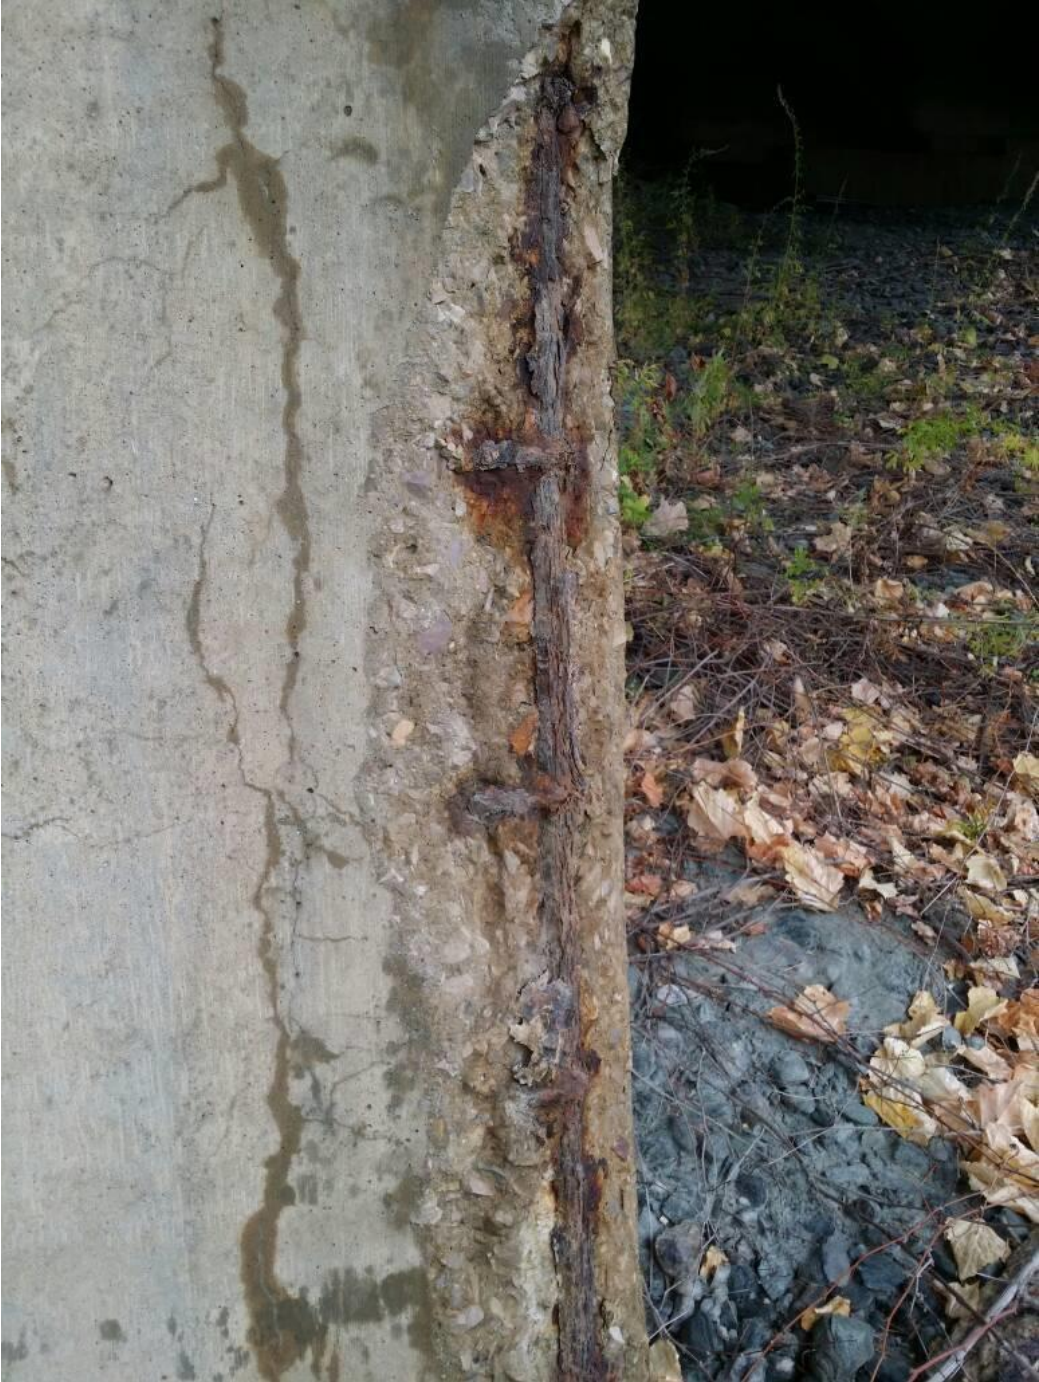
Figure 5.29 Distressed column on Richmond I-89 US 2 Underpass Bridge

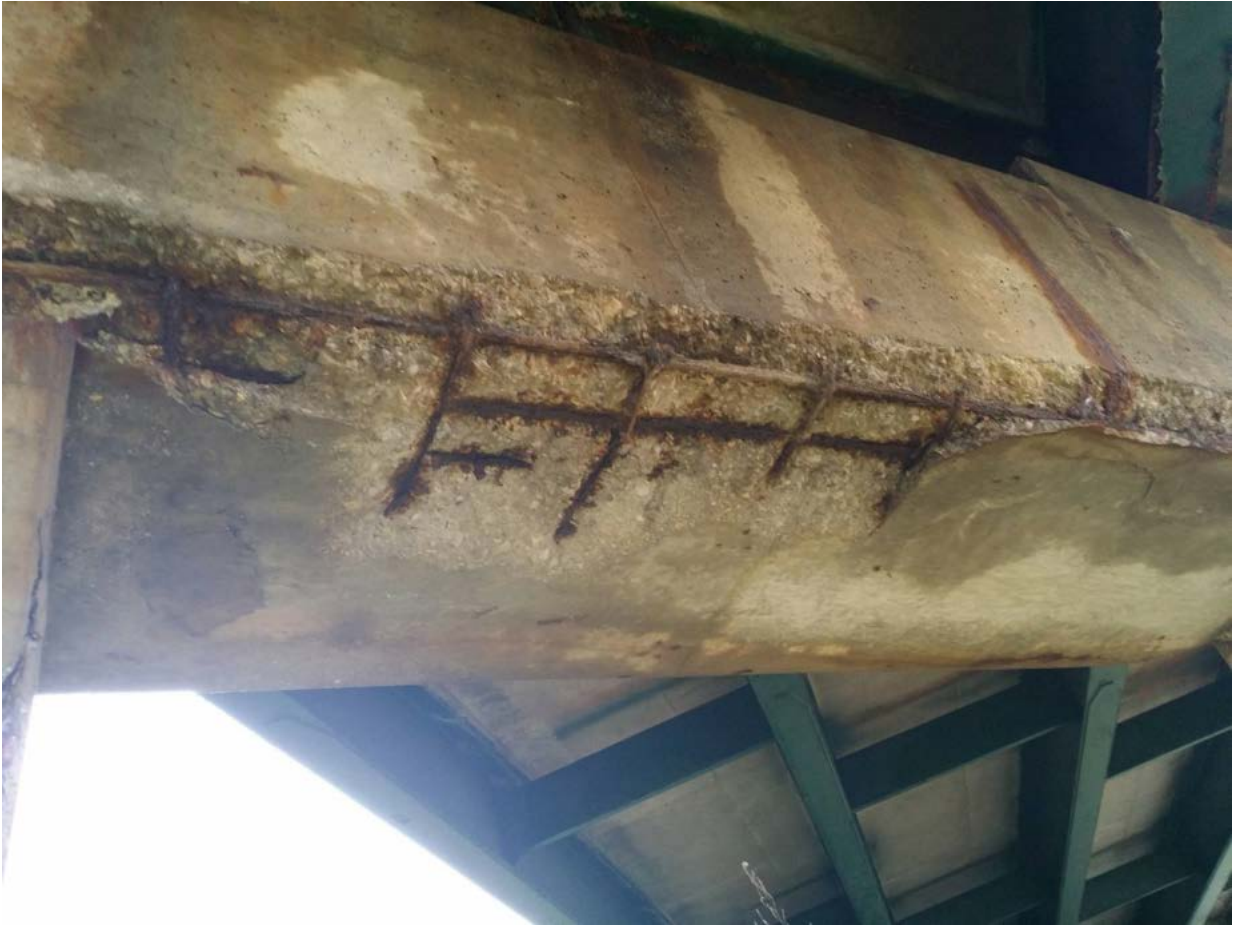
Figure 5.32 Pier cap with spalling on Richmond I 89 US 2 Underpass Bridge

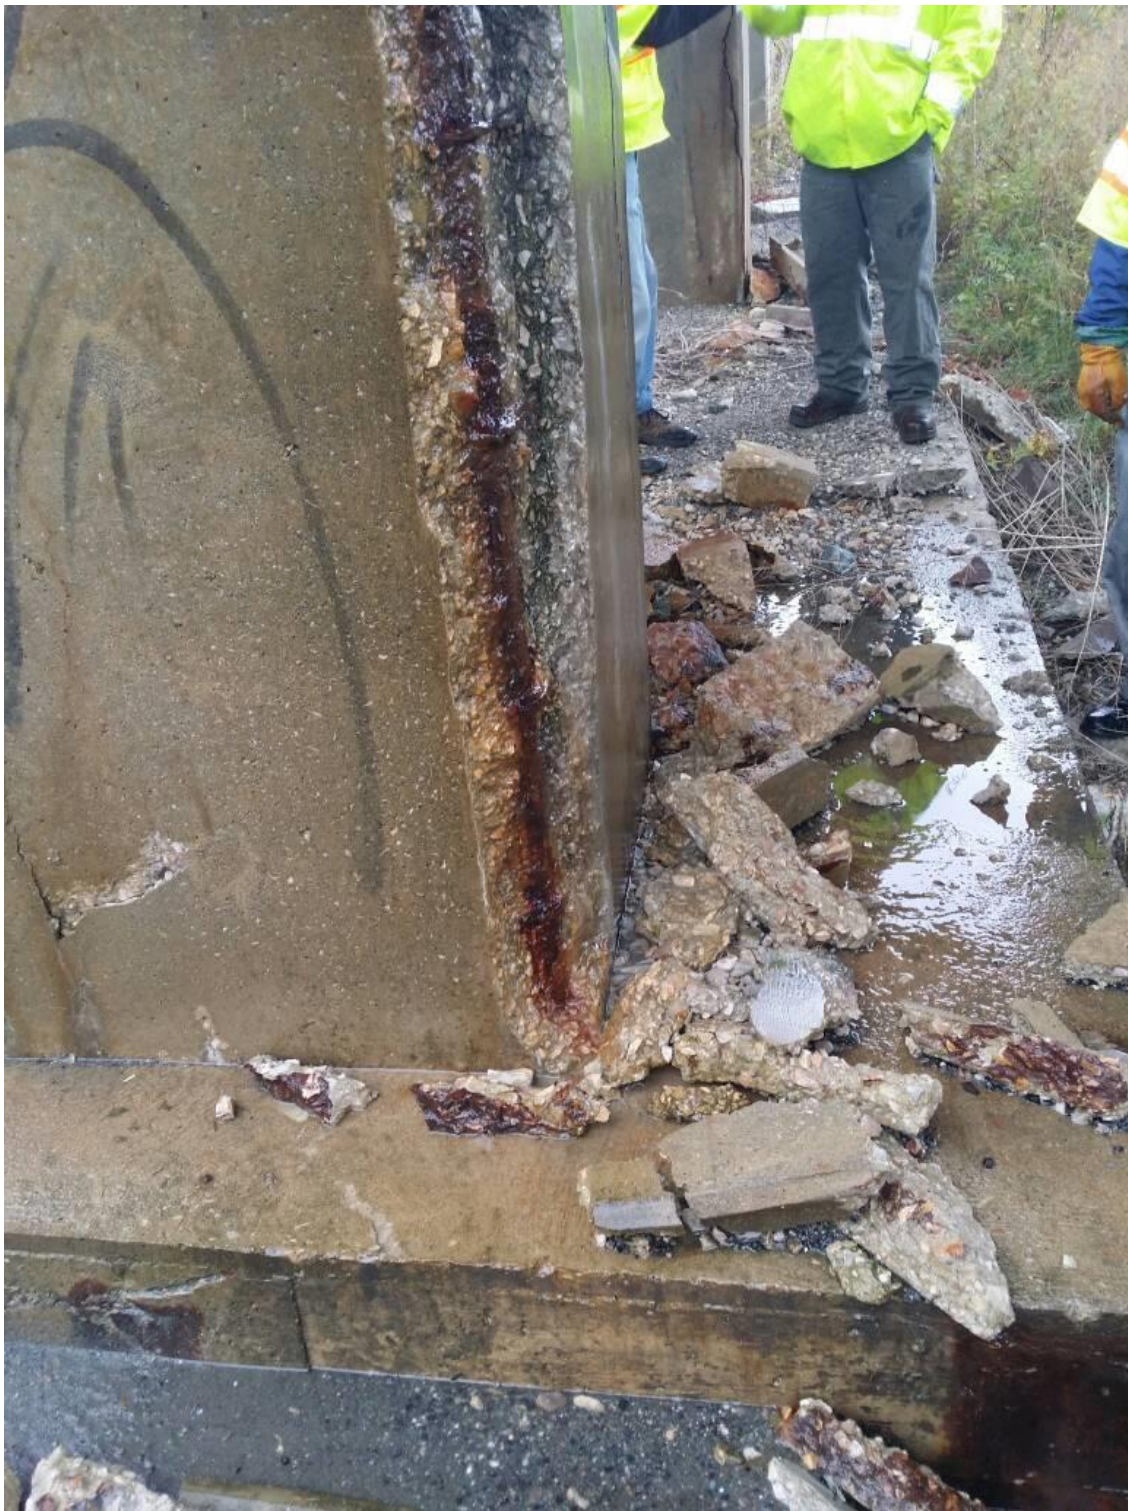
Figure 5.33 Square column with spalling at the corners on Richmond I-89 US 2 Underpass Bridge

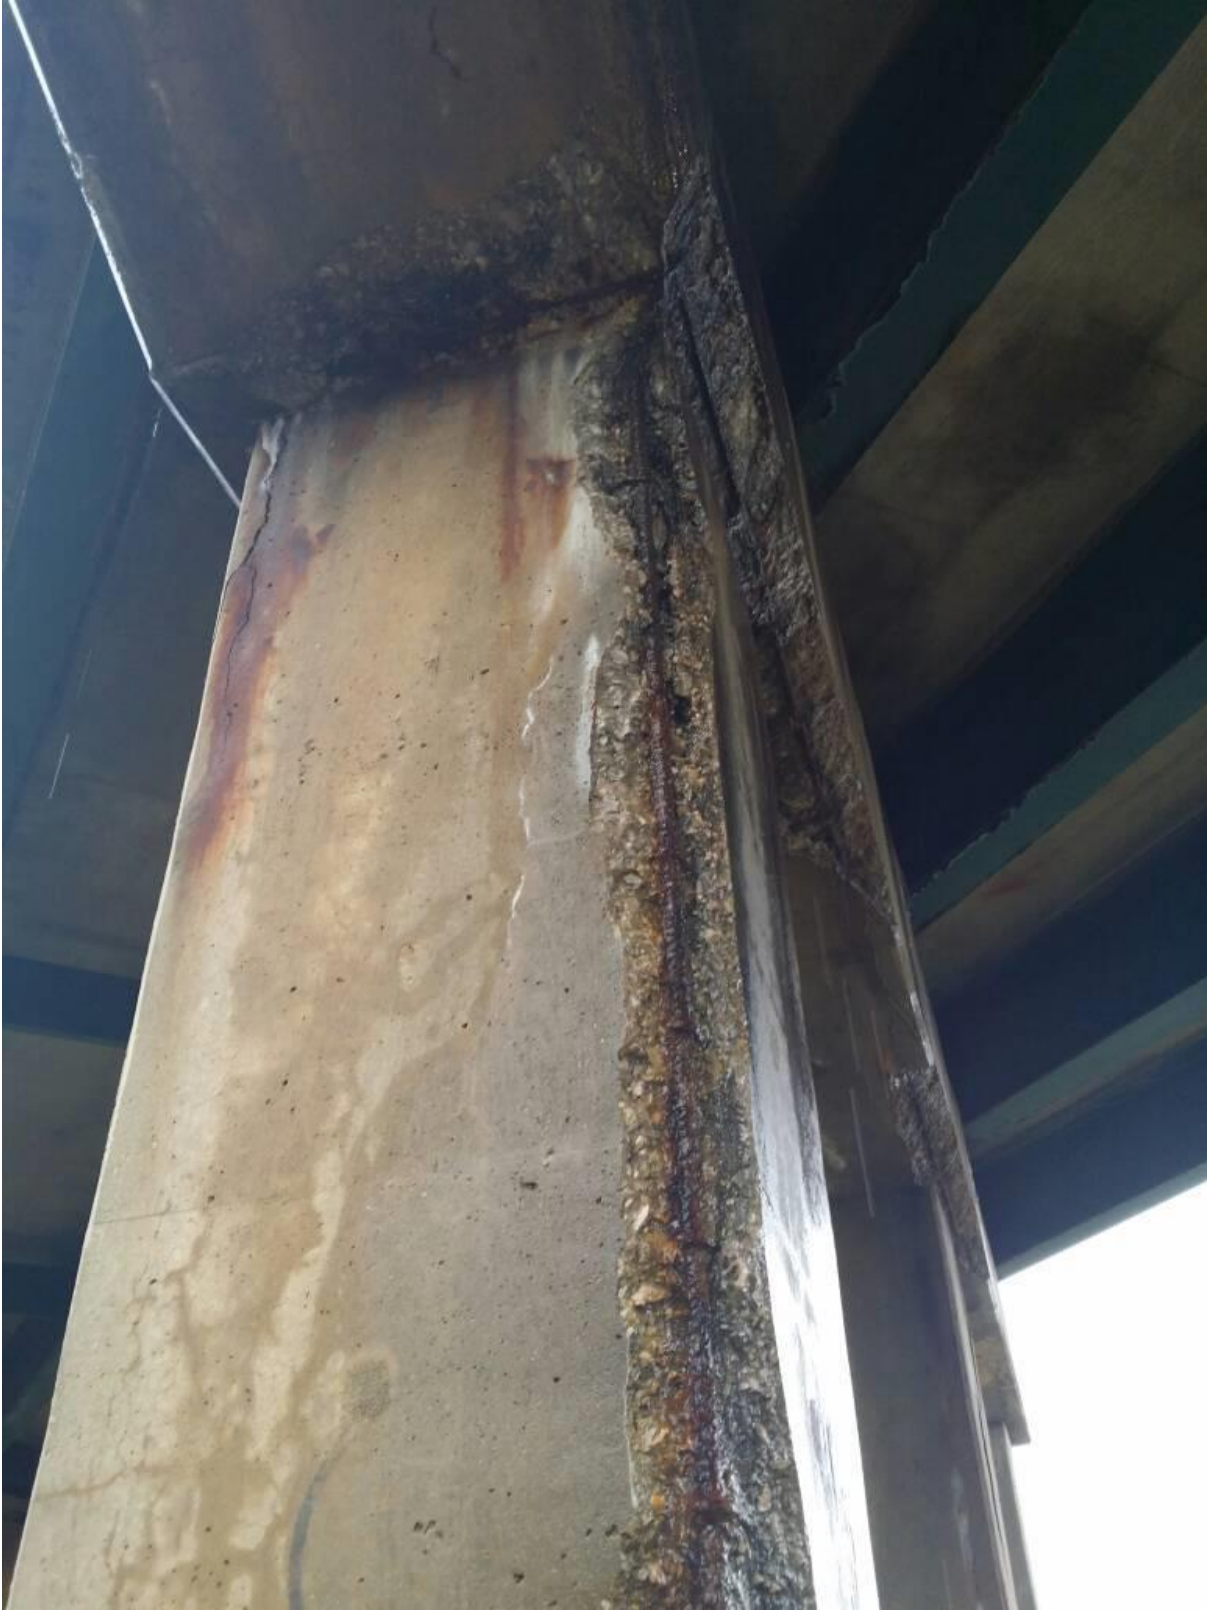
Figure 5.34 Square column with spalling at the corners and pier cap on Richmond I-89 US 2 Underpass Bridge

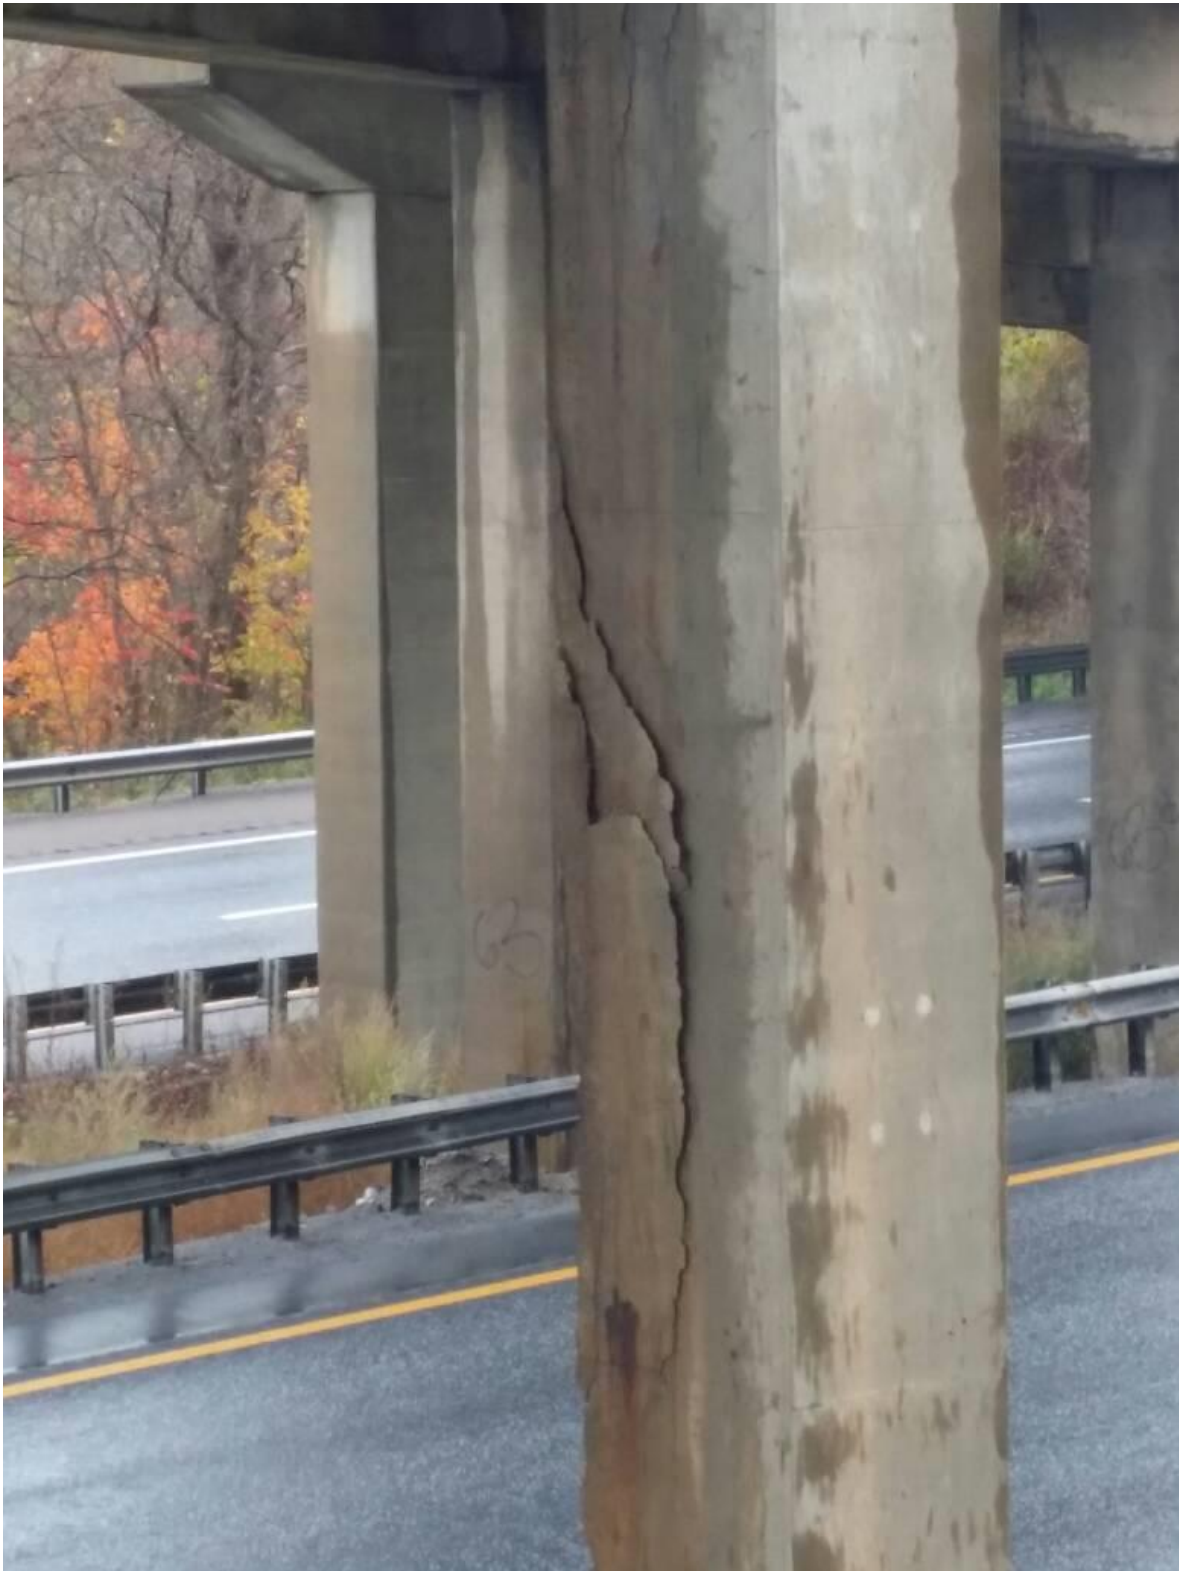
Figure 5.35 Column with spalling at the corners on Richmond I 89 US 2 Underpass Bridge

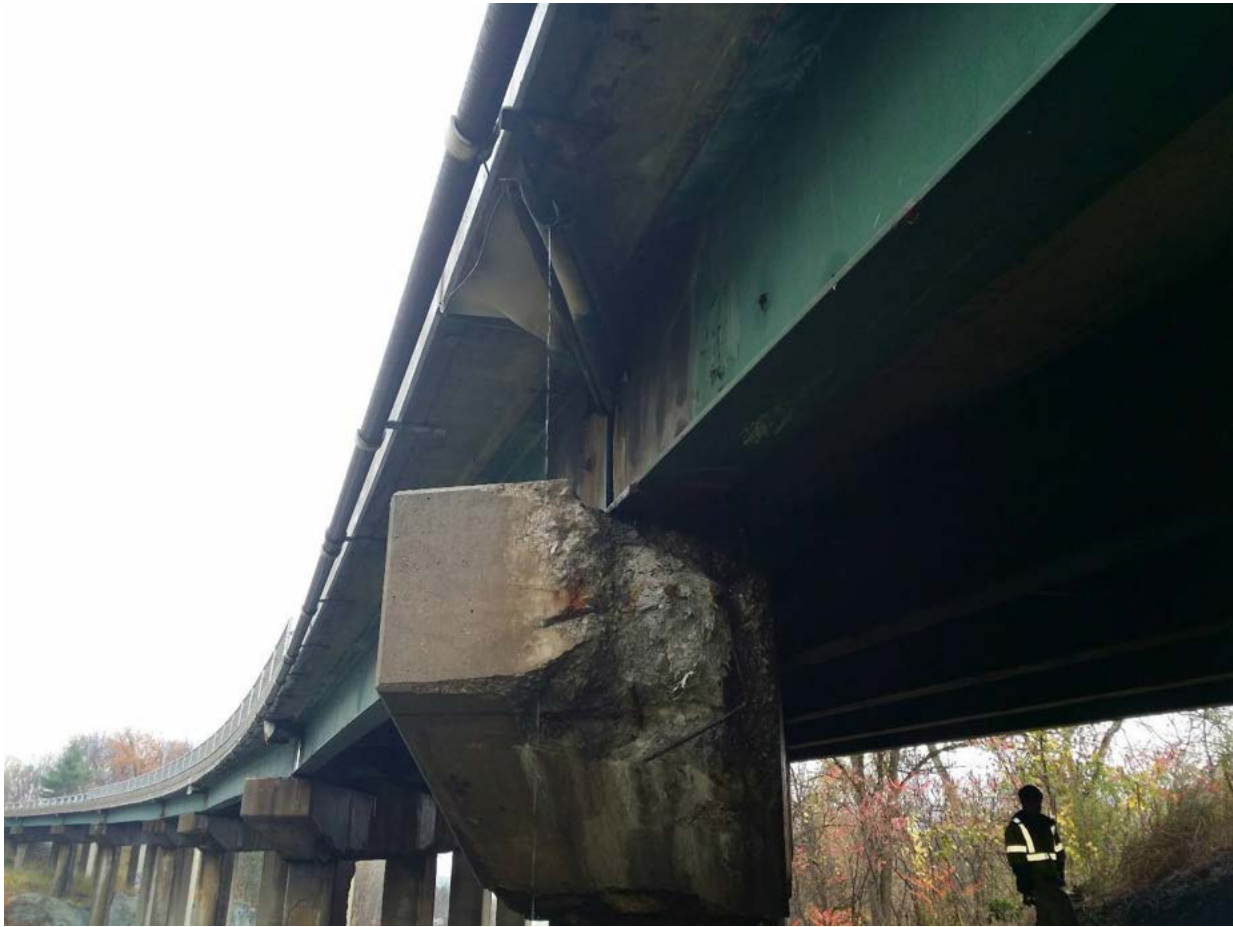
Figure 5.37 Pier cap with lost corner section leading to subsided bearing on Richmond I 89 US 2 Underpass Bridge

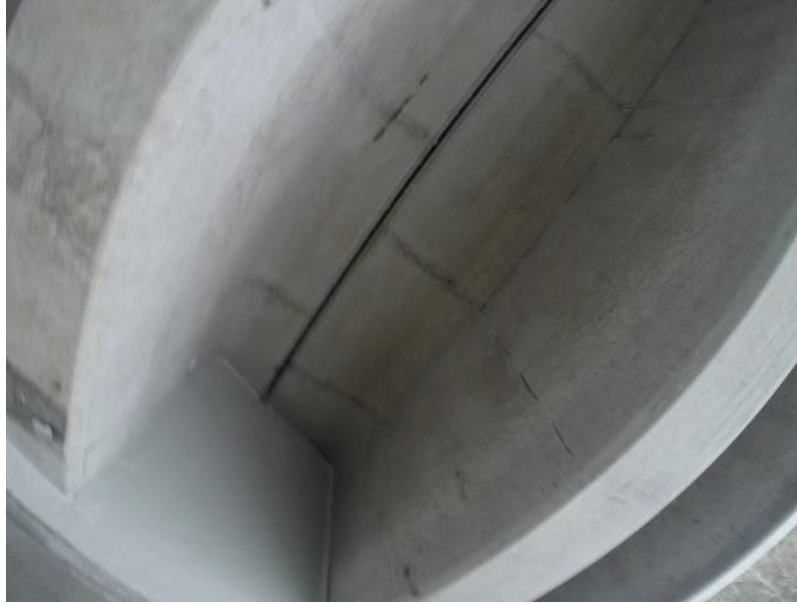
Figure 5.43 Girders have multiple cracks in top flanges, Stowe Rte 100 Gold Brook Crossing Bridge

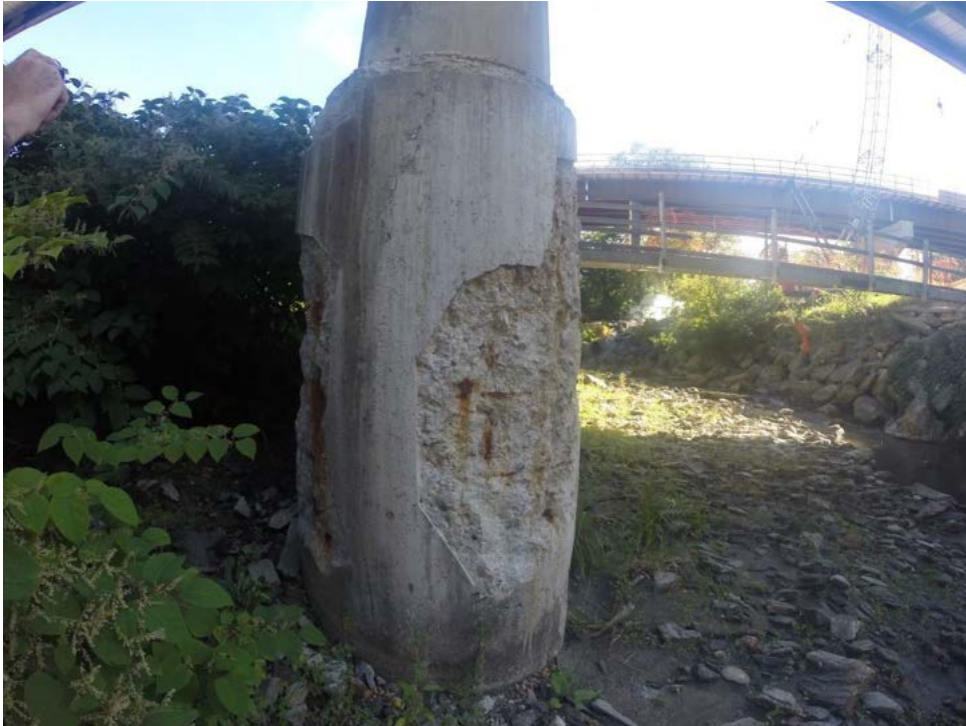
Figure 5.45 End view of pier base with damaged concrete removed on I-89 Waterbury Overpass Bridge

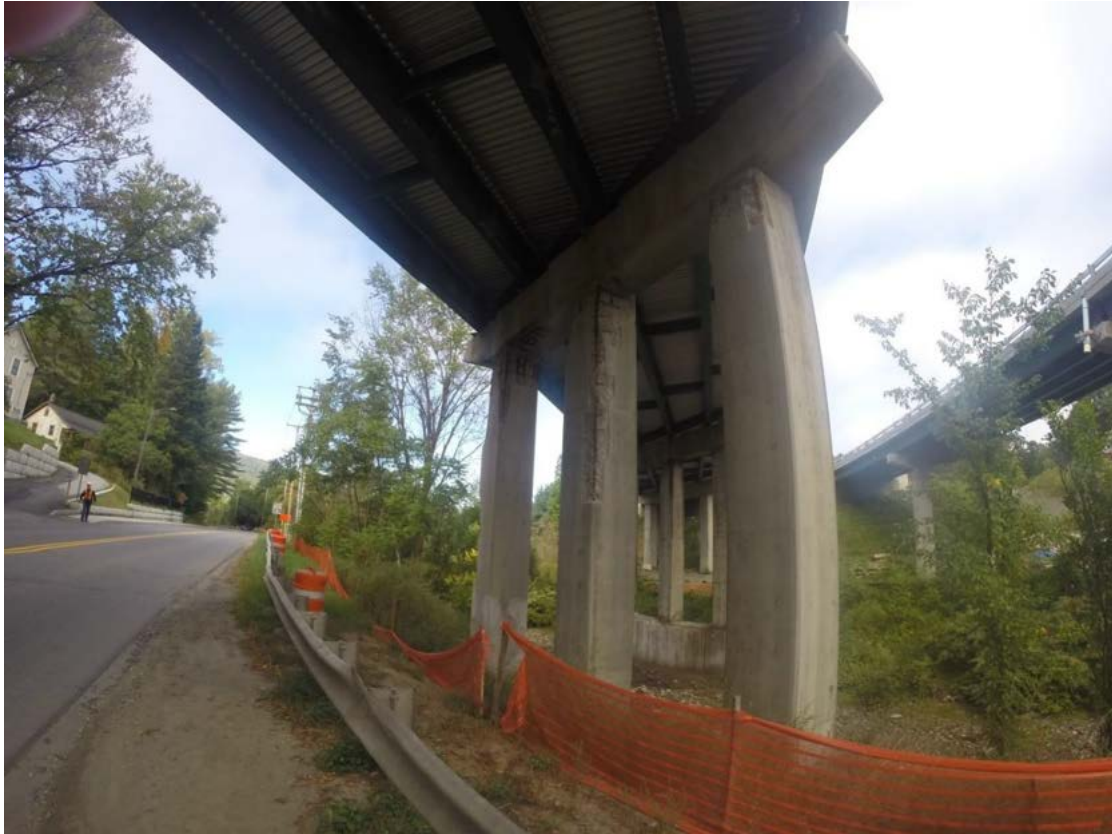
Figure 5.48 Pier on I-89 Waterbury Overpass Bridge with corners prepared for patch repairs

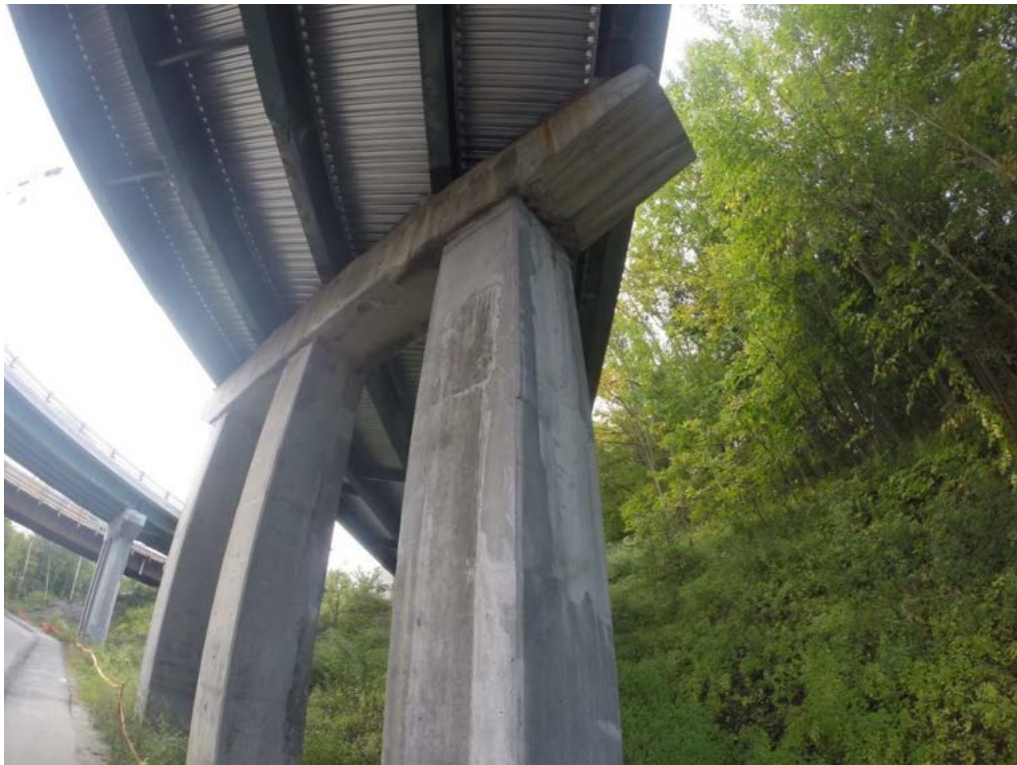
Figure 5.49 Pier on I-89 Waterbury Overpass Bridge with patch repairs

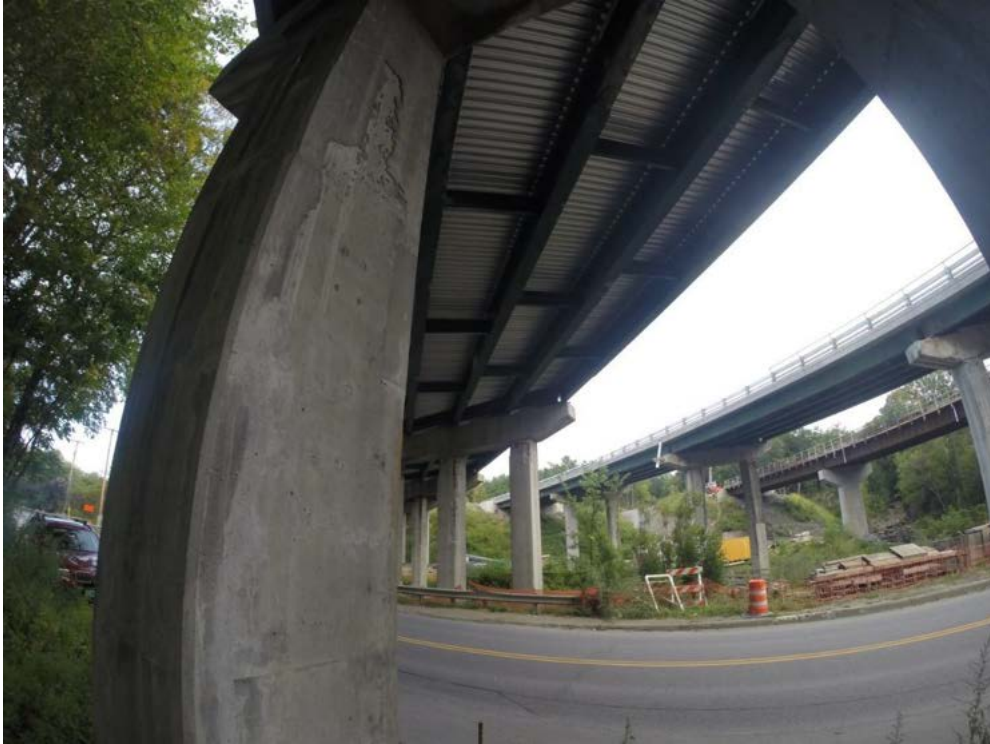
Figure 5.50 Pier on I-89 Waterbury Overpass Bridge with patch repairs, note the extended gutters on span in background

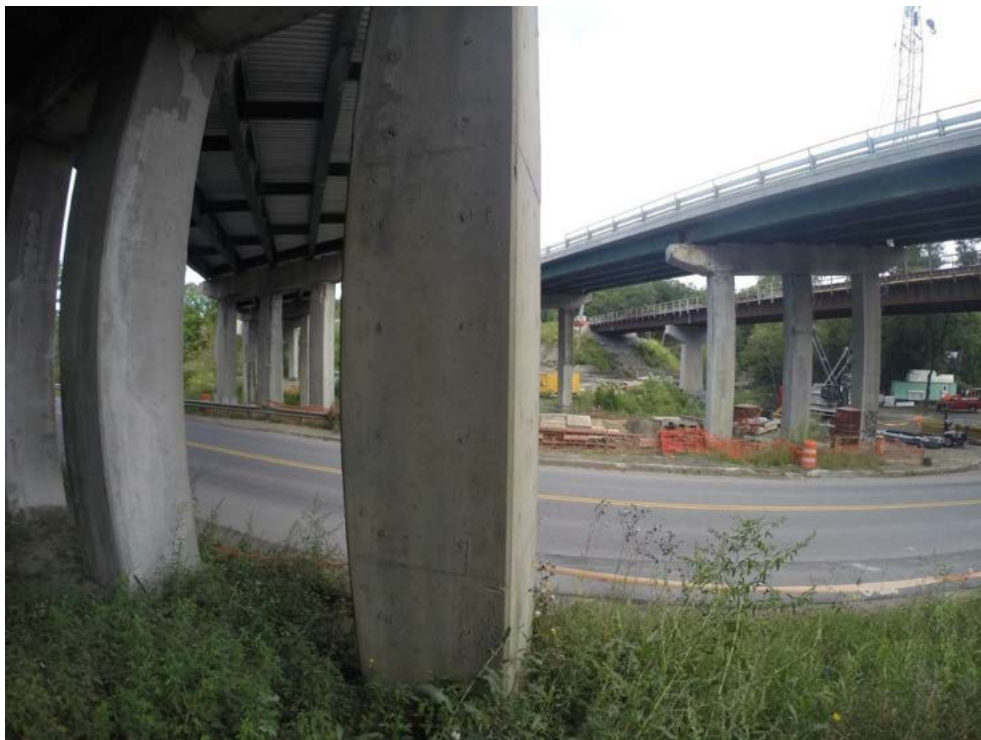
Figure 5.51 Pier on I-89 Waterbury Overpass Bridge with patch repairs

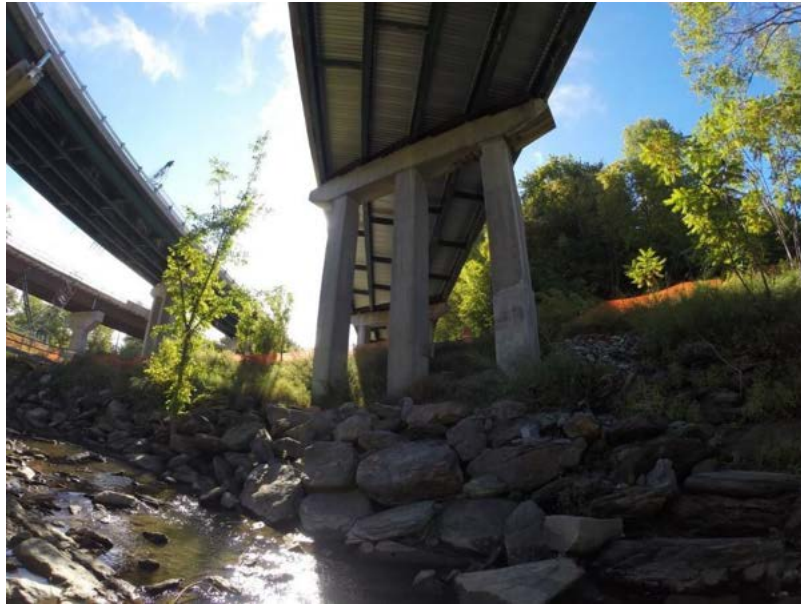
Figure 5.52 Repaired pier on I-89 Waterbury Overpass Bridge with patch repairs, note the use of integrated corrugated panels on new concrete deck.

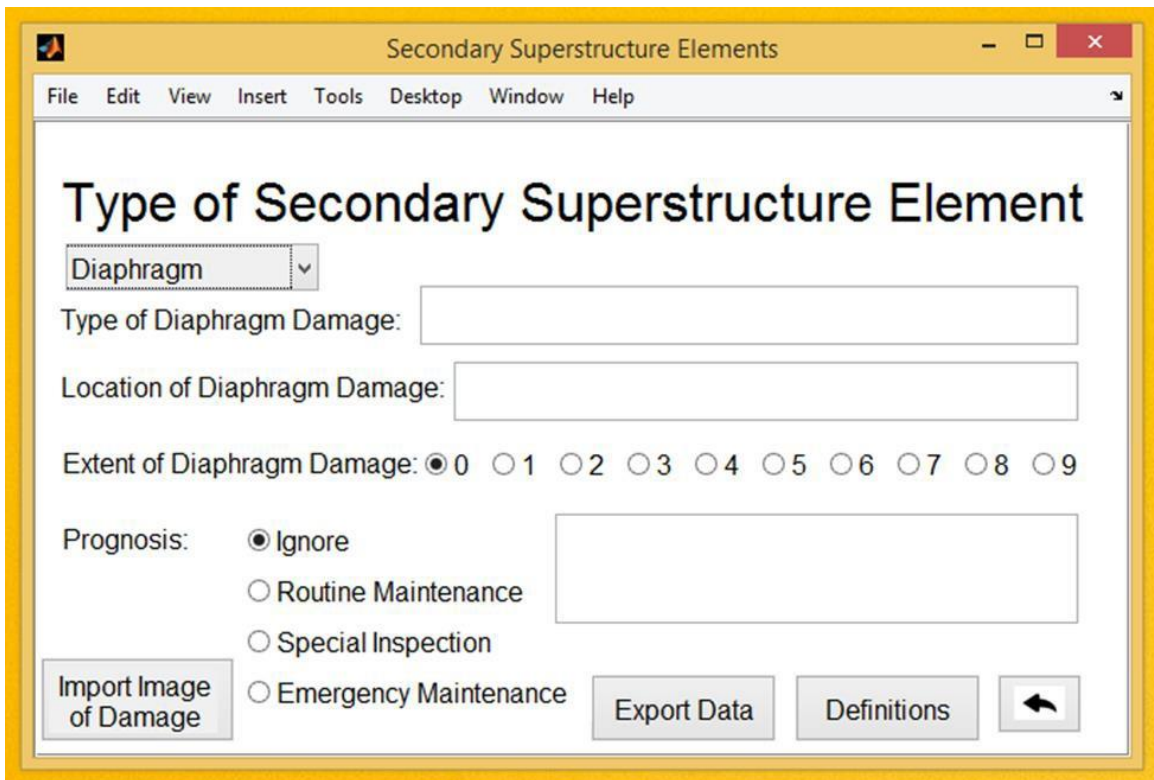
Figure 6.5 Assessment of bridge structure GUI, assessment of damage and prognosis, exports data to an excel spreadsheet. An image of structural damage can be uploaded.

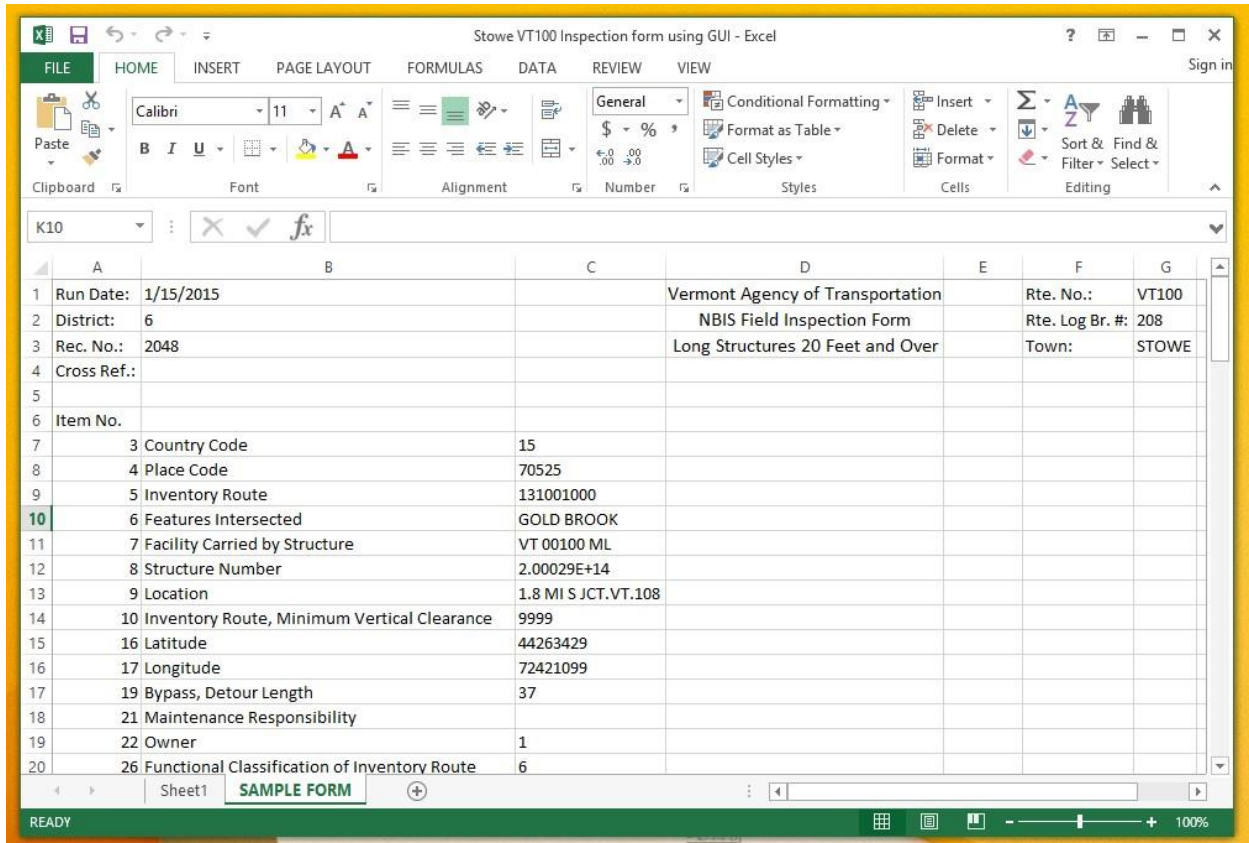
Figure 6.7 Bridge Inspection Form outputting data into an Excel spreadsheet

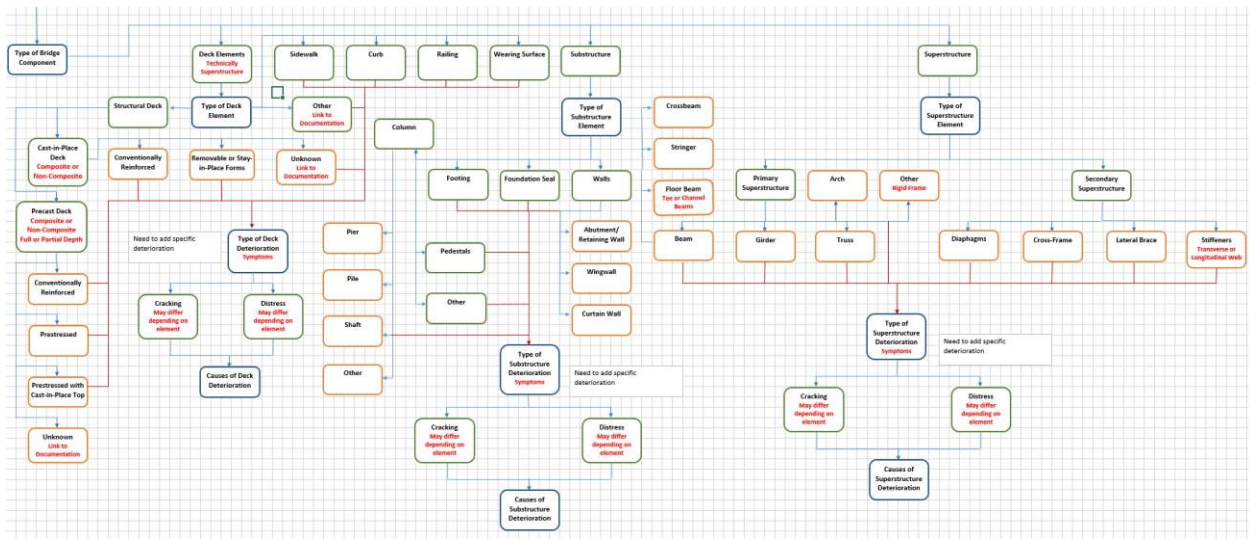
Figure 6.9 Bridge concrete repair decision tree, Adapted from ACI Concrete Repair Process Flow Chart (ACI Concrete Repair Manual 2013).

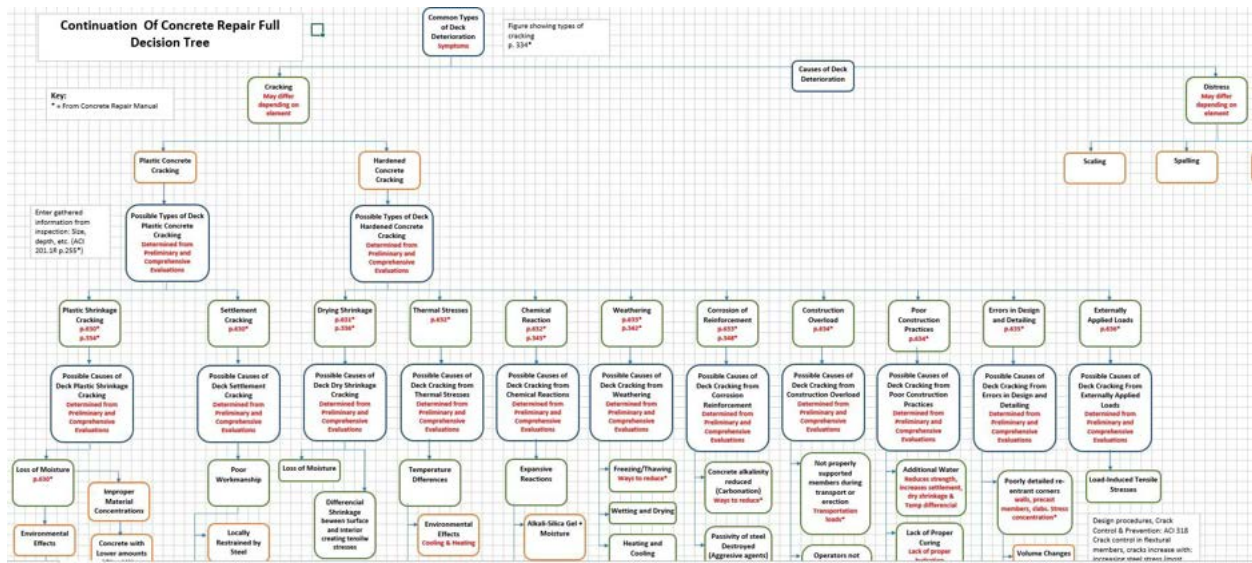
Figure 6.10 Deck branch of concrete repair decision tree, adapted from ACI Concrete Repair Process Flow Chart (ACI Concrete Repair Manual 2013)

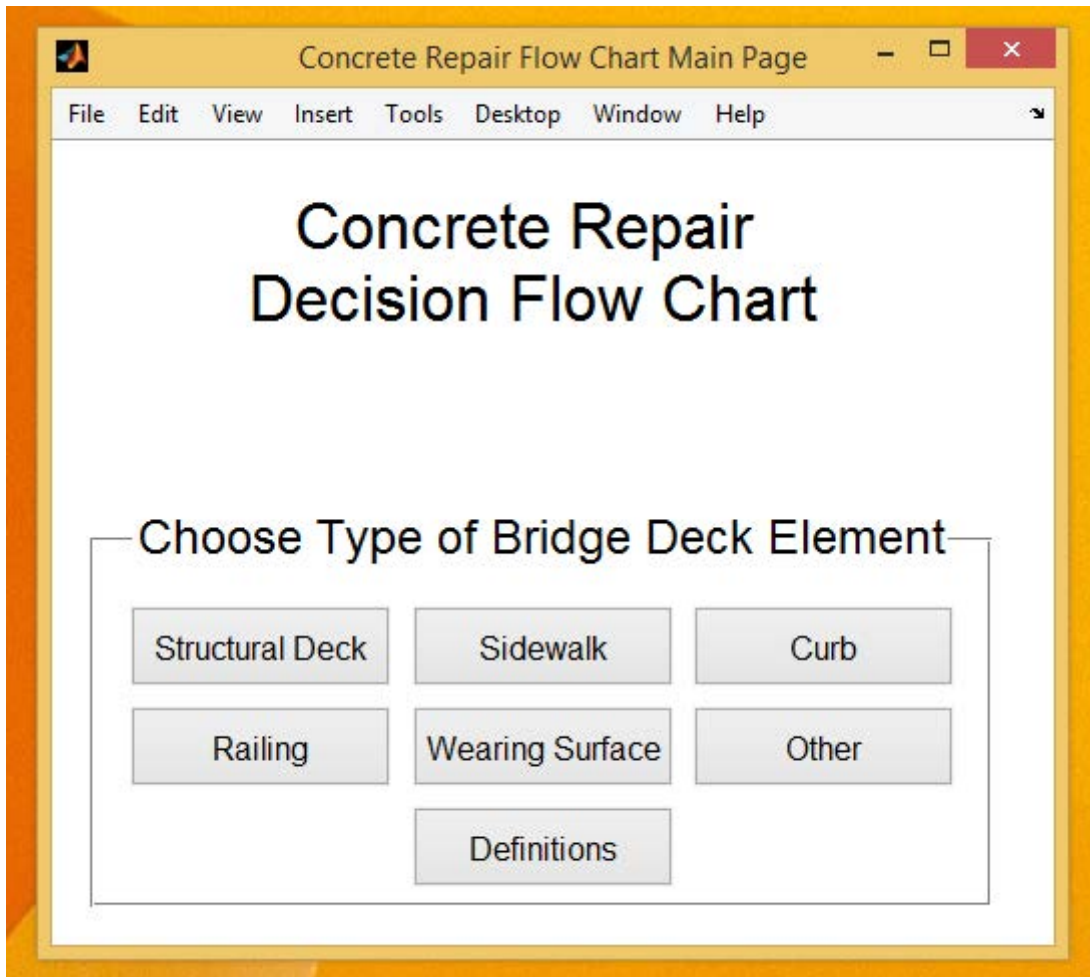
Figure 6.13 Screen shot of Concrete Repair Decision Flow Chart GUI main page, with user friendly features including definitions of terms in current GUI page

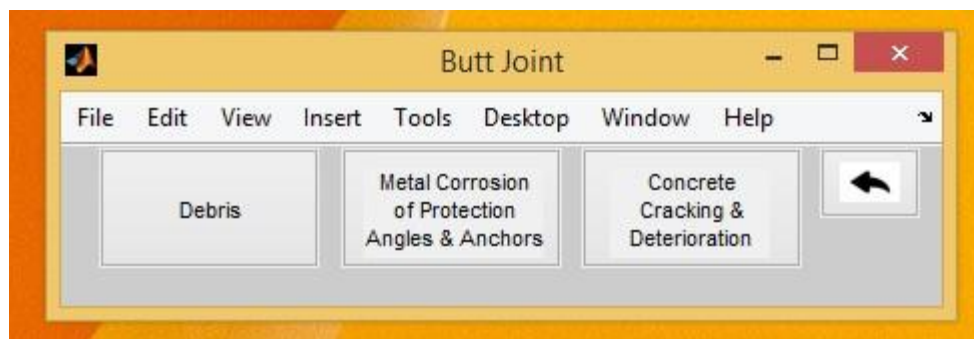
Figure 6.14 Screen shot of particular bridge deck element GUI (going through flowchart), enables picking type of damage to element to select proper repair procedure

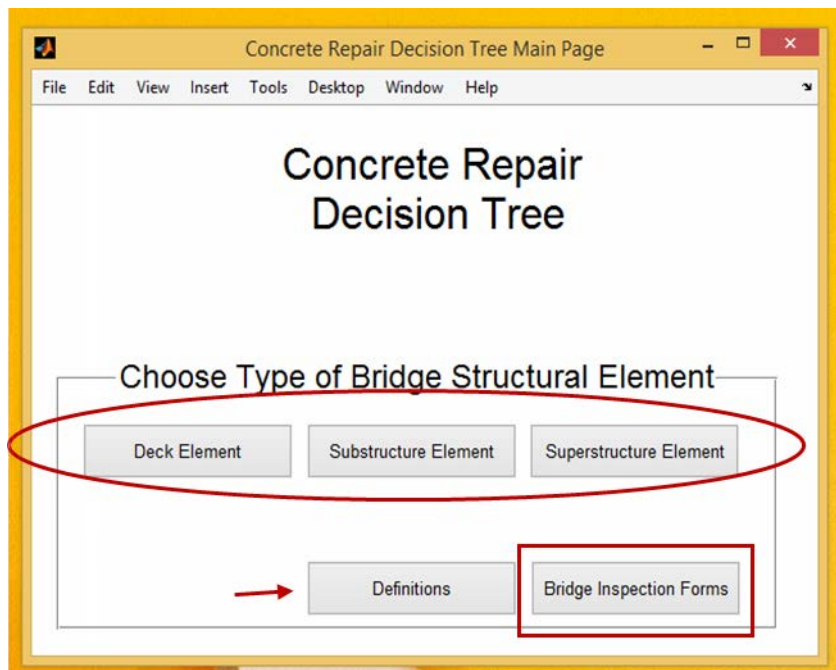
Figure 6.16 Concrete Repair Decision Tree Main Page
