University of Vermont

ScholarWorks @ UVM

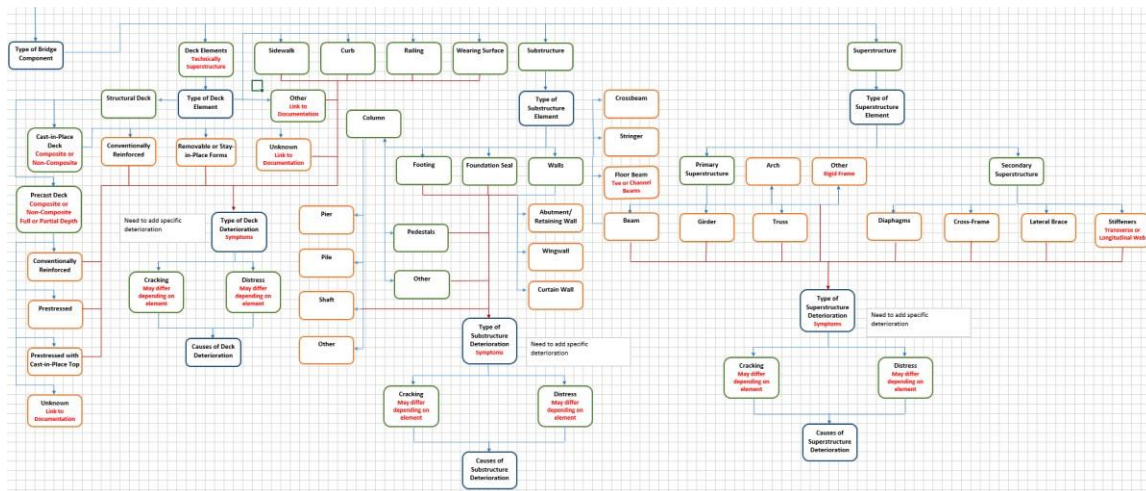
Figure 1: The Full Decision Tree can be accessed as the Excel File: (Concrete Repair Full Decision Tree)

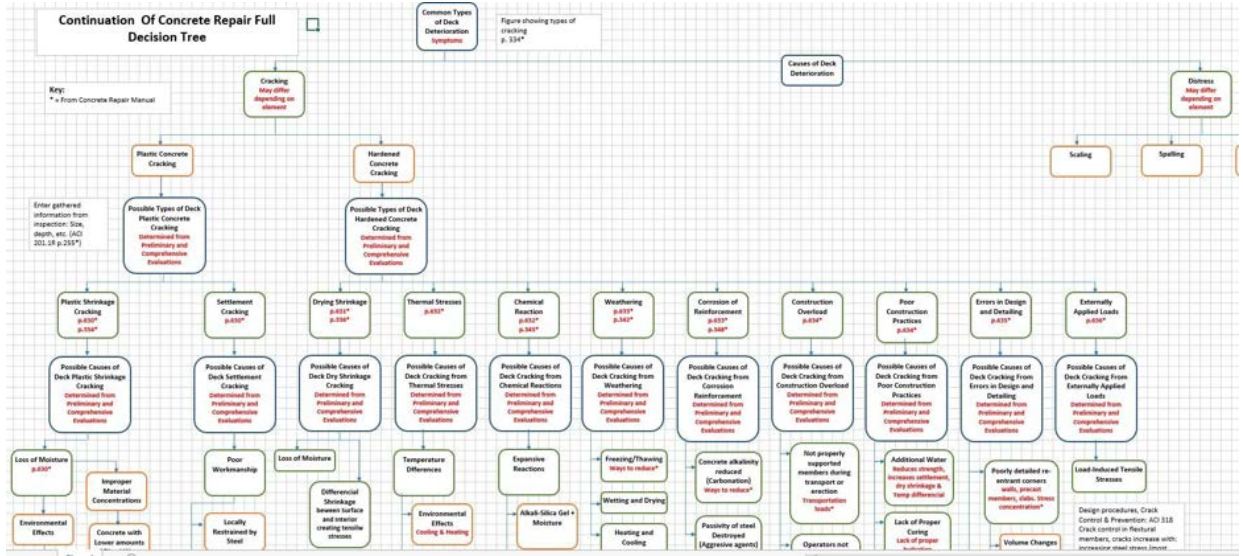
Figure 2: The Full Decision Tree can be accessed as the Excel File: (Deck Deterioration Repair Decision Tree)

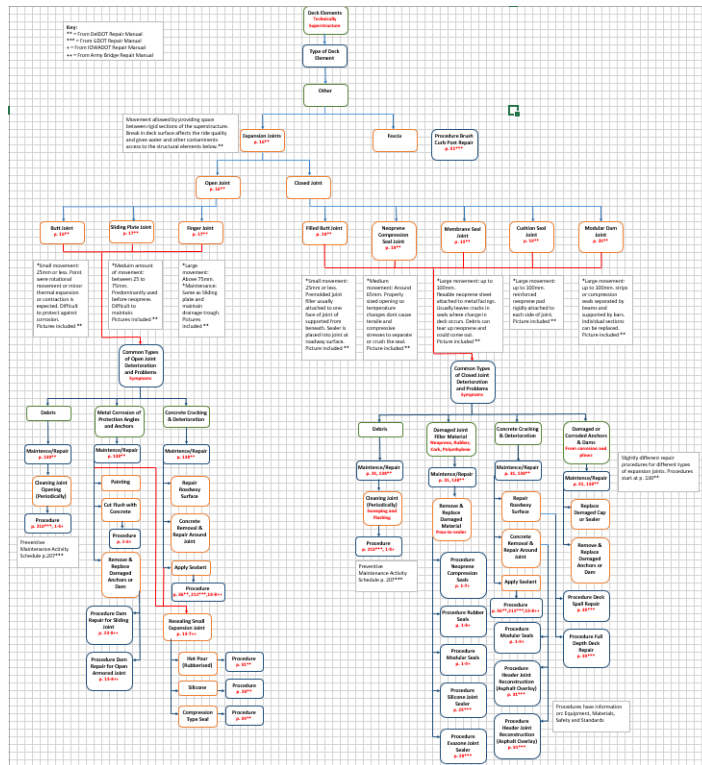
Figure 3: The Full Decision Tree can be accessed as the Excel File: (Expansion Joint and Fascia Deterioration Repair Decision Tree)

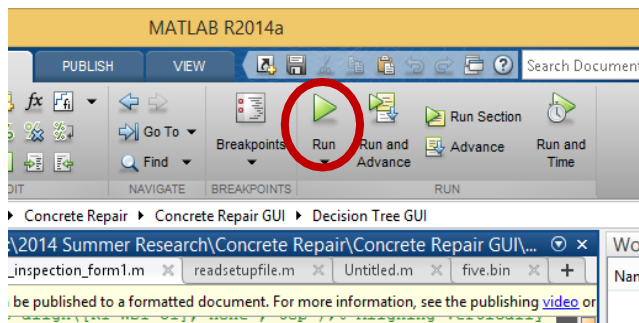
3. The **Bridge Inspection Form** window should pop-up, depicted in Figure (Figure 5). The window gives the user the option of clicking between two buttons:
 - a. The **Field Inspection Form** button, which directs the user to the electronic form
 - b. The **Field Inspection Coding Guide** button, which directs the user to a PDF version of the guide.

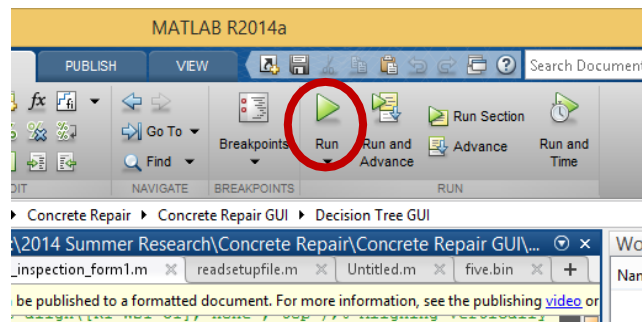
3. The **Concrete Repair Decision Tree** window should pop-up, depicted in Figure (Figure 10). The window gives the user the option of clicking between multiple buttons:
 - a. Choose from three structural element categories: **Deck Element**, **Substructure Element** or **Superstructure Element** (shown by red oval)
 - b. The **Field Inspection Form** button (shown by red rectangle), which directs the user to the electronic form
 - c. The **Definitions** button (to the right of the red arrow), which directs the user to a Definitions pop-up window that defines the bridge terminology of the previous window.

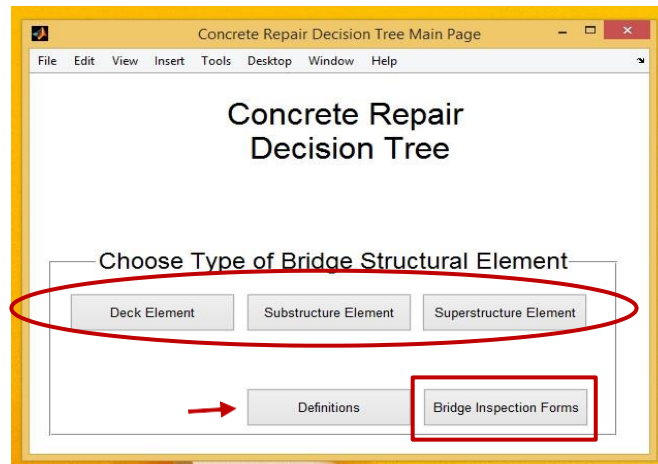
Figure 10: Concrete Repair Decision Tree Main Page

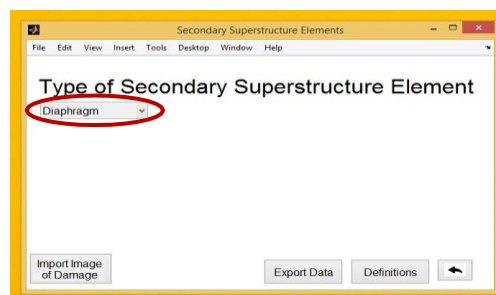
Figure 11: Damage and Prognosis Pop-up Window

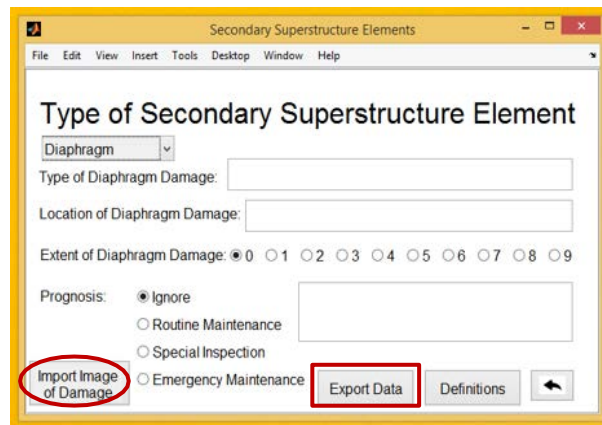
Figure 12: Damage and Prognosis Pop-up Window with Full Options

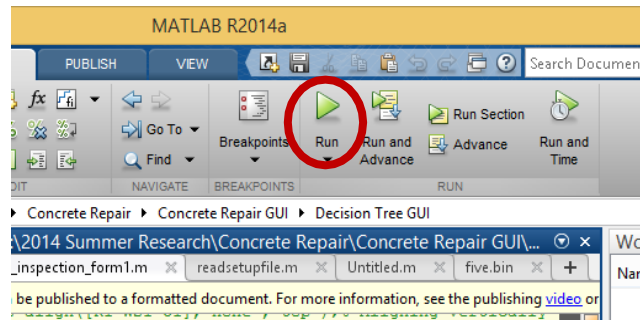
3. The **Concrete Repair Flow Chart** window should pop-up, depicted in Figure (Figure 15). The window gives the user the option of clicking between multiple buttons:
 - a. Choose from six deck elements: **Structural Deck, Sidewalk, Curb, Railing, Wearing Surface** or **Other** (shown by red oval) *Only **Other** is currently active*
 - b. The **Definitions** button (to the right of the red arrow), which directs the user to a Definitions pop-up window that defines the bridge terminology of the previous window. *For Further Information on the **Definitions** window, reference **Step 11** in **1.2. Decision Tree GUI**.*

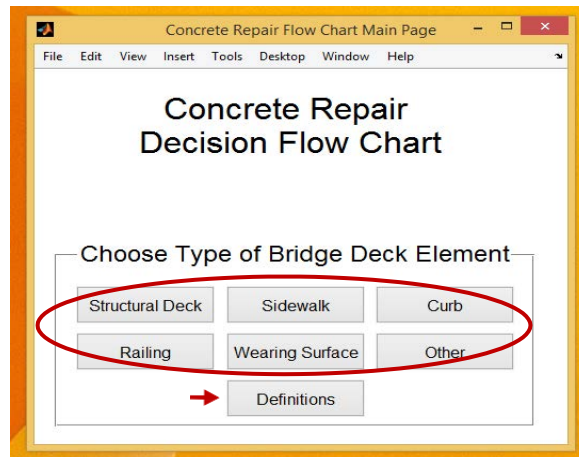
Figure 15: Concrete Repair Flow Chart Main Page

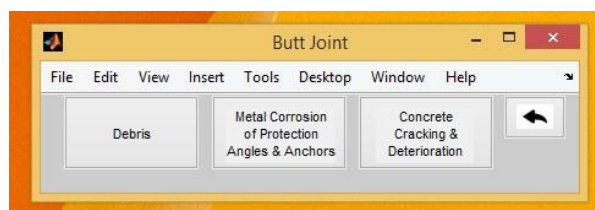
Figure 16: Butt Joint Pop-up Window

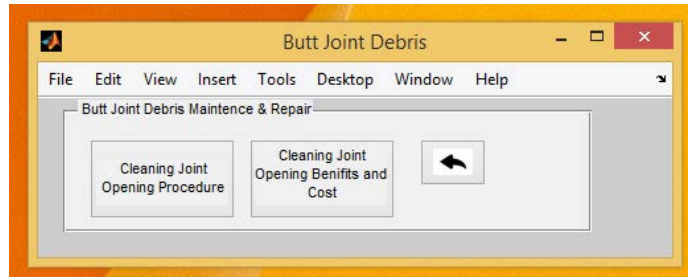
Figure 17: Butt Joint Debris Pop-up Window

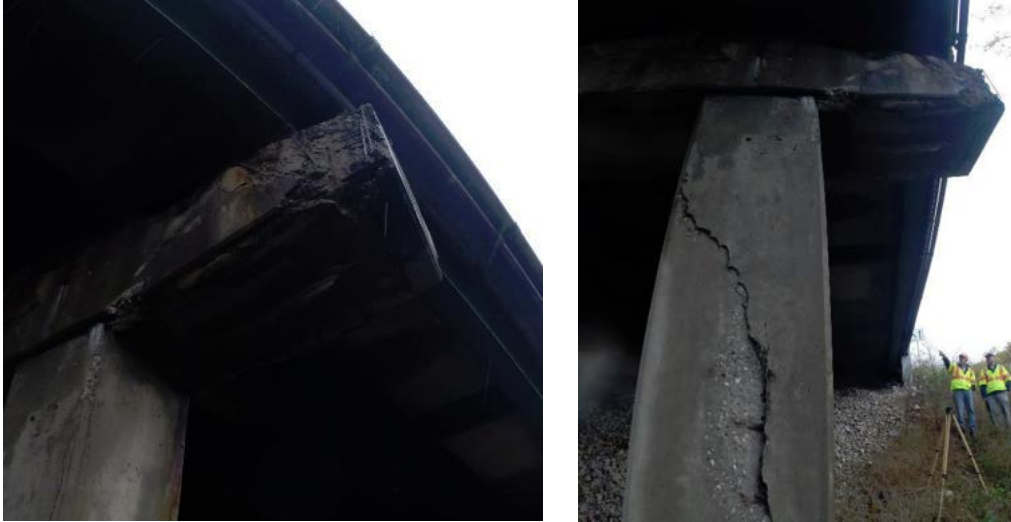
Figure 22: Spalling on end cap and a large crack on end column

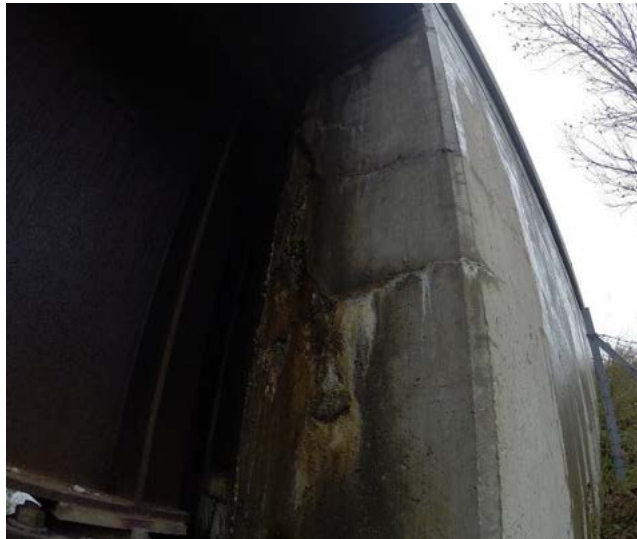
Figure 25: Scaling and cracking on abutment. Corrosion stains from steel beams

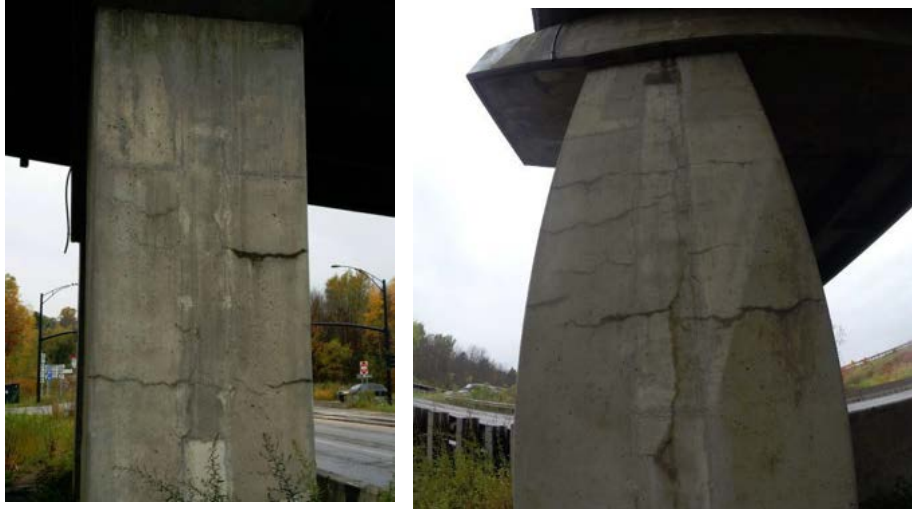
Figure 26: Possible dry shrinkage cracks on concrete column that has had a 6" thick concrete jacket around column.

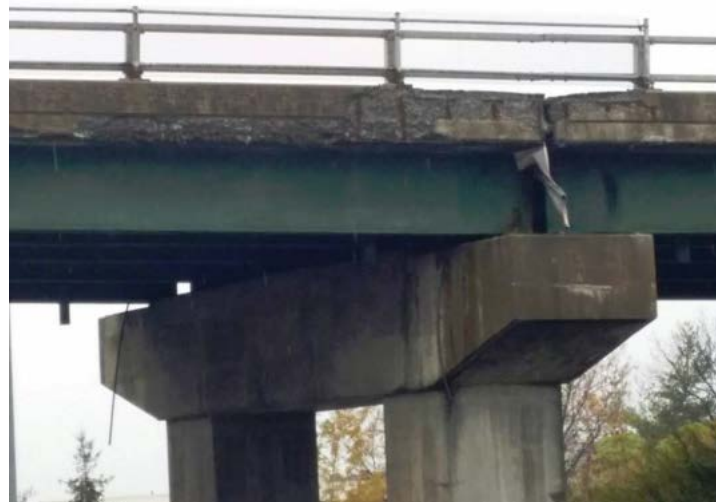
Figure 27: Spalling and steel corrosion on concrete fascia.

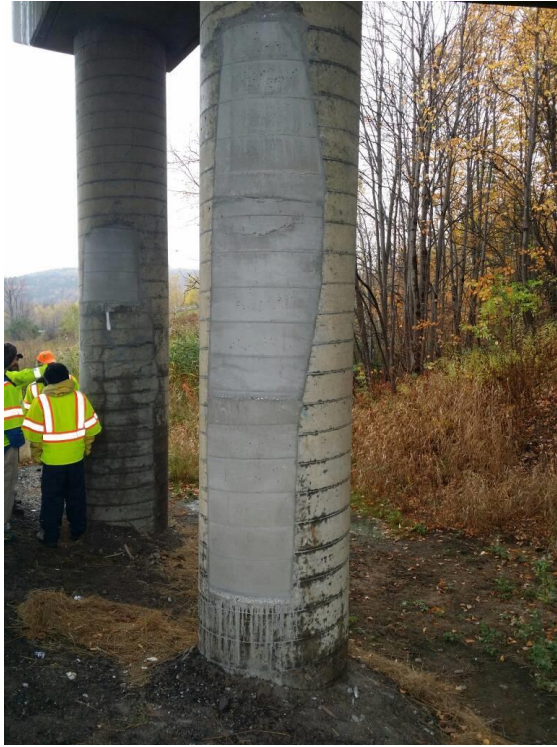
Figure 28: Patches on columns to fix spalling and cracking.

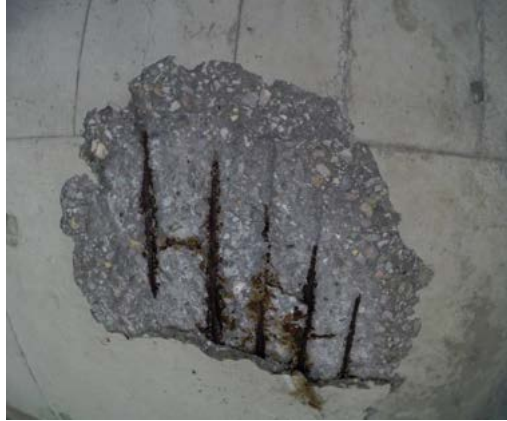
Figure 30: Spalling and slight steel reinforcement corrosion on underneath portion of concrete deck

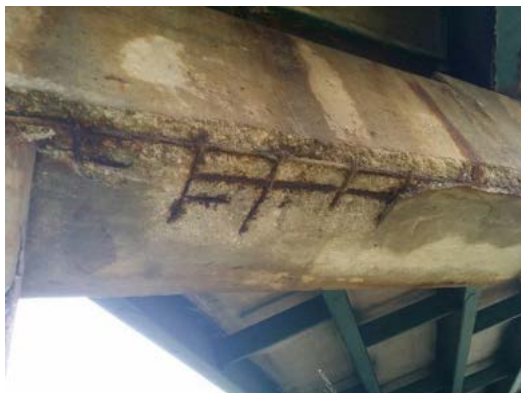
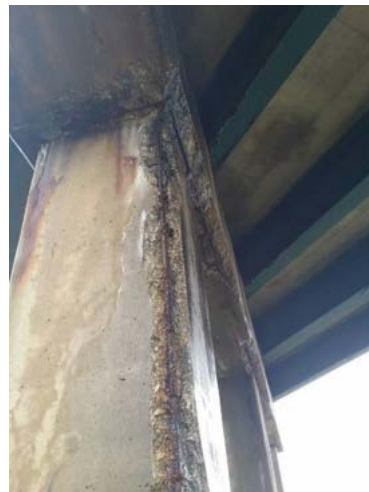
Figure 32: Spalling and steel corrosion on columns and caps

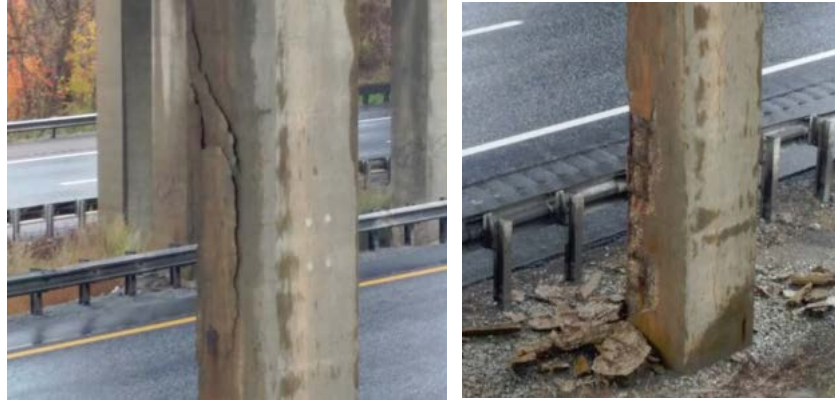
Figure 33: Spalling and steel corrosion on concrete column. Notice concrete fragments falling near road.

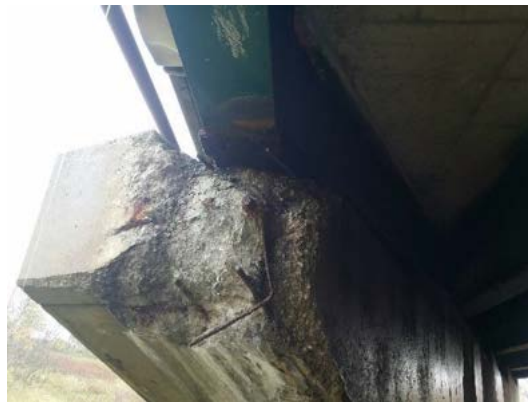
Figure 34: End cap spalling and steel corrosion with non-existing bearing.

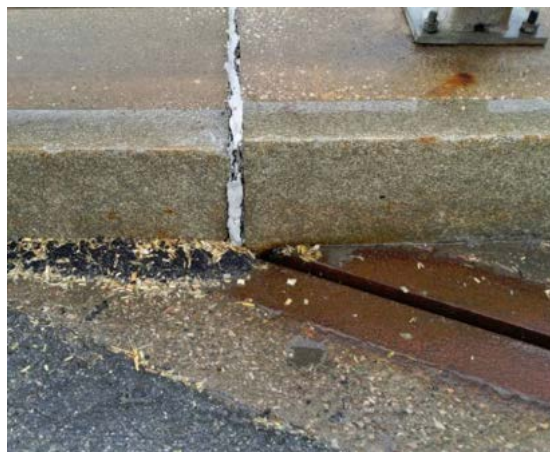
Figure 35: Bridge deck and expansion joint. Because of non-existing bearing bridge deck has settled down about 1.5”.

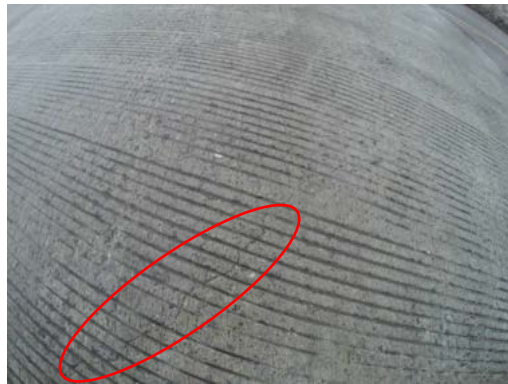
Figure 37: Crack on Deck Surface. Highlighted by Red Oval

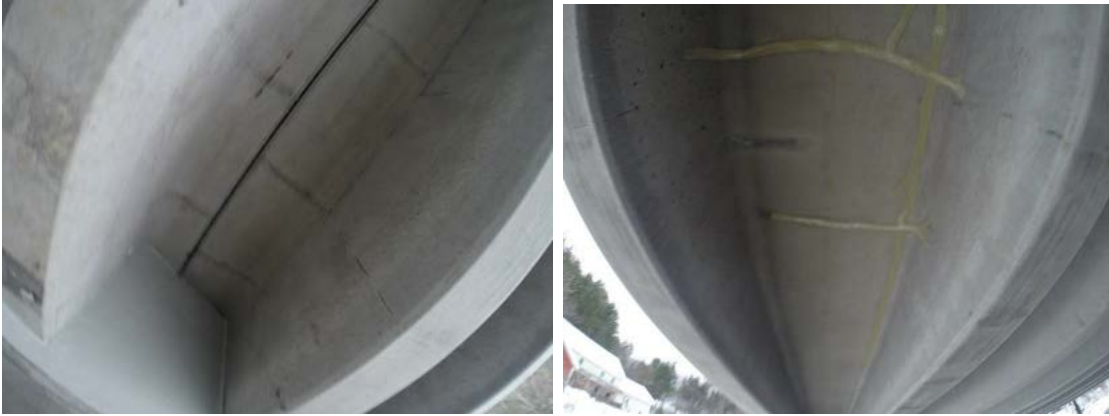
Figure 38: Underside of Concrete Deck. Left Image: shows cracks going at the way through concrete deck. Cracks are highlighted by red ovals. Right Image: sealant used to seal large cracks.
