**Video and Laser Microscopy Investigation of Adhesive
Joint Fracture in Fiber Reinforced Composite Materials**

Master of Science in Naval Architecture and Marine
Engineering

MASSACHUSETTS INSTITUTE OF TECHNOLOGY

June 1996

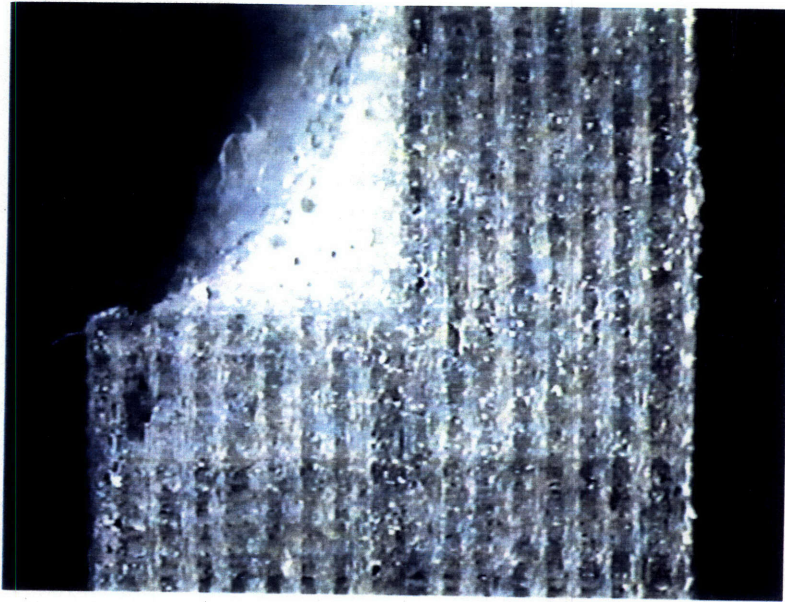
Figure 4.5: h2, Start of Test

This is the sample before loading is applied. Note that the spew fillet is relatively large, extending out of the field of view towards the top of the image. It is important to note that there are no existing cracks under the spew fillet or within the joint area itself.

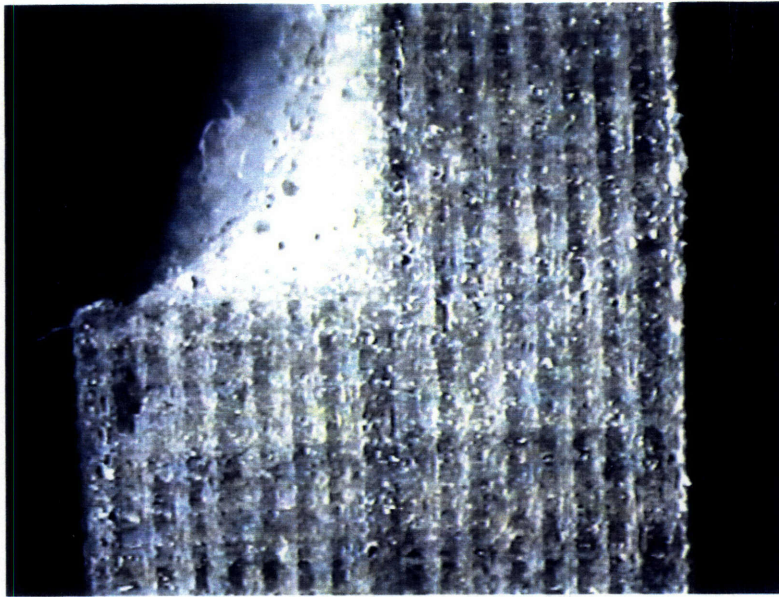
Figure 4.6: h2, 55 seconds

At this time, it can be seen that cracking has been initiated. What is interesting is that the crack is actually originating outside of the actual joint area. The crack actually extends out of the picture towards the top, away from the immediate joint area.

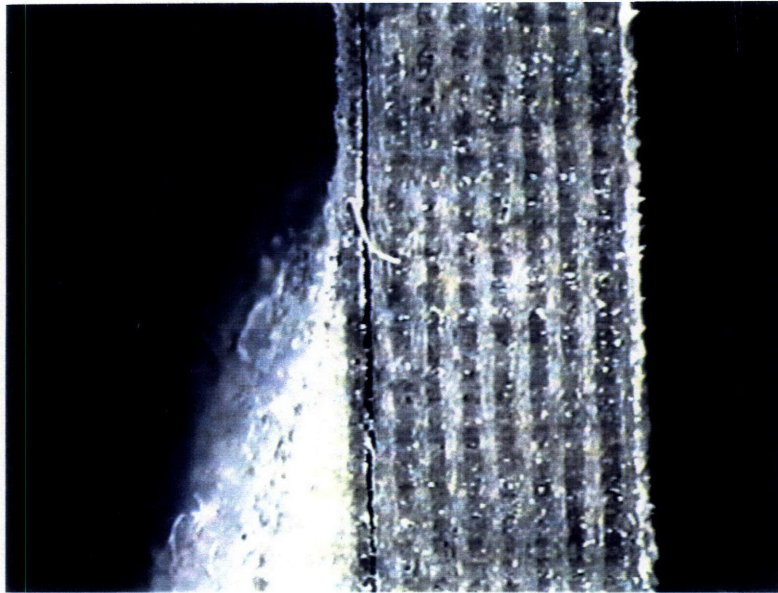
Figure 4.7: h2, 65 seconds

In this image, the video microscope has been raised to view the crack beyond the joint. The crack extends beyond the spew fillet, and the opening is greatest at the end of the spew fillet, which can be seen approximately one third of the way from the top of the image. It can be seen that the crack is lengthening in the direction of the applied load, but is opening in a direction normal to the applied load. Referring back to the load graph, figure 4.4, the load increase is still basically linear.

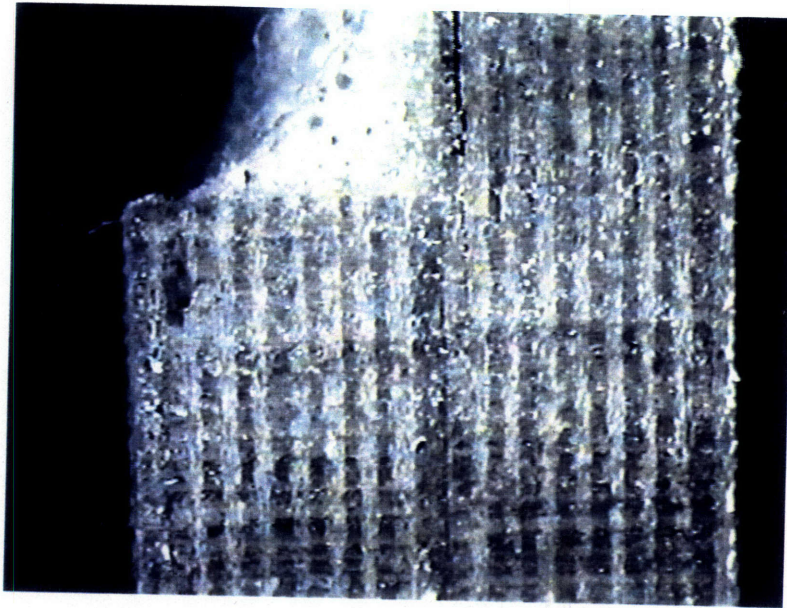
Figure 4.8: h2, 75 seconds

At this point, the crack has just reached the end of the joint. It has not lengthened much as compared with figure 4.6, 50 seconds, but the opening displacement is greater. At this point the load graph is beginning to exhibit a non-linear load increase.

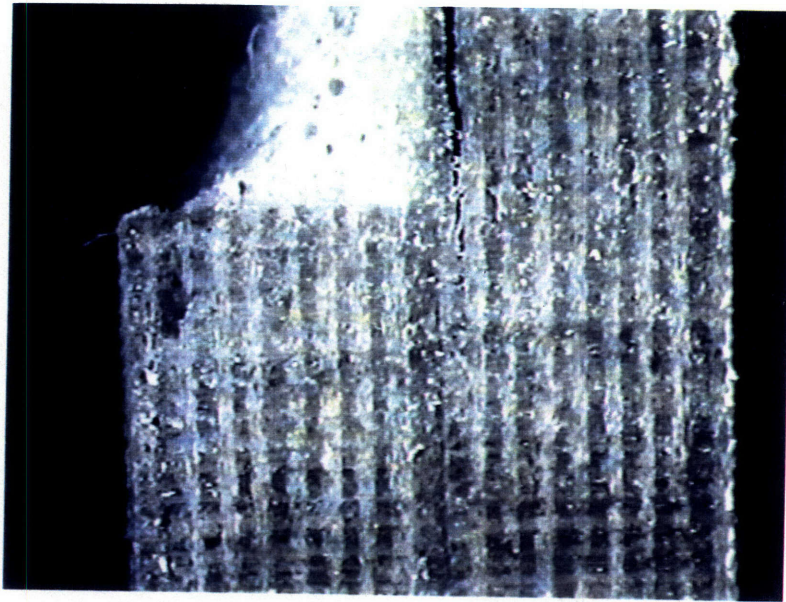
Figure 4.9: h2, 85 seconds

The crack has now distinctly opened, and can be seen to be progressing actually under the joint. The opening displacement is approximately twice the displacement in figure 4.8, 75 seconds. Note that the opening of the crack is increasing farther from the joint.

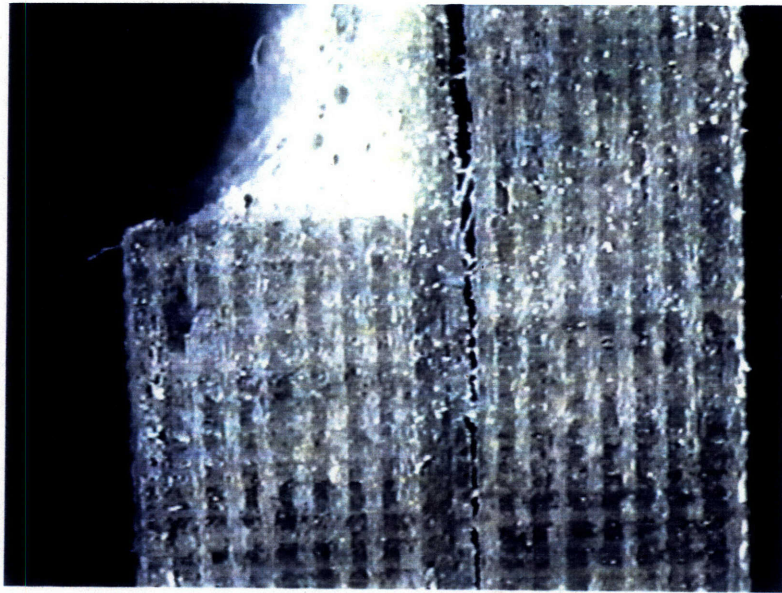
Figure 4.10: h2, 95 seconds

Here the crack is progressing under the joint at an increasing rate. An interesting observation is the much greater opening of the crack just outside of the joint area. This supports the prediction of peel stresses, and the greater opening outside of the joint would be due to the much lower stiffness.

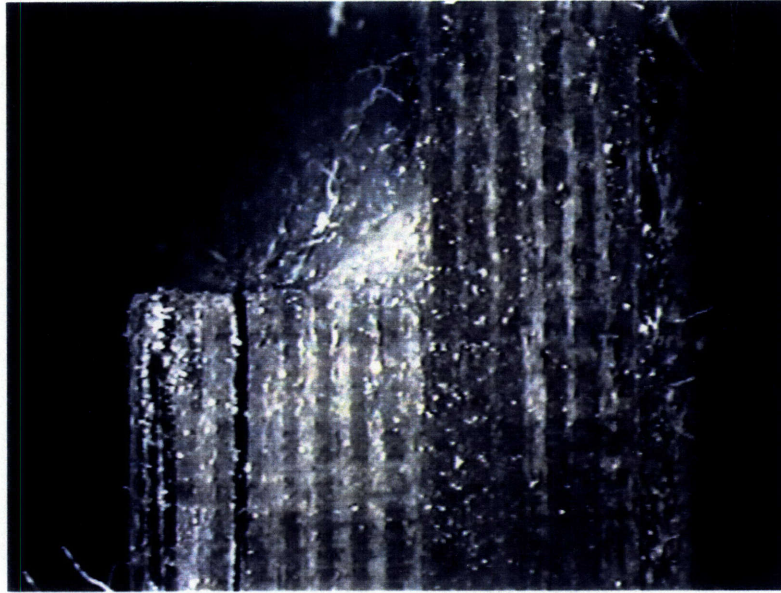
Figure 4.12: h5, Start of test

This is the sample at the beginning of the test, prior to any loading being applied. There are no existing cracks in the joint area, although a crack does exist in the adherend at the left side of the picture. This crack was the result of the cutting operation when trimming the strips to length.

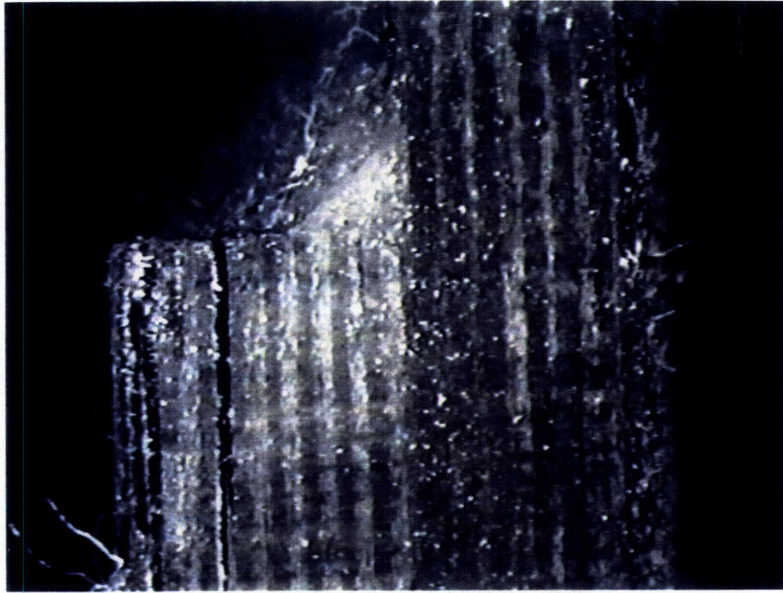
Figure 4.13: h5, 50 seconds

At this time, no cracking can be observed. The load increase, see figure 4.11, is still linear.

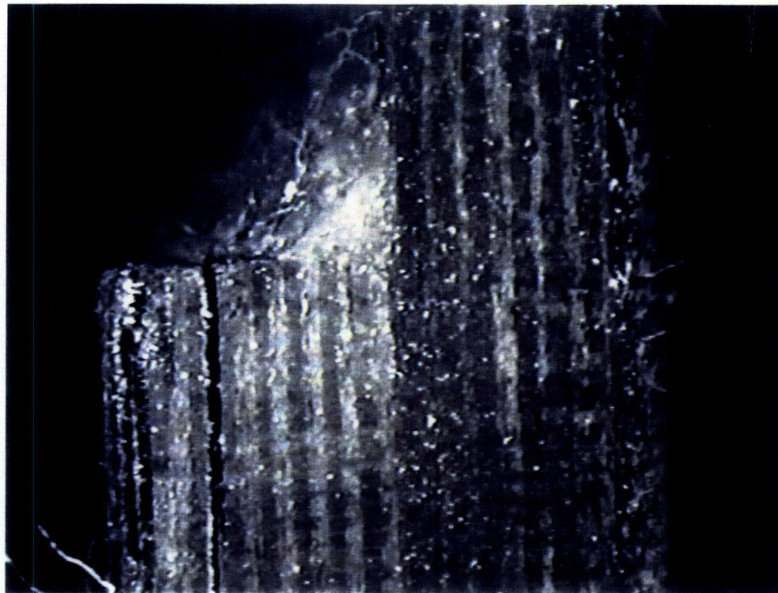
Figure 4.14: h5, 75 seconds

The very beginnings of a crack can be observed at this point. The crack is occurring underneath the end of the joint, in the middle of the image. The load increase in figure 4.11 shows the beginnings of a non-linear behavior at this time.

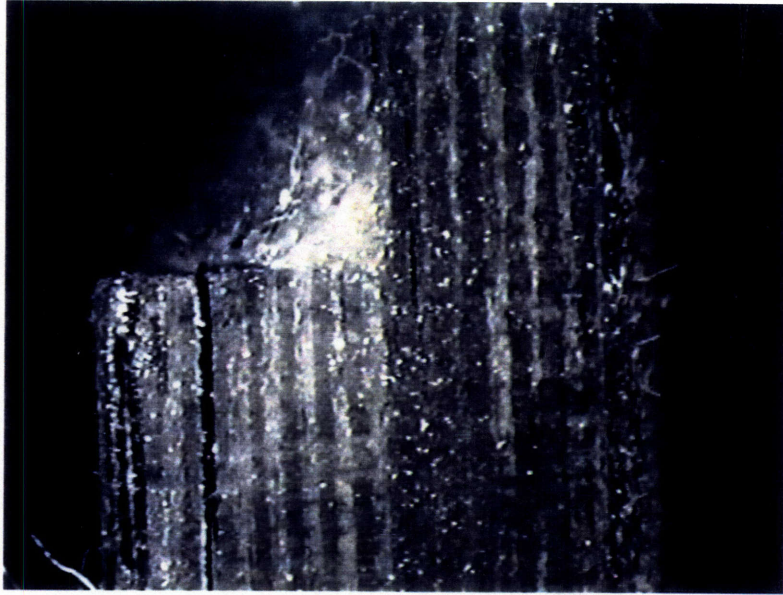
Figure 4.15: h5, 85 seconds

The crack is becoming more visible. At this point, the load increase graph shows an increasingly non-linear behavior.

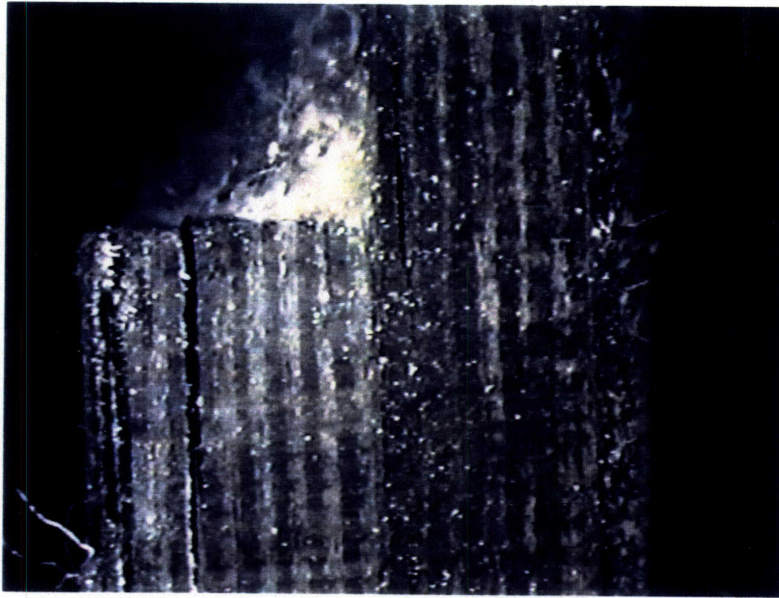
Figure 4.16: h5, 95 seconds

The crack has now become distinct. In a similar manner to the behavior of the crack in sample **h2**, the crack is exhibiting the majority of the opening beyond the end of the joint. Again, this supports the prediction of peel stresses concentrated at the end of the joint.

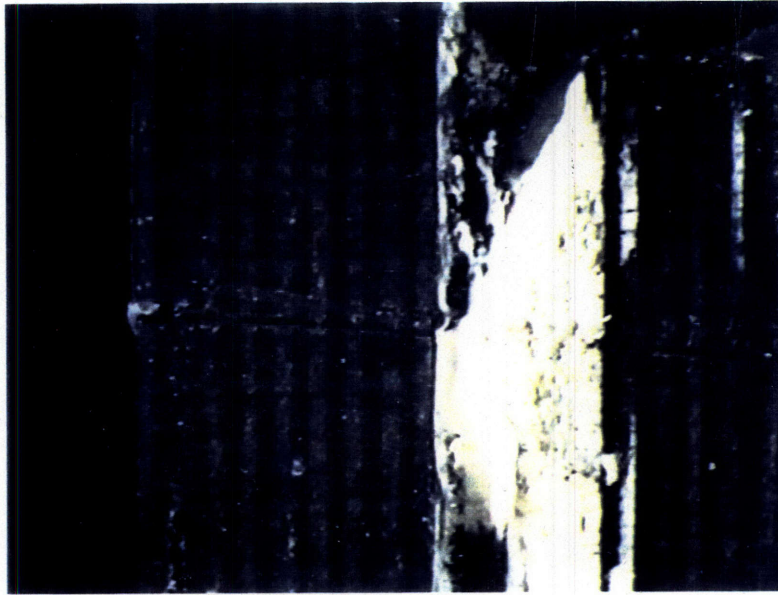
Figure 4.19: p1, start of test

This is sample p1 at the beginning of testing, with no significant tensile loading. There is a reference mark scribed across the joint, it can be seen in the approximate middle of the image. There is an existing flaw in the edge of the adhesive, the joint area is not completely filled with adhesive, this can be seen at the top of the image.

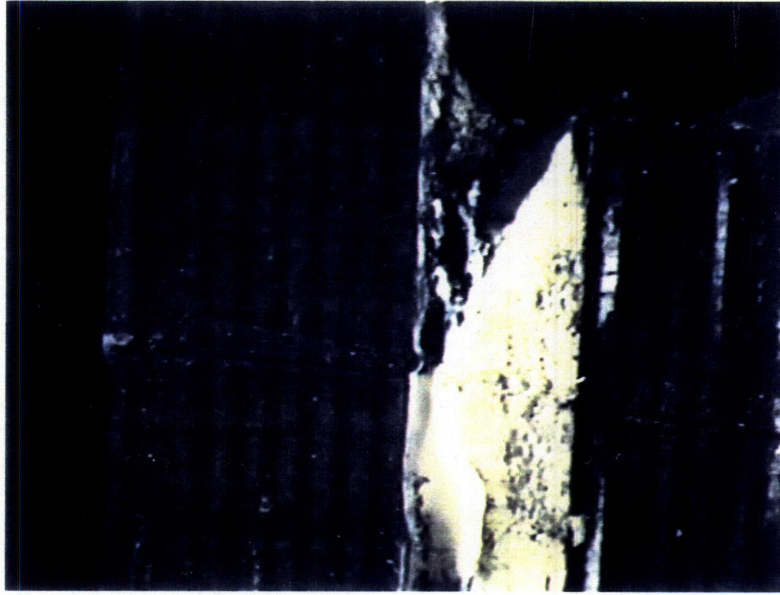
Figure 4.20: p1, 60 seconds

This image is taken at 60 seconds. As can be seen in figure 4.18, the load increase has just begun to exhibit a non-linear behavior. It can be seen that the adhesive has begun to distort in a Mode II manner, the scribed reference mark is no longer in a straight line.

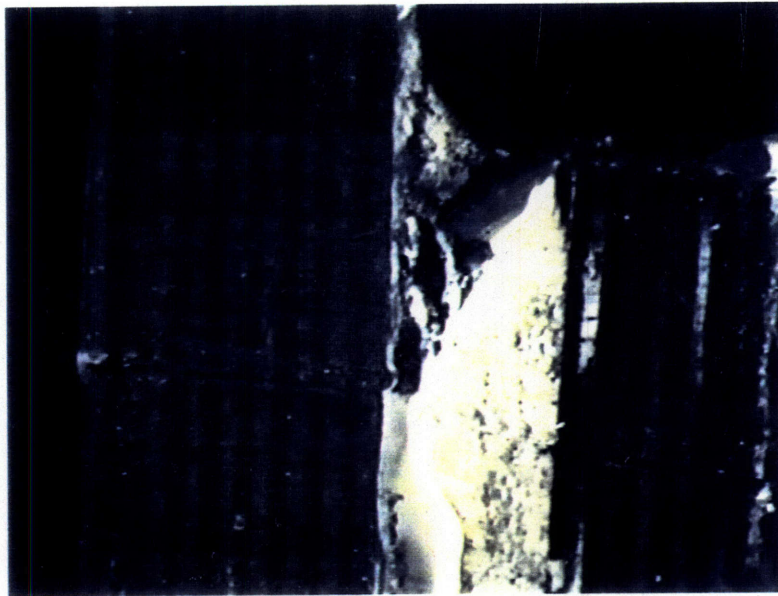
Figure 4.21: p1, 90 seconds

The Mode II distortion is evident here when examining the reference mark and the sanding marks in the adhesive. Mode I failure can also be observed in the adhesive originating from the end of the flaw in the edge of the adhesive.

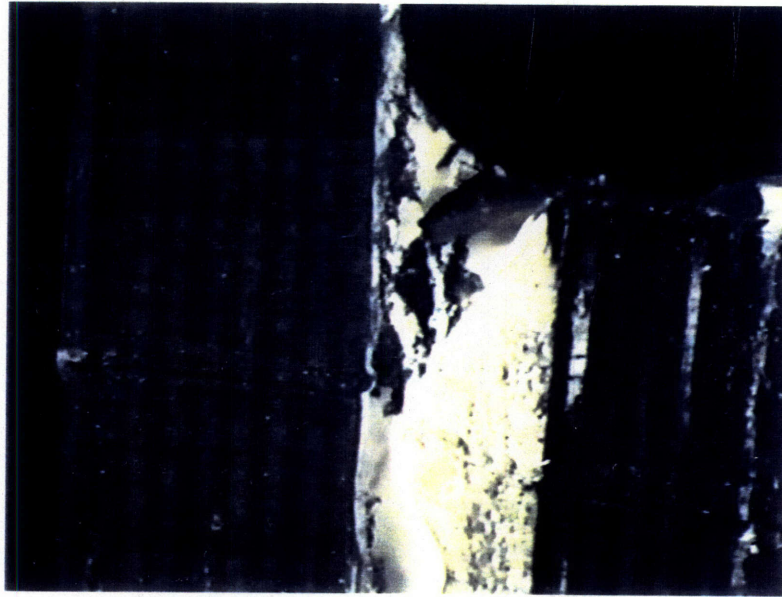
Figure 4.22: p1, 110 seconds

Mode I failure is continuing, and a large amount of distortion in the Mode II direction can also be observed. The Mode II failure is exhibited both by the distortion of the sanding marks and the extreme mismatch of the reference mark.

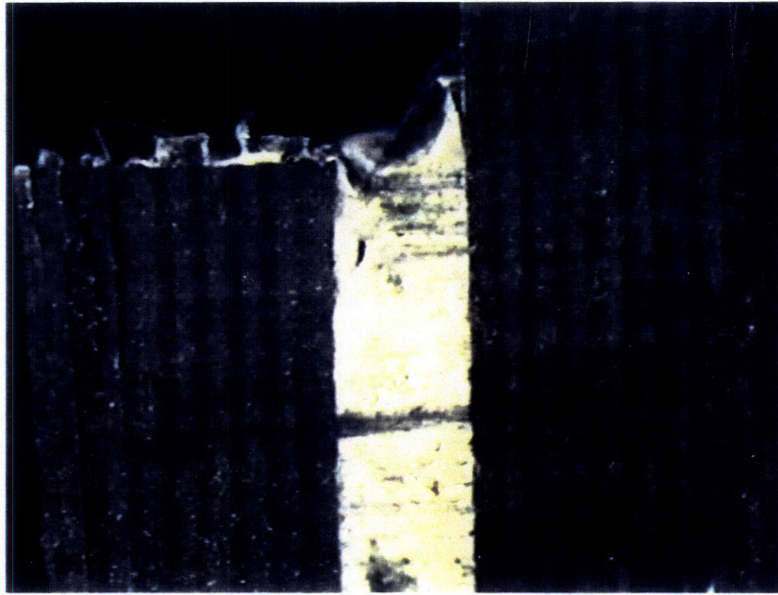
Figure 4.24: p4, start of test

This image shows the sample at the beginning of the test. Note the reference mark scratched across the joint, which has been highlighted across the adhesive with pencil. There is an existing void near the upper left edge of the joint. At the upper right edge of the joint the adhesive can be seen to be lifting slightly. These all were existing before loading of any significant amount occurred.

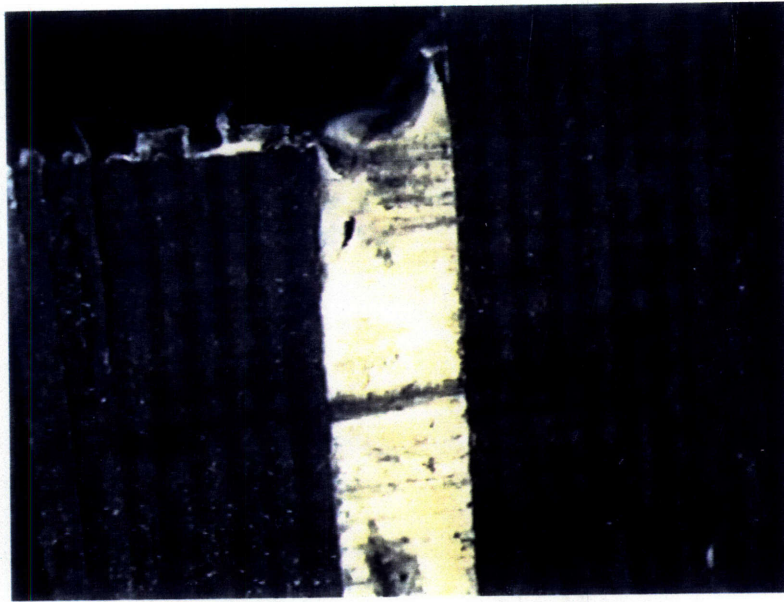
Figure 4.25: p4, 45 seconds

At this time, the void can be seen to be distorting. In addition, the reference mark shows Mode II movement of the joint. Figure 4.23 shows that the load data is beginning to exhibit a non-linear behavior at this time.

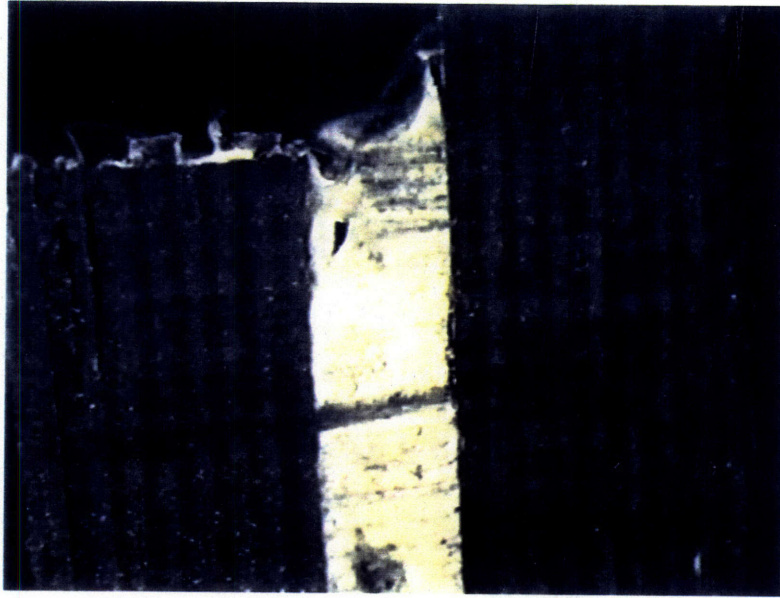
Figure 4.26: p4, 55 seconds

The void is much more severely distorting. The pre-existing curled area in the upper right is curling more. There is a crack forming along the adhesive-adherend interface at the right end of the pencil reference mark. This crack is opening in a Mode I fashion.

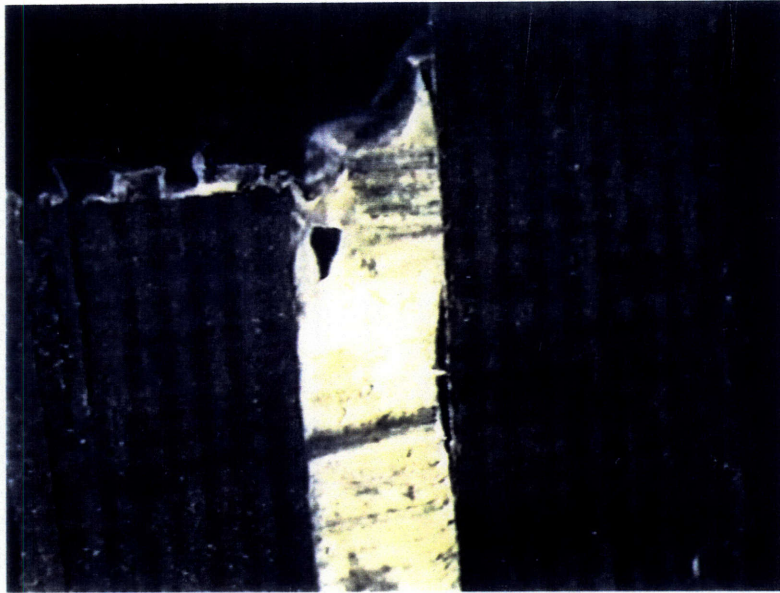
Figure 4.27: p4, 75 seconds

The void has become extremely distorted and enlarged. The crack formed at the right end of the reference mark has lengthened slightly, but opened considerably, indicating the presence of peel stresses at the end of the joint

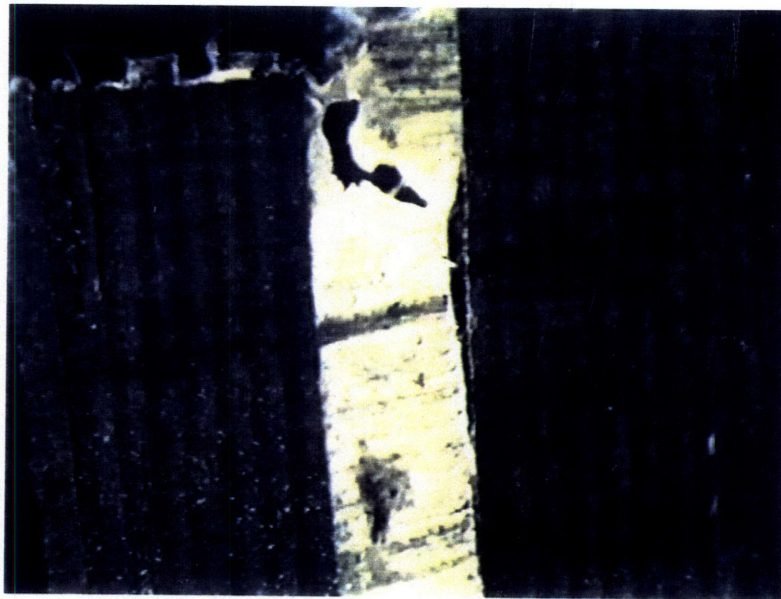
Figure 4.28: p4, 85 seconds

At this time, a crack has propagated across the joint. This crack has linked the void and the upper end of the crack on the right side of the joint. It propagated at an angle across the joint, which would indicate some shearing stress.

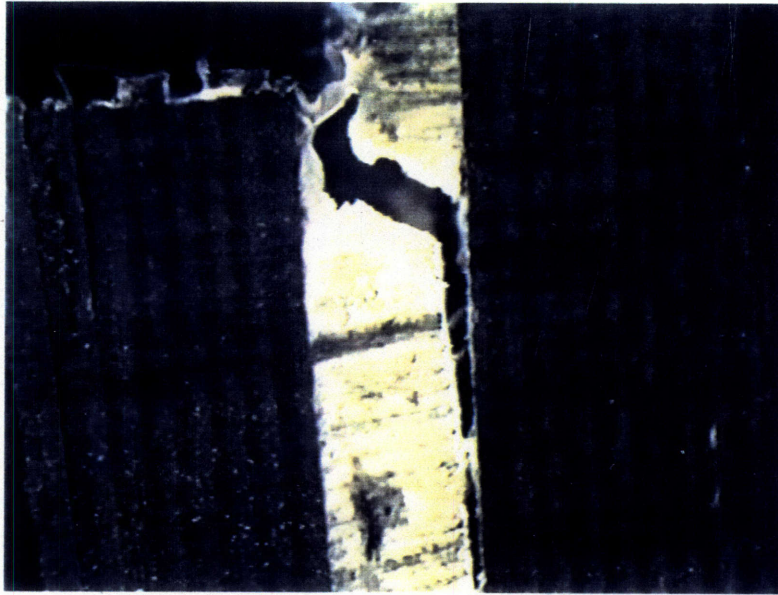
Figure 4.29: p4, 95 seconds

This is an interesting image. The microscope has been lowered slightly to observe the crack tip progression. There has clearly been Mode II movement of the adherends, which can be seen by the mismatch in the reference marks and the widening transverse gap at the top of the image. That there are also peel stresses present can be seen by the wider end of the crack at the top, making a tall, narrow v along the right side of the joint. There has been some elastic recovery of the adhesive where this crack has propagated. This can be seen by the relative straightening of the transverse sanding marks in the middle of the image as compared to the distorted sanding marks across the joint at the bottom of the image.

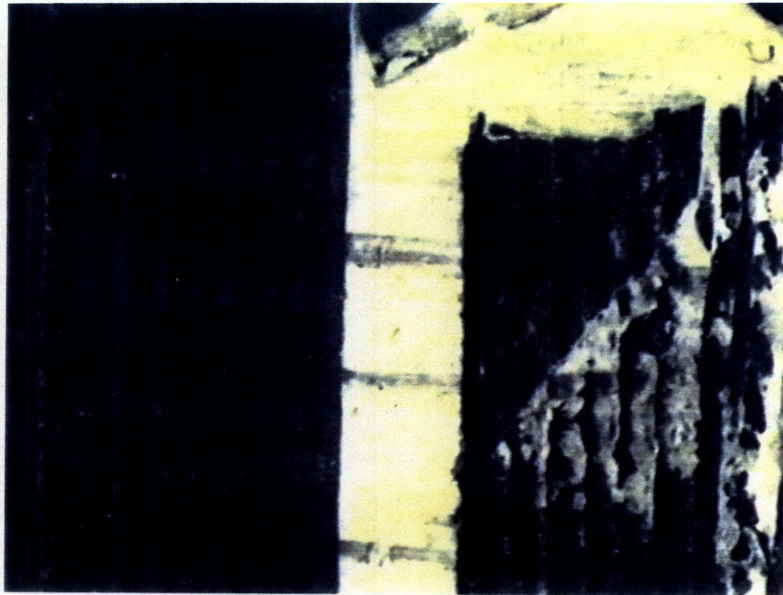
Figure 4.31: p5, Start of test

This sample has several reference marks across the edge of the joint. There are no significant voids, although the end of the joint exhibits a slight undercut.

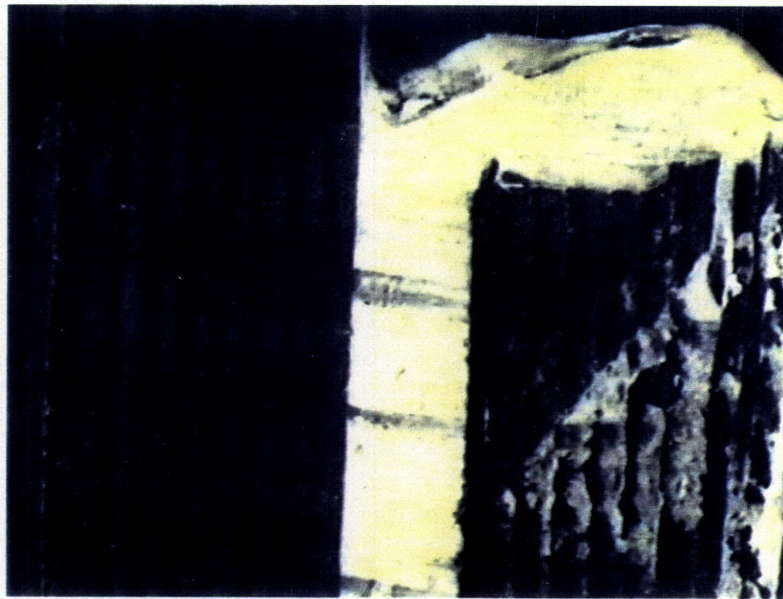
Figure 4.32: p5, 50 seconds

This image shows only Mode II motion at this point. This can be clearly seen by the distortion of the reference marks across the joint. The microscope has been lowered slightly as compared to figure 4.31.

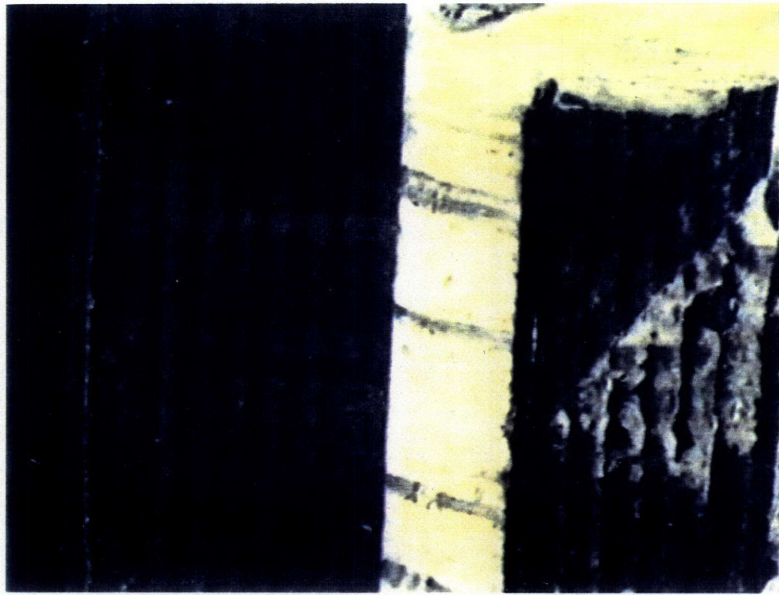
Figure 4.33: p5, 80 seconds

This image continues to show Mode II movement. There is a crack forming between the first 0° and the first 90° plies just to the right of the adhesive.

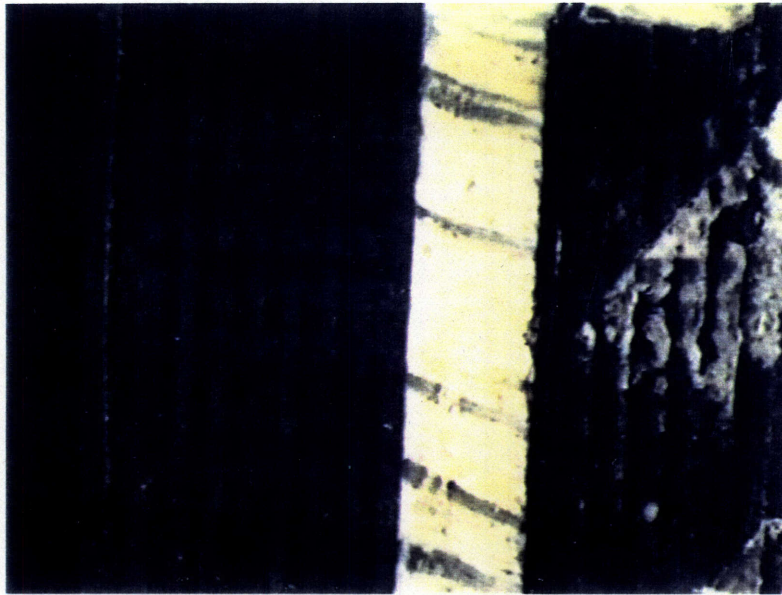
Figure 4.34: p5, 90 seconds

In this image it can be seen that the crack between the 0° and the 90° plies is continuing to open. Mode I failure of the adhesive has not begun to occur.

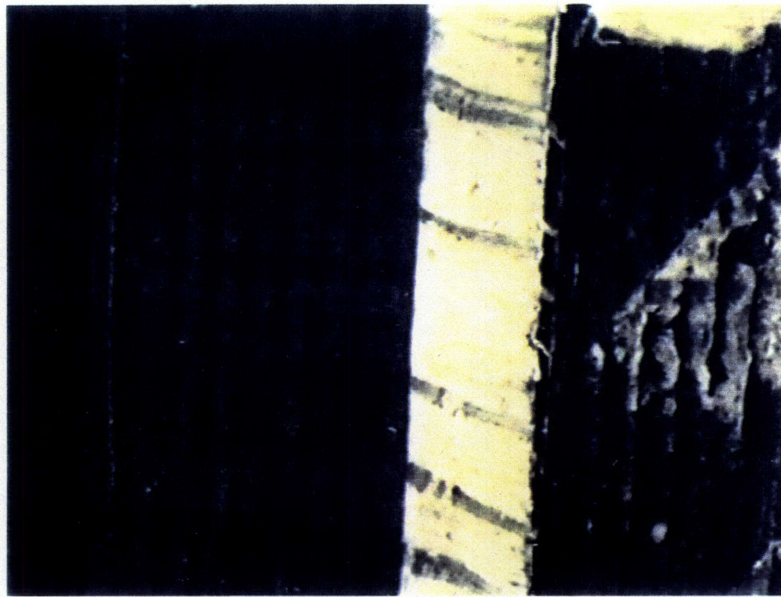
Figure 4.35: p5, 100 seconds

Mode I failure is now occurring along the right side of the joint along the adhesive-adherend interface and the interlaminar crack in figure 4.33 has closed up. The elastic recovery of the adhesive can be seen by the straightening of the reference marks at the top of the image as compared with the much more distorted reference marks at the bottom of the image.

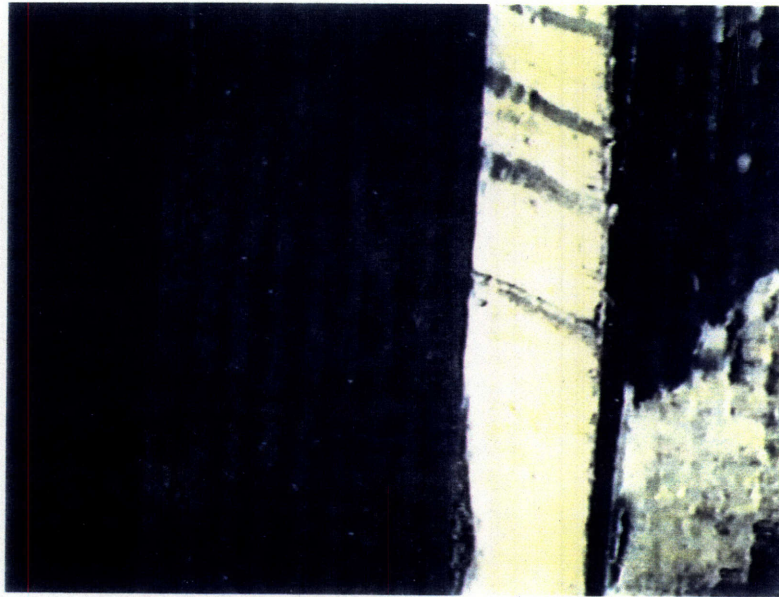
Figure 4.36: p5, 110 seconds

seconds this crack is more evident (see fig. 4.33). At 110 seconds, the crack is clear, and recovery of some of the Mode II distortion can be seen where the crack has occurred. The sanding marks have straightened where the crack has opened, but there is still Mode II distortion at the crack tip (see fig. 4.34). At 110 seconds the crack is opening and progressing at an increasing rate (see fig. 4.36).

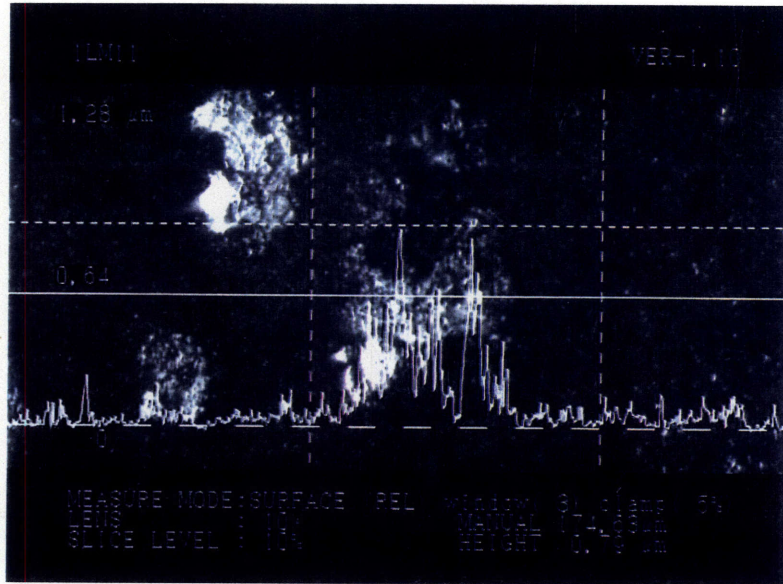
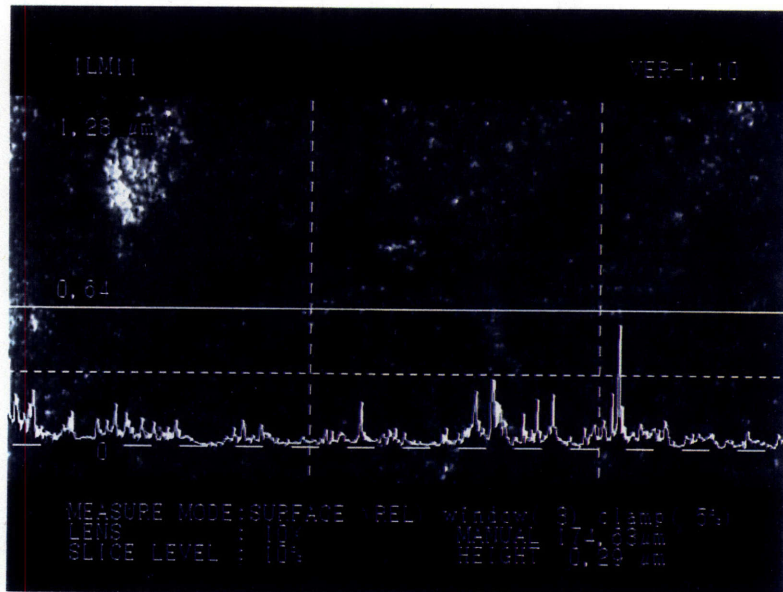
Figure 4.38: Laser Microscope measurement of corresponding point on other half of fractured sample

The laser microscope was used in an attempt to measure the plastic deformation of the adhesive surfaces after fracture. A Plexus sample was selected for this. The profiles of the mating surfaces at the same point were measured. The samples were carefully aligned, in order to ensure that the same point was, indeed, being measured. A profile was measured, but no correlation between the two surfaces could be observed (see figures 4.36, 4.37).
