# Horn Operational Experience in K2K, MiniBooNE, NuMI and CNGS

Ans Pardons<sup>1</sup> CERN Geneva, Switzerland E-mail: ans.pardons@cern.ch

10th International Workshop on Neutrino Factories, Super beams and Beta beams Valencia, Spain 30 June – 05 July, 2008

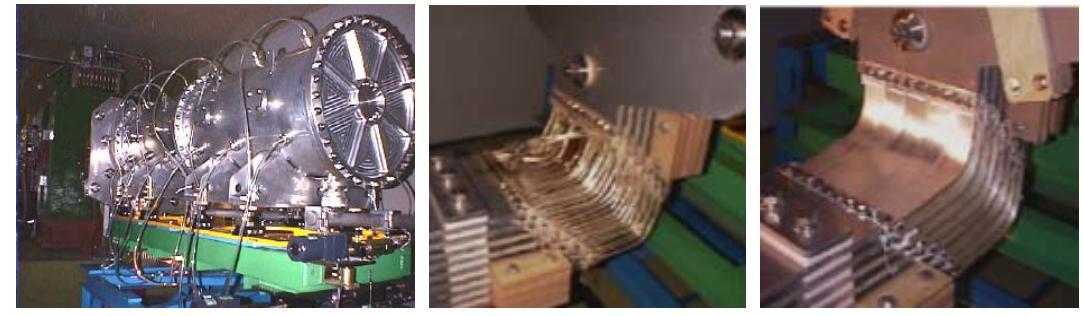
Figures 3a-c: K2K horn new water lines, faulty and new horn-busbar connection.

During its five years of operation, the K2K beam line saw two major horn failures, both in the first year. The first was a leak in a cracked weld on the straight water inlet pipes, induced by fatigue stress from cyclic thermal expansion of the horn outer conductor to which they were attached. Figure 3a shows the new semi-flexible pipes that were installed on all following horns to absorb the thermal expansion. The second failure occurred in a semi-flexible busbar connection consisting of twisted copper cables, where strong magnetic forces between conductors of different polarities deformed the cables (Figure 3b) and caused a short circuit. The cables were successfully replaced with more rigid plates as shown in Figure 3c.

- Protect water input lines from vibrations of the outer conductor.
- Take magnetic forces into account when designing busbars and other conductors.
- Design future horn for remote exchange.

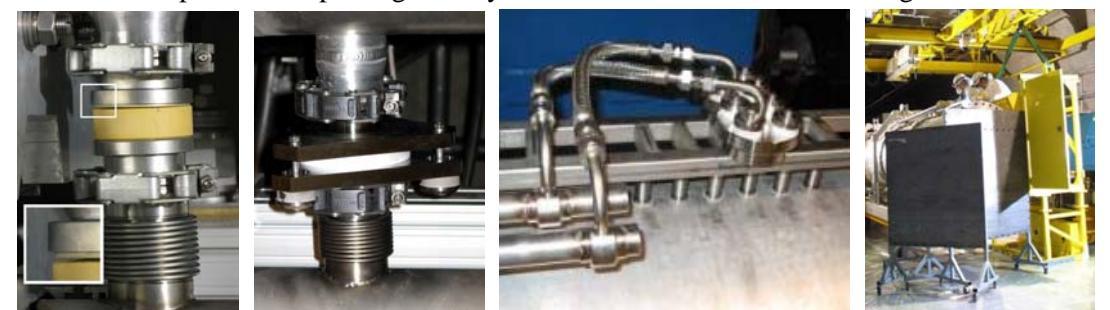
Figures 4 a-d: Faulty and new water outlet, new water inlets and in-situ intervention.

After half a million pulses and a month of beam, a water leak appeared in the second (most downstream) horn's cooling circuit. One of the horn's electrically insulated brazed water outlets had a broken ceramic muff, as visible on Figure 4a. Analysis shows that the thin ceramic muff was weakened from machining and brazing. As a consequence, the relatively small forces from the horn pulsing sufficed to break the ceramic. A brazing-free alternative, where leak tightness

is ensured by pressing soft graphite seals on a ceramic ring (Figure 4b-c), was installed. All brazed assemblies (outlets and inlets) were preventively replaced on both horns in a makeshift shielded area upstream of the target (Figure 4d). To reduce the personnel radiation dose, the intervention was carefully optimized and practised beforehand on the spare horn.

- Avoid brazing in the ceramic insulating assemblies of the cooling circuit.
- Invest in tooling, training and local shielding in case of local interventions.
