January 2012

# Establishing the quality management baseline in the use of computed tomography machines in Kenya

Korir, G. K., Wambani, J. S., Korir, I. K., Ochieng, B. O. (2012). Establishing the quality management baseline in the use of computed tomography machines in Kenya. *Journal of Applied Clinical Medical Physics*, 13(1), 187-196. **Available at:** http://ecommons.aku.edu/eastafrica\_fhs\_mc\_imaging\_diagn\_radiol/5

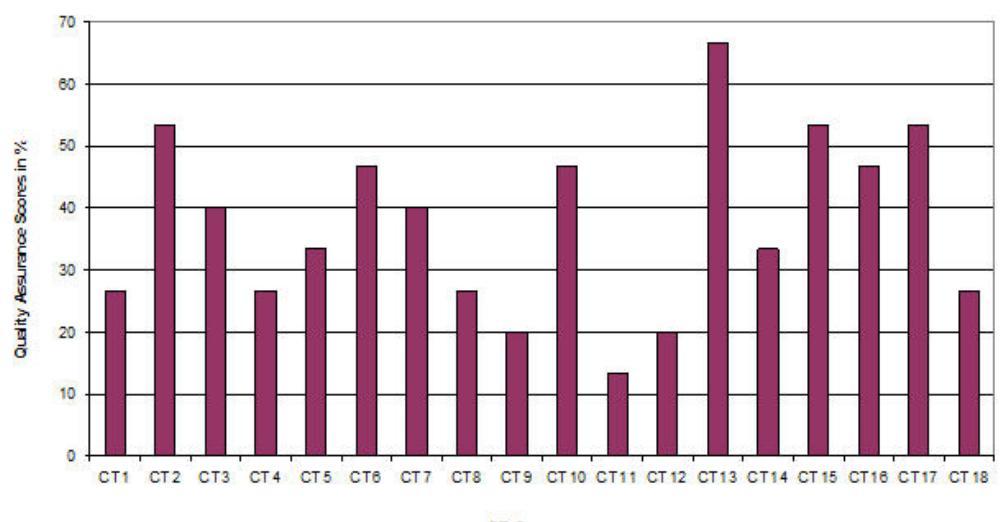
Figure 1 indicates the quality assurance performance results for each CT scanner facility with respect to all four categories stated above. According to the criteria used, none of the CT scanner facility scored above 75% or excellent, four were good, seven were fair, and seven were poor.

The contents in Table 3 indicate fair performance with respect to compliance with annual effective dose limits. In most facilities, the shielding integrity was compromised by lack of lead overlaps between the doors and door frames, as well as with the adjacent walls. In the control room, there was no lead equivalence between the observation window and the window frame.

FIG. 1. Quality assurance performance per CT scanner facility.

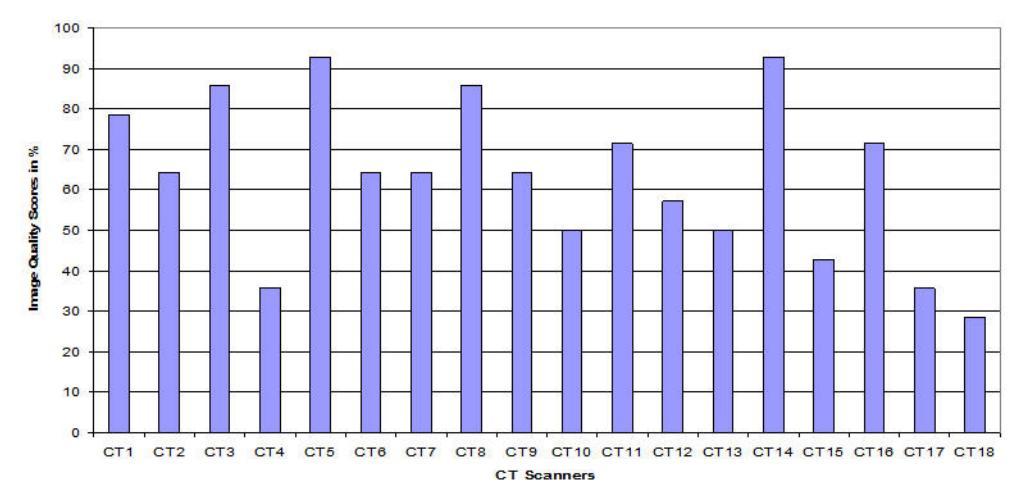
Figure 2 indicates the image quality performance. According to the criteria, five CT scanners achieved excellent image quality, seven were good, six were fair, and none was poor.

FIG. 2. Image quality performance per CT scanner facility.

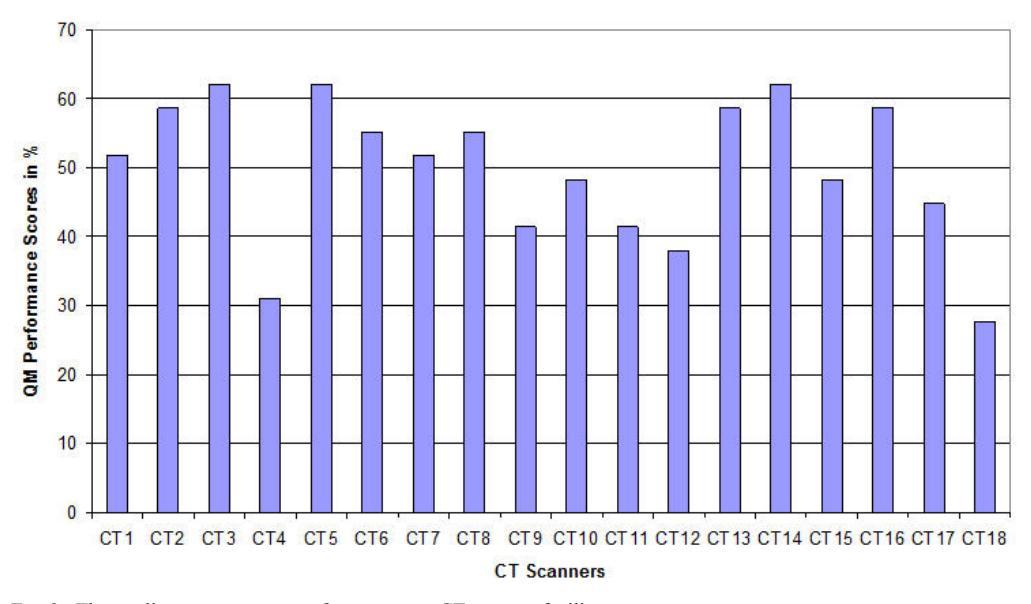
Figure 3 indicates the overall quality management performance. None of the CT scanner facilities scored above 75%, 10 were good, seven fair and one poor. Most CT scanners were accurate with respect to CT number uniformity (83%) and least accurate in high spatial resolution measurements (17%).

FIG. 3. The quality management performance per CT scanner facility.
