Living Shoreline Sea-Level Resiliency: Performance and Adaptive Management of Existing Sites Year 3 Summary Report

Donna A. Milligan
Virginia Institute of Marine Science

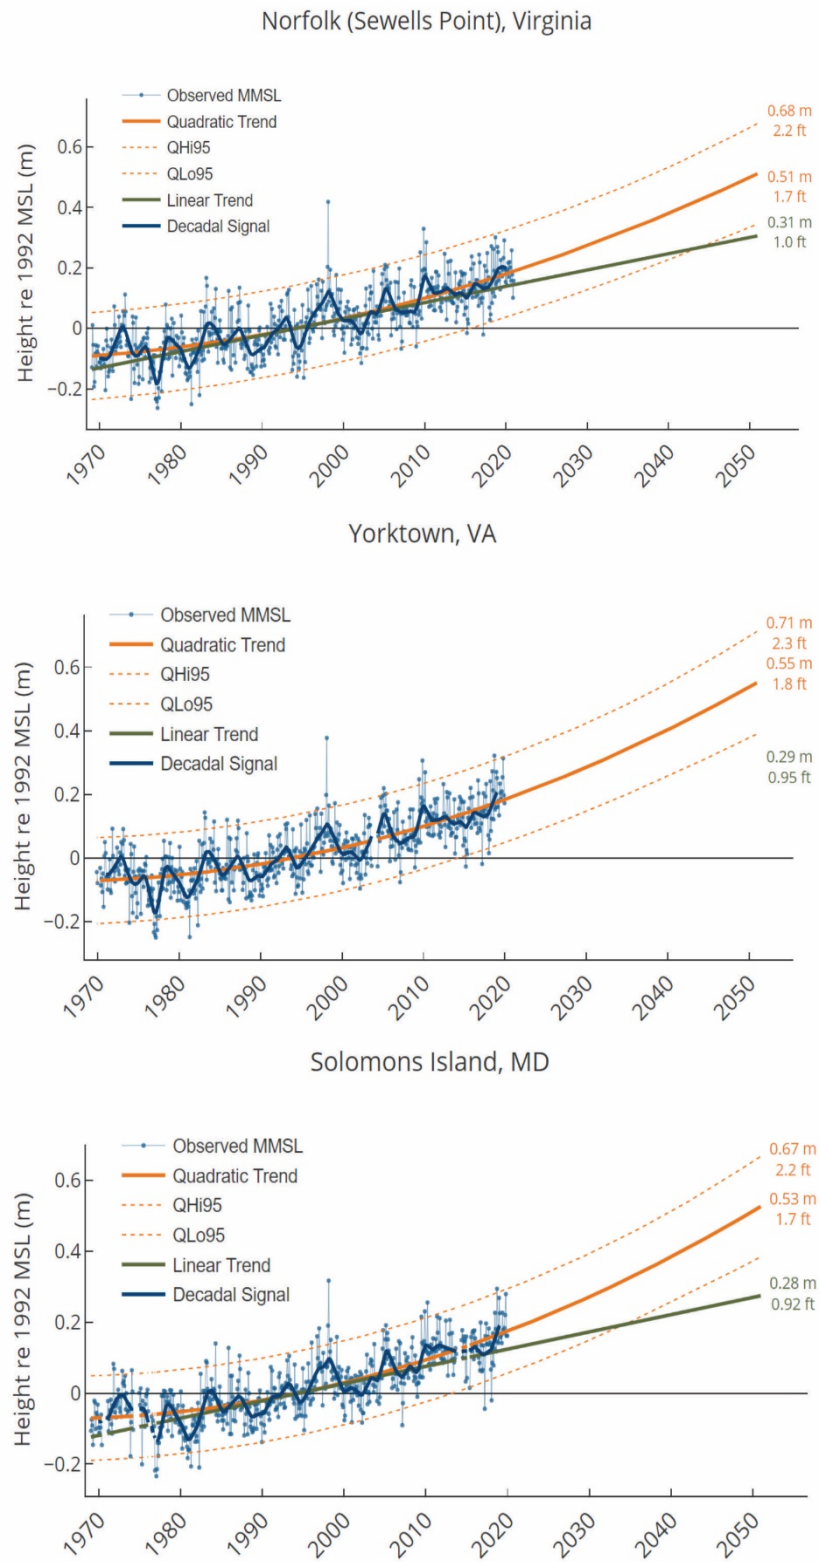
Figure 2-1. Sea-level rise projections based on NOAA tide gauge data. From https://www.vims.edu/bayinfo/bay_slrc/index.php

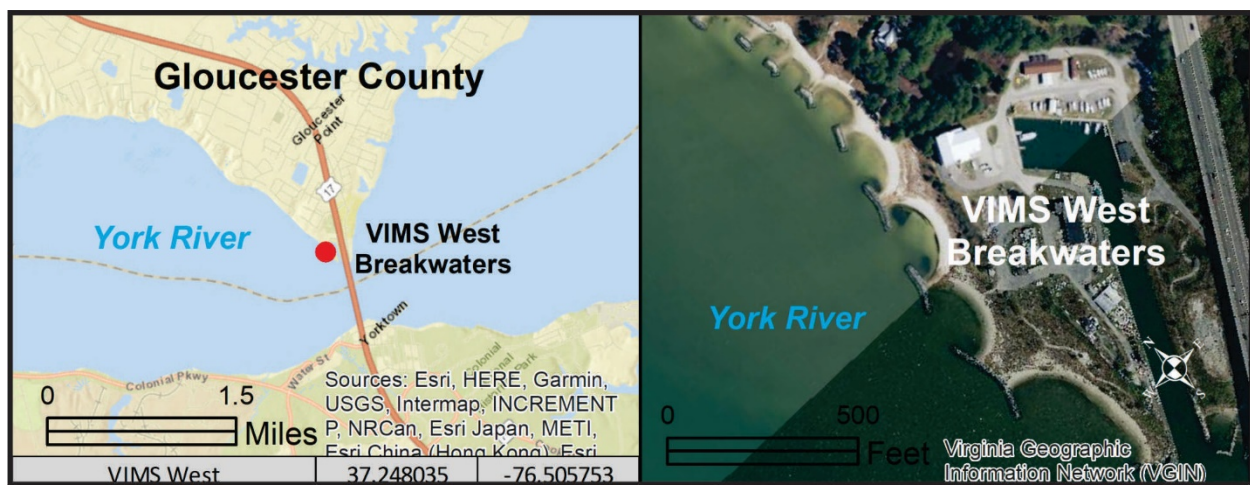
Figure 6-1. Location of VIMS West living shoreline breakwater shore protection system.

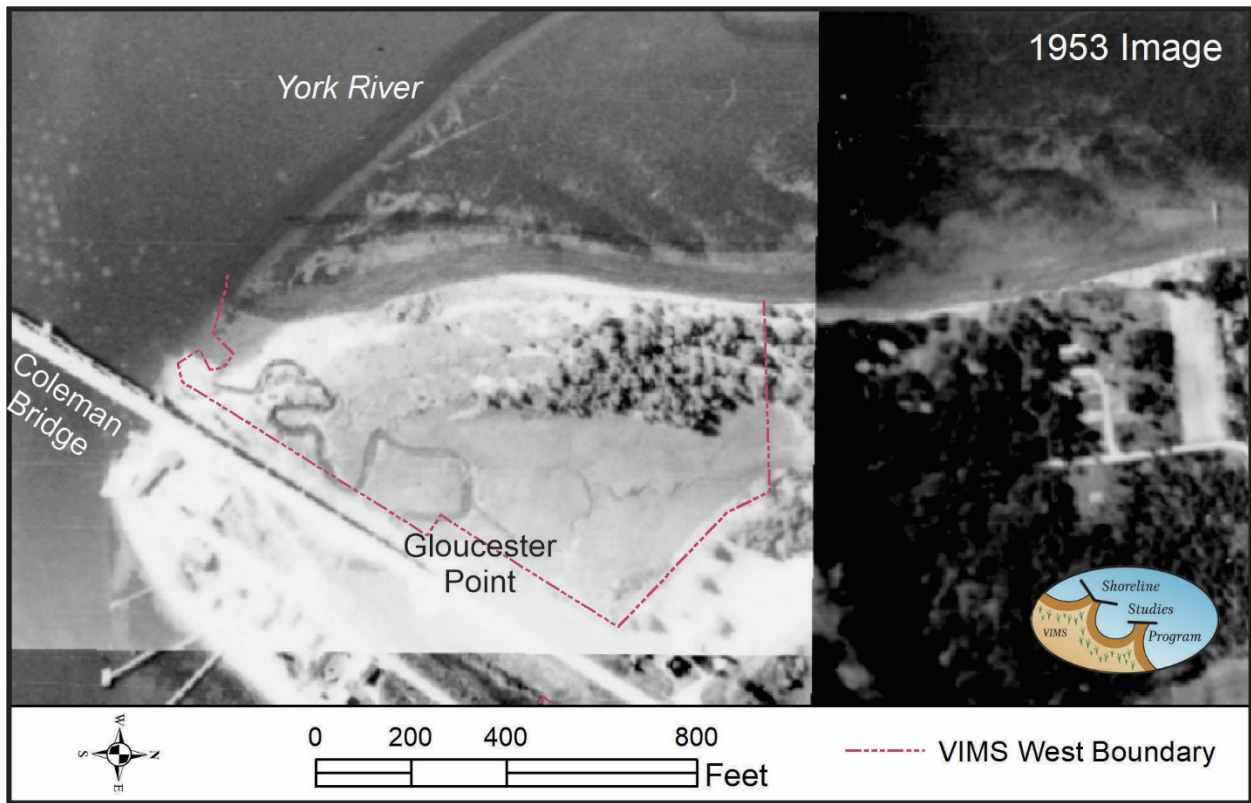
Figure 6-2. VIMS West shoreline in 1953 showing the present-day boundary of the VIMS West campus. In subsequent years, the tidal marsh was dredged to become the marine institute’s boat basin (from Shoreline Studies Program shore change database).

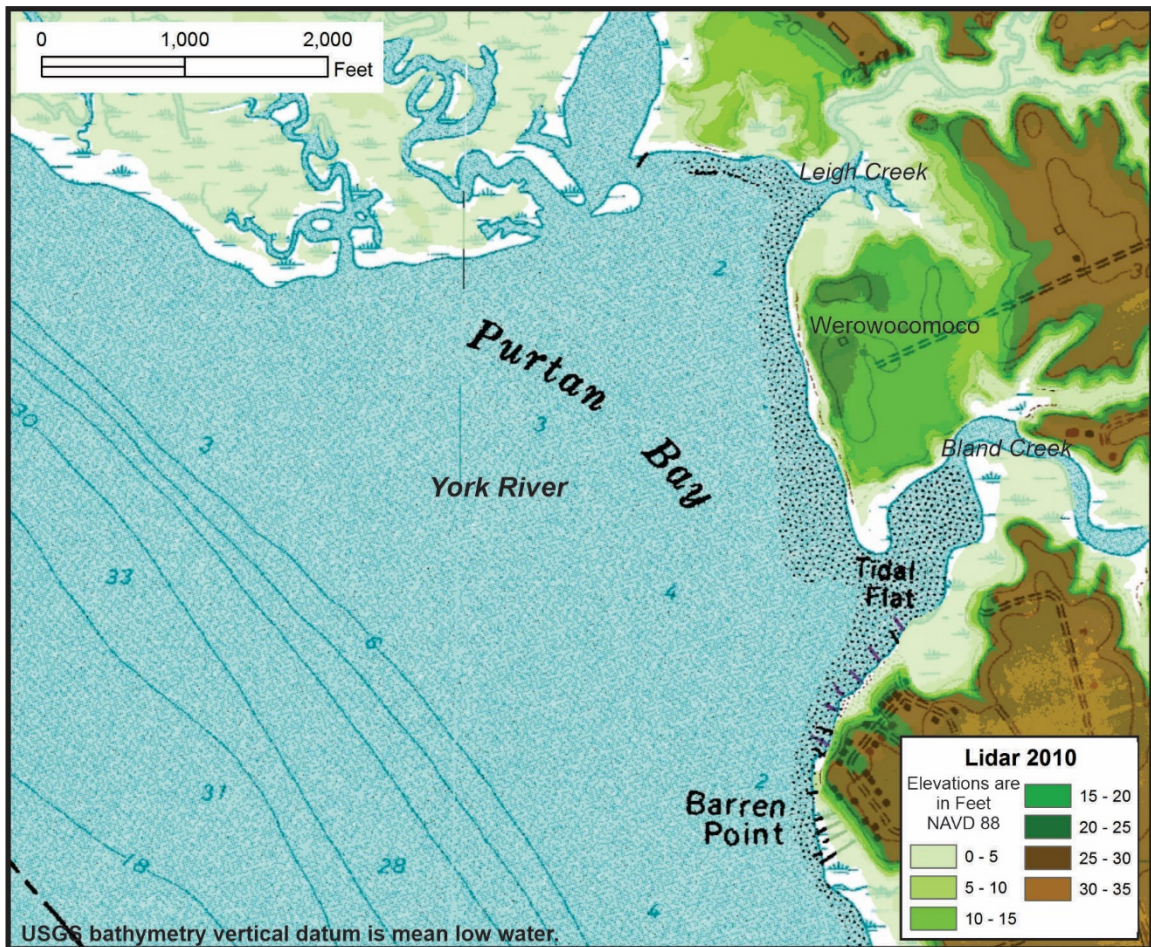
Figure 7-2. Lidar elevation data and bathymetric data in the vicinity of Werowocomoco. From Milligan et al., 2016.

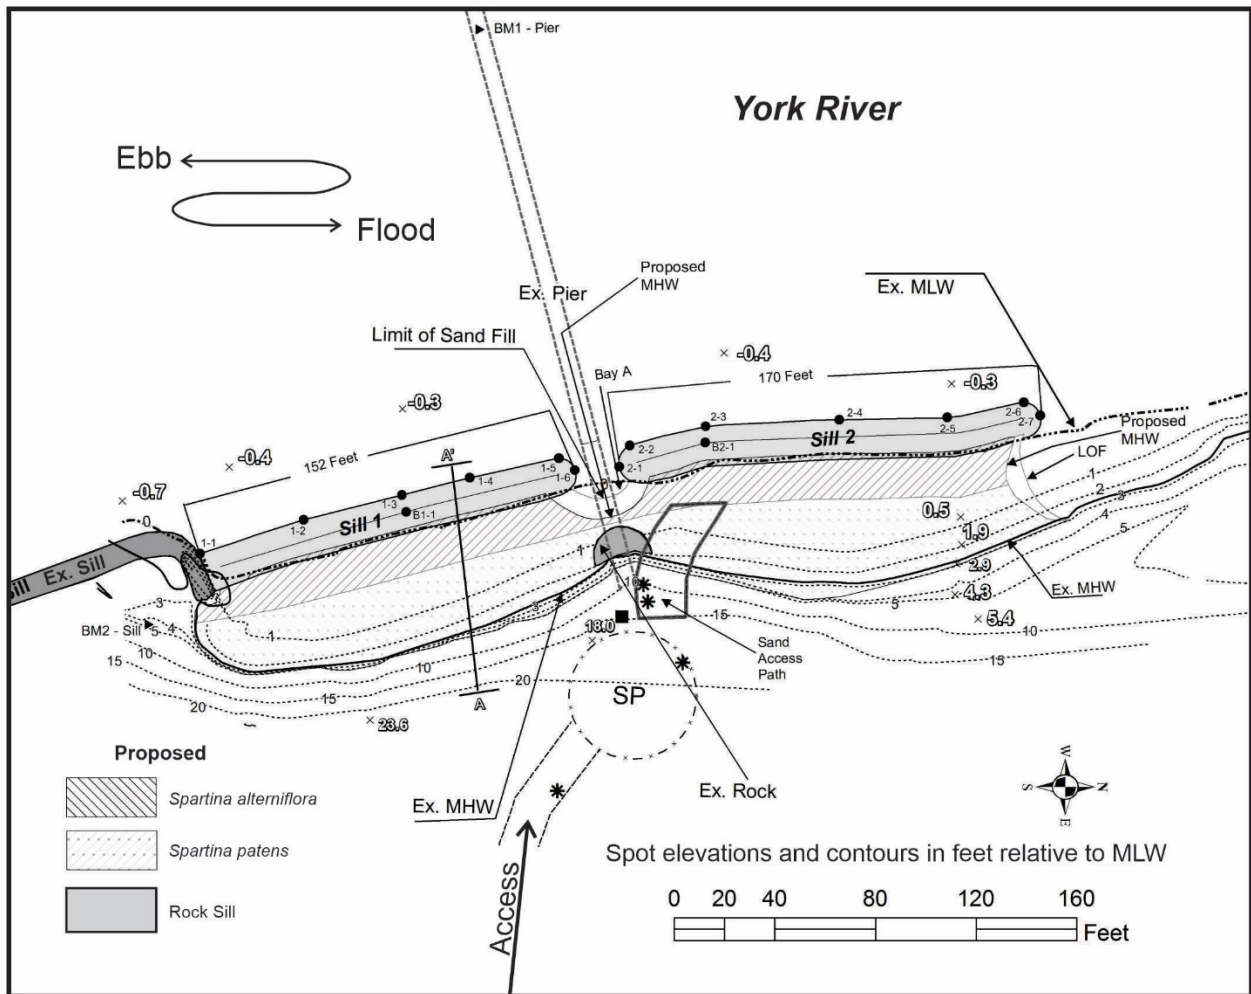
Figure 7-5. Planform of existing and proposed conditions at Werowocomoco living shoreline project.

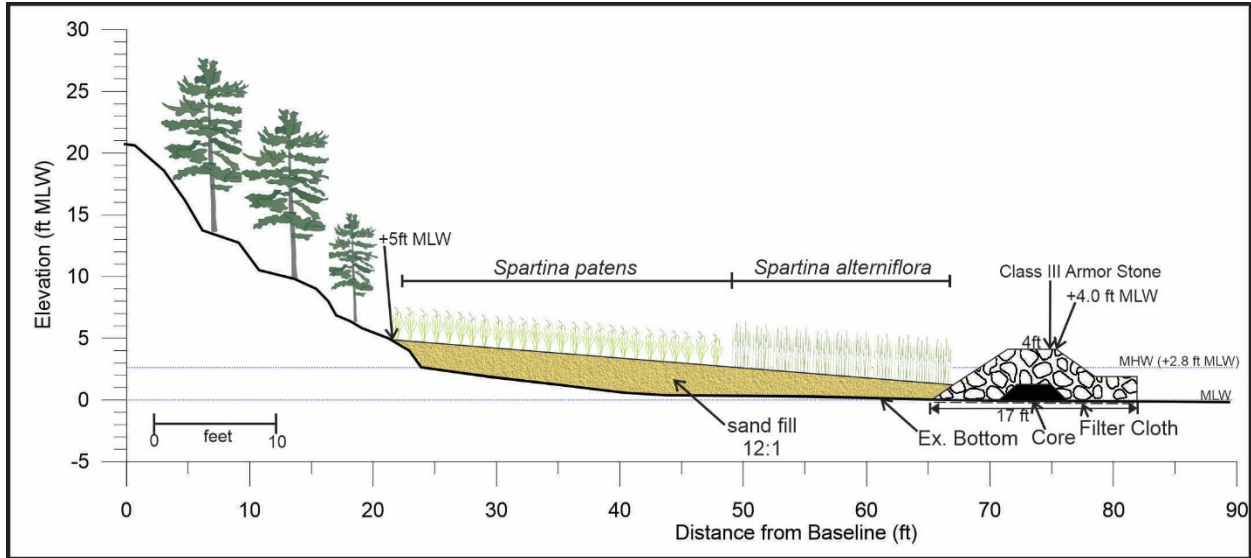
Figure 7-6. Typical cross-section of the sill and sand fill at Werowocomoco living shoreline project.

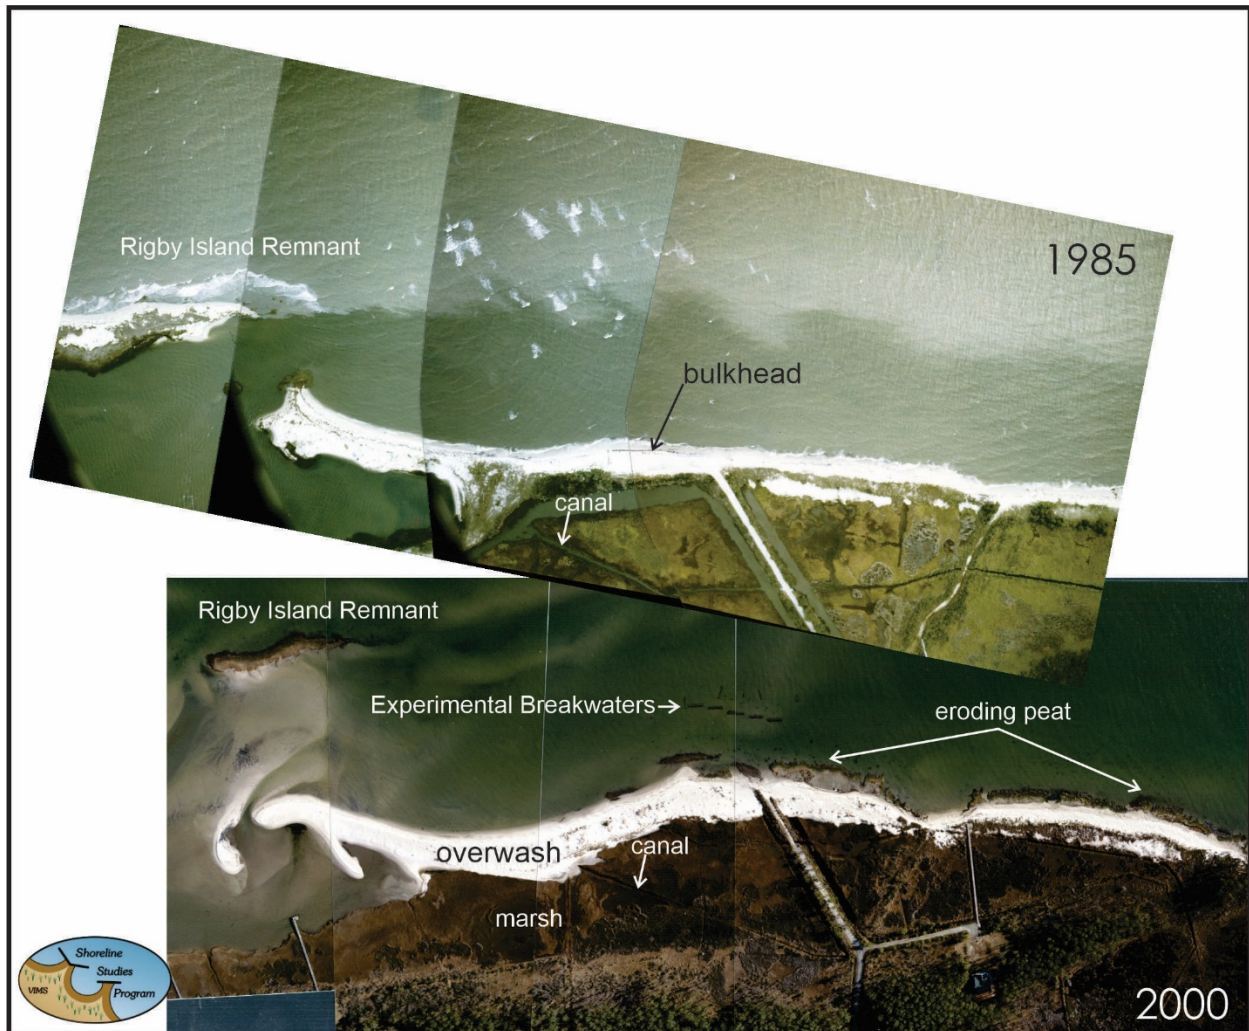
Figure 8-5. Aerial photos taken in 1985 and 2000. Previous shore protection structures such as the timber bulkhead in 1985 and the experimental breakwaters shown in 2000 failed.

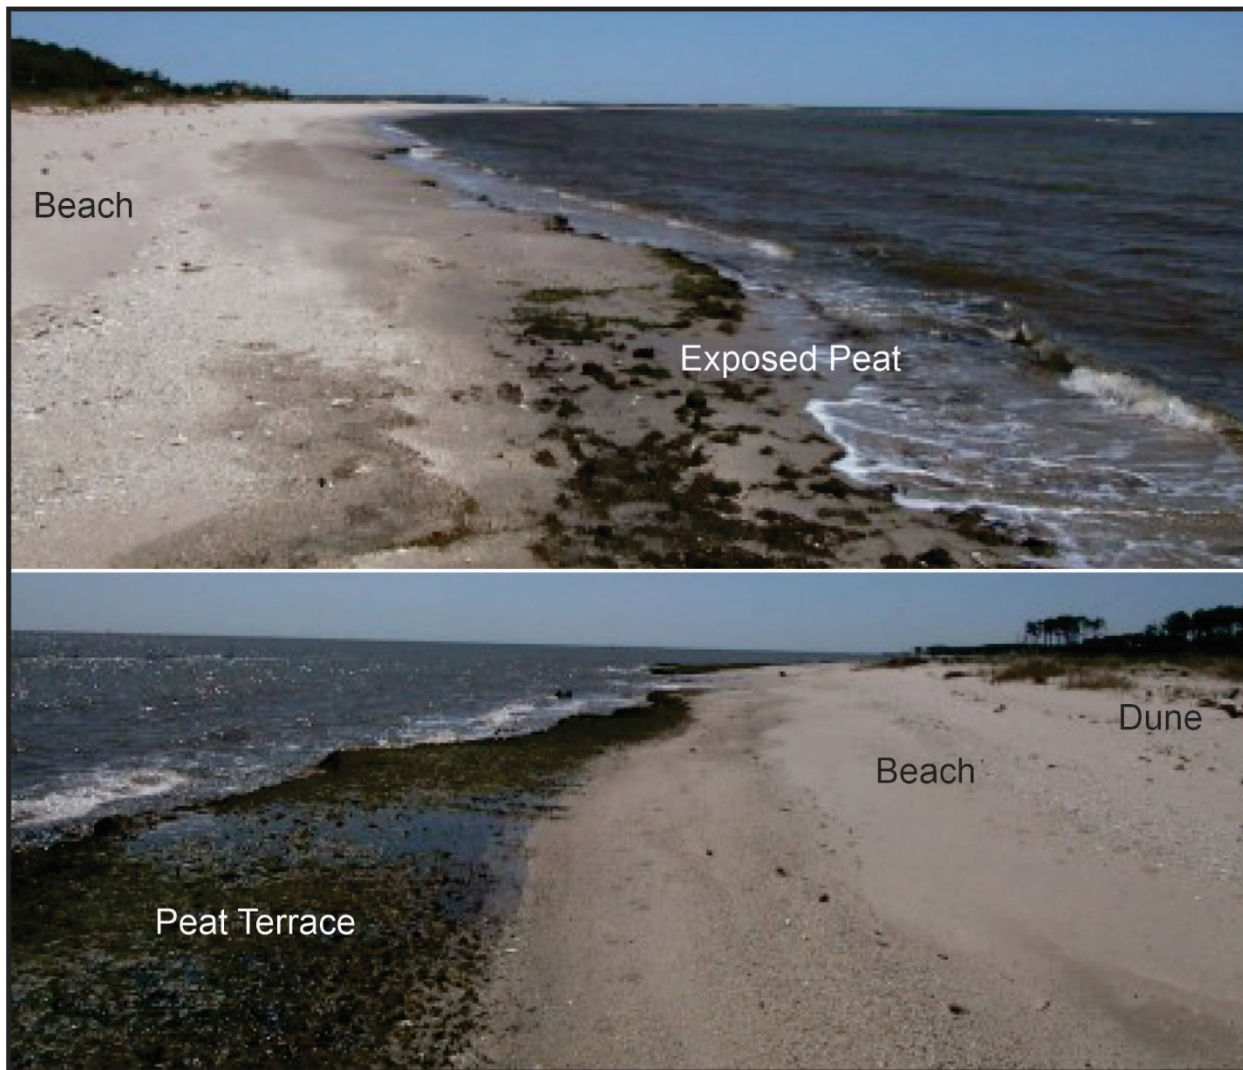
Figure 8-6. Photos at Haven Beach submitted with the Virginia Marine Resource Commission permit application #20022188. Top shows the view looking north along the site and bottom shows the view looking south. Exposed peat and wider peat terraces occur along the site. Above these, a beach and dune/washover occur.

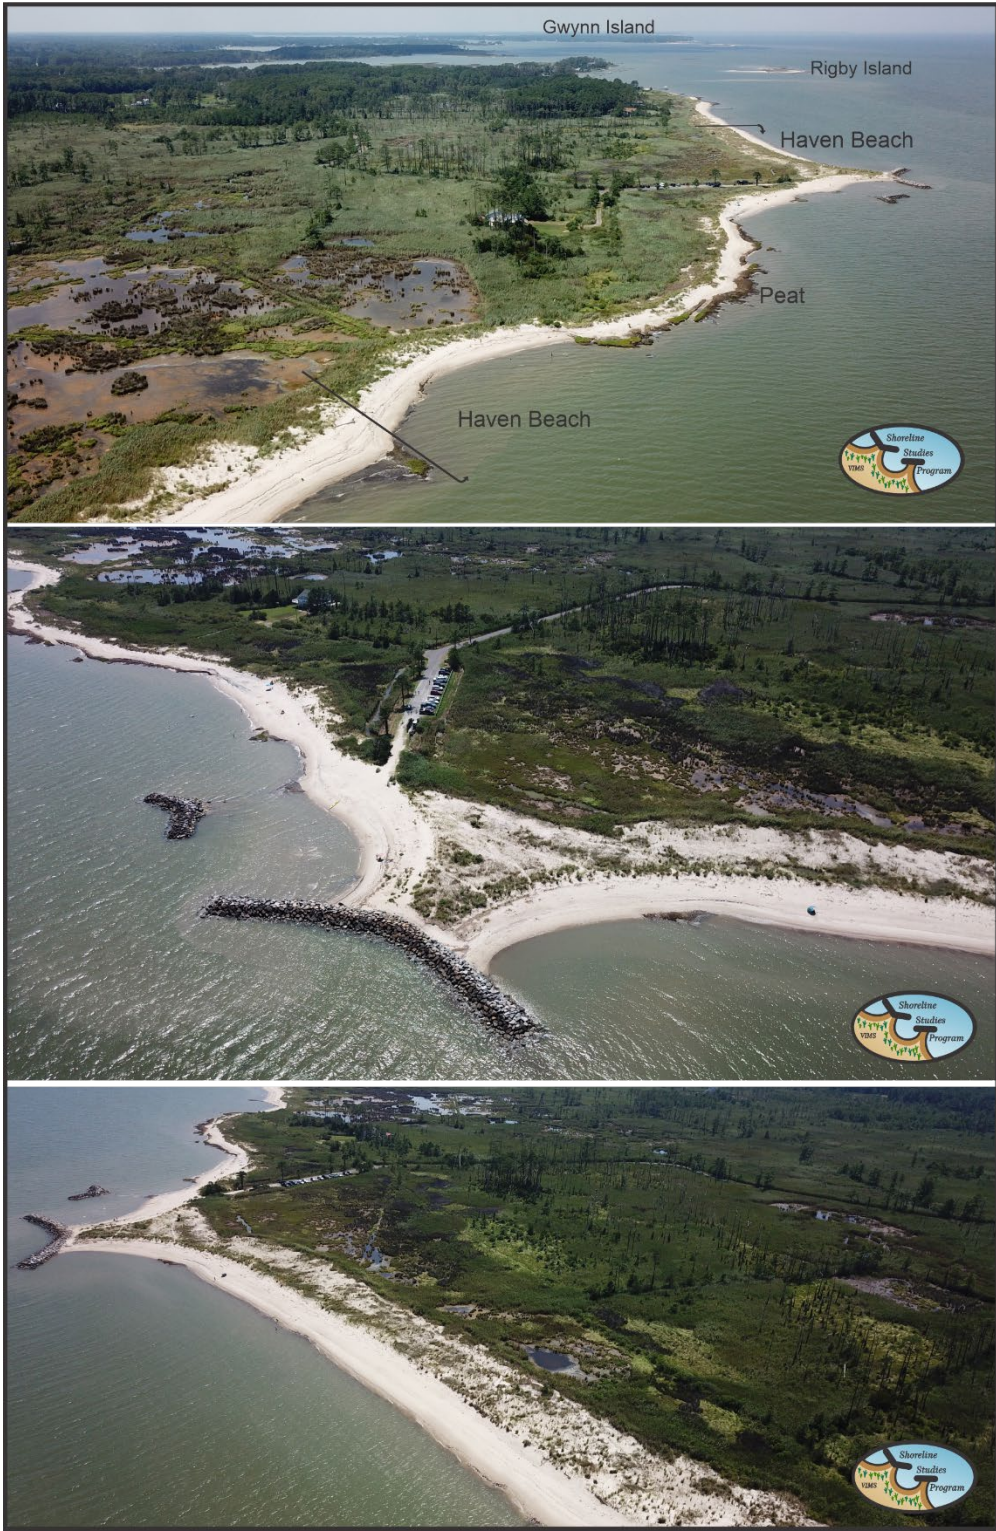
Figure 8-8. Drone imagery taken in July 2020 showing the evolution of Haven Beach. Top: the boundaries Haven Beach are shown. South of the breakwaters, erosion is still occurring and peat is exposed. Middle: The tombolo behind the large breakwater is well-formed with beach and dune vegetation while no sand occurs behind the small breakwater. Top: North of the breakwater, a large beach/dune system has grown since installation of the structures.

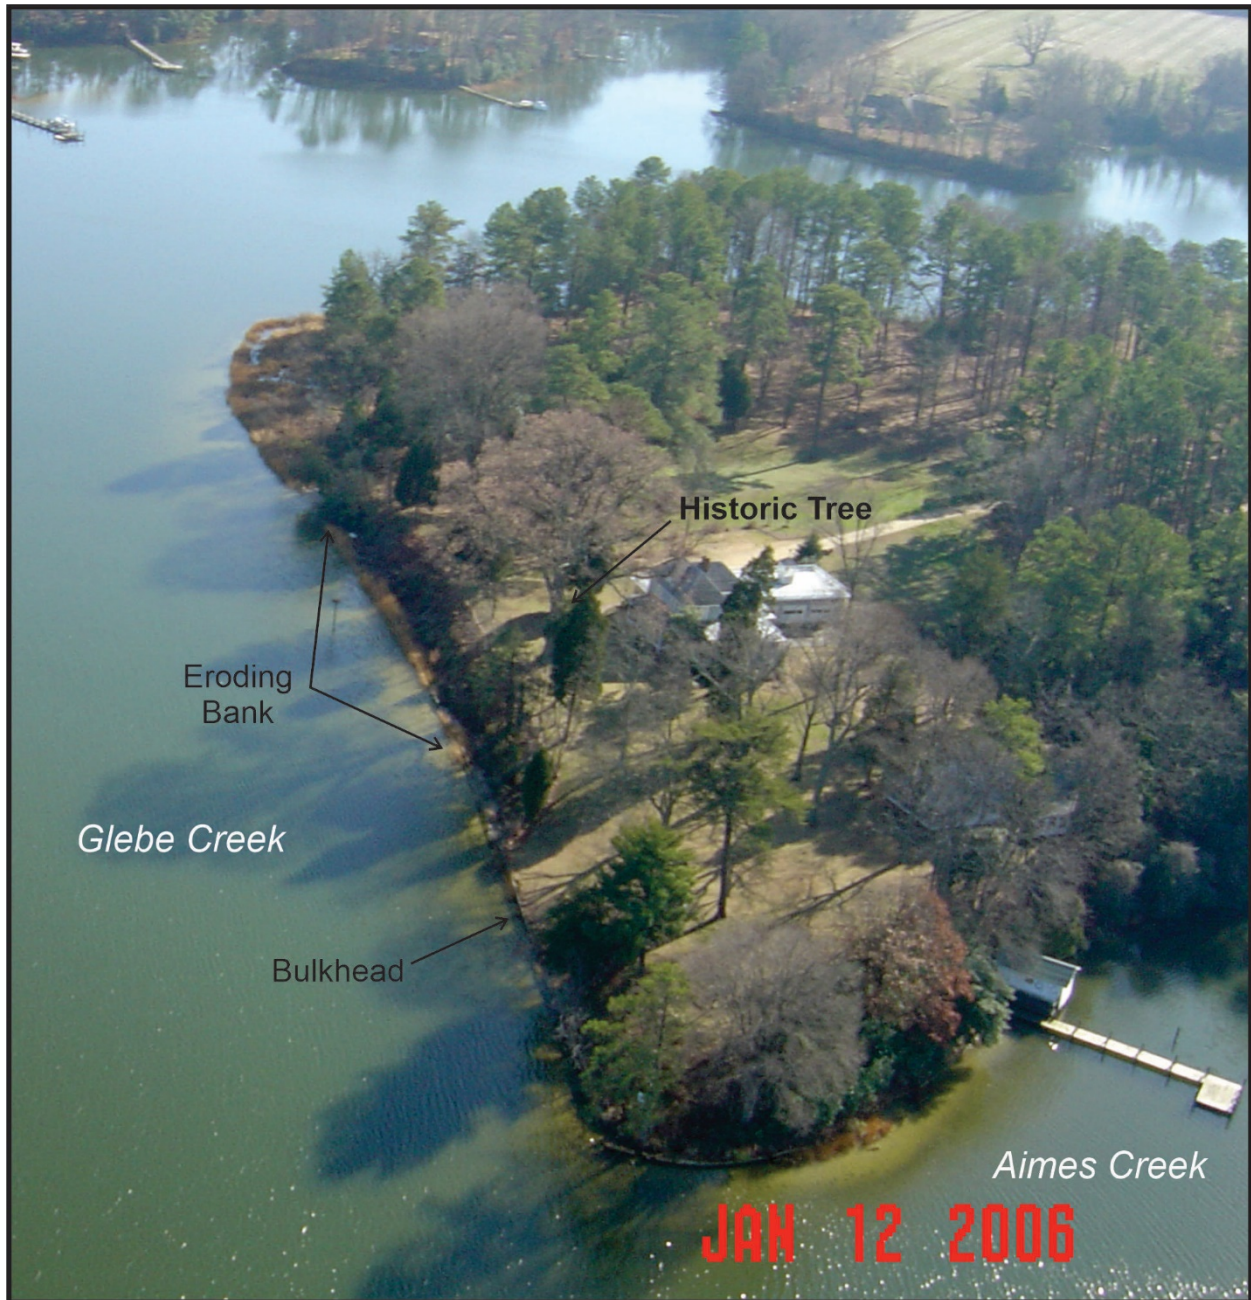
Figure 9-4. Aerial photo of the peninsula that Hull Springs Farm sits on. The shoreline has a high eroding bank and a failing bulkhead. The historic tree was a key part of the project design. Photo credit: Shoreline Studies Program, VIMS.

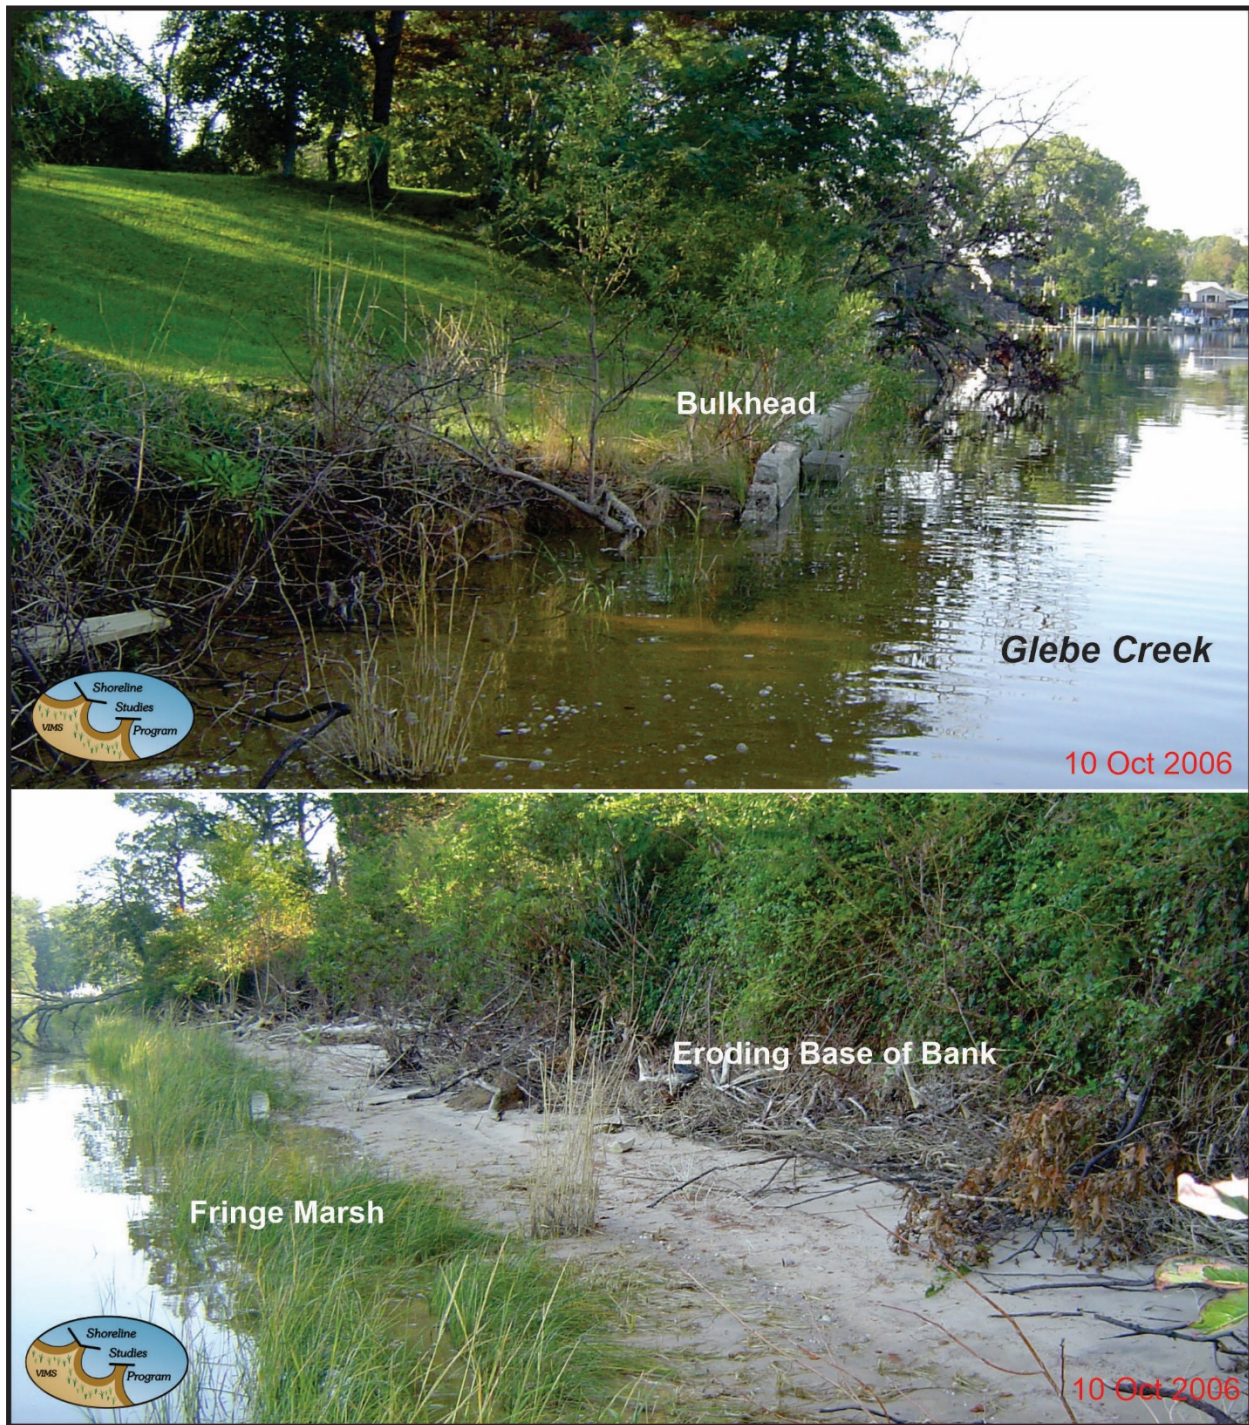
Figure 9-4. Ground photos of the Hull Springs Farm shoreline. Top: the western section of shoreline has a failing bulkhead; Bottom: Post Ernesto: the center section of the peninsula has an eroding base of bank and a fringe marsh. Photo credit: Shoreline Studies Program, VIMS.

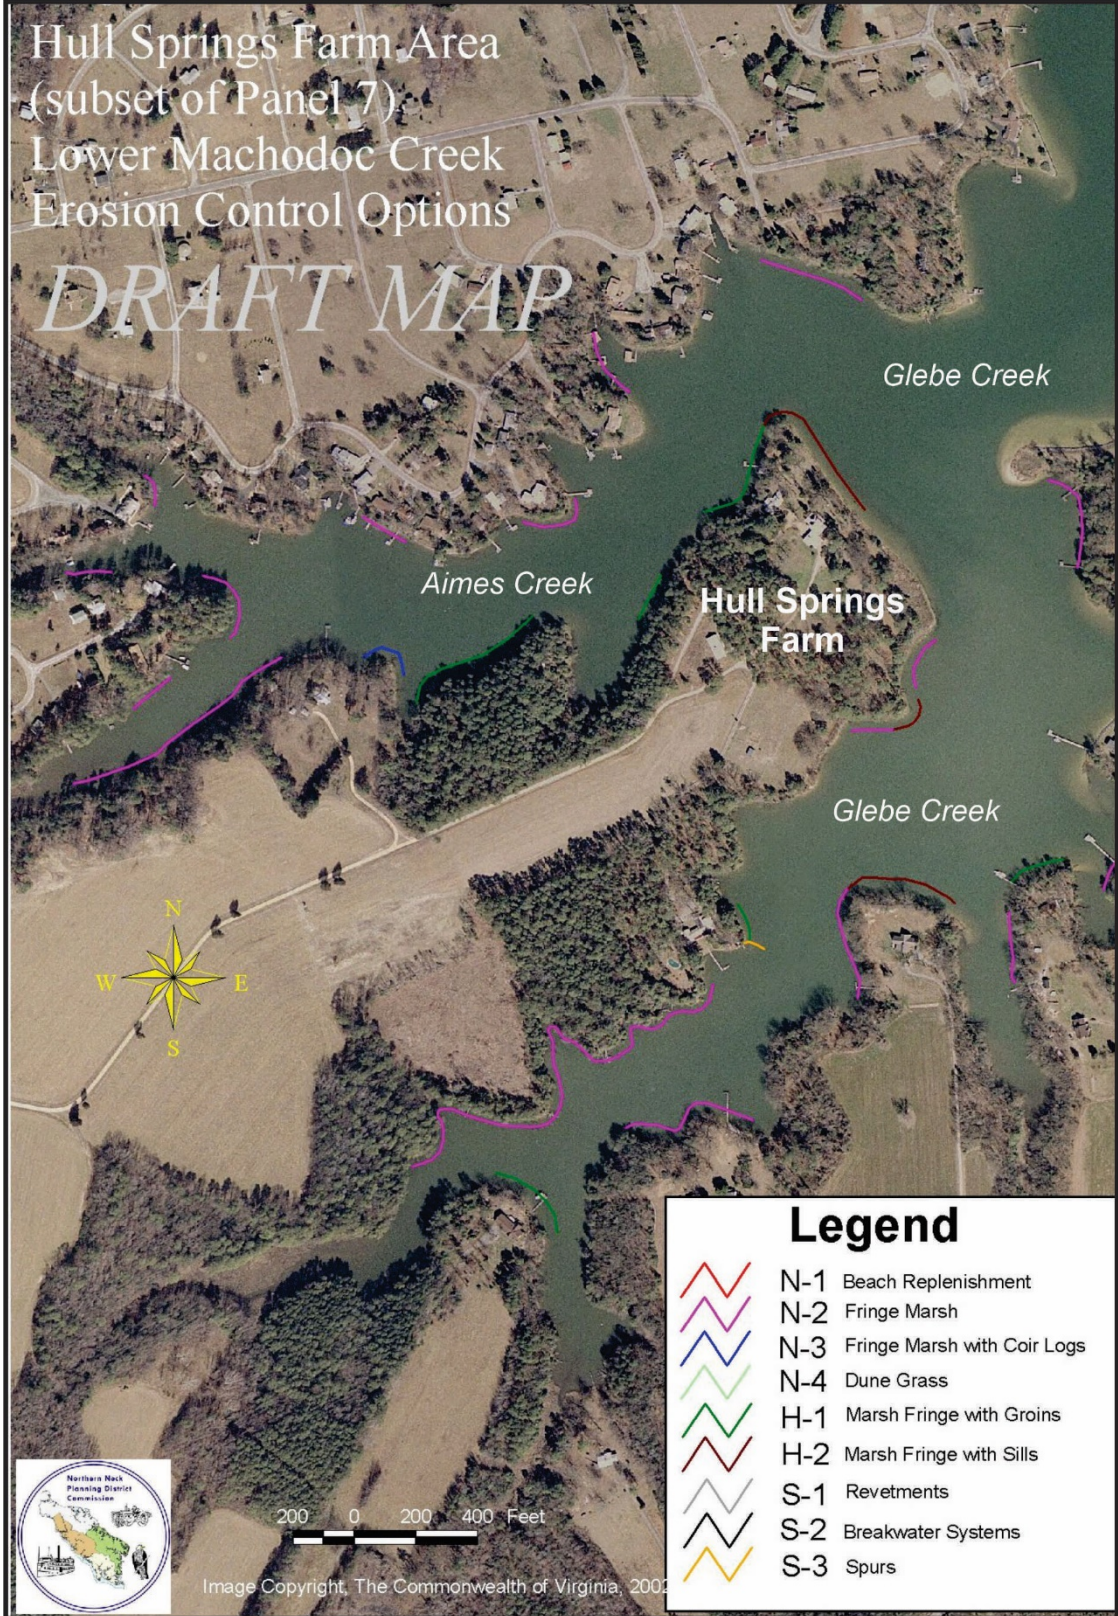
Figure 9-6. Lower Machodoc Creek Living Shoreline Management Plan created by the Northern Neck Planning District Commission.

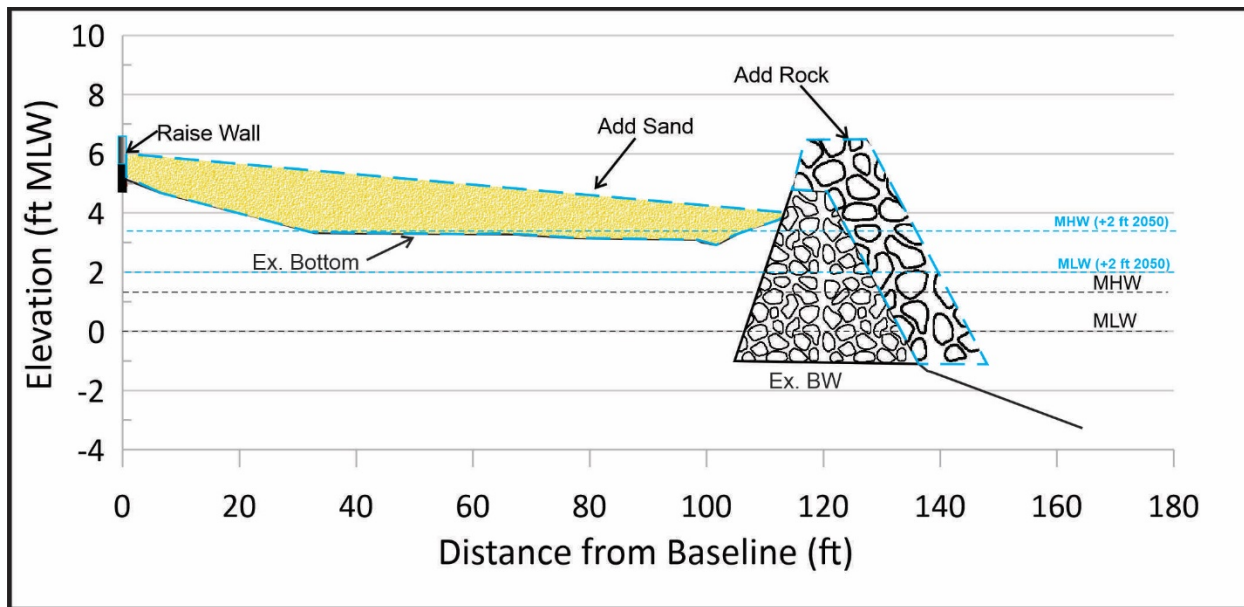
Figure 10-2. A typical cross-section of existing conditions at a low bank breakwater site (Aquia Landing). The system is backed by a low wall that could be raised to contain the added sand to adapt the system to 2050 projected sea levels (blue). Rock could be added to the breakwater structures. After Hardaway et al. (2019).

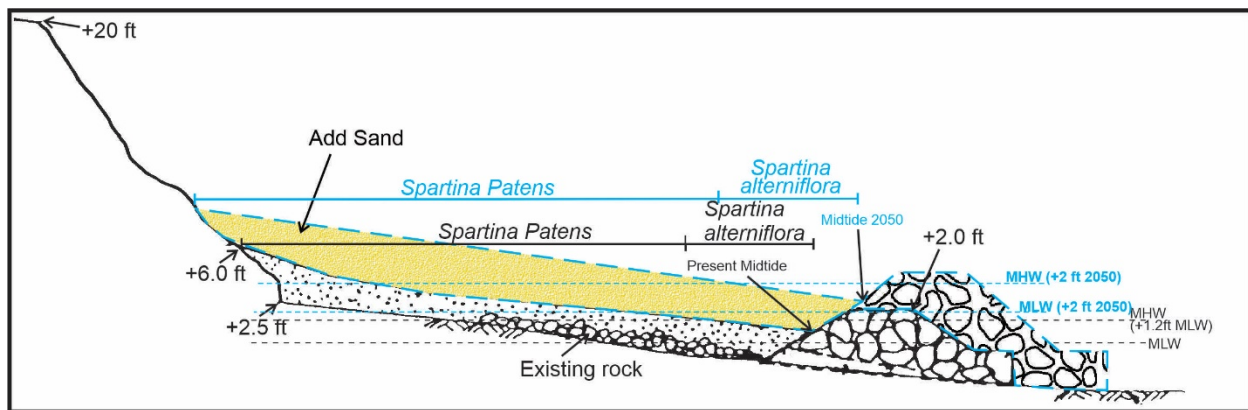
Figure 10-3. A high bank sill system (Jefferson Patterson) typical cross-section showing the design conditions at the site as well as the projected 2050 tide level (blue). Rock and sand can be added to the system to maintain its effectiveness. To not squeeze the system, rock would need to be added to the outside of the structure. After Hardaway et al., (2018).

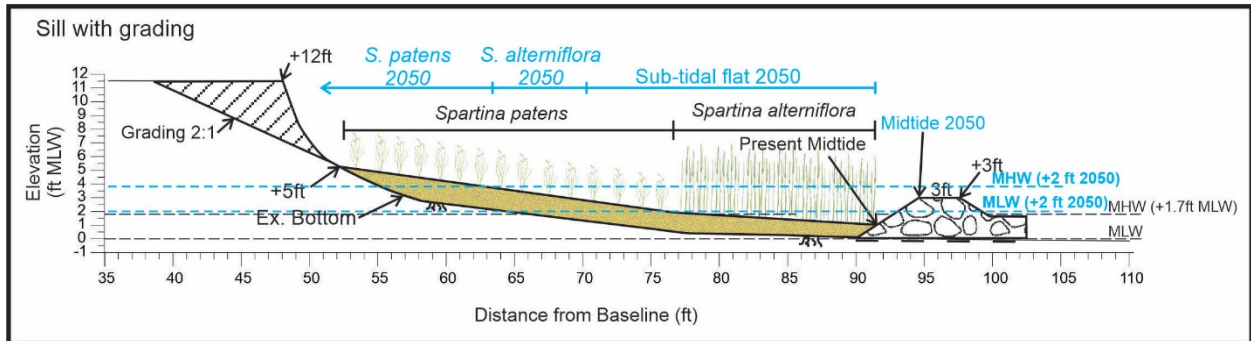
Figure 10-4. A high bank sill system typical design cross-section showing the adaptation to 2050 tide levels (blue). The top of the bank can be graded which will allow the marsh to migrate up the bank. The area behind the structure would become an intertidal and subtidal flat and only top of the structure would be at about mid-tide. Sill system at Occohannock on the Bay in Accomack County, after Hardaway et al. (2018).

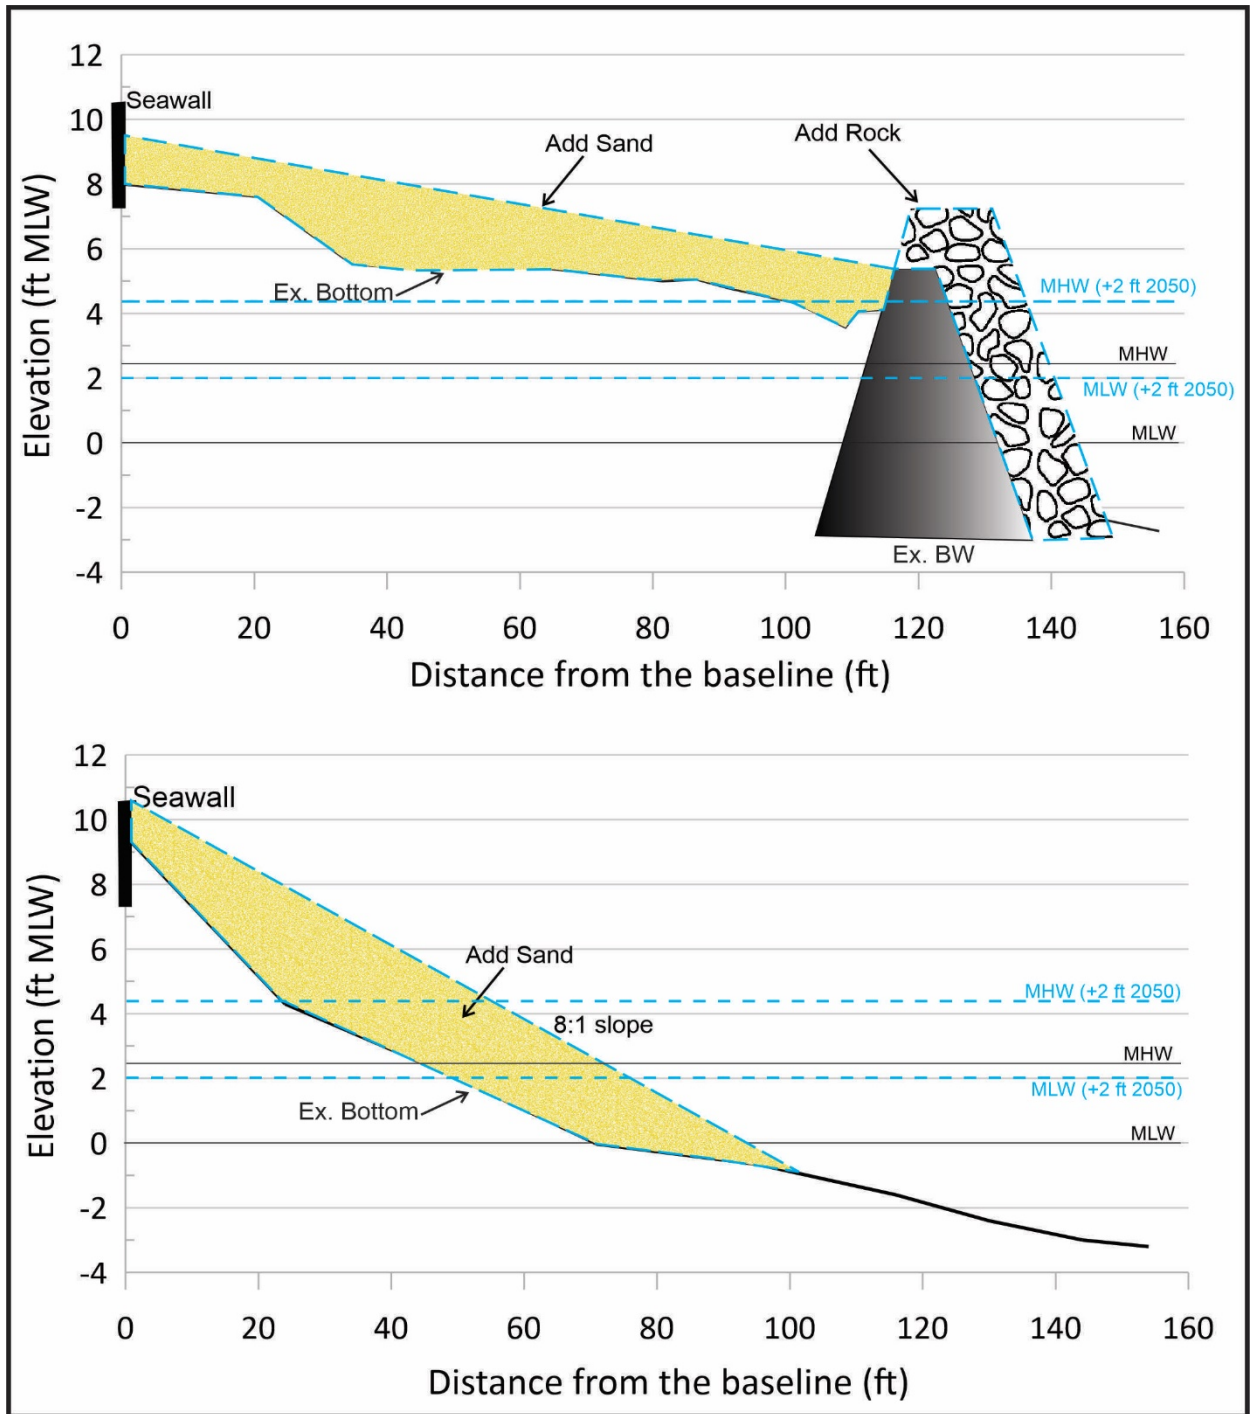
Figure 10-5. Existing conditions at a high bank breakwater site (VIMS East). The land continues to rise behind the seawall and infrastructure exists so the site could not be graded. To raise the elevation of the system to adjust for the projected 2050 tide level (blue) rock can be added to the structures. In addition, sand can be added behind the structures and in the embayments to enhance adaptability. After Hardaway et al., (2019).
