Electronic Supplementary Material for Materials and Structures

Assessment of test methods for the durability of thermal mortars exposure to freezing

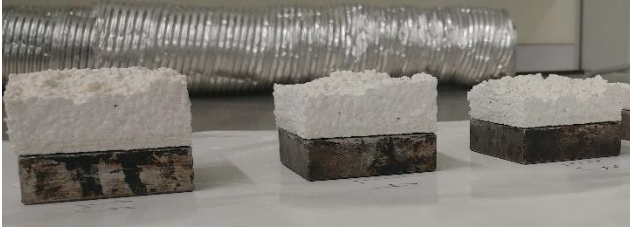
SM3. Representative cohesive fracture patterns, obtained in: a) S2; b) S3.

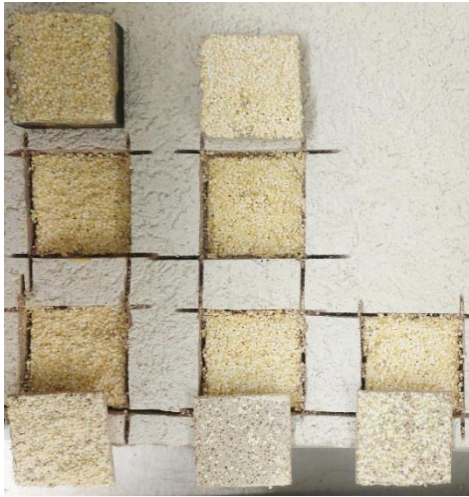
SM4. Adhesive fracture pattern obtained in S1, after freeze-thaw ageing cycles: a) Specimens overview; b) Detailed view.

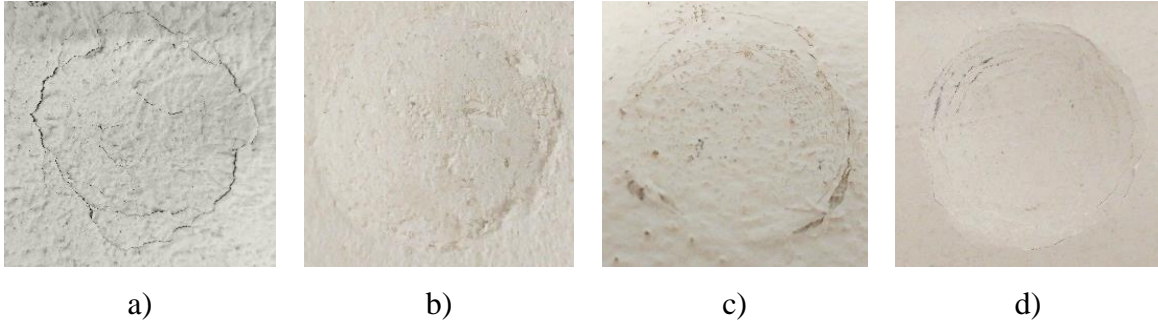
SM6. Visual observation of a representative dent after the hard body impact (10J) after ageing in:
a) S1-O; b) S1-M; c) S2; d) S3.

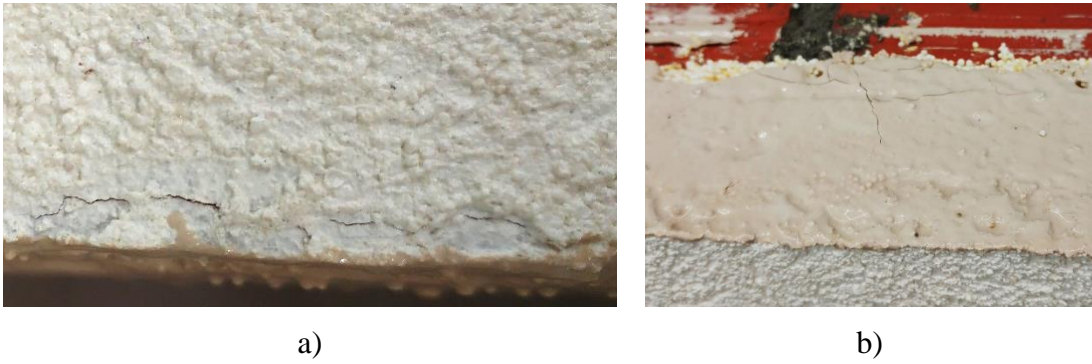
SM7. Representative damages: a) Damage of the coating; b) Cracks on the sealant, after freeze-thaw ageing cycles.
