10
I29A
300
copy 3

CIVIL ENGINEERING STUDIES

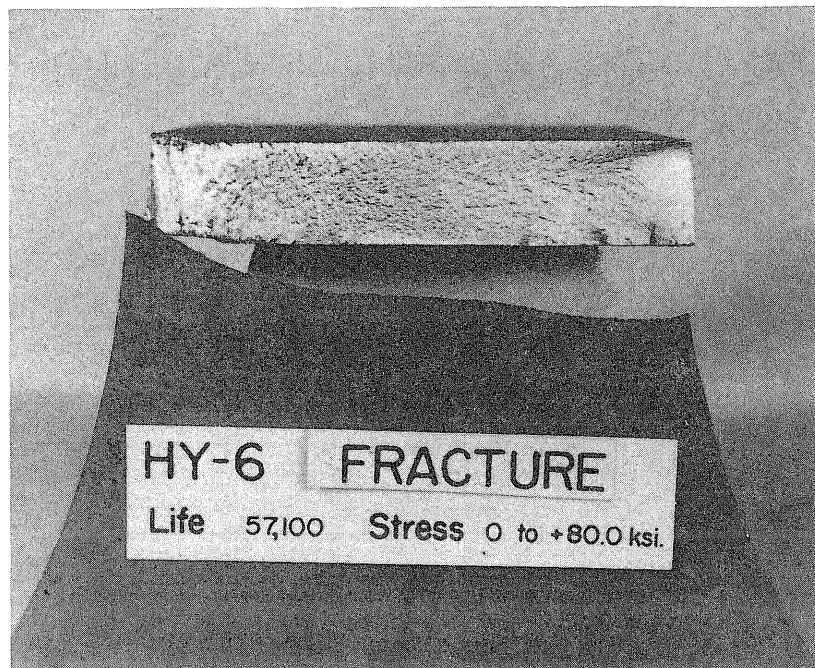
NOTE: FAILURE INITIATED AT MILL SCALE SURFACE.

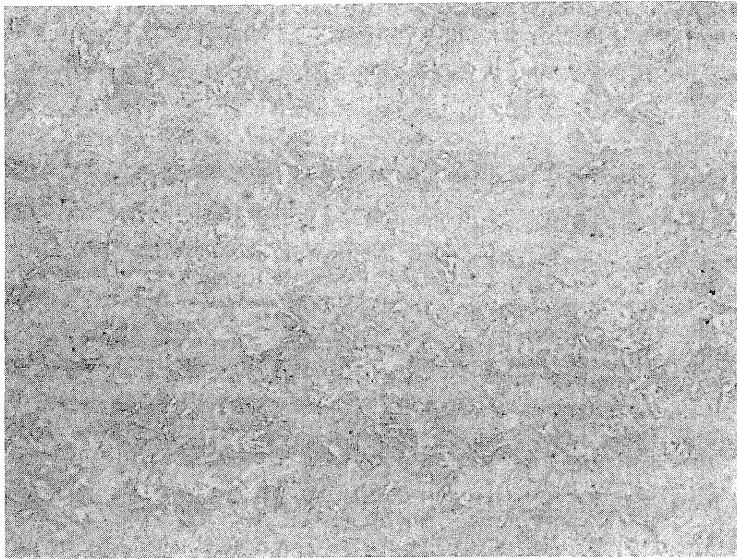
a) Base Metal (200X)

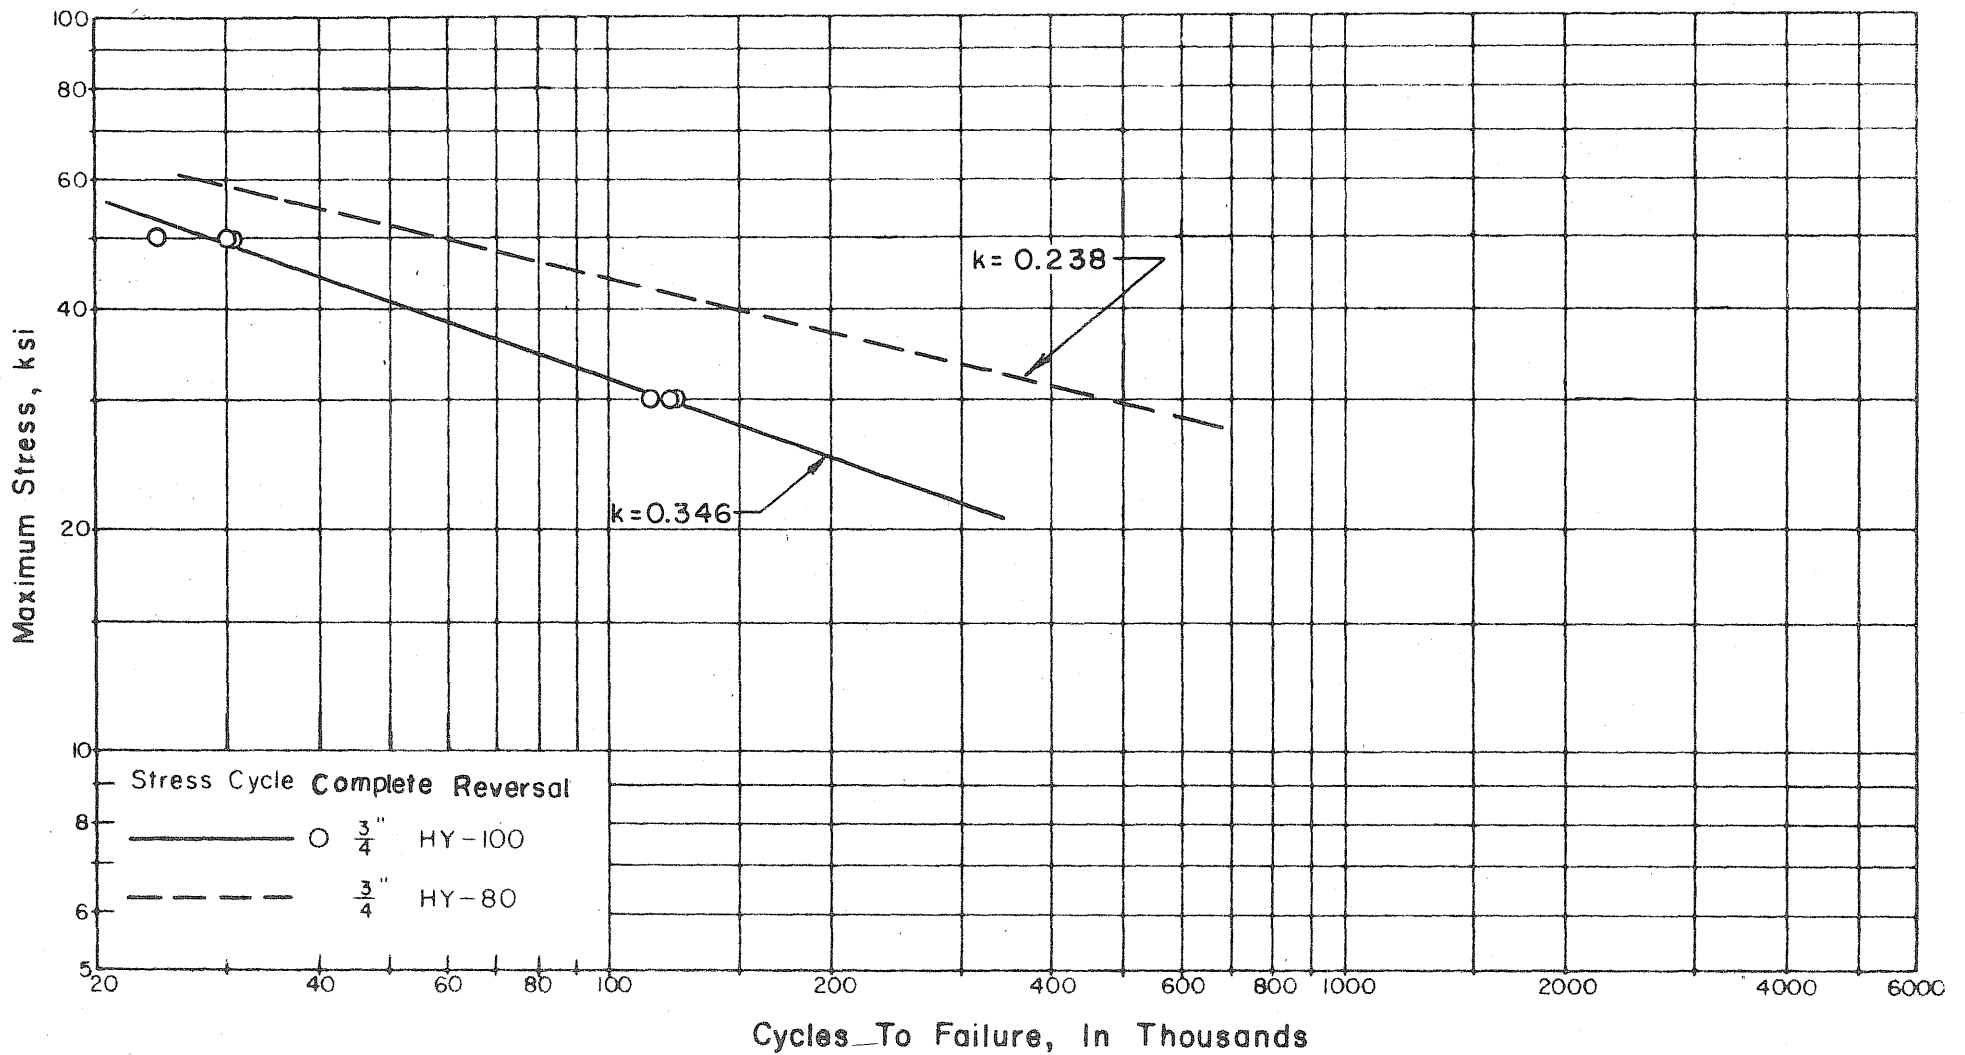
FIG.3.5 RESULTS OF FATIGUE TESTS OF HY-100 TRANSVERSE BUTT WELDS IN THE AS-WELDED CONDITION (COMPLETE REVERSAL).

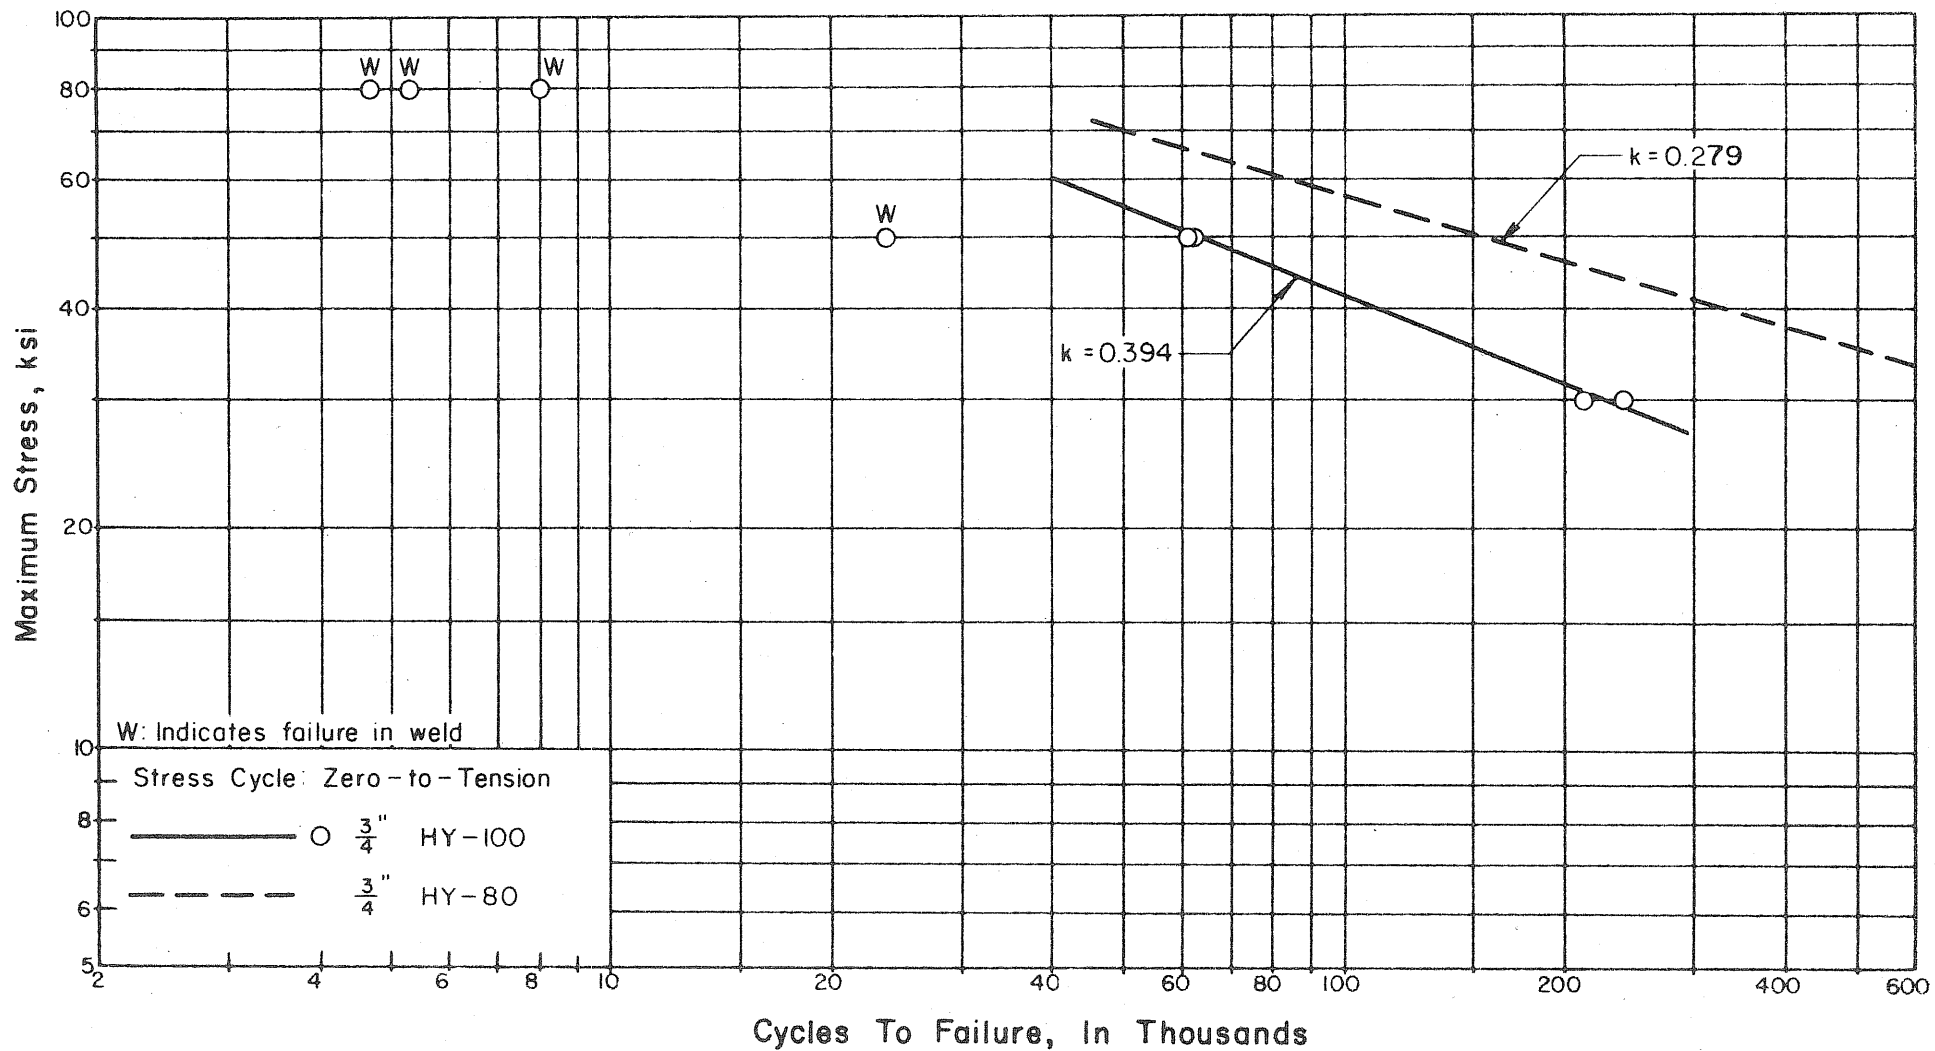
FIG.3.6 RESULTS OF FATIGUE TESTS OF HY-100 TRANSVERSE BUTT WELDS IN THE AS-WELDED CONDITION (ZERO - TO - TENSION).

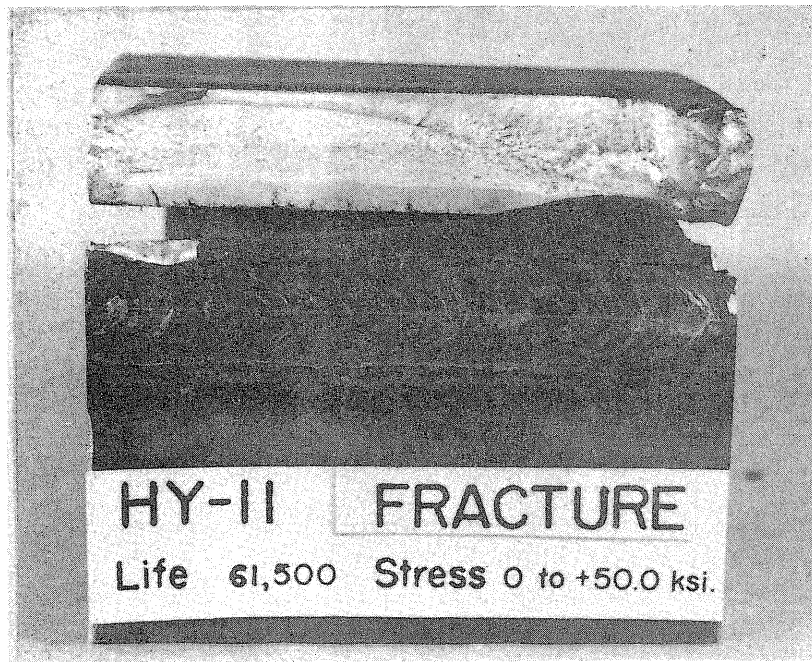
a) FAILURE INITIATED AT EDGE OF WELD REINFORCEMENT.

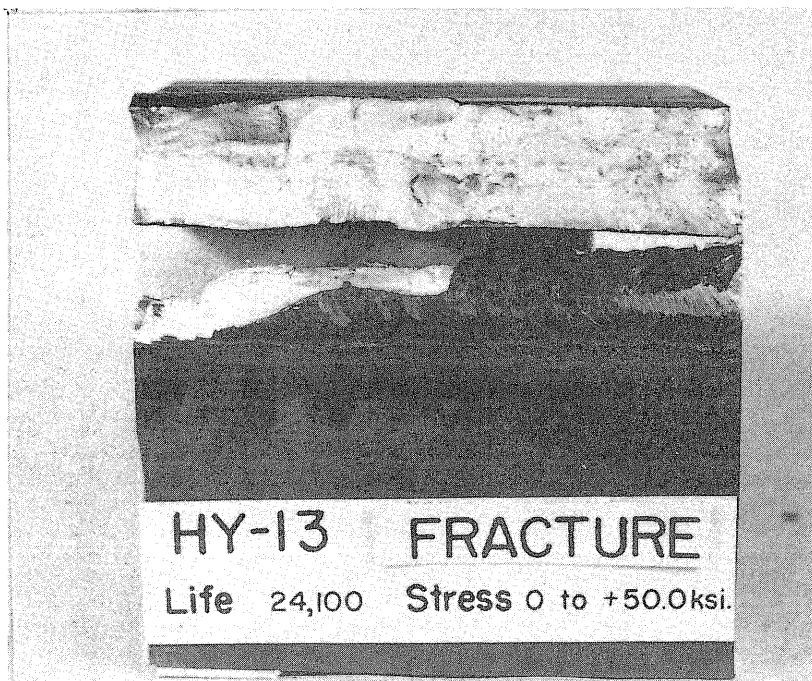
b) FAILURE INITIATED IN WELD.

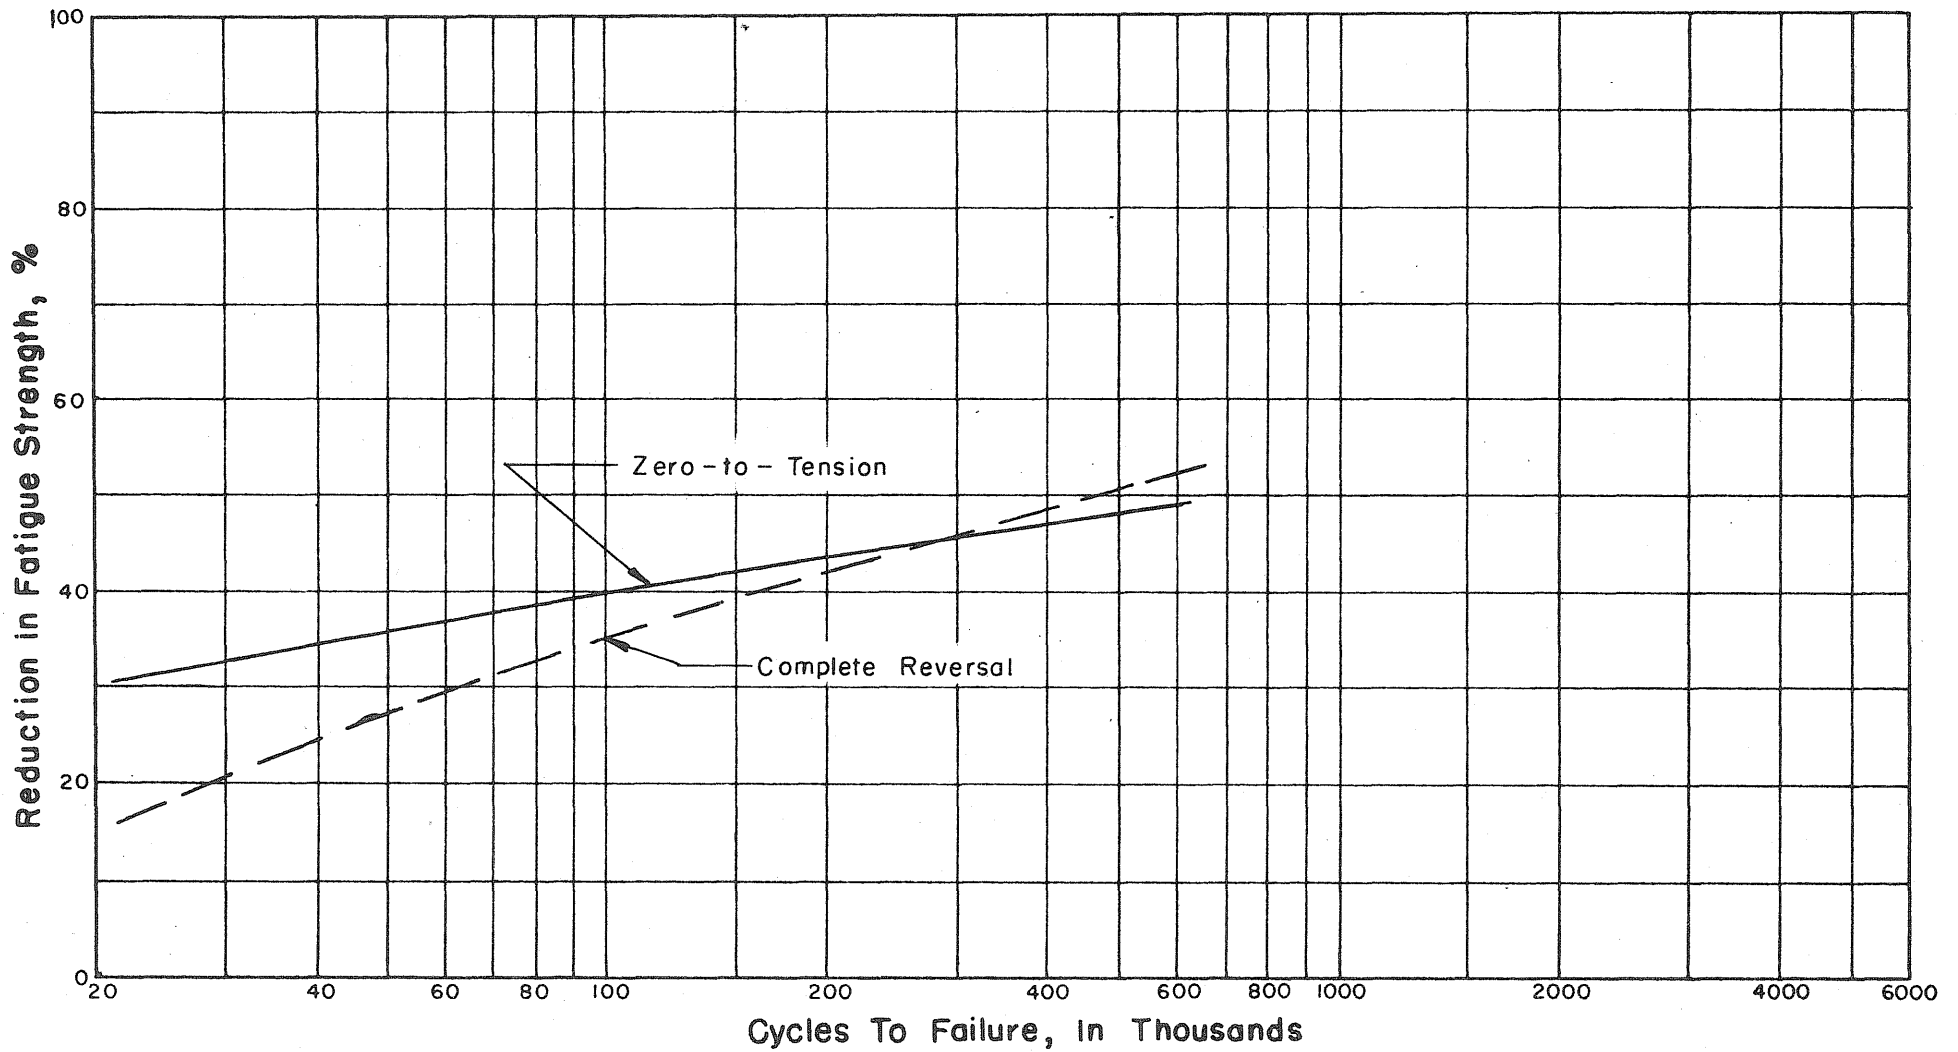
FIG.3.8 REDUCTION IN FATIGUE STRENGTH FROM AS-RECEIVED PLAIN PLATES DUE TO A TRANSVERSE BUTT WELD IN THE AS-WELDED CONDITION.

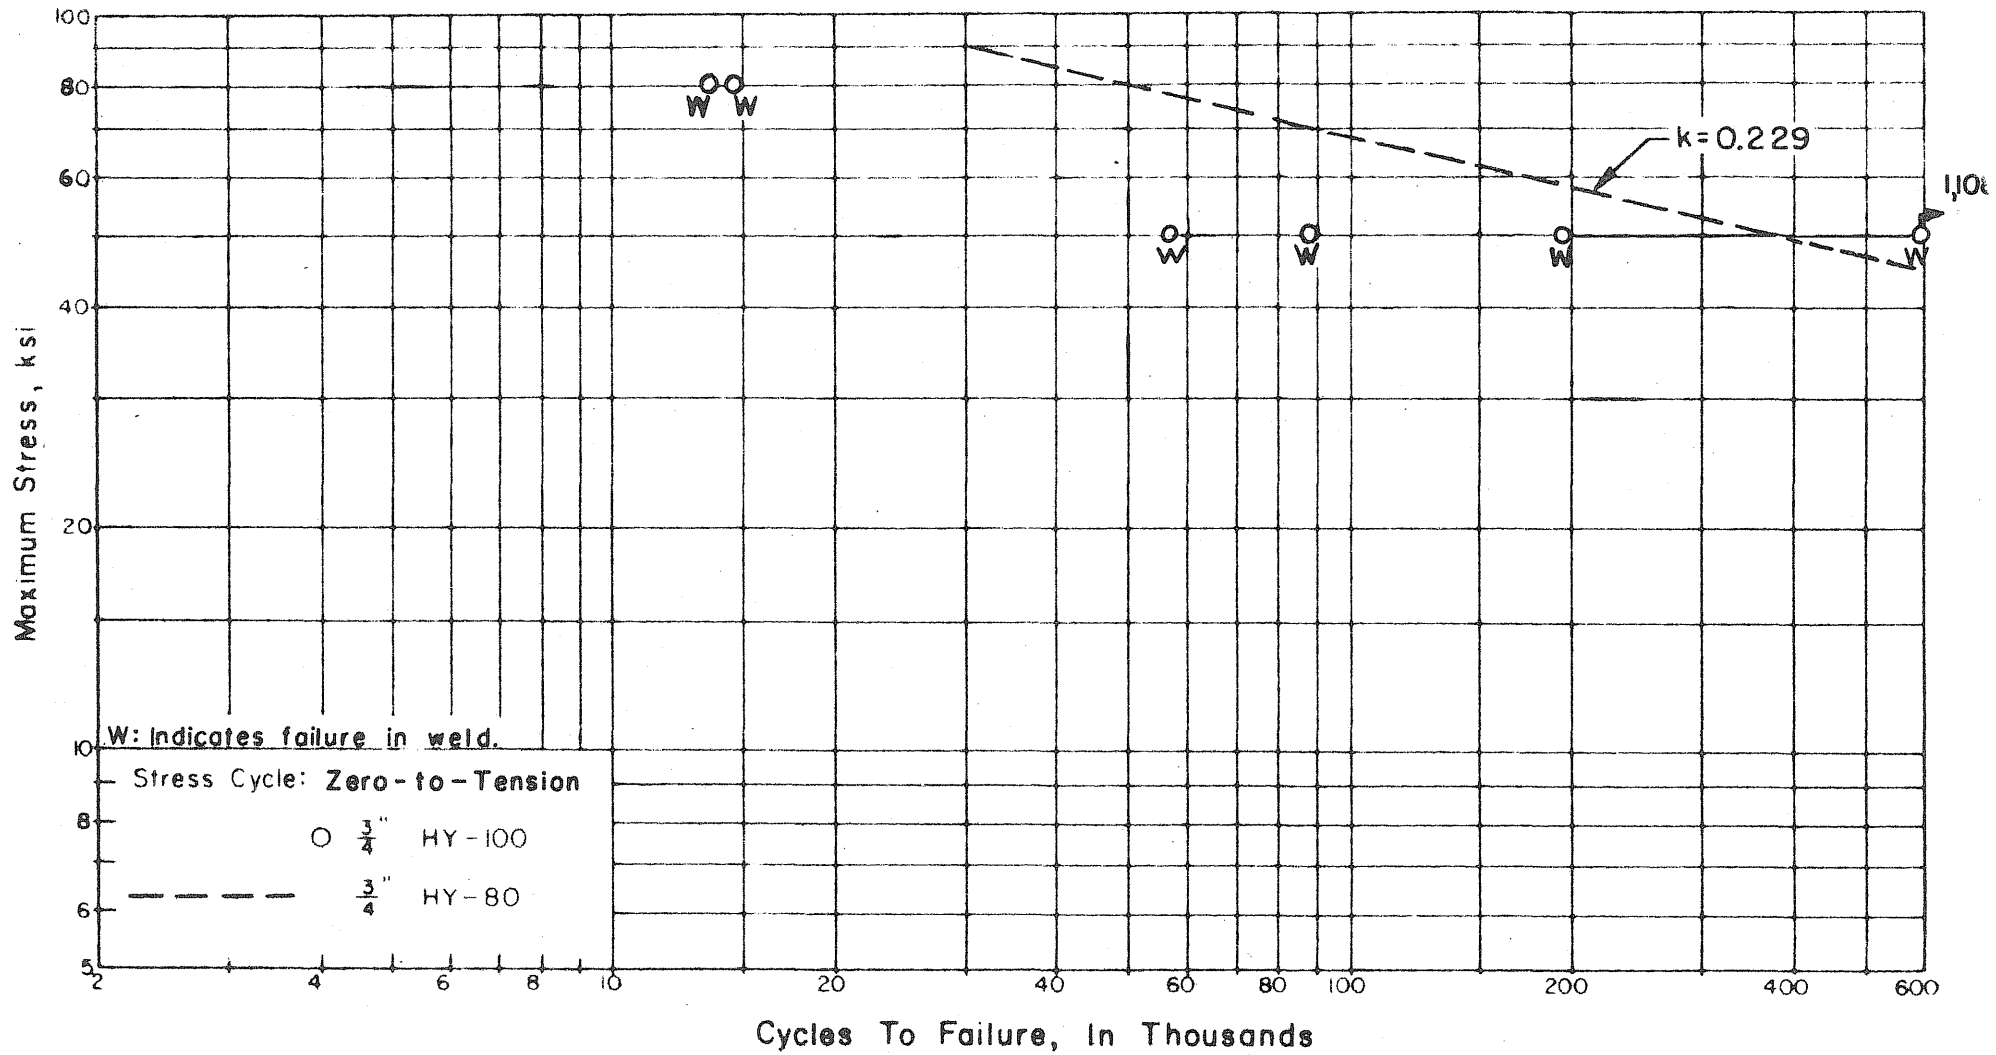
FIG.3.9 RESULTS OF FATIGUE TESTS OF HY-100 TRANSVERSE BUTT WELDS WITH REINFORCEMENT REMOVED. (ZERO-TO-TENSION)

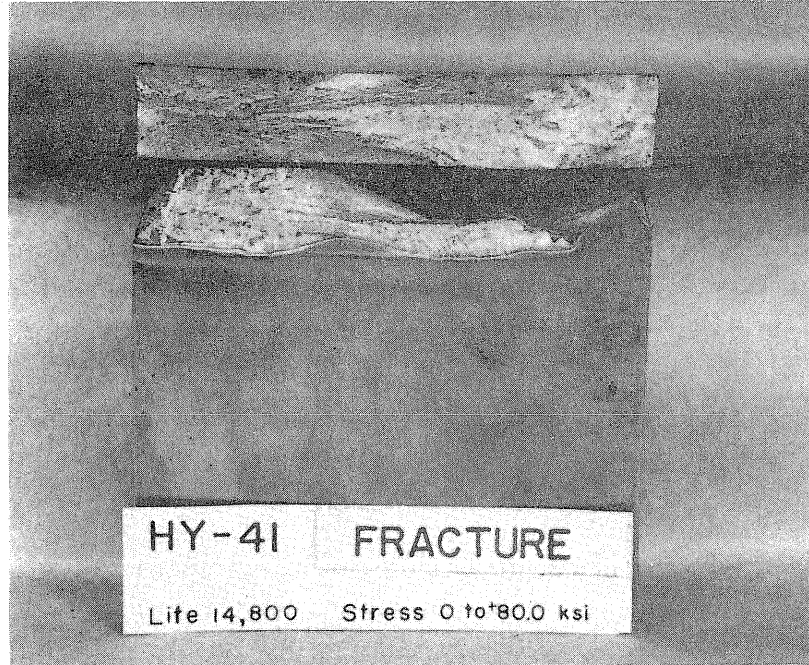
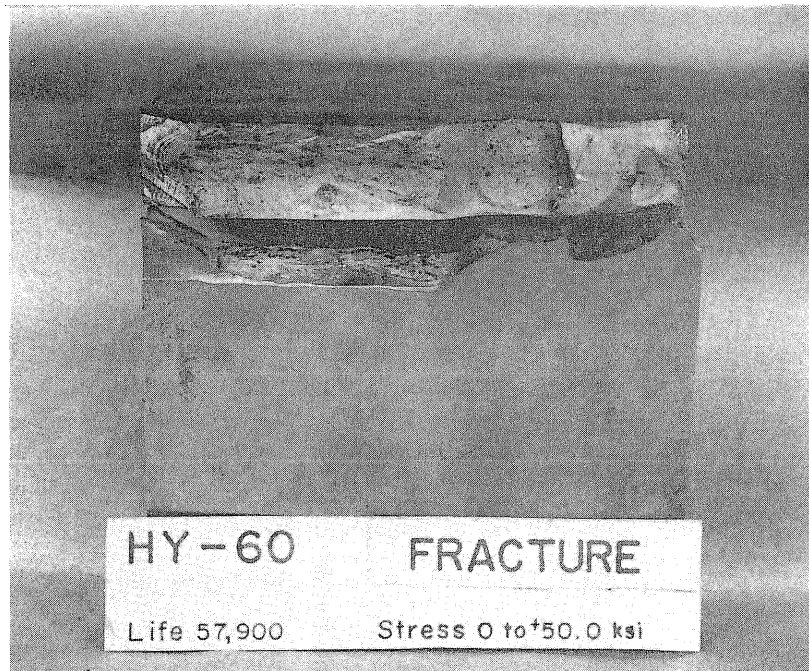
FIG. 3.10 TYPICAL FRACTURES OF TRANSVERSE BUTT WELDS WITH REINFORCEMENT REMOVED. (3/4 IN. HY-100 MATERIAL)

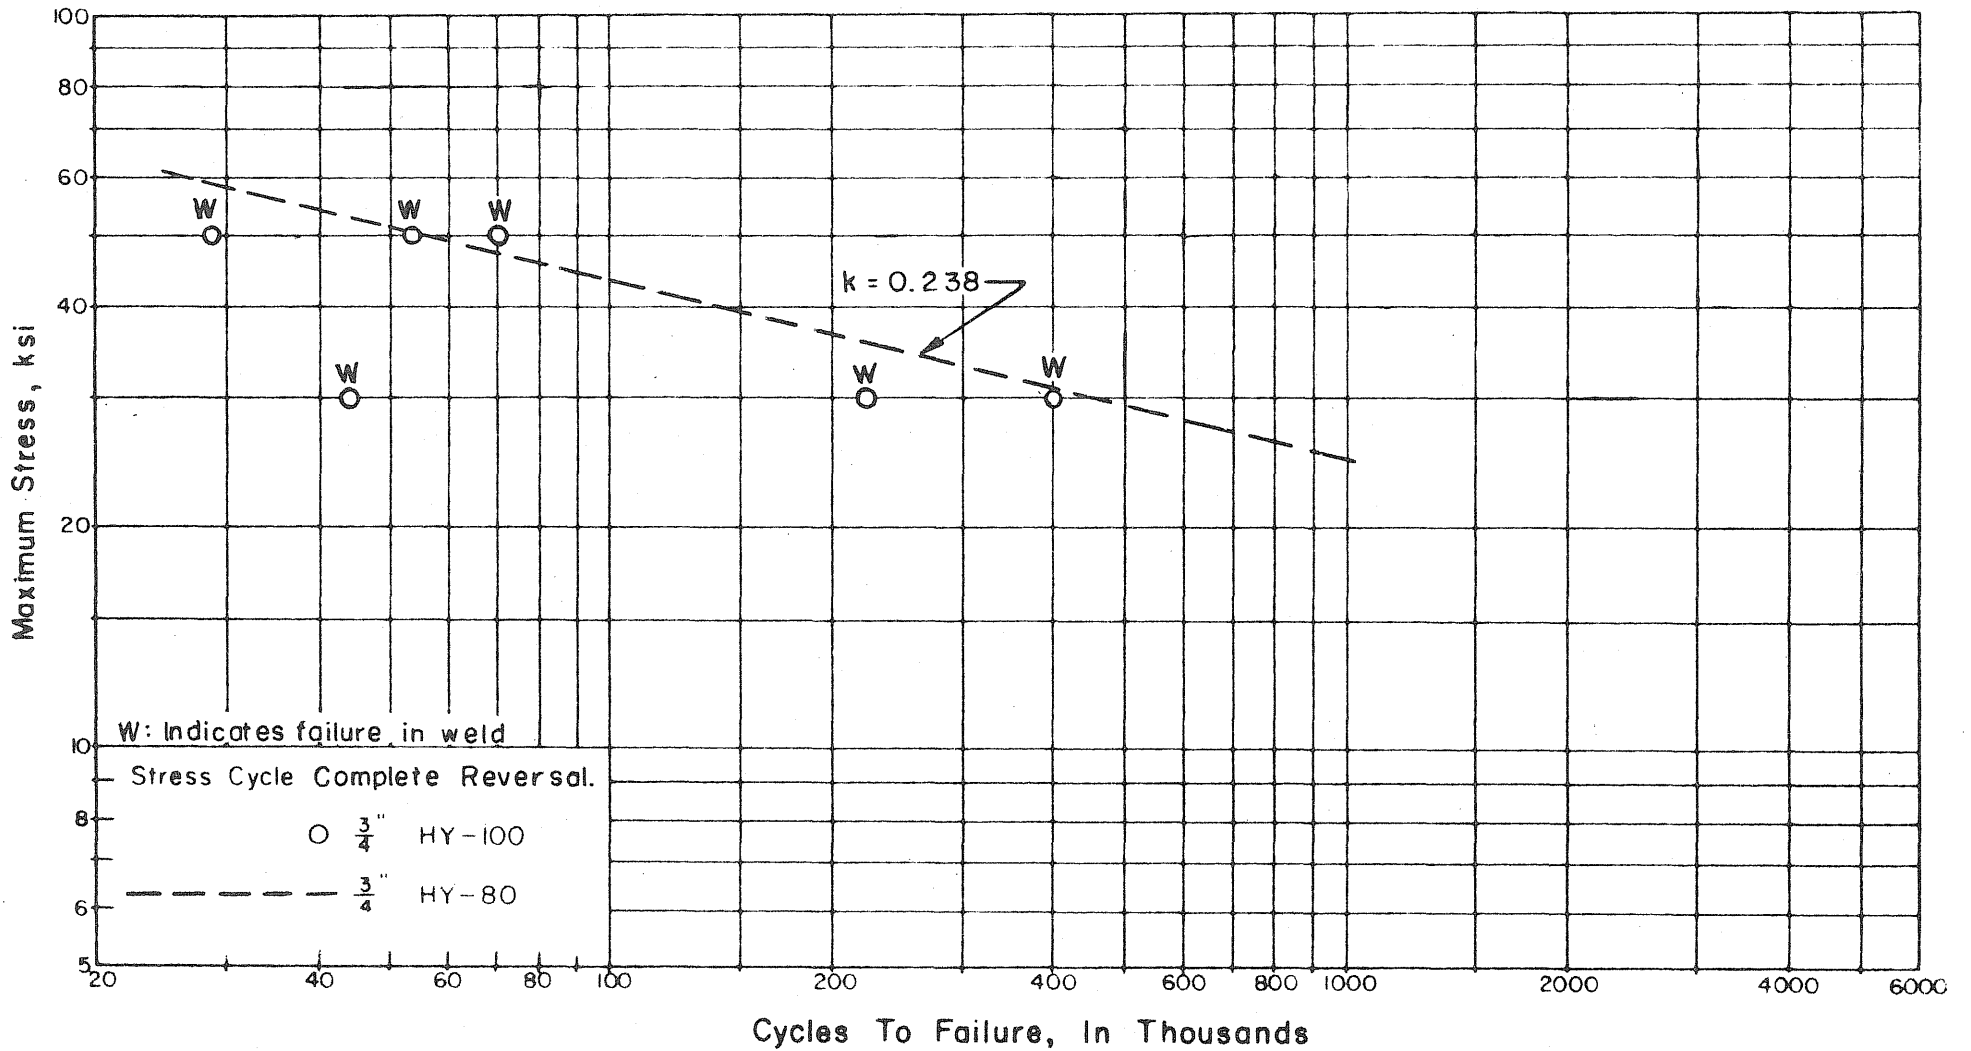
FIG.3.11 RESULTS OF FATIGUE TESTS OF HY-100 TRANSVERSE BUTT WELDS WITH REINFORCEMENT REMOVED (COMPLETE REVERSAL).

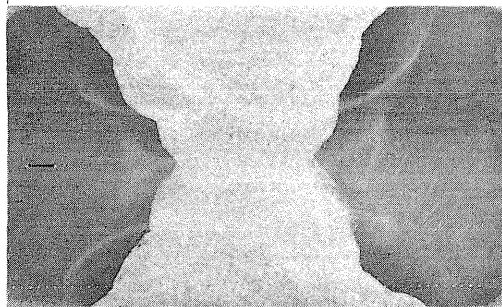
c) Low Energy, 12 Pass Weldment (Sample 3)

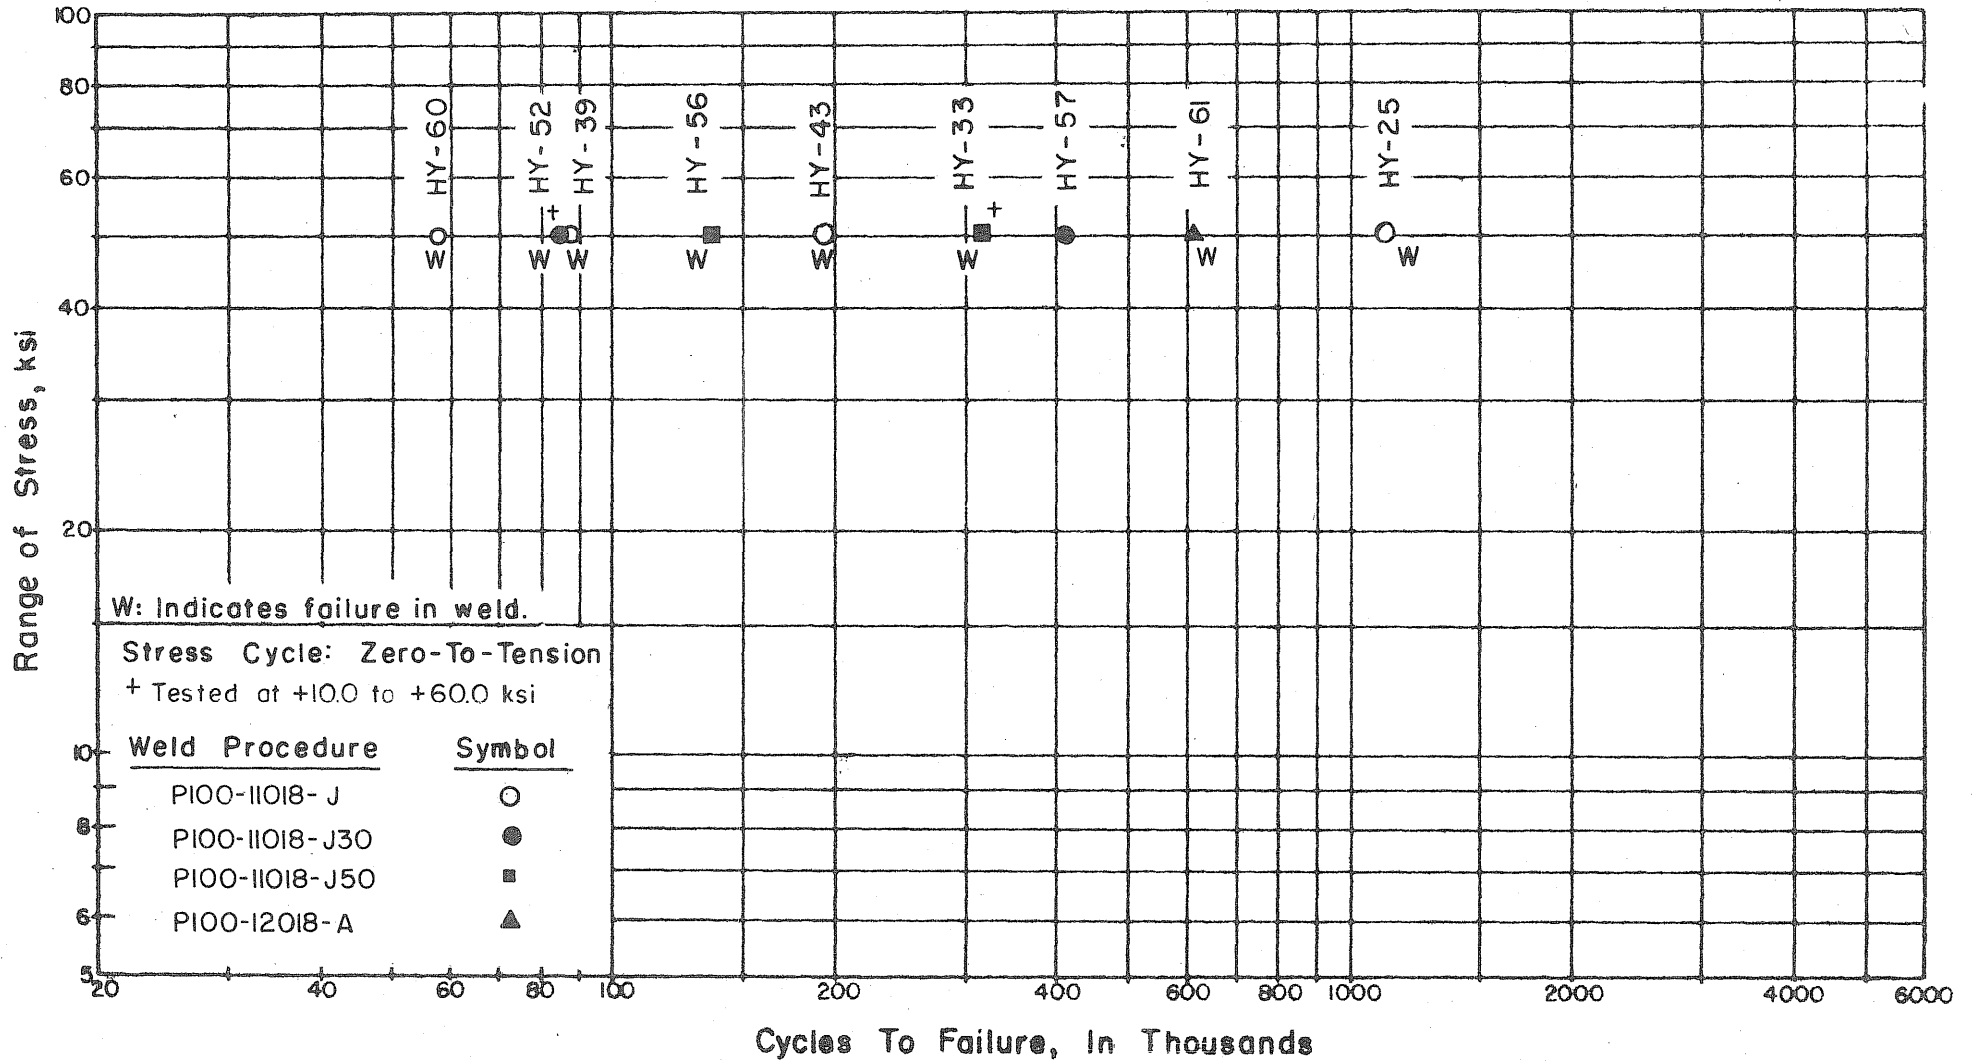
FIG.3.17 RESULTS OF FATIGUE TESTS OF EXPERIMENTAL HY-100 TRANSVERSE BUTT WELDS WITH REINFORCEMENT REMOVED (ZERO-TO-TENSION).

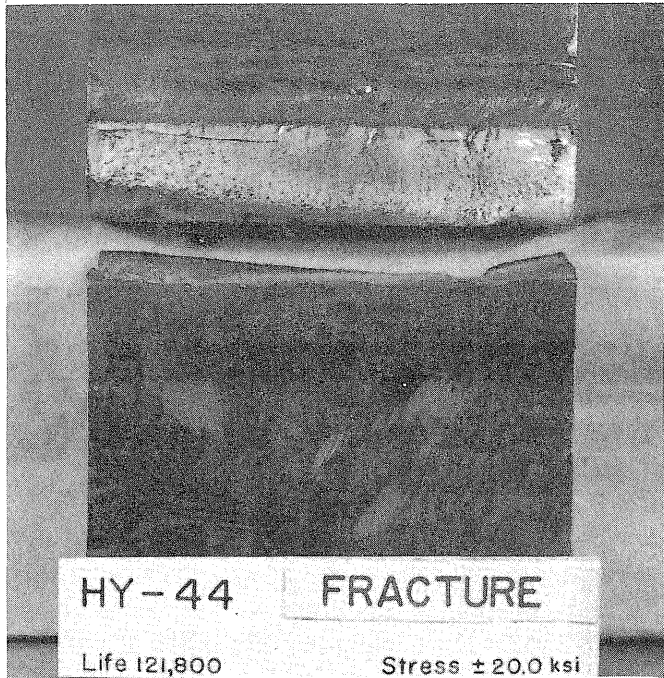
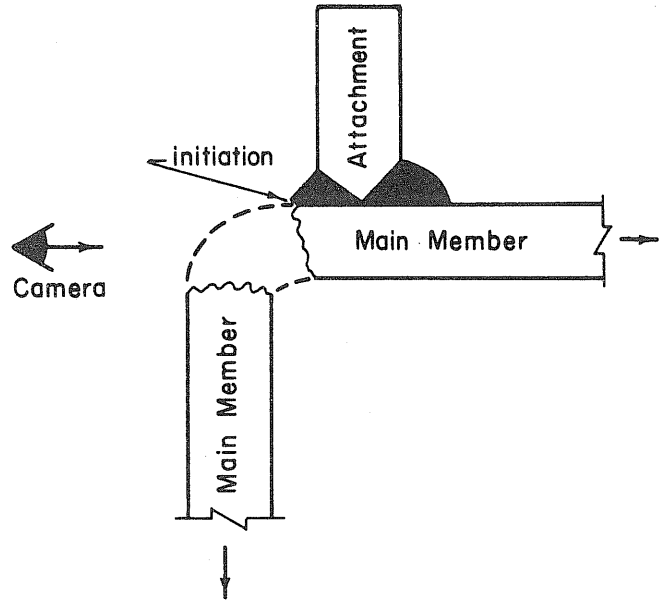
a) FAILURE INITIATED AT TOE OF WELD.

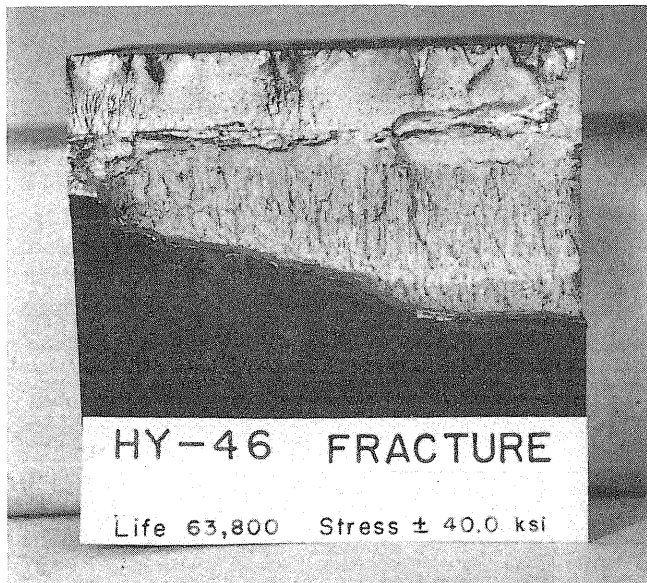
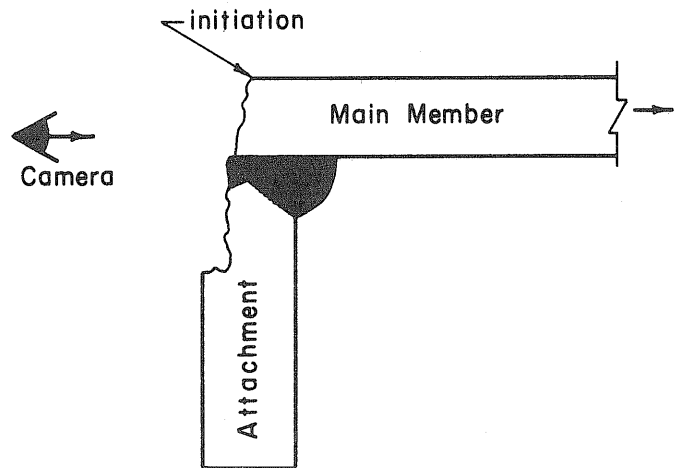
b) FAILURE INITIATED ON MILL SCALE SURFACE.

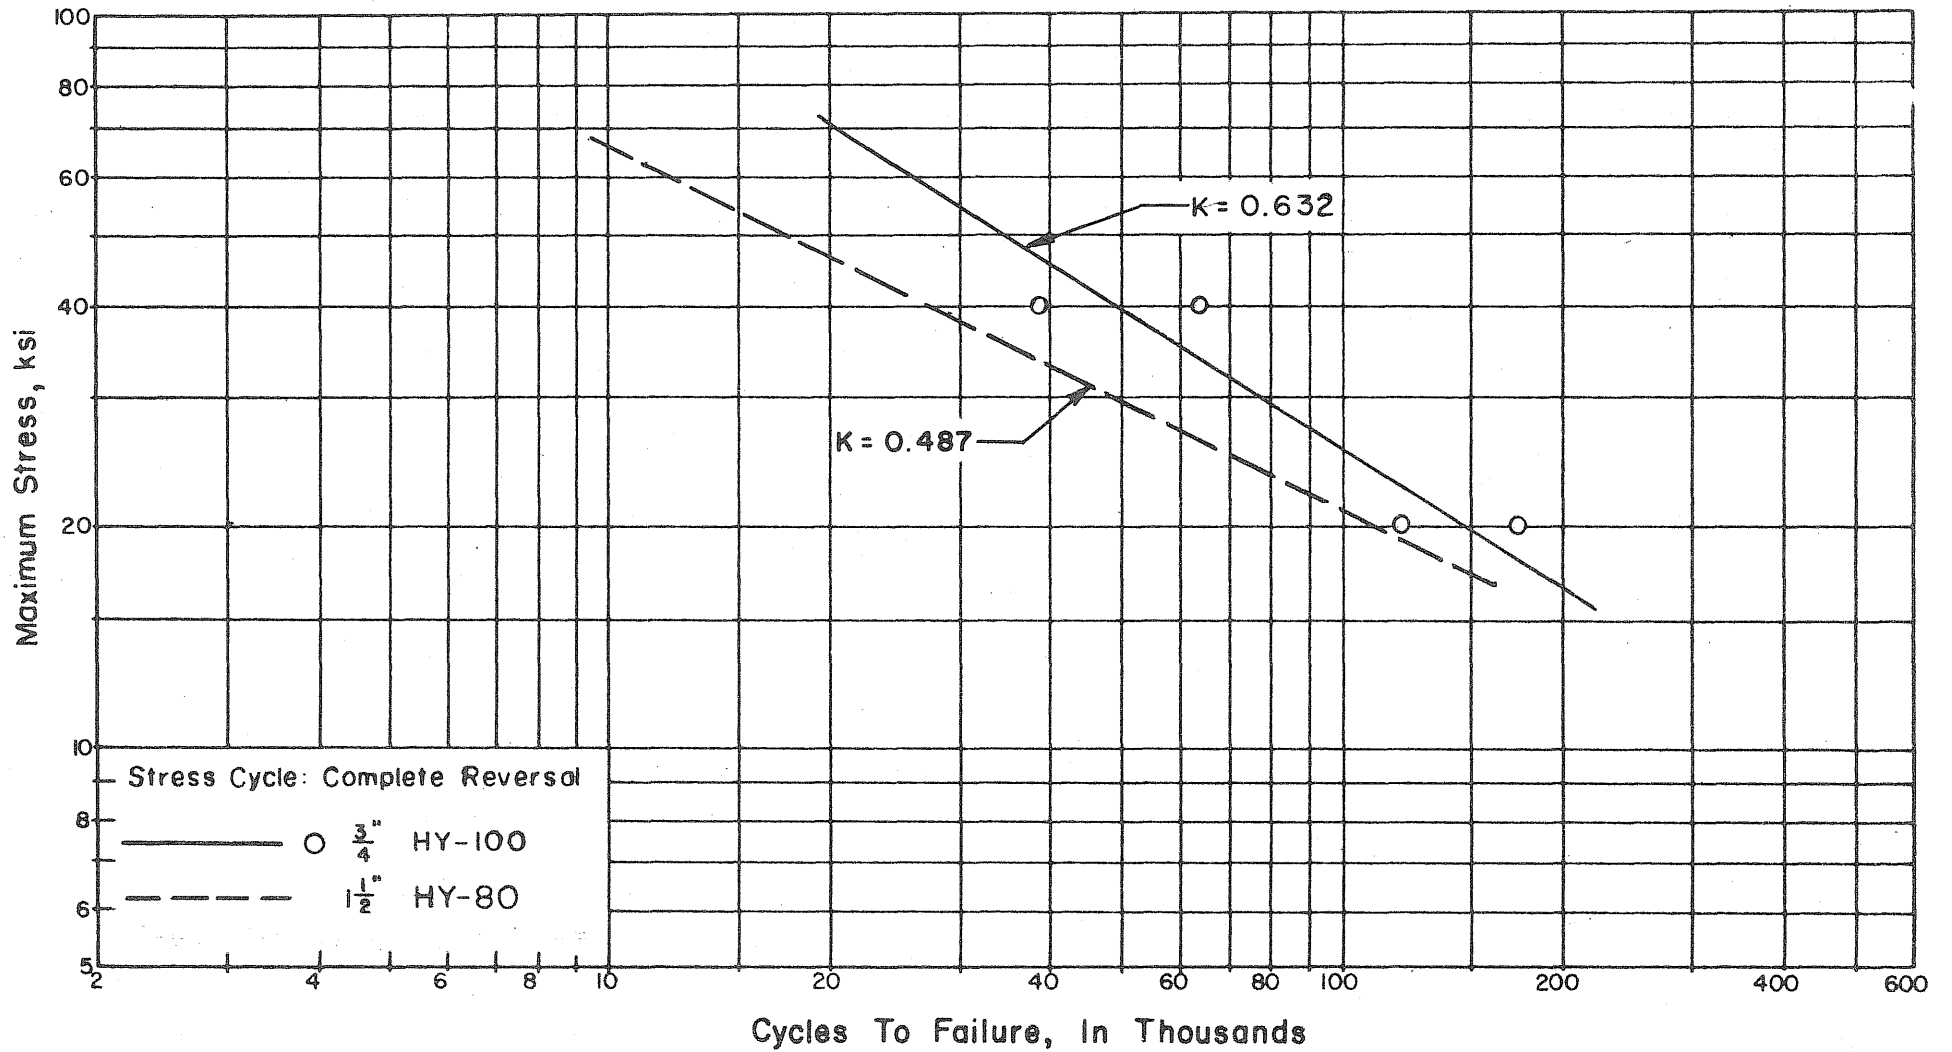
FIG.3.21 RESULTS OF FATIGUE TESTS OF HY-100 PLATES WITH FULL PENETRATION TRANSVERSE ATTACHMENT ON ONE SIDE (COMPLETE REVERSAL).

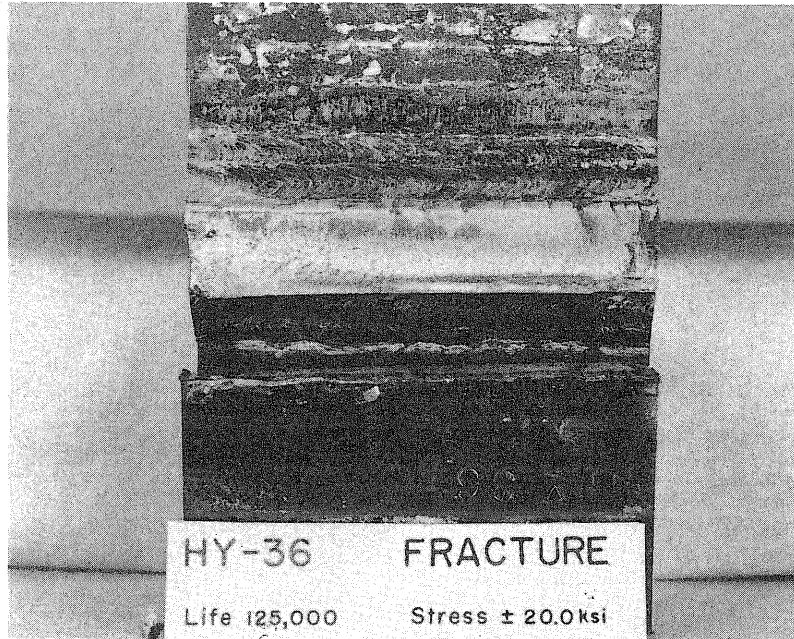
FAILURE INITIATED AT TOE OF WELD.

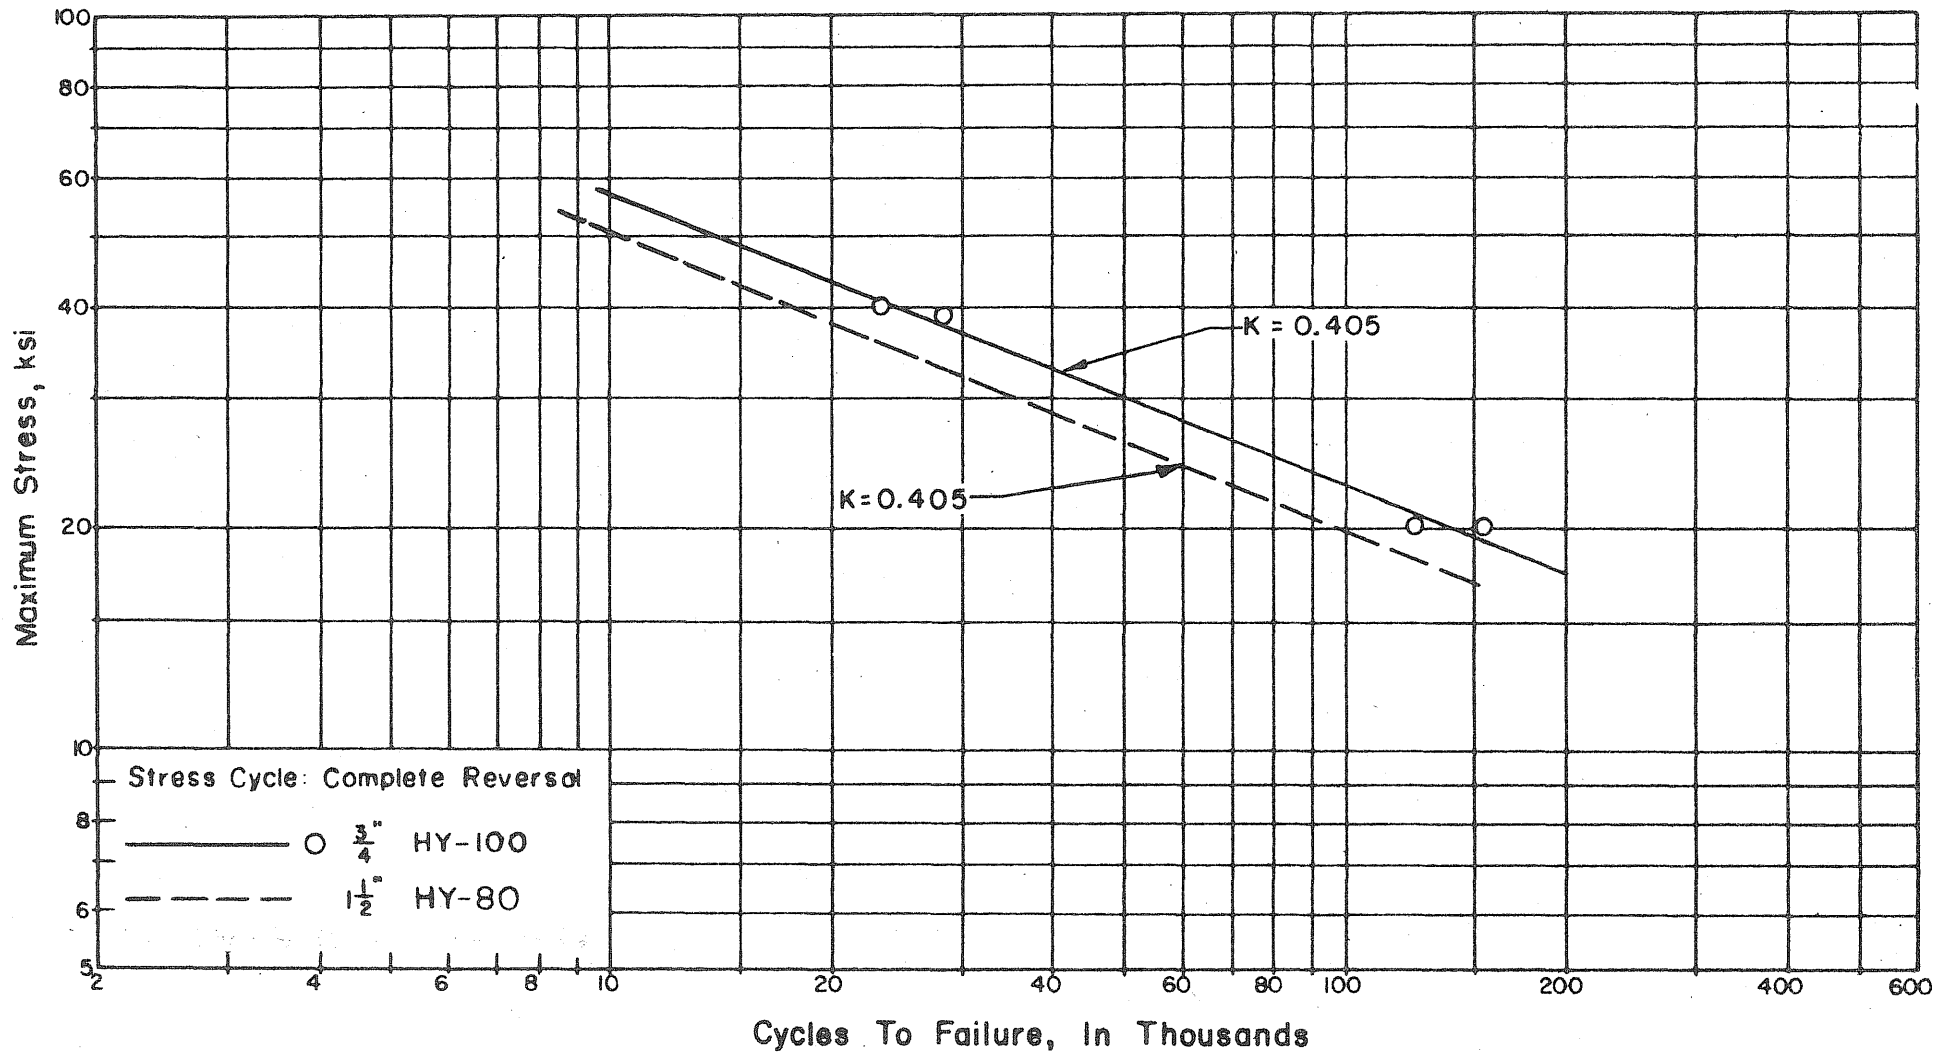
FIG.3.23 RESULTS OF FATIGUE TESTS OF HY-100 PLATES WITH FULL PENETRATION TRANSVERSE ATTACHMENTS ON TWO SIDES. (COMPLETE REVERSAL).

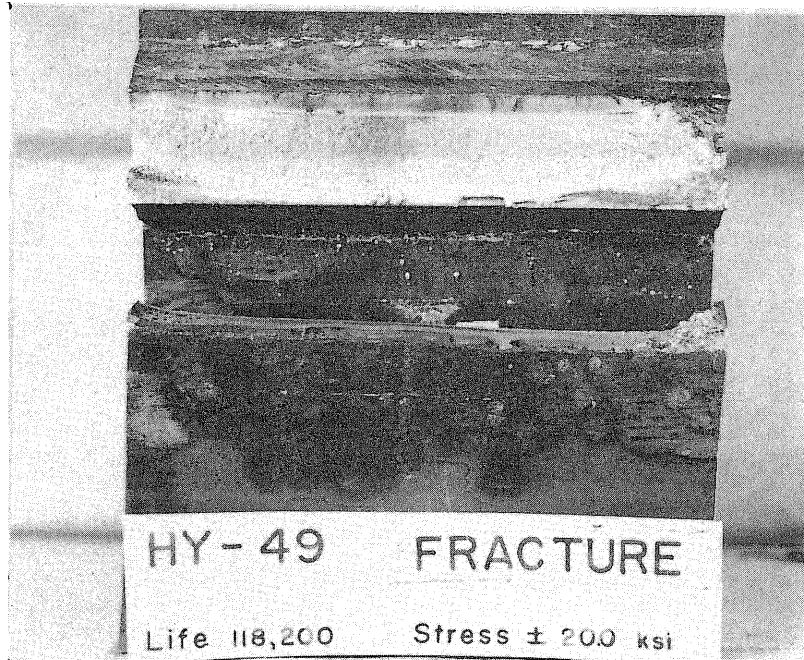
FAILURE INITIATED AT TOE OF WELD.
