10
I29A
300
copy 3

CIVIL ENGINEERING STUDIES

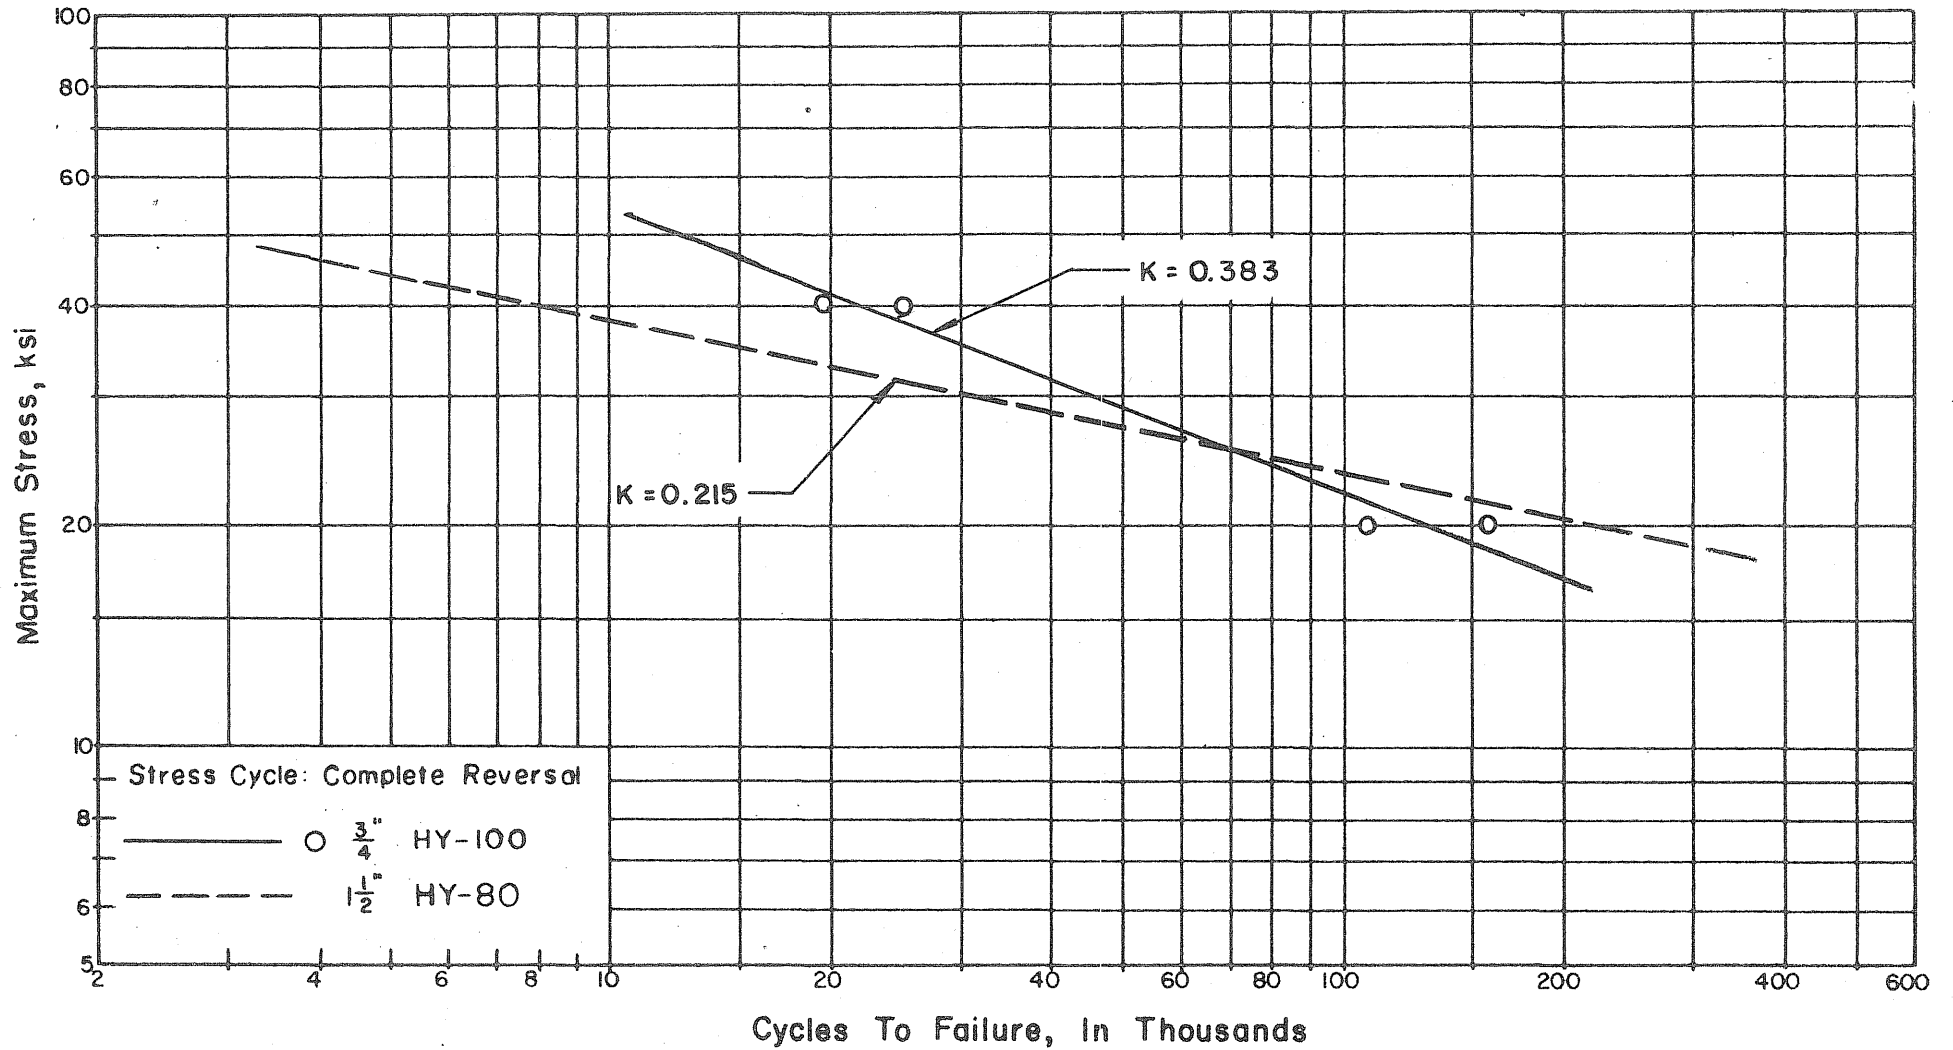
FIG.3.25 RESULTS OF FATIGUE TESTS OF HY-100 PLATES WITH FULL PENETRATION TRANSVERSE TEE JOINTS. (COMPLETE REVERSAL).

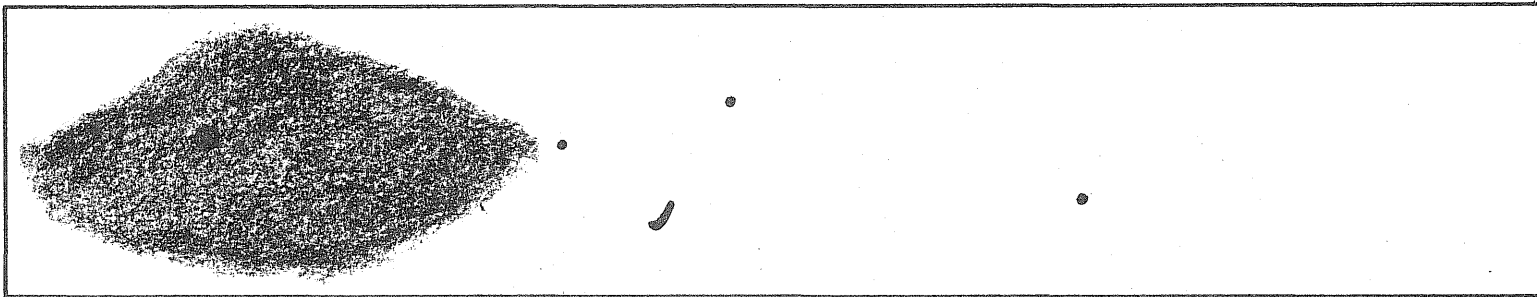
- 1) Location and extent of responses as indicated on detector scope
- 2) a. Number designation corresponds to magnitude of peak response as indicated on detector scope.
- b. Letter designation corresponds to location along the length of the specimen and with respect to the weld. (Section A and E are at the toes of the weld)

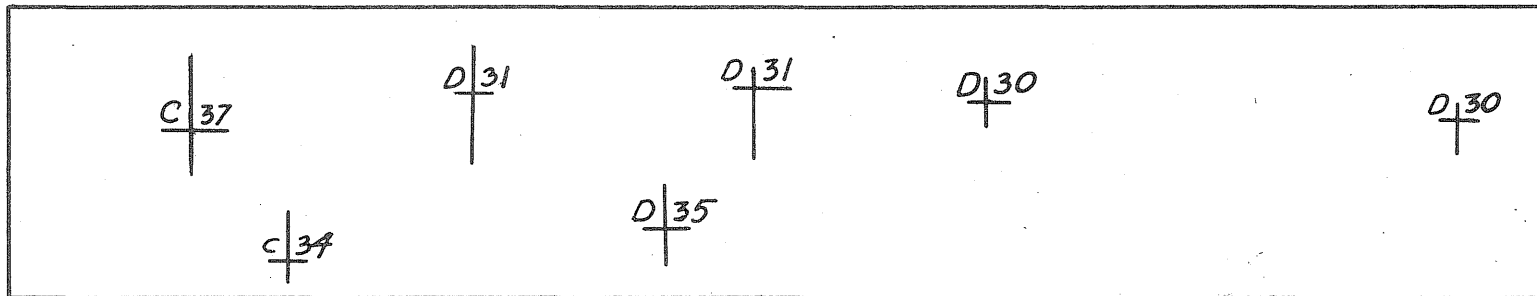
ULTRASONIC READINGS
 (Projection on a plane perpendicular to longitudinal axis of specimen)

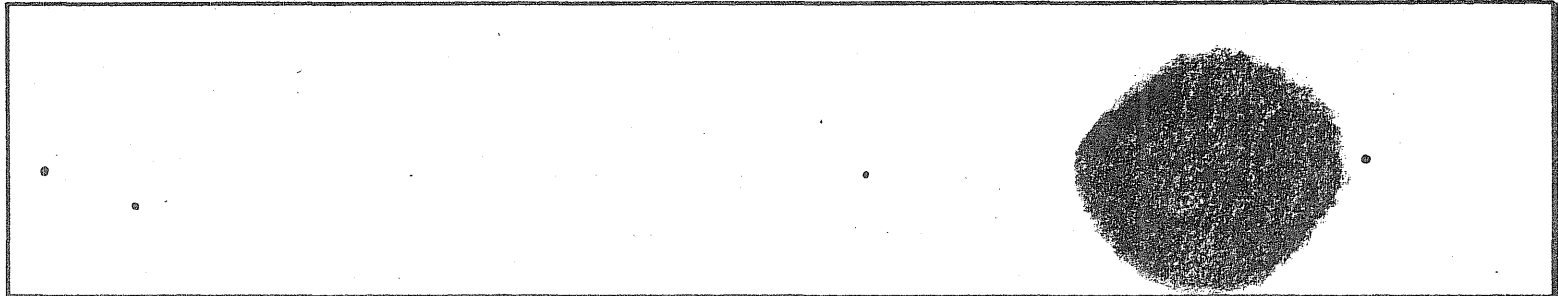
FRACTURE SURFACE
(See Fig. 5.1)

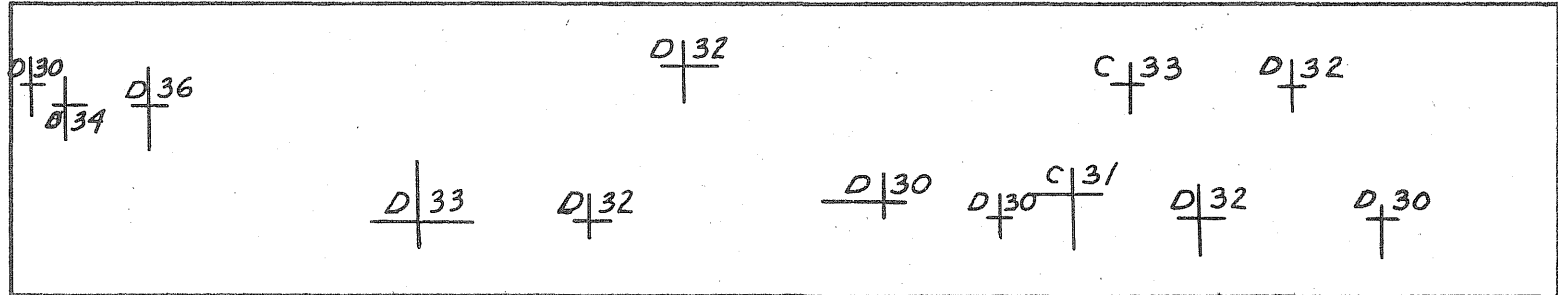
ULTRASONIC READINGS
(Projection on a plane perpendicular to longitudinal axis of specimen)
0 Cycles

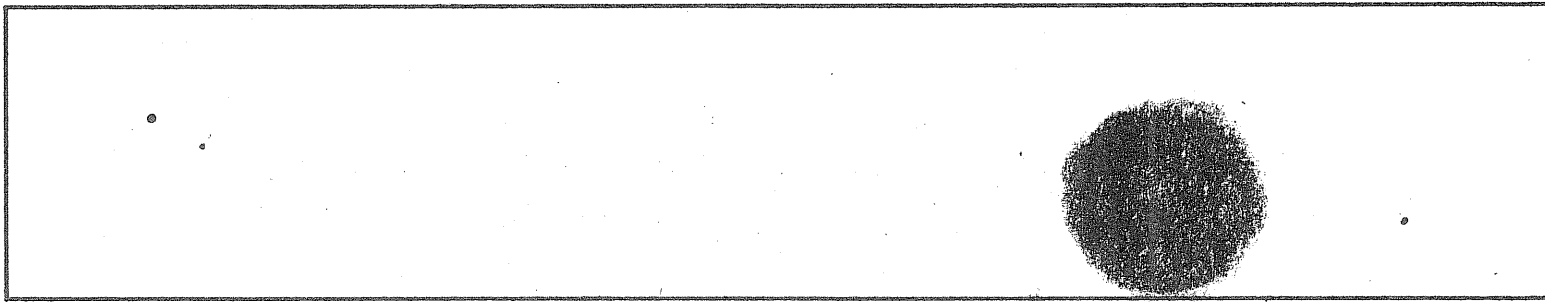
- 1) Location and extent of responses as indicated on detector scope
- 2) a. Number designation corresponds to magnitude of peak response as indicated on detector scope.
- b. Letter designation corresponds to location along the length of the specimen and with respect to the weld. (Section A and E are at the toes of the weld)

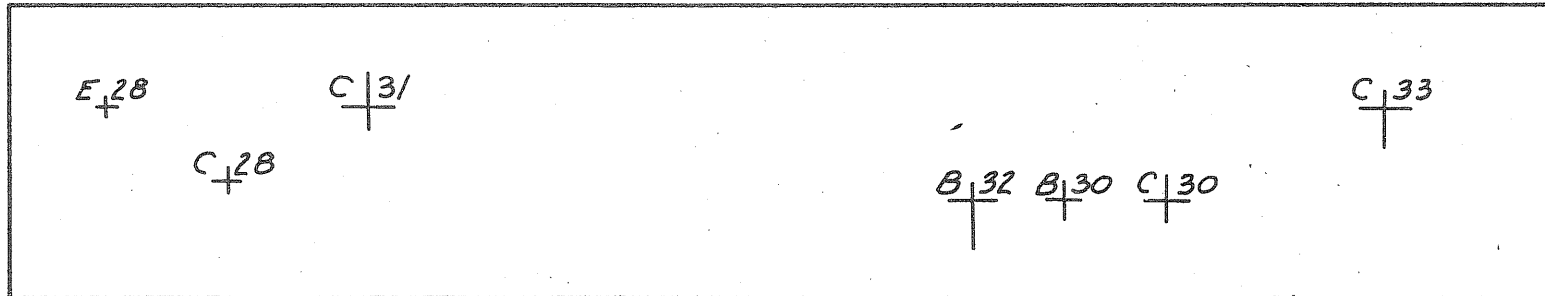
ULTRASONIC READINGS
 (Projection on a plane perpendicular to longitudinal axis of specimen)

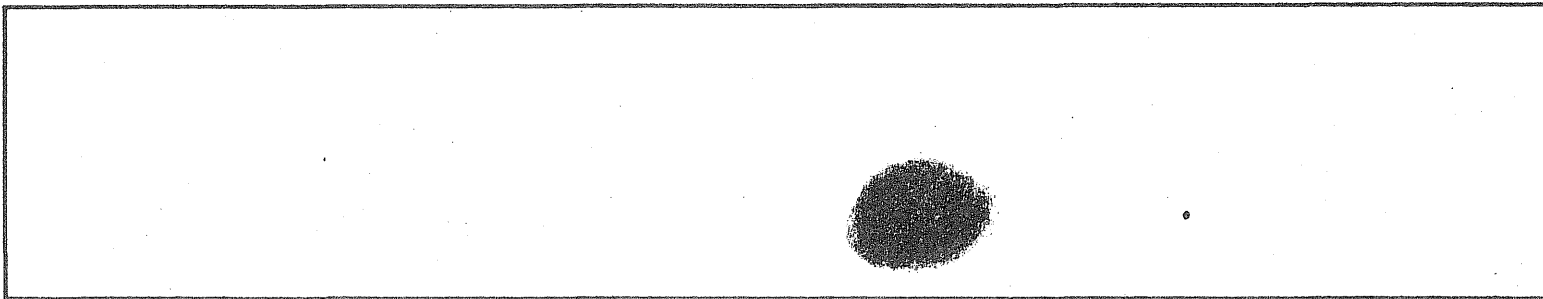
- 1) Location and extent of responses as indicated on detector scope
- 2) a. Number designation corresponds to magnitude of peak response as indicated on detector scope.
- b. Letter designation corresponds to location along the length of the specimen and with respect to the weld. (Section A and E are at the toes of the weld).

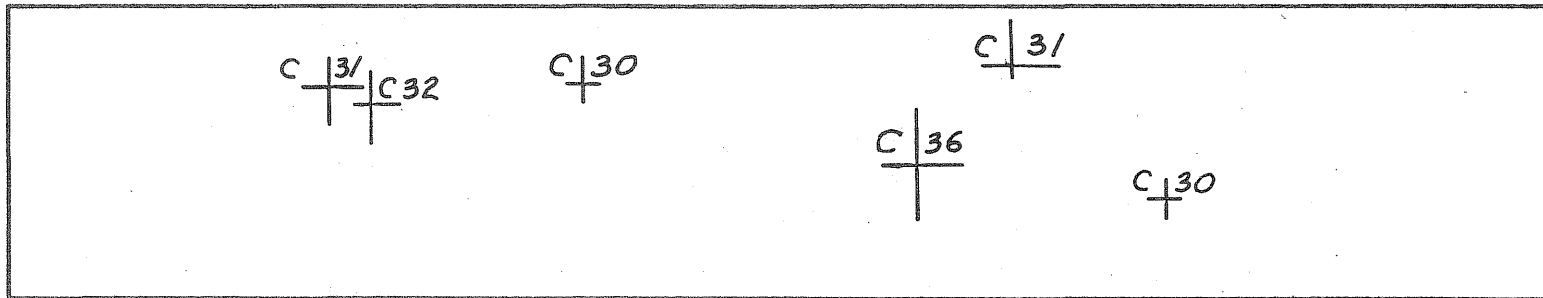
ULTRASONIC READINGS
 (Projection on a plane perpendicular to longitudinal axis of specimen)

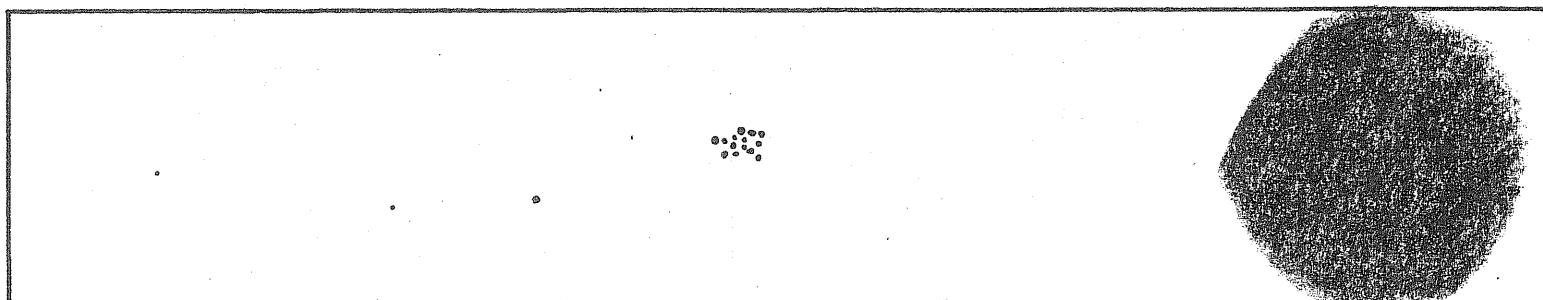
- 1) Location and extent of responses as indicated on detector scope
- 2) a. Number designation corresponds to magnitude of peak response as indicated on detector scope.
- b. Letter designation corresponds to location along the length of the specimen and with respect to the weld. (Section A and E are at the toes of the weld)

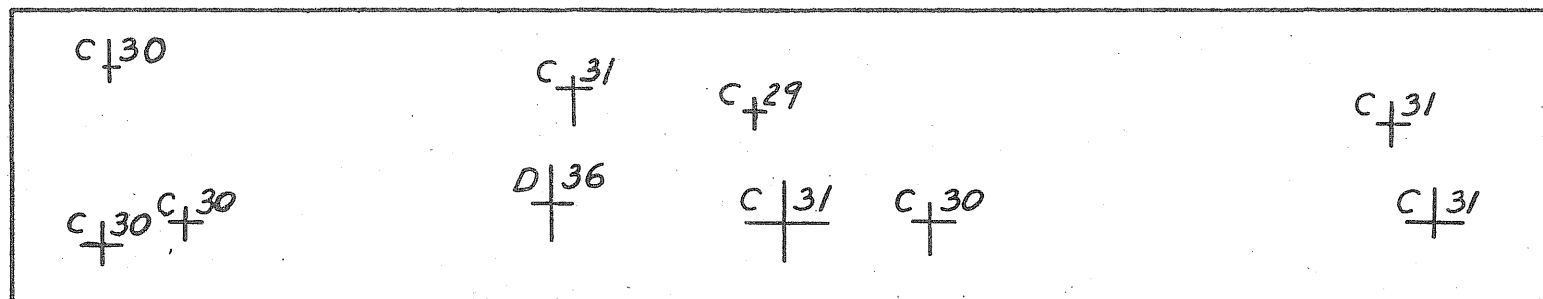
ULTRASONIC READINGS
 (Projection on a plane perpendicular to longitudinal axis of specimen)
 0 Cycles

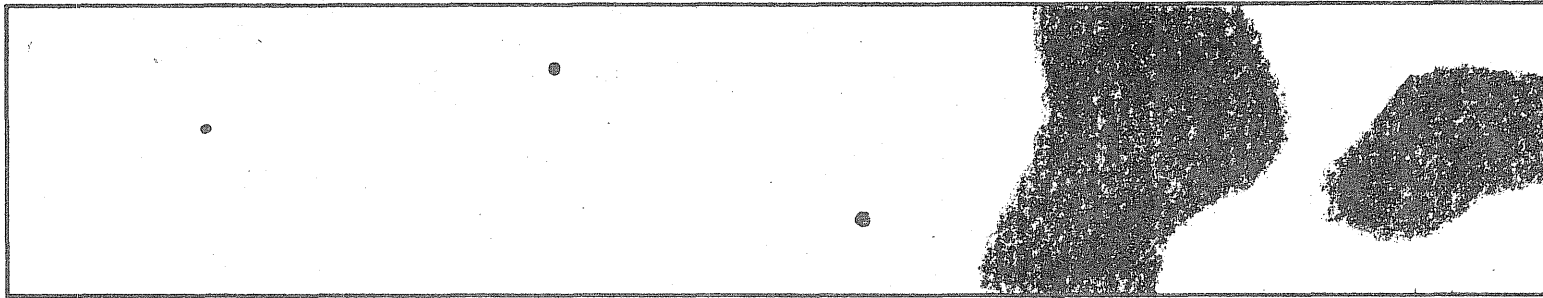
- 1) Location and extent of responses as indicated on detector scope
- 2) a. Number designation corresponds to magnitude of peak response as indicated on detector scope.
- b. Letter designation corresponds to location along the length of the specimen and with respect to the weld. (Section A and E are at the toes of the weld)

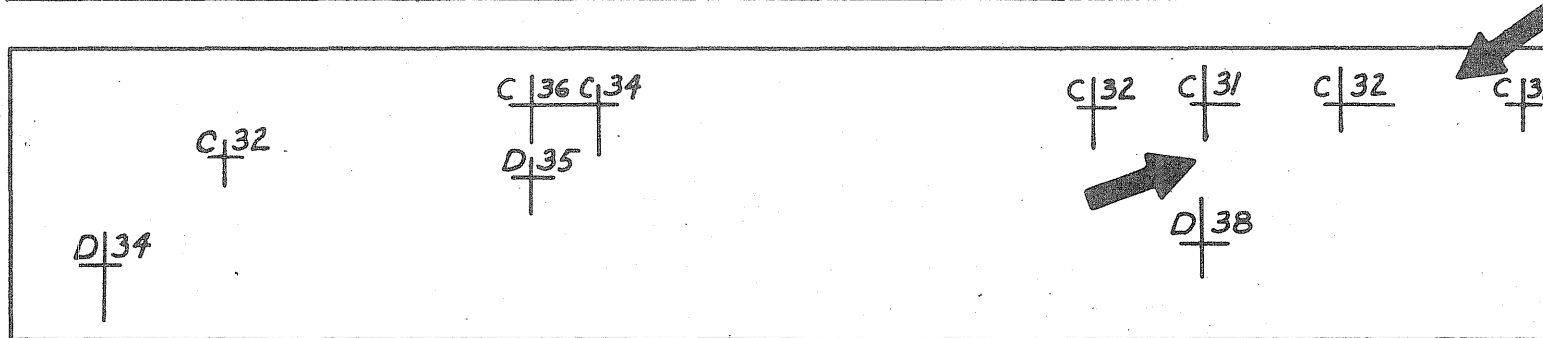
ULTRASONIC READINGS
 (Projection on a plane perpendicular to longitudinal axis of specimen)

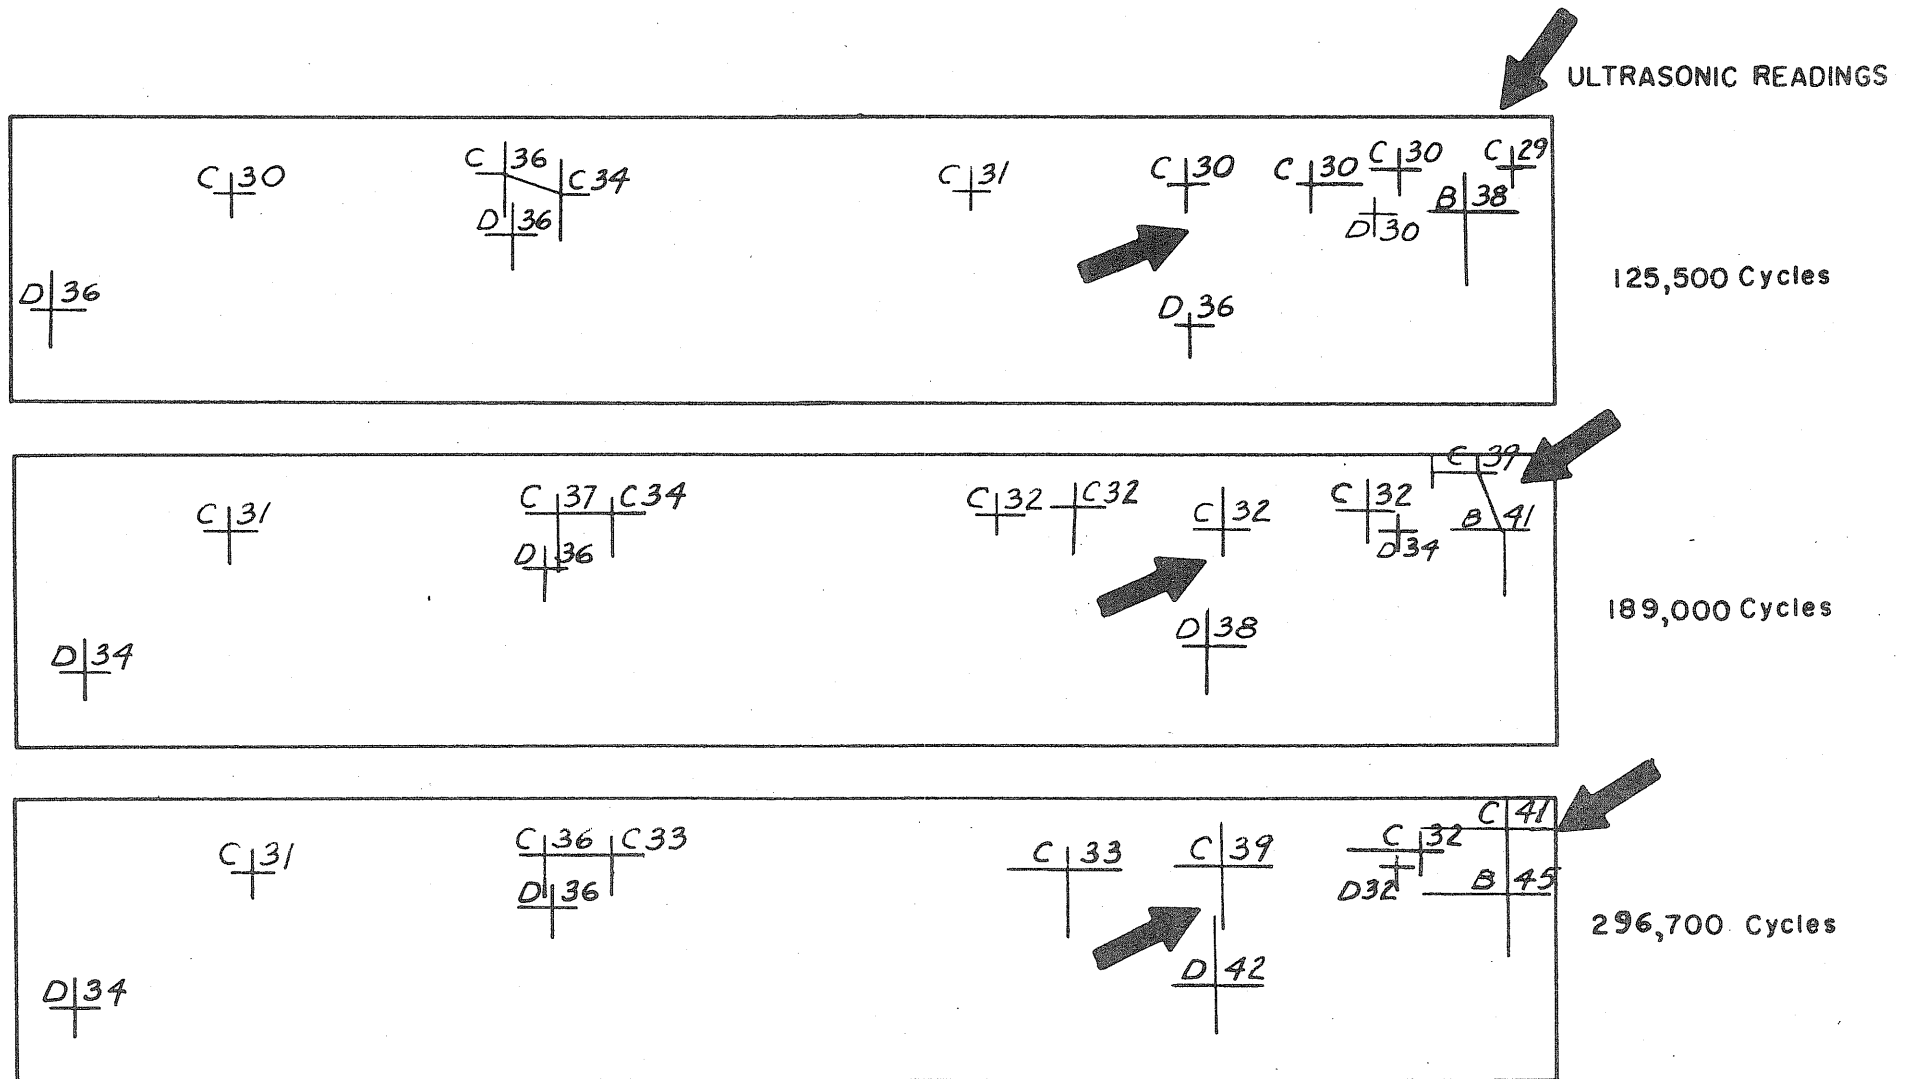
FIG.4.8 (CONT.) SKETCH OF FRACTURE SURFACE AND ULTRASONIC READINGS FOR FLAWS IN WELD OF SPECIMEN HY-35.

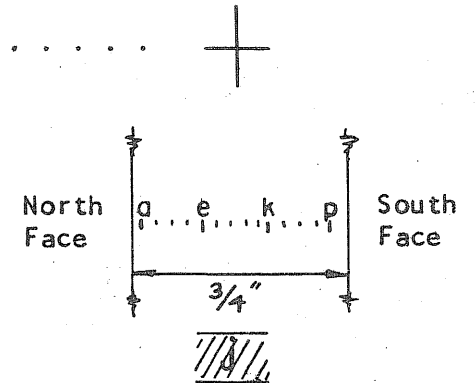
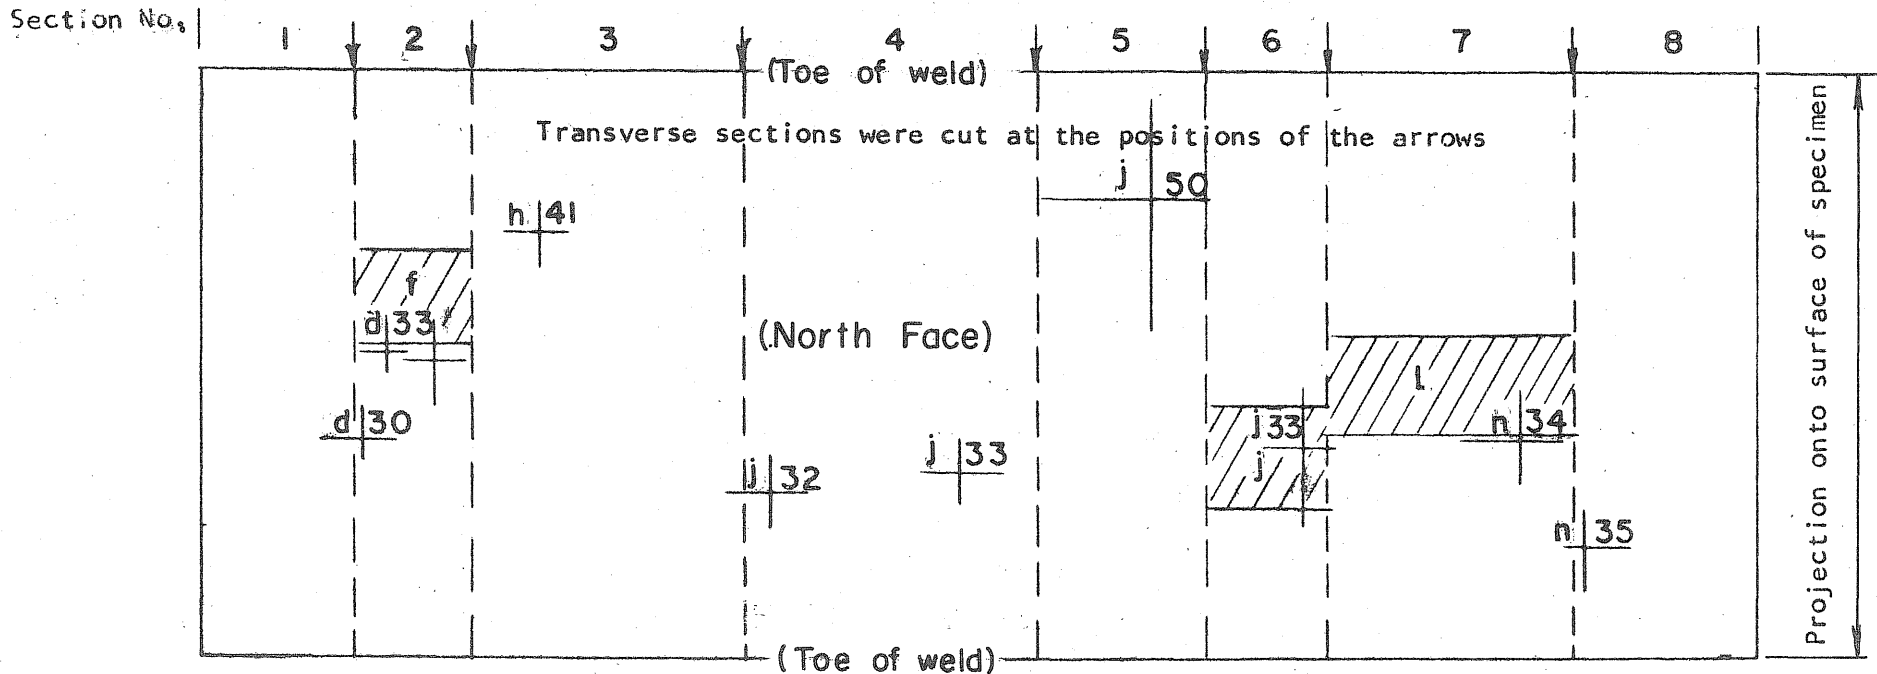
FIG.4.9 METALLOGRAPHIC SURFACES AND ULTRASONIC READINGS OF SPECIMEN HY-34.

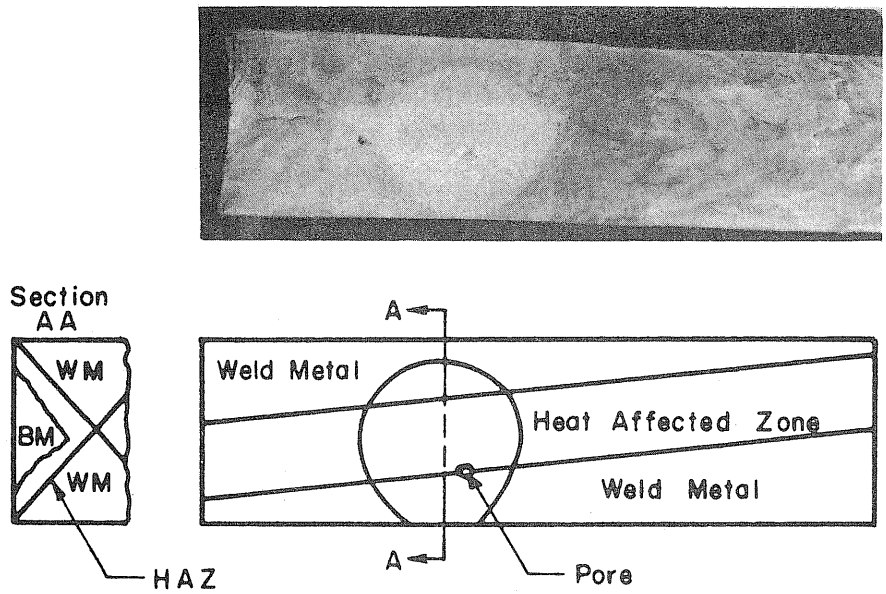
FIG.5.1 FRACTURE SURFACE OF SPECIMEN HY-43.

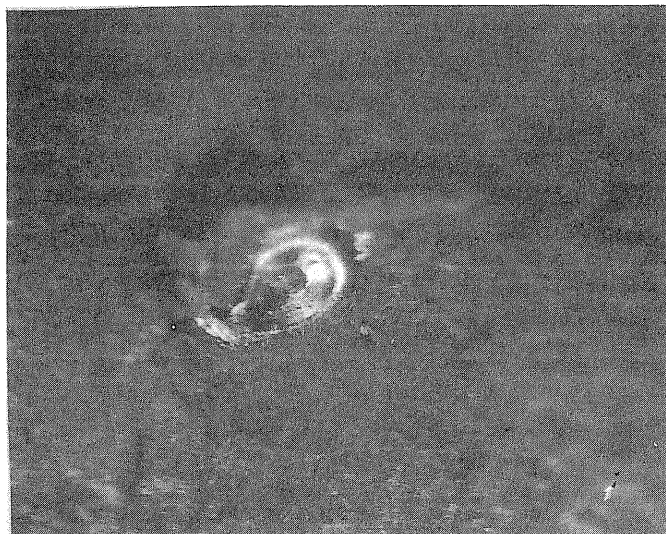
FIG.5.2 PORE AT THE CENTER OF THE FRACTURE SURFACE OF SPECIMEN HY-43. 15X.

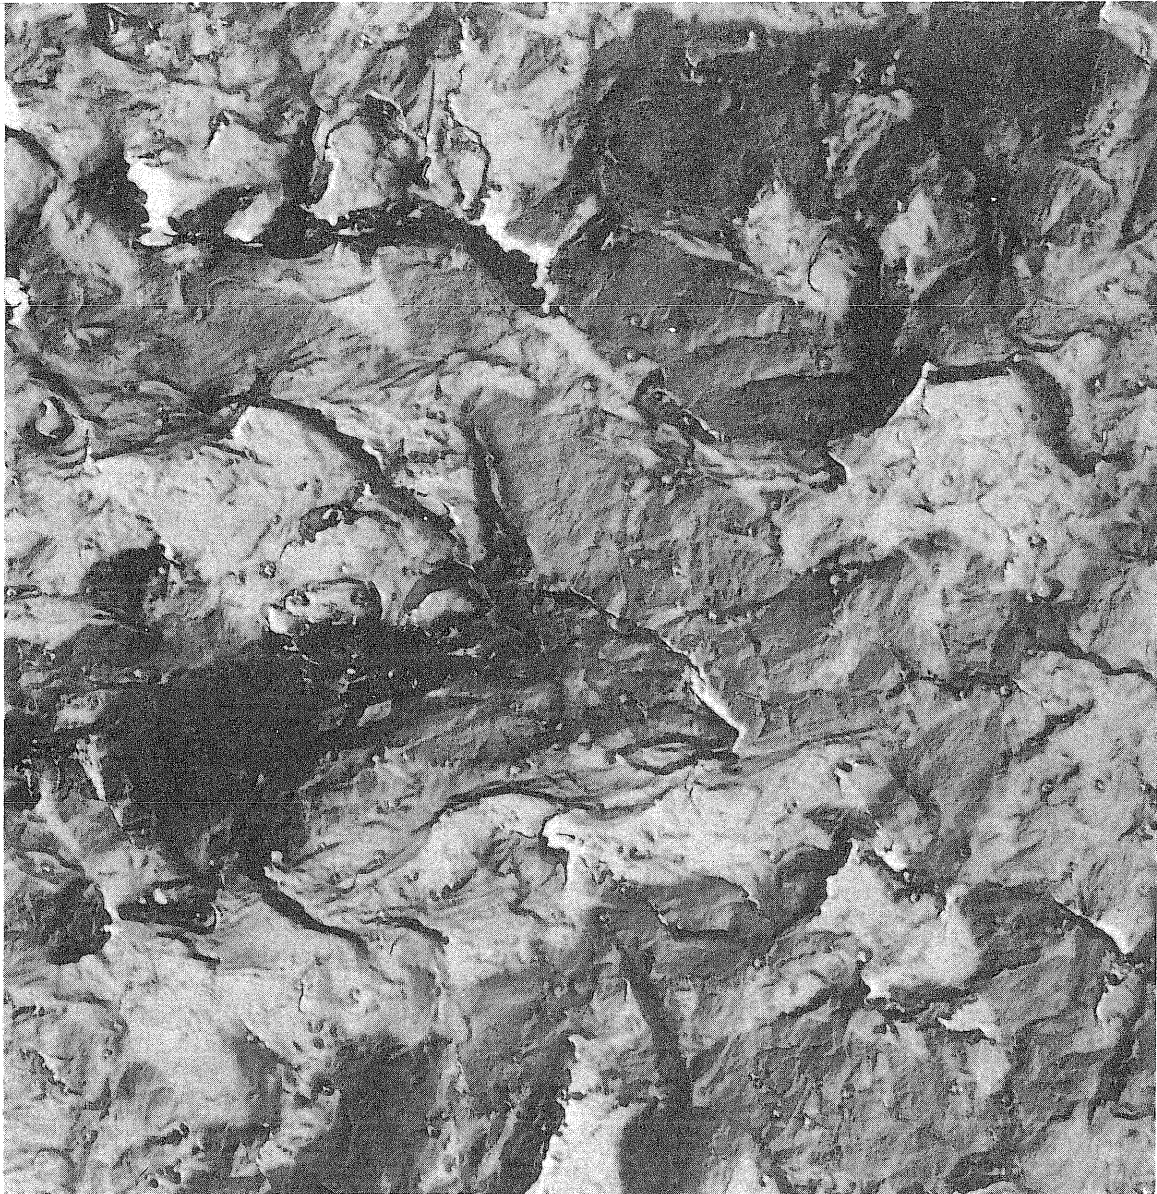
FIG. 5.3 ELECTRON MICROGRAPH SHOWING FRACTURE SURFACE OF THE WELD METAL OF SPECIMEN HY-43. 6,400X

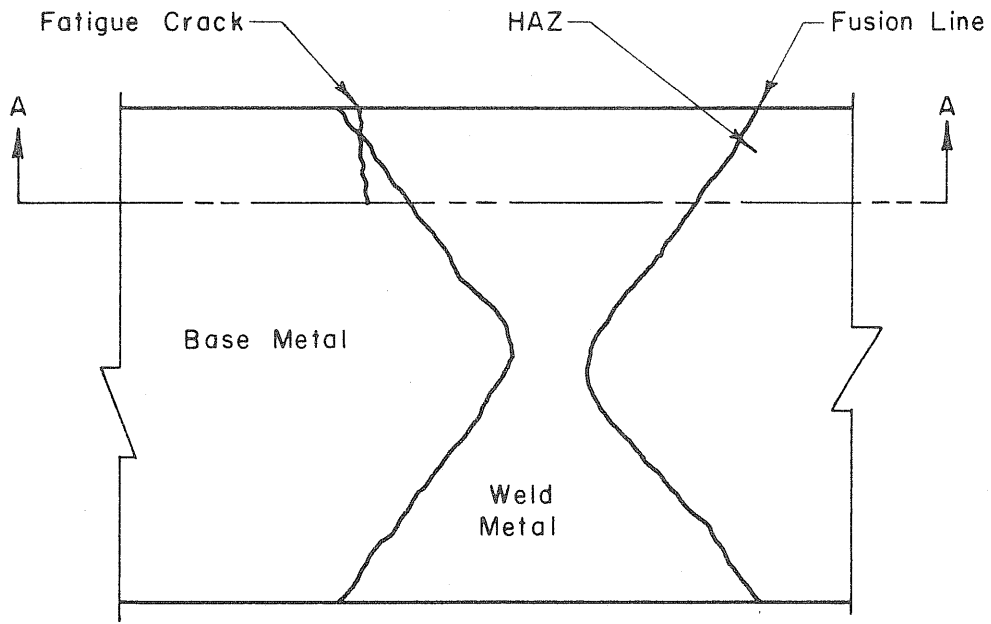
Cross Section of Weld.

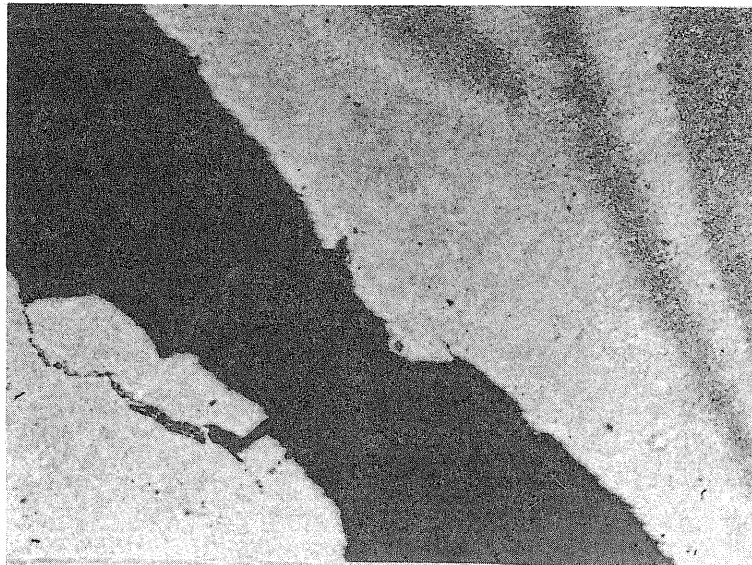
FIG. 5.5a TRANSVERSE SECTION OF FRACTURE
SURFACE CUT FROM SPECIMEN HY-25
SHOWING H. A. Z. 100X

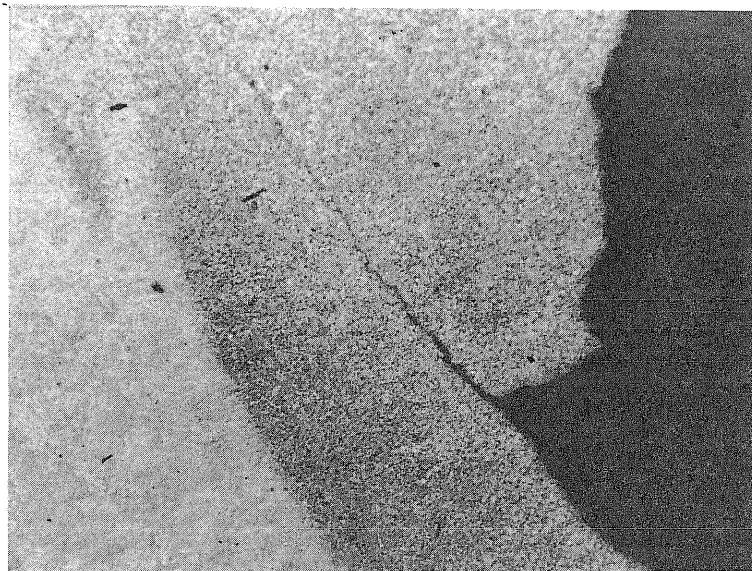
FIG. 5.5b TRANSVERSE SECTION OF FRACTURE
SURFACE OF SPECIMEN HY-25 SHOWING
WELD METAL. 100X

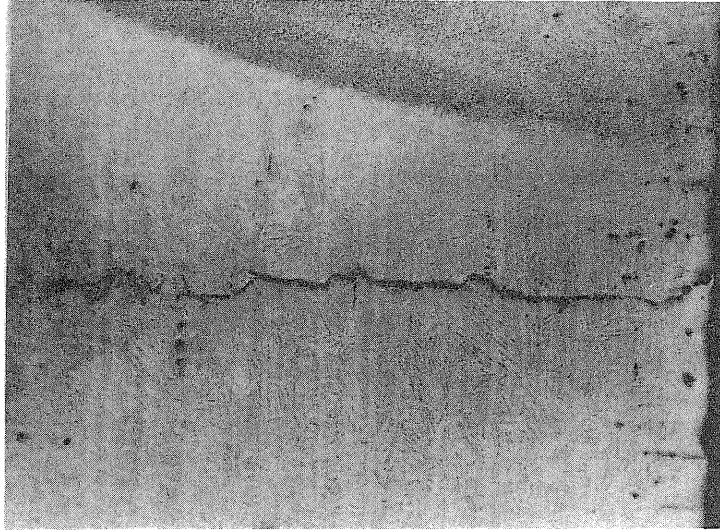
FIG. 5.6 TRANSVERSE SECTION OF SLICE 6 WEST
(FIG. 4. II) SHOWING THE FATIGUE CRACK
IN SPECIMEN HY-34. 100X

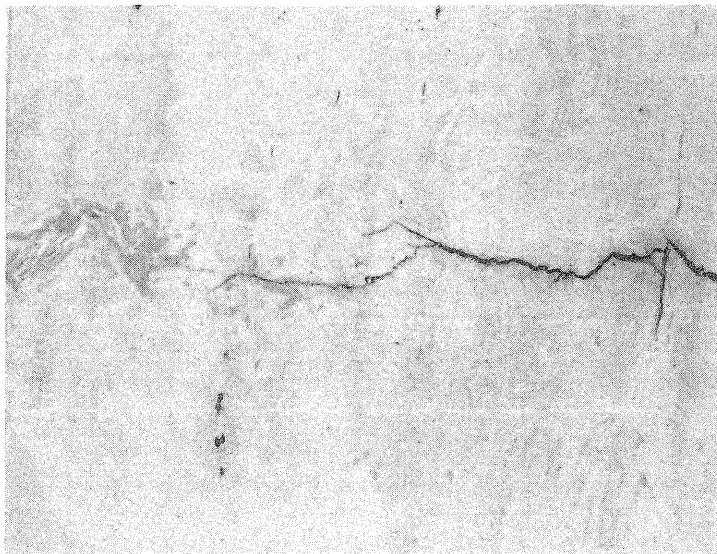
FIG. 5.7 HIGHER MAGNIFICATION OF FATIGUE CRACK
SHOWN IN FIG. 5.6. 200X

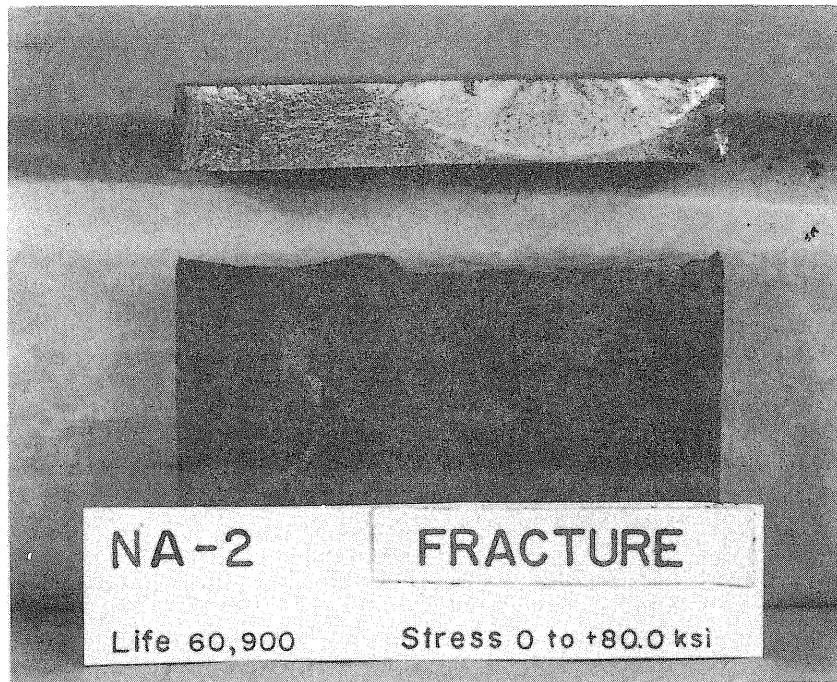
a) Failure Initiated At Mill Scale Surface

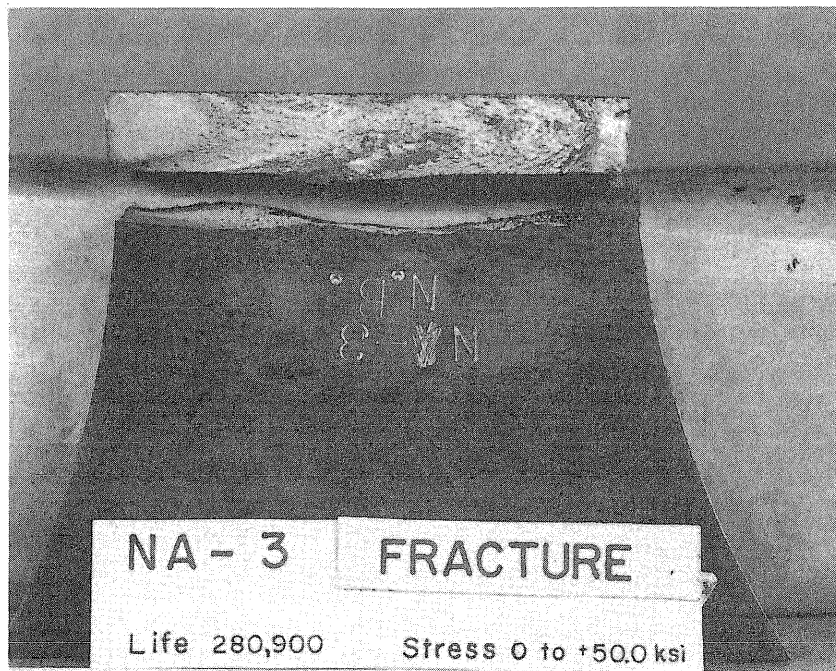
b) Failure Initiated At Radius
