FATIGUE OF PLATES AND WELDMENTS IN HIGH STRENGTH STEELS

Final Report

The Naval Ship Systems Command, U. S. Navy
Contract N0bs 94232
Project Serial No. SF-020-01-05, Task 729-0

February 1967

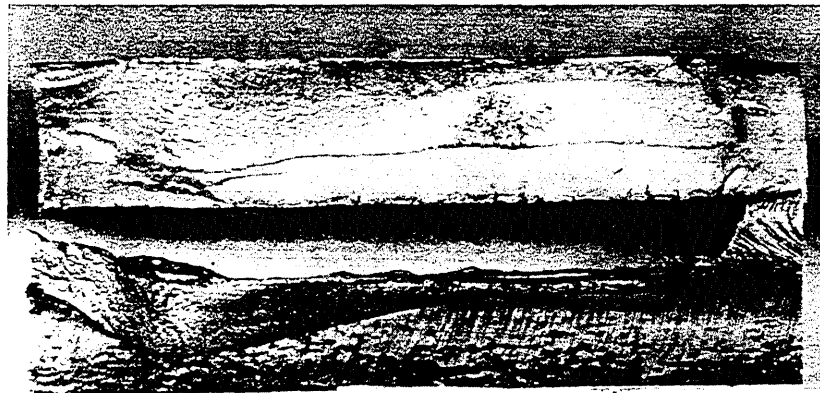
HY-67 FRACTURE

specimens prepared with the MIL-12018 electrode. A typical fracture surface for a specimen prepared using a carbide grinding wheel and failing in fatigue at the toe of the weld is shown in Fig. 3.7b.

Life 87,500 Stress 0 to +50.0ksi

(b) Failure Initiated At Toe Of Weld

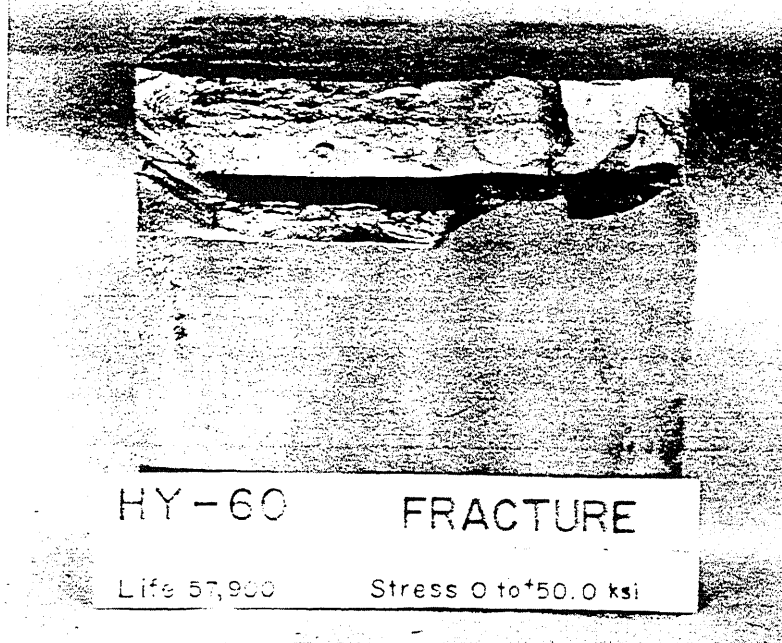
(a) Failure Initiated At Internal Flaws

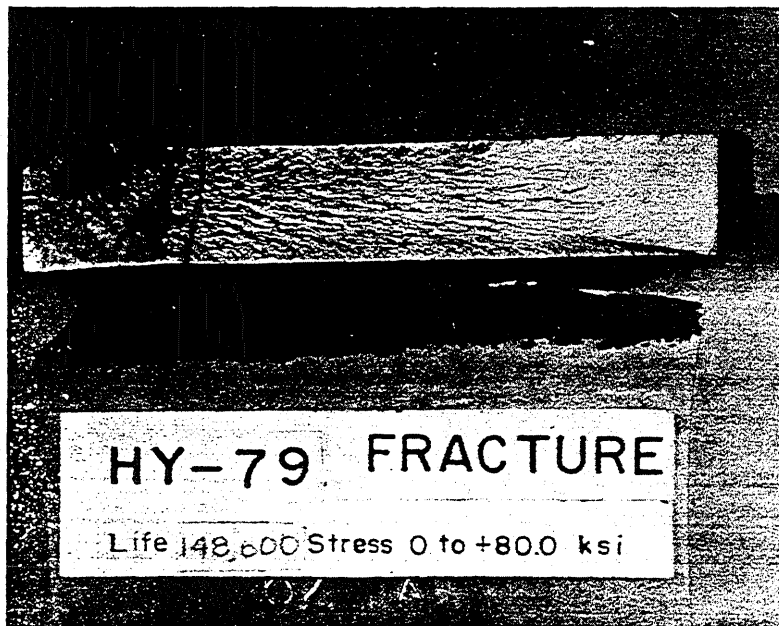
(b) Failure Initiated At Radius Of Test Section

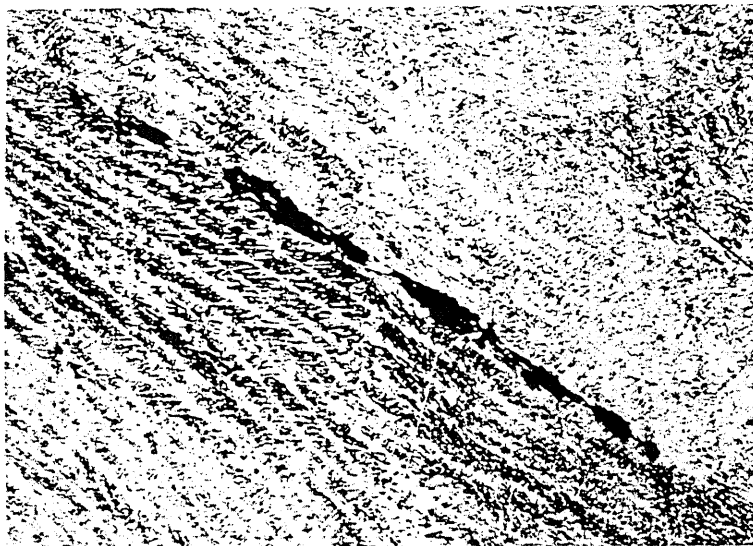
(a) PROCEDURE P150-X150-A

FIG.4.13 HOT CRACKS LOCATED IN WELD METAL
DEPOSITED IN ACCORDANCE WITH
PROCEDURES P150-X150-A & P150-X150-B

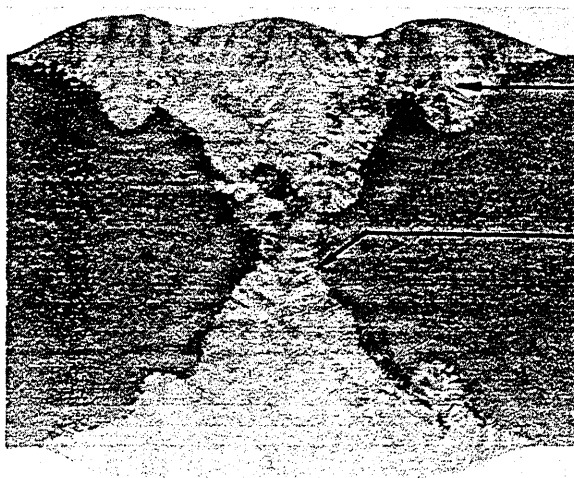
(c) University of Illinois 2x

Lobe of weld bead

Crack in center of
lobe.

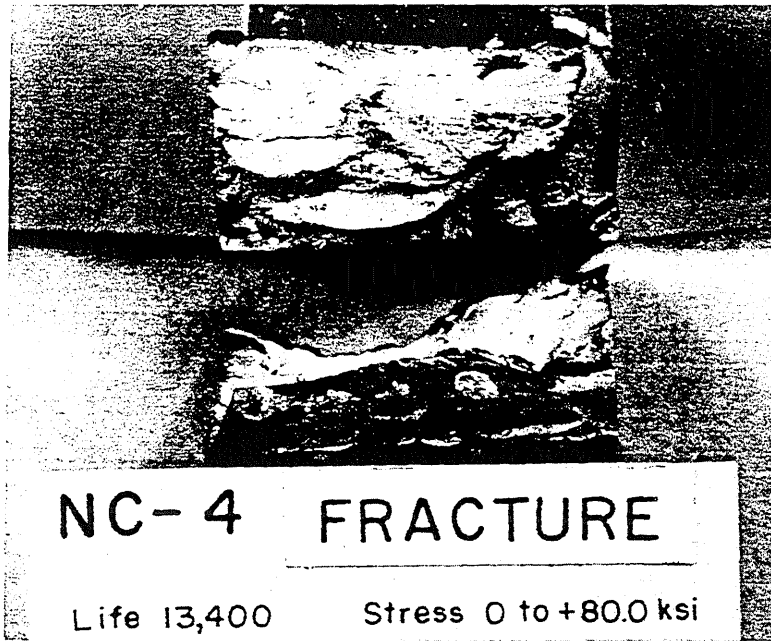
(a) Failure Initiated At Porosity

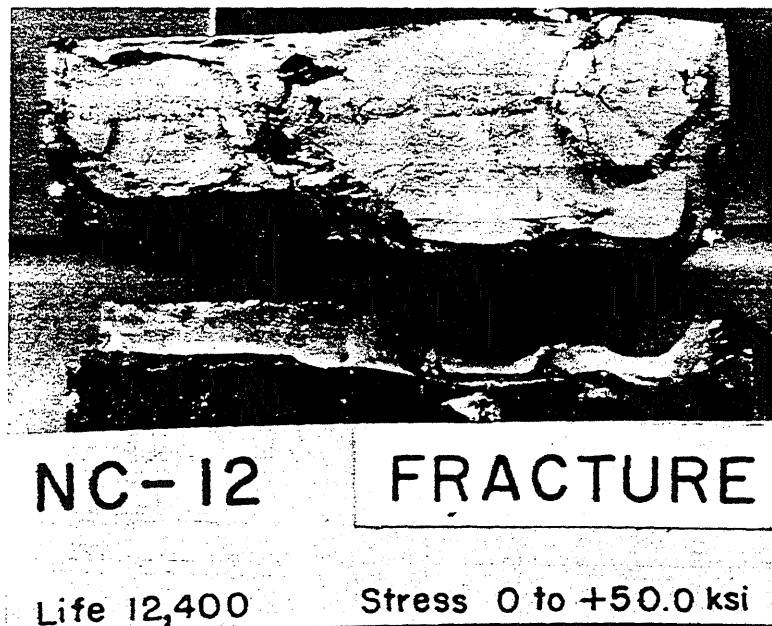
(b) Failure Initiated In The Lobe Of A Weld Bead

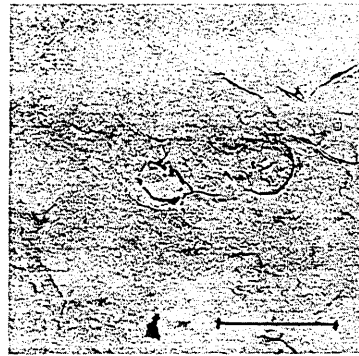
FIG. 4.22 PLASTIC REPLICA OF A LOBE CRACK (ARROW) EXPOSED BY THE STATIC FRACTURE OF WELDED SAMPLE NC-1-D
