# Pathology, Evaluation and Repair of Bridges in Masonry

# 3. The case study: the bridge on river Kentra Stora Skida (North-East of Algeria)

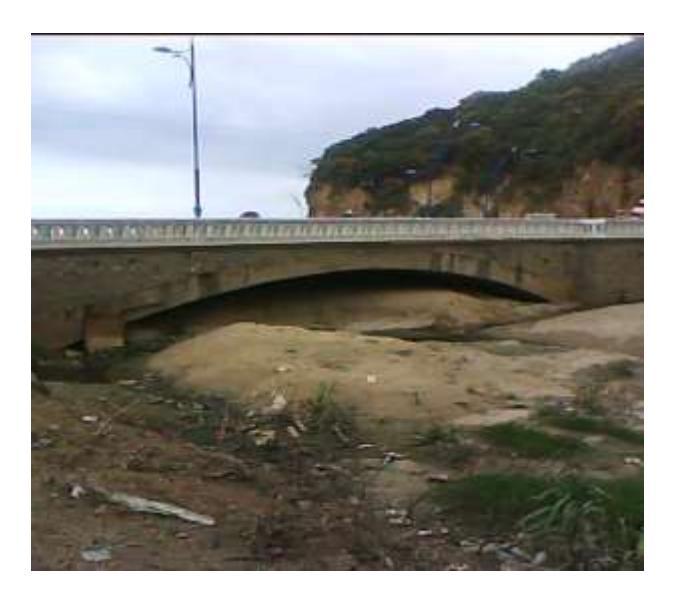
The presence of significant cracks on the entire structure: The slab of the deck also has significant delamination areas in addition to having a thickness insufficient by standards. The vault and the abutment show traces of water infiltration. The bursting of concrete with stripping and corrosion of the reinforcement at the cornices. Cracks are also visible on the masonry in Fig. 2. They usually run along the joints. Locally, splinters between the rubble are also visible.

The cracking developed is due to the presence of microcracking in the mass of the mortar and to the weaknesses of the stone - mortar interface (Stablon, 2011).

Fig 2. Bridge over the River river Kentra Stora, in Skikda.

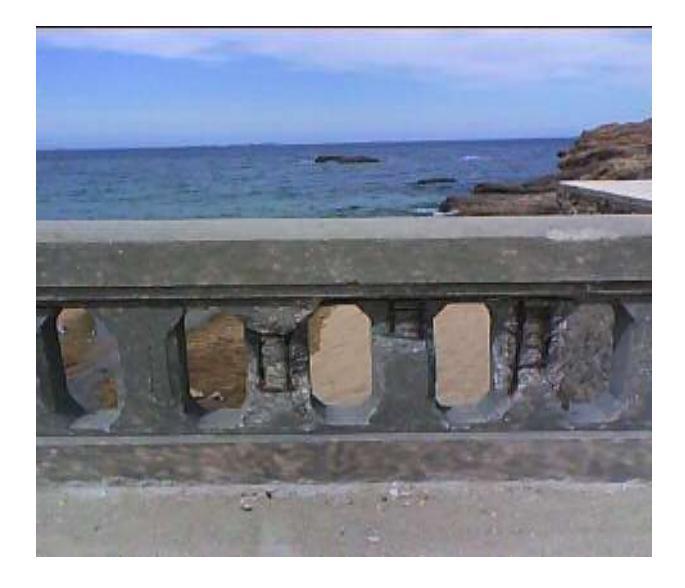
As the bridge is located in an area close to the sea, special attention has been paid to this factor in order to limit the problems and damages related to this environment (Fig.3 and Fig.4).

Fig 3. Defects affecting the reinforcing concrete.

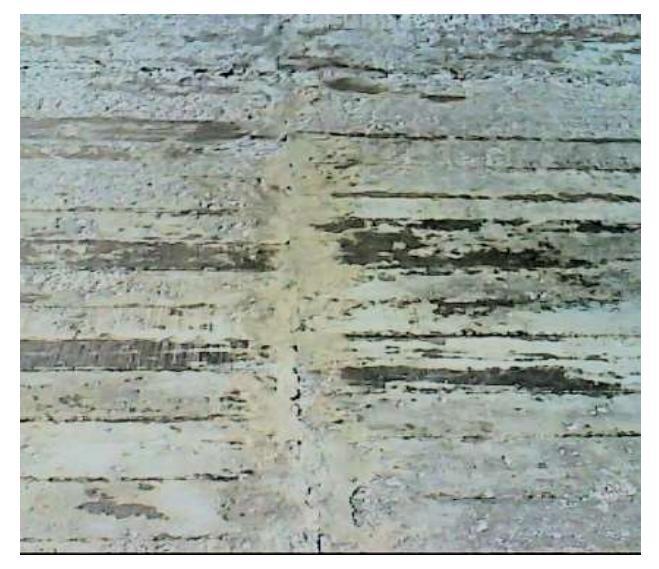
Fig 4. Cracks and stains on the surface.

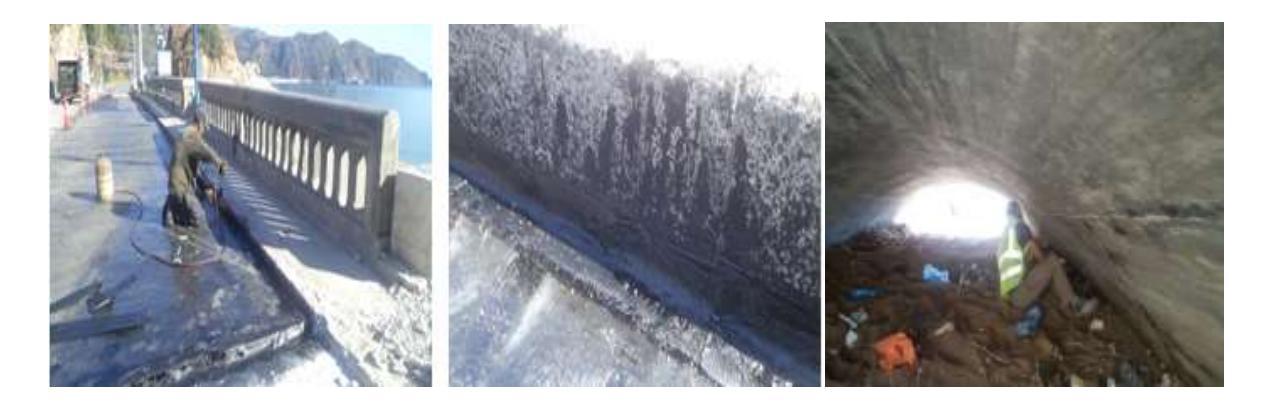
Apart from the deteriorations observed, our structure is in an "acceptable" state from the point of view of mechanical functioning. Thus, we offer maintenance and repair of degraded parts of the work (Fig. 5 and Fig. 6), this work which lasts approximately two months and essentially comprises the following stages:

Fig 5. Bridge Repair Works.

- Paved body debris on a thickness of 30 cm.
- Realization of a screed of 5cm concrete cleanliness.
- Realization of a slab (high seal) to the right of the 15cm structure with reinforced National road 27 concrete mesh welded after cleaning, surface preparation and all subjections of good execution.

- Implementation of a sealing complex.
- Implementation of an asphalt concrete wearing course (8cm thick).
- Washing masonry and reinforced concrete facings with pressurized water (6 bars).

- Stitching and blowing in the compressed area of degraded concrete surface (Corniche + Railing) with energetic brushing of exposed steel.
- Repair of degraded concrete (cornice + guardrail) with hydraulic mortar based on resin emulsion, including primer primer on any thickness <5cm.

- Injection of fissures with the resin (SIKADUR 52 or equivalent).
- Sanding of railings.
- Applying layers of paint on railings

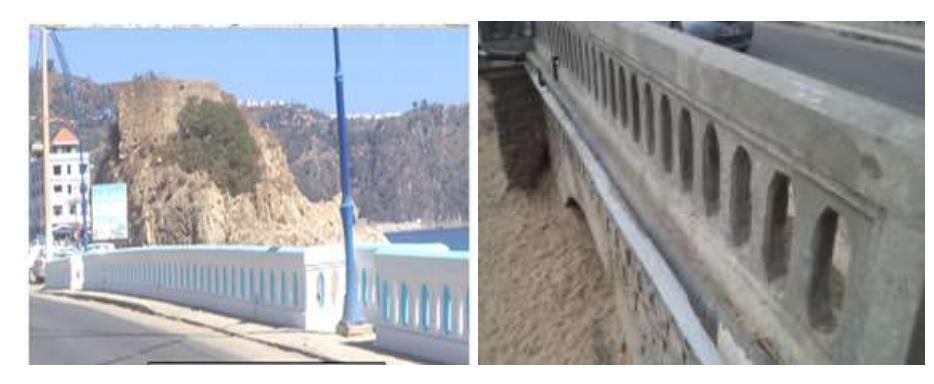
Fig 6. Bridge after rehabilitation Works.
