# A case study on deterioration assessment and rehabilitation of fire damaged reinforced concrete structure

Ojha P N, Brijesh Singh<sup>\*</sup>, Adarsh Kumar N S, Abhishek Singh, Vikas Patel

National Council for Cement and Building Materials, India. Corresponding Author: <u>brijeshsehwagiitr96@gmail.com</u>

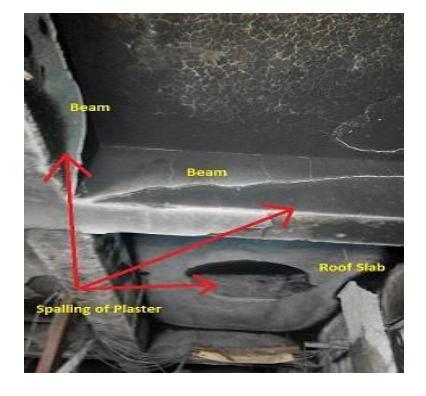
In order to take up the research project on fire damaged structures, during the preliminary site investigation it was observed that the fire has occurred at the fifth floor room of the building and its fumes/gases escaped through the duct opening in the roof slab to mezzanine floor at the top. The spalling of plaster from roof slab, beams and columns had occurred at several places (refer Fig. 1-2). No documents or drawings other than a basic plan view of the arrangement of rooms on the floors was available. No details regarding the structural design or mix design of concrete were available. Accordingly the authors decided to categorize the various investigation studies in two parts i.e. field investigation and laboratory investigation. The field investigation covered (i) determination of Quality of concrete using UPV testing technique as per IS: 13311 (Part – I) - 1992, (ii) Concrete cover study and (iii) extraction of concrete cores samples from identified members for Carbonation study at site and to further carry out the laboratory investigation on concrete core as per IS 456 (2000) & IS:516(1959) (b) Chemical analysis of hardened concrete to determine pH value, chloride content and Sulphate content.

Fig. 1. Spalling of Plaster in Beams & Slabs

- i) Removal of all cracked and loose cement plaster from the Reinforced Cement Concrete members and walls in fire damaged area by chiseling out surface concrete up to 20mm depth in deteriorated structural elements and to remove the existing plaster over the wall also.

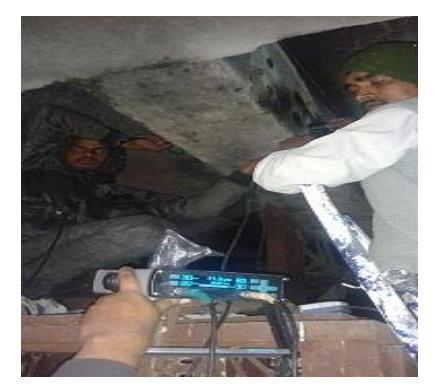
Measurements were taken by direct method (cross-probing) as shown in fig.3. Based on Ultrasonic Pulse Velocity obtained, the overall quality of concrete was graded as 'Good'.

Fig. 3. UPV Measurement being recorded

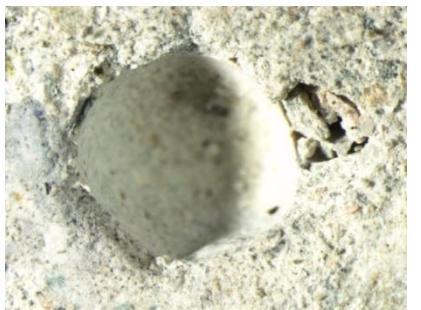
Fig. 4. C-32-Bottom-1: Voids filled with crystalline material

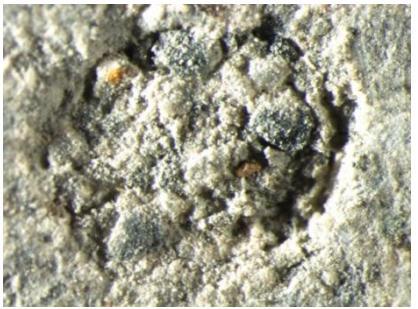
Fig. 6. S-6-Middle-3: Voids filled with crystalline material

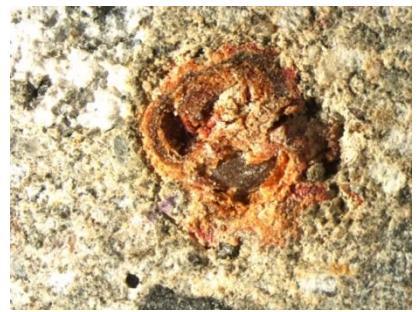
Fig. 5. -1-Middle-2: Leached out materials as observed in the sample

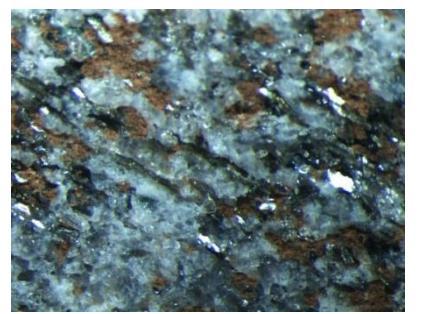
Fig. 7. S-6-Bottom-3: Stretching of coarse and fine aggregate due to temperature rise

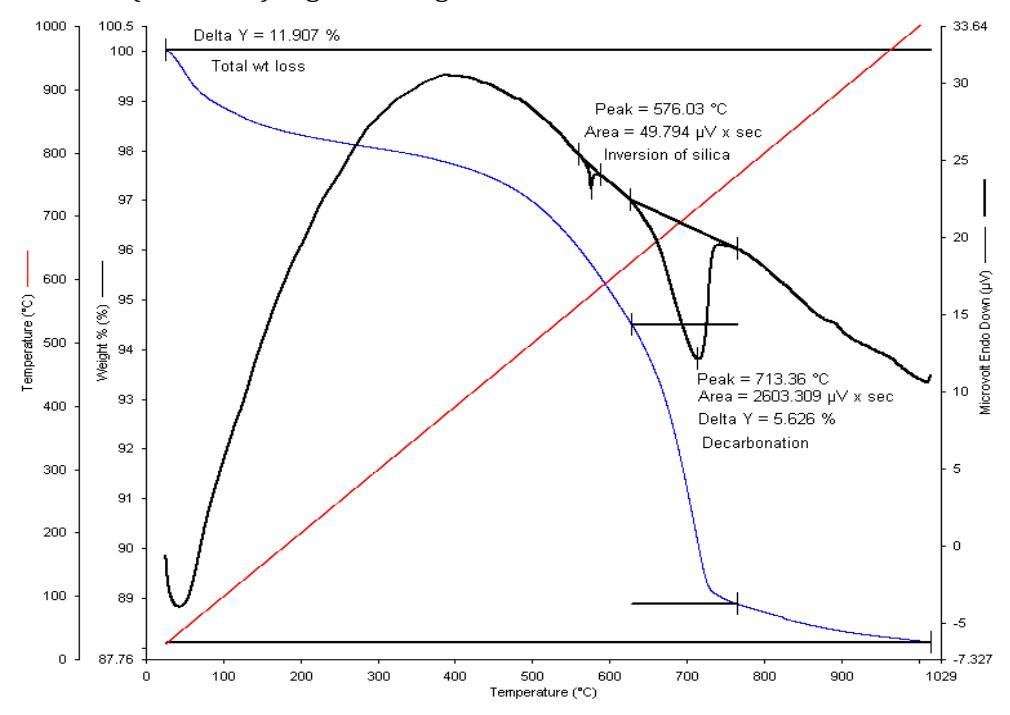
The samples from identified locations covering Plaster from Beam B8 & Beam B32 and sliced concrete cores in layers (0-20mm), (20-40mm) & (40-80mm) from Beam B8 and Slab S1, were grinded to powder passing 150 micron IS sieve. The Differential Thermal Analysis was carried out to assess weight loss corresponding to different temperatures. In sample of Beam-B8 Plaster, the total weight loss of 11.91 percent for (0-20mm) depth up to a temperature of 1000°C from ambient@ 10°C/minute. Graph for Beam B8 Plaster (0 - 20mm) shown in fig. 8. In Beam-B32 Plaster, the total weight loss of 11.069 percent for (0-20mm) depth up to a temperature of

Fig. 8. Graphical Representations of study on plaster samples from Beam B8 of fire damaged area

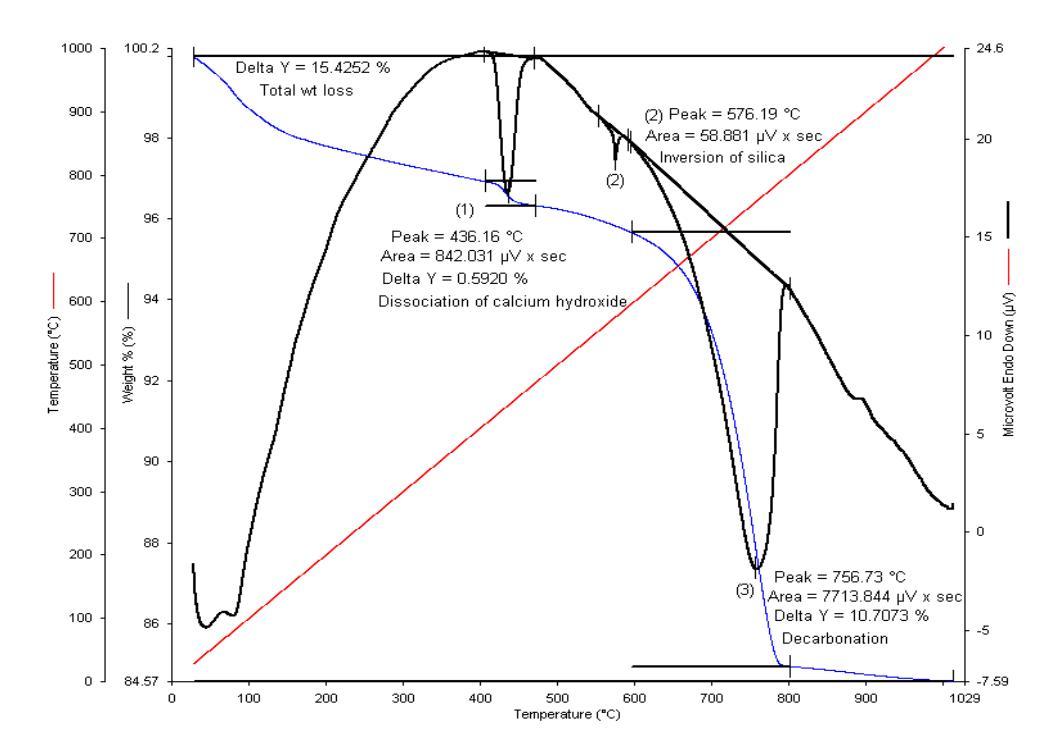
1000°C from ambient@ 10°C/minute was observed. In sample from Slab S1, the total weight loss of 15.42 percent for (0-20mm) depth, 15.16 percent for (20-40mm) depth and 13.82 percent for (40-80mm) depth up to a temperature of 1000°C from ambient@ 10°C/minute was observed. Graph for Slab S1 (0 - 20mm) is given in Fig. 9.

Fig. 9. Graphical Representations of study on concrete samples from Slab S1 of fire damaged area
