An experimental damage tolerance investigation of CFRP composites on a substructural level

Raffael Bogenfeld*, Christopher Gorsky, Tobias Wille

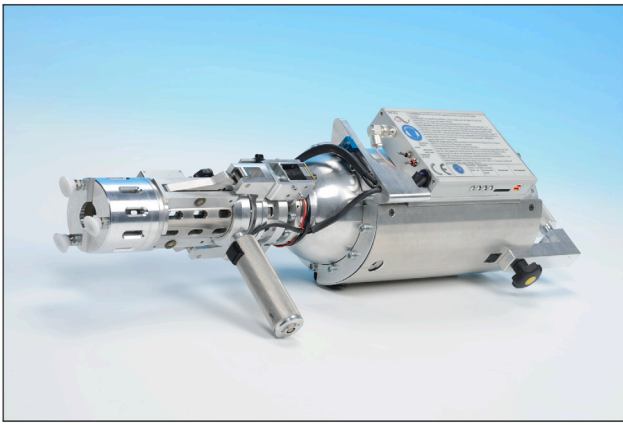
Fig. 3. Gas gun for the impact tests.

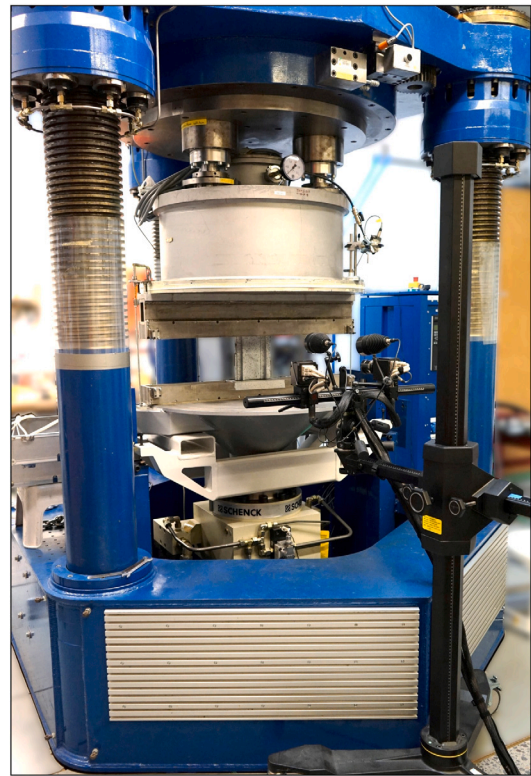
Fig. 4. Test setup for the panel compression tests in the DLR buckling test facility.

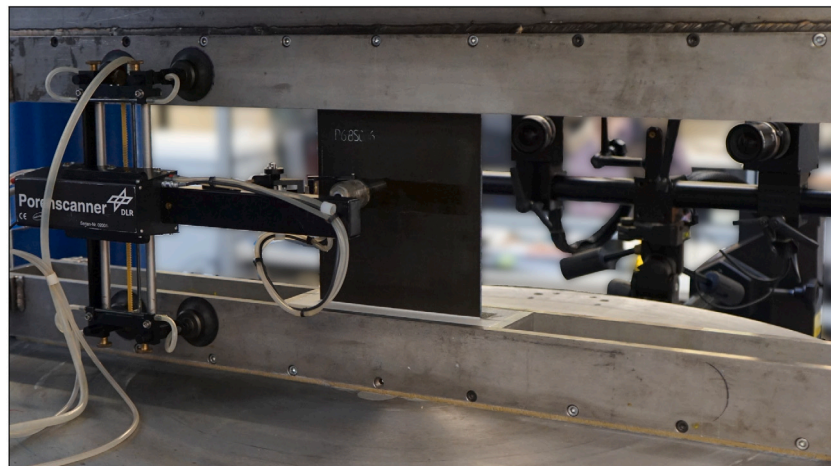
Fig. 5. Ultrasonic scan of the panel mounted in the testing machine.

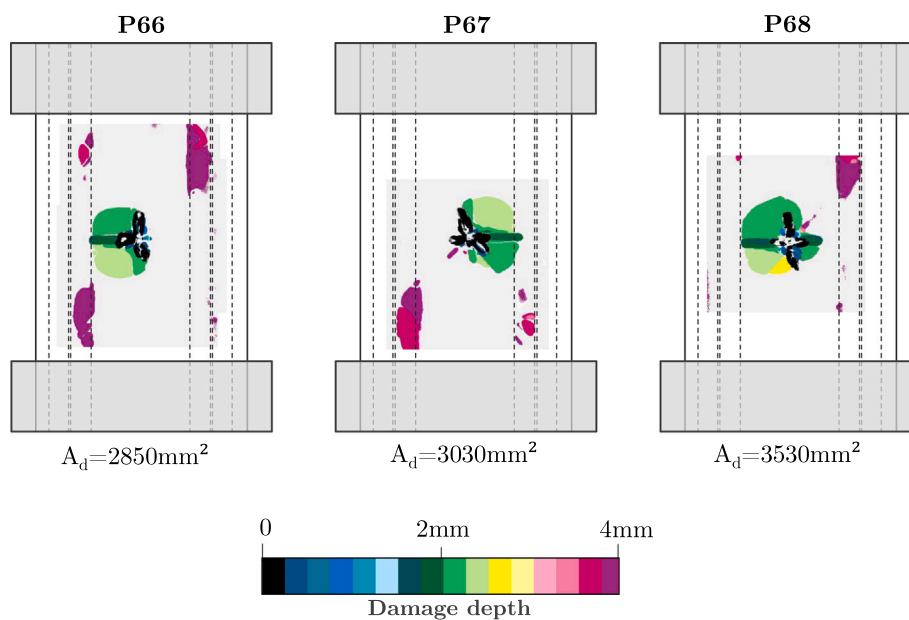
Fig. 6. Ultrasonic D-Scan results of each panel with its initial impact damage.

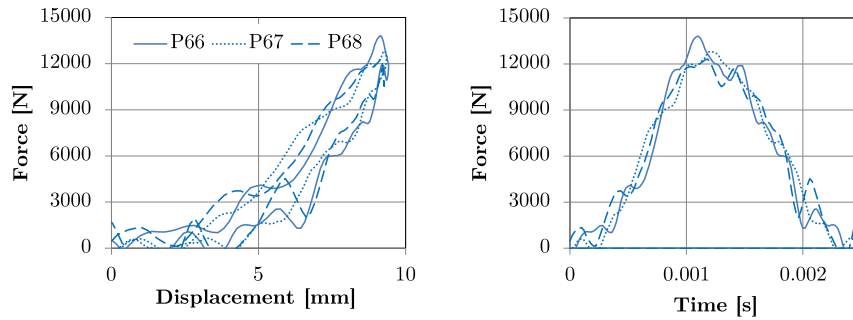
Fig. 7. Set of history curves of the 42 J impacts on the center of the substructure panels.

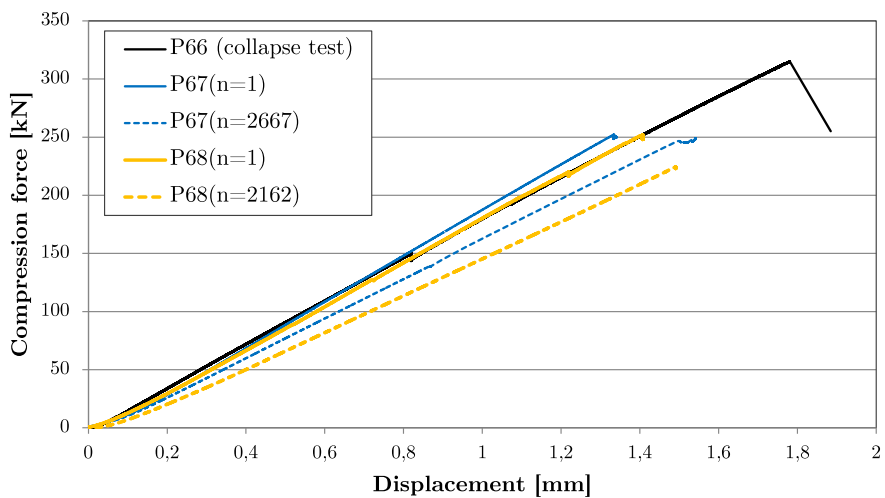
Fig. 8. Force-displacement curves of the quasi-static test of all three stiffened panels. P66 was tested until ultimate failure occurred.

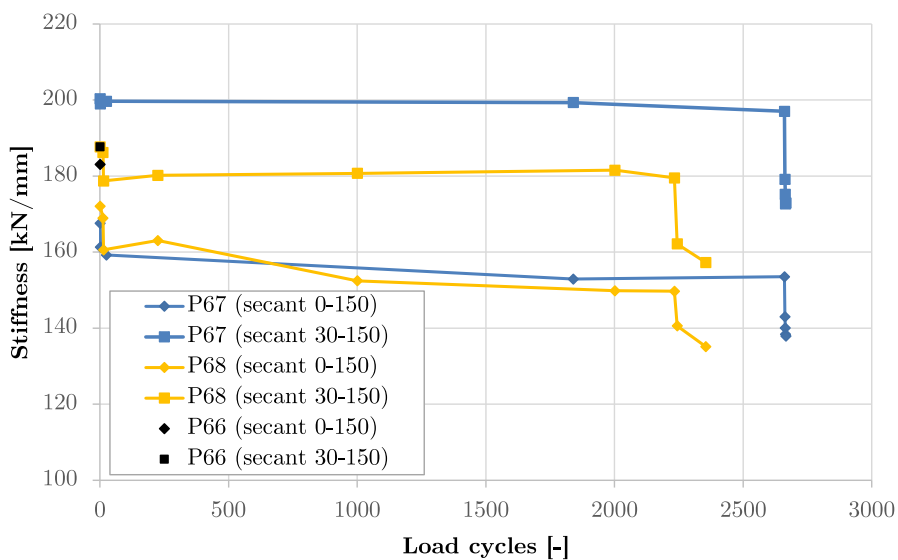
Fig. 9. Force-displacement curves of the quasi-static test of all three stiffened panels. P66 was tested until ultimate failure occurred.

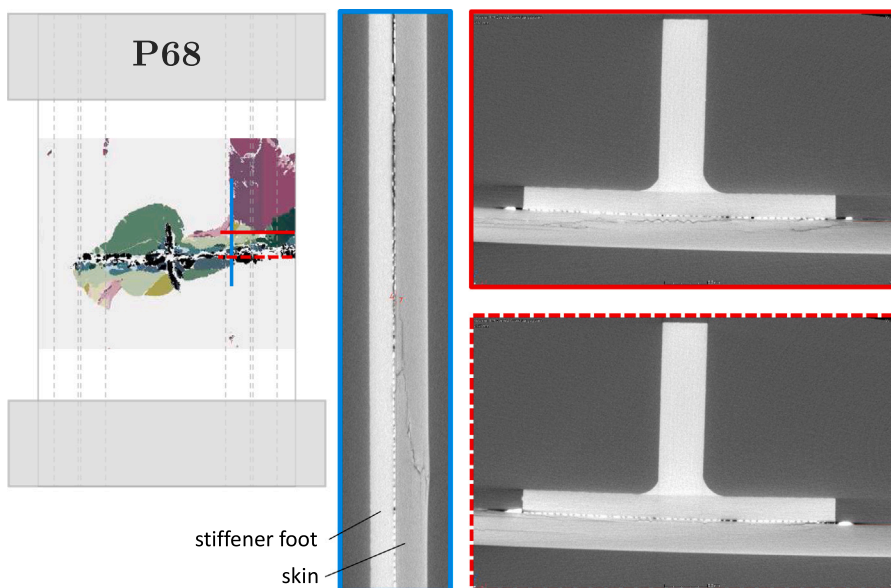
Fig. 10. CT scan of P68 after ultimate failure. The cross section images show the skin damage, the undamaged stiffener and its debonding from the skin.

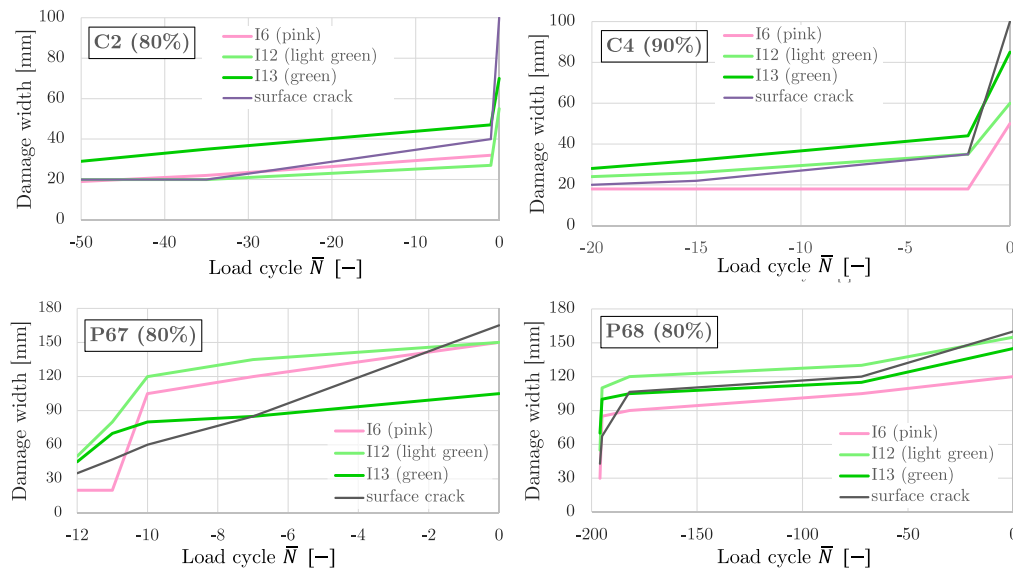
Fig. 11. Damage growth history in individual delamination interfaces and the surface crack on two exemplary coupon specimens (C2 and C4 in Fig. A.15) and the panels P67 and P68. \bar{N} refers to the number of cycles until final failure. (For interpretation of the references to color in this figure legend, the reader is referred to the web version of this article.)

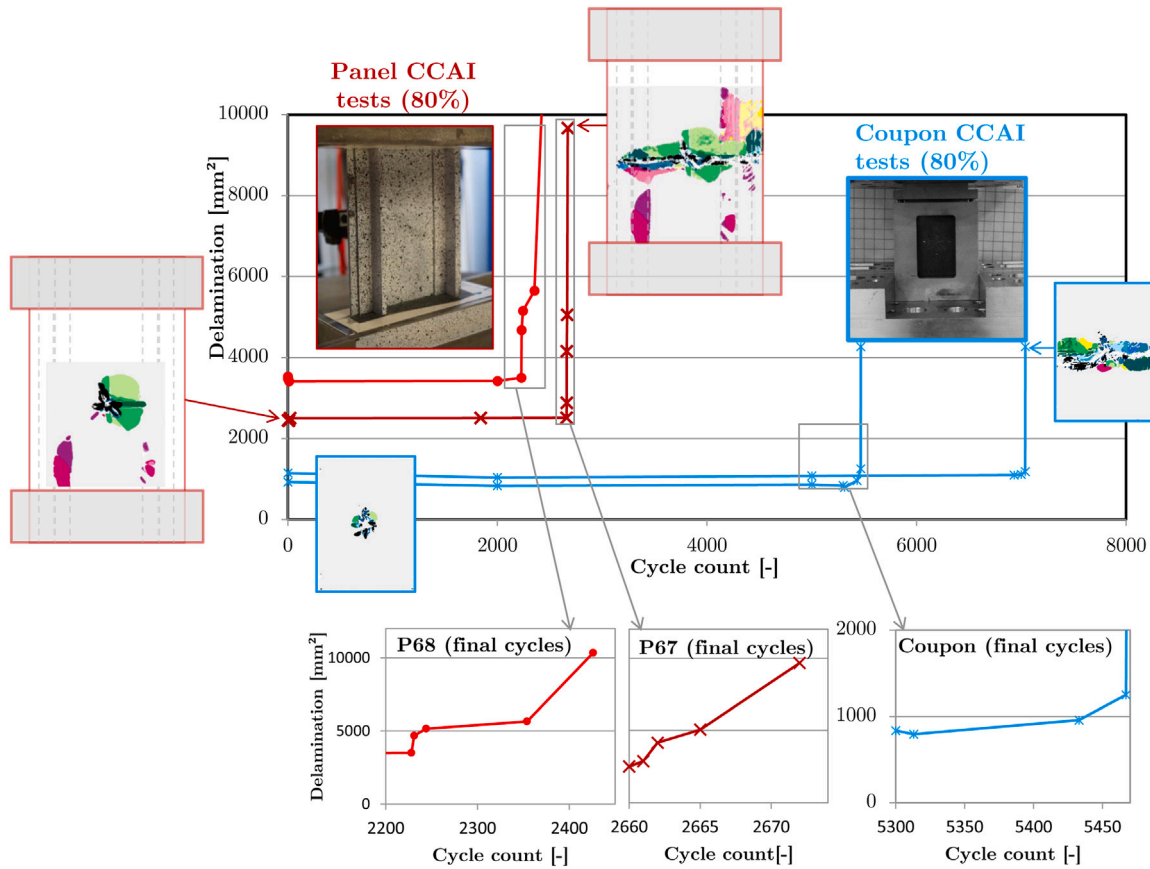
Fig. 12. Delamination growth in the stiffened panel in comparison with the analog coupon results.

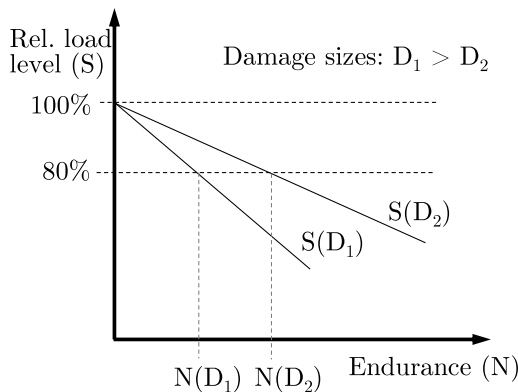
Fig. 13. Hypothesis for the influence of the damage size to the dimensionless S-N-curve (the interval until damage growth onset is considered as the endurance (N)).

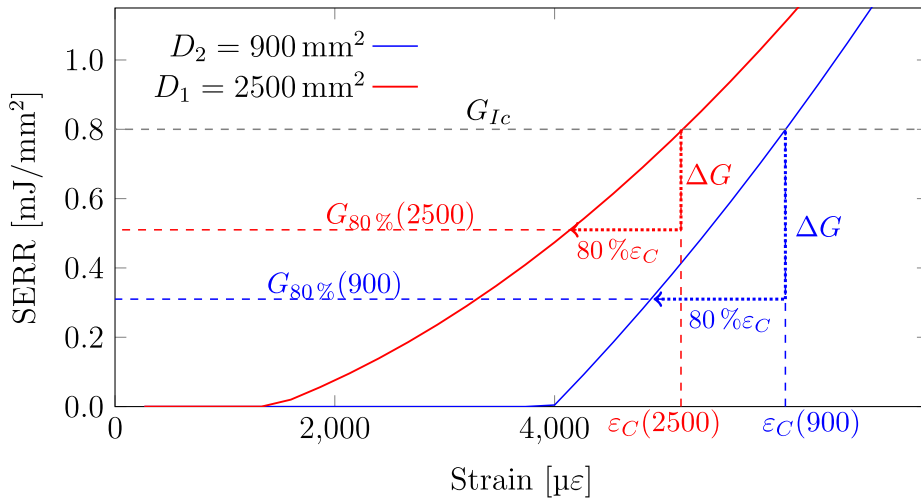
Fig. 14. Calculated ERR at the delamination front for the damage sizes observed on the coupon and on the panel.

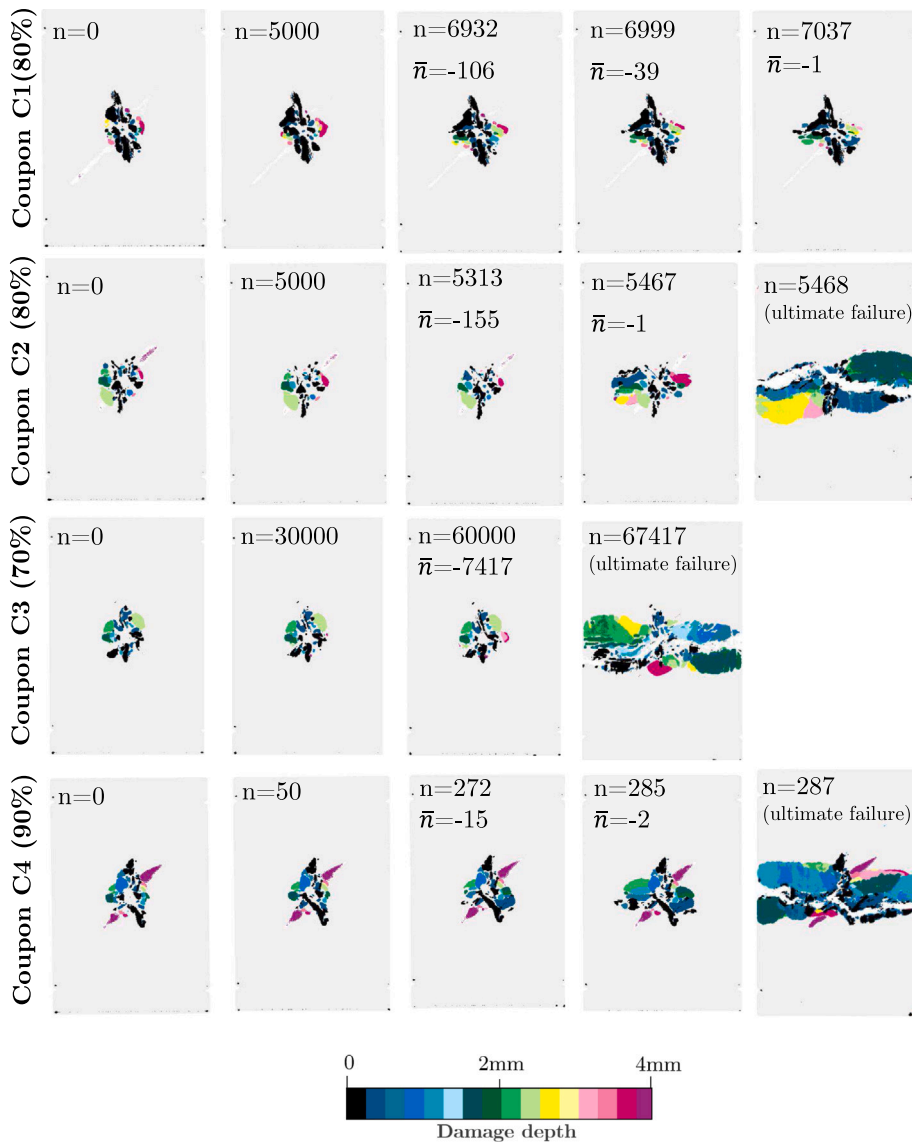
Fig. A.15. Observation of the delamination growth in the ultrasonic D-scan of four selected CCAI experiments with $100 \times 150 \text{ mm}^2$ coupon specimens (published in [16]).

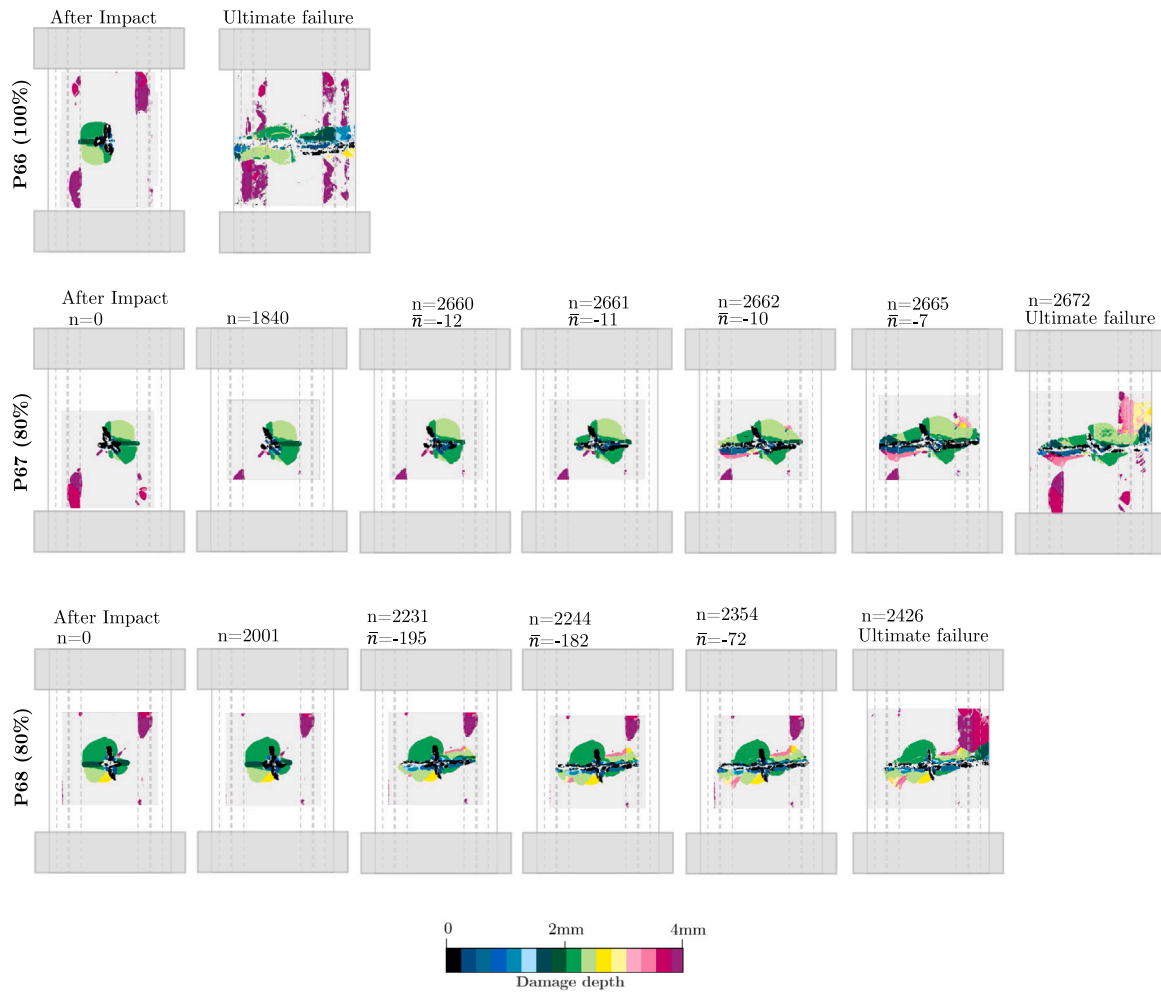
Fig. A.16. Ultrasonic D-scans of the three each panel throughout its test. Each scan is depicted in a sketch of the specimen to show the damage evolution in relation to the panel geometry. (For interpretation of the references to color in this figure legend, the reader is referred to the web version of this article.)

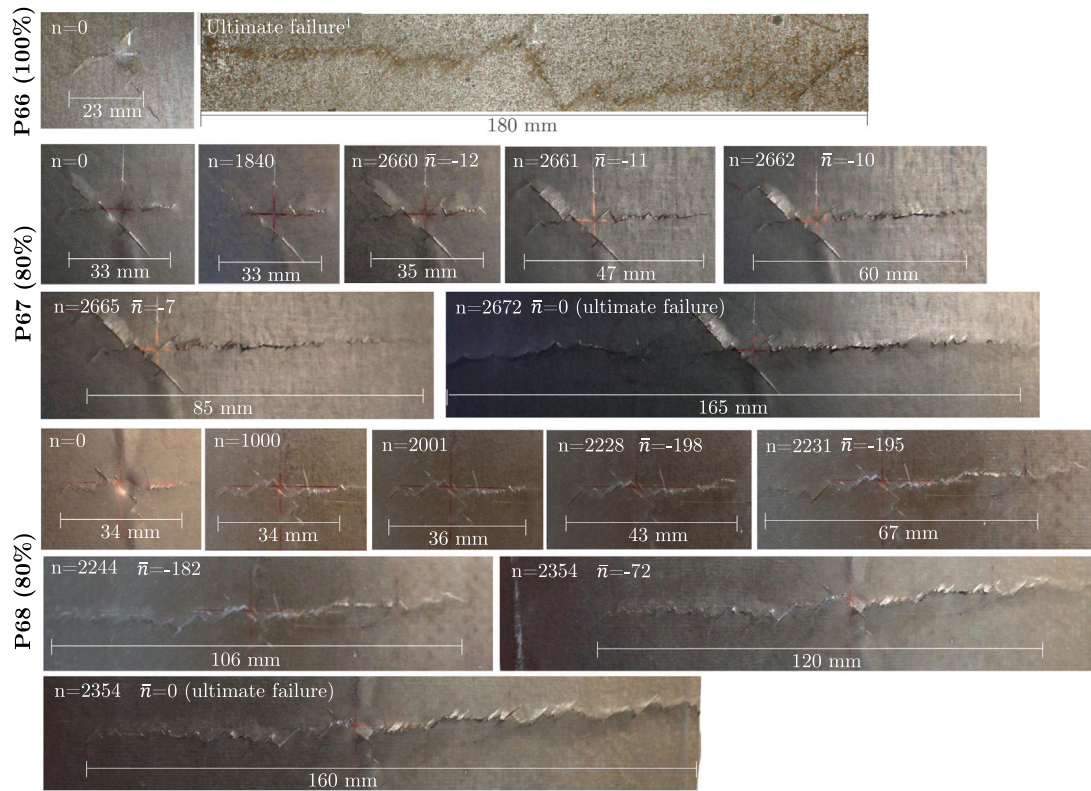
Fig. A.17. Evolution of the fiber cracking on the impact side of each panel throughout its test.¹

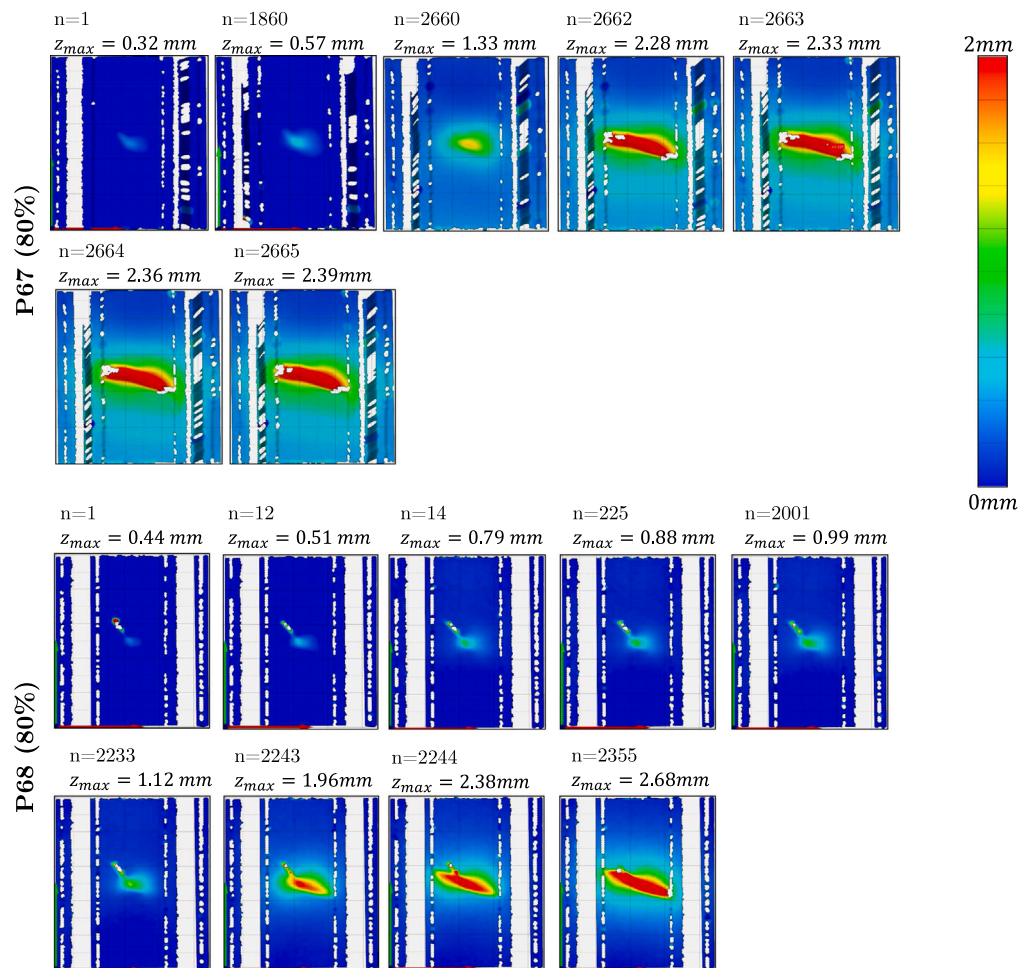
Fig. A.18. Out-of-plane displacement from the DIC measurements of the specimens P67 and P68 at the peak load (252 kN) of the quasi-static load cycles.
