Geology of Belton Reservoir Area Leon River, Bell County, Texas

By JACK COLLIGAN*

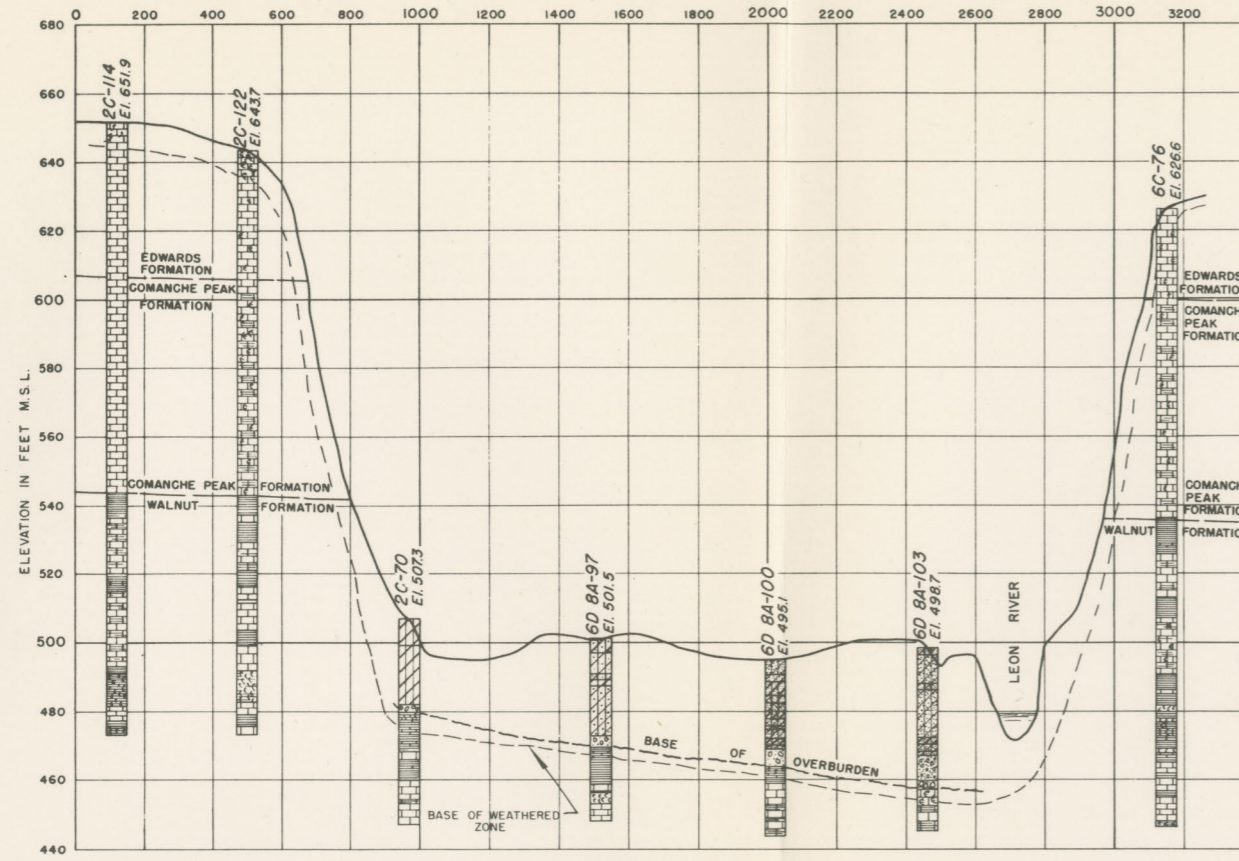
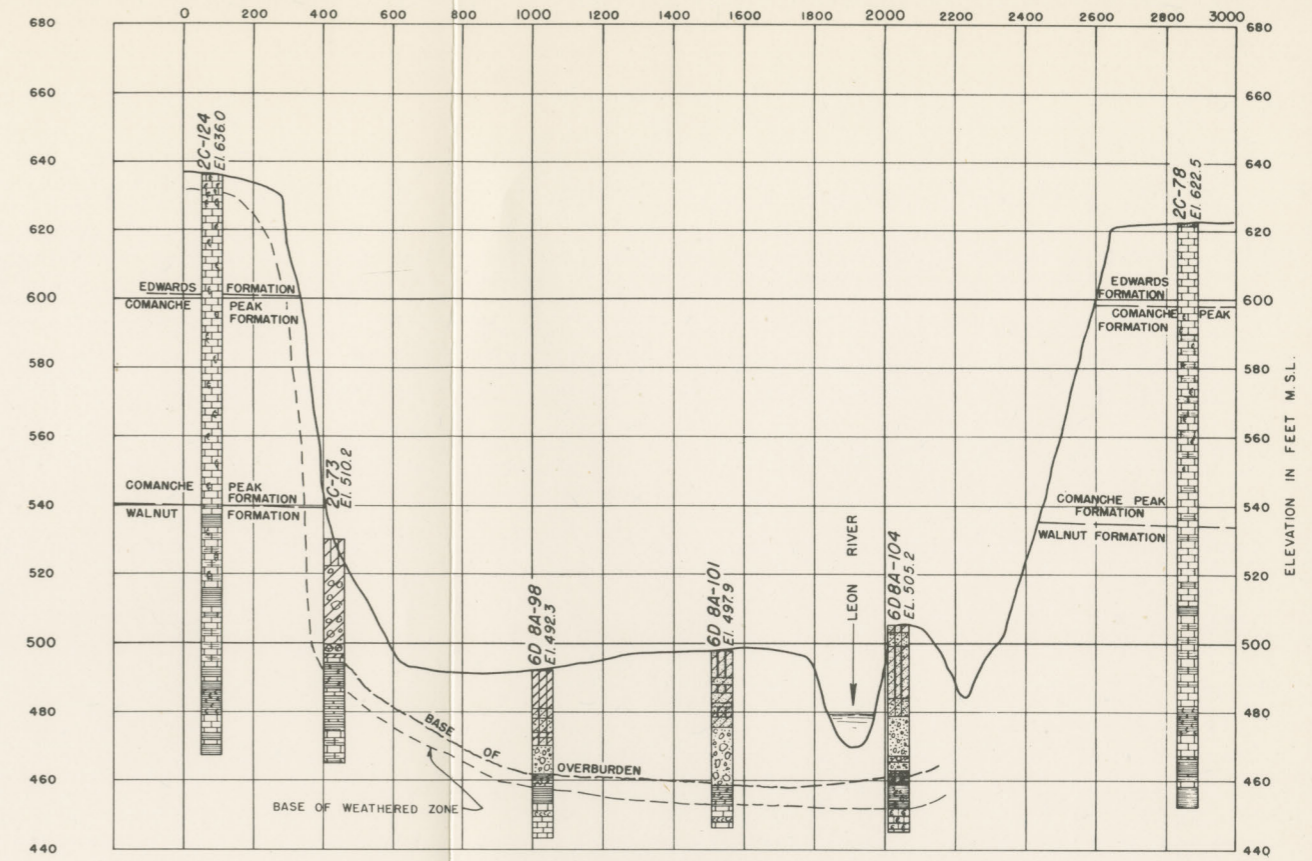
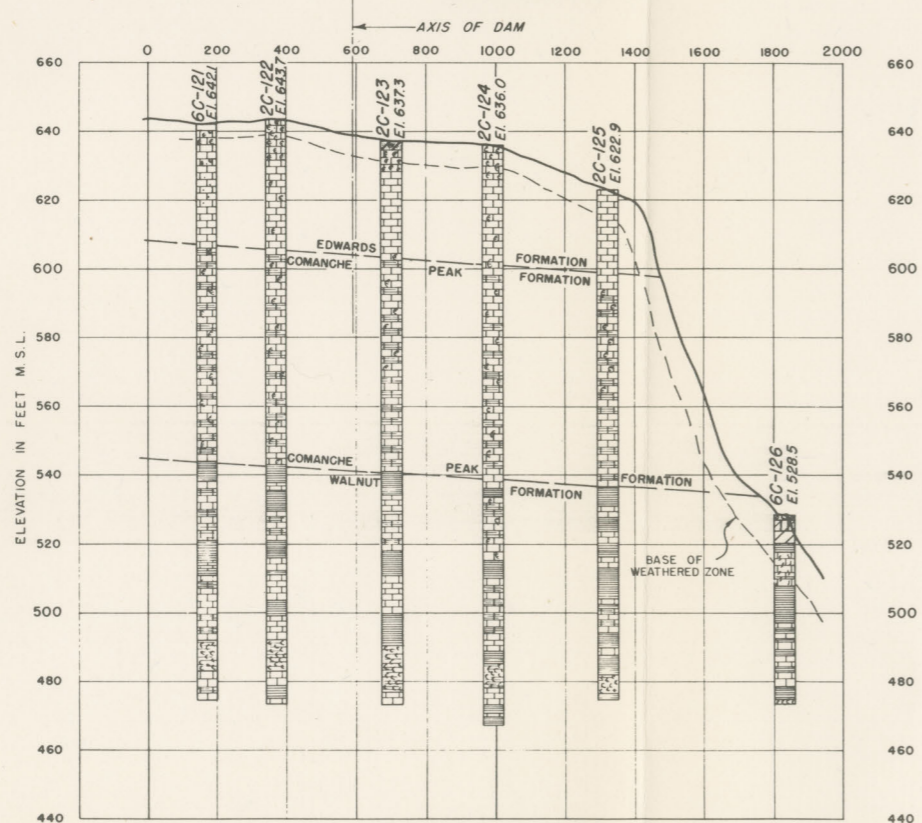
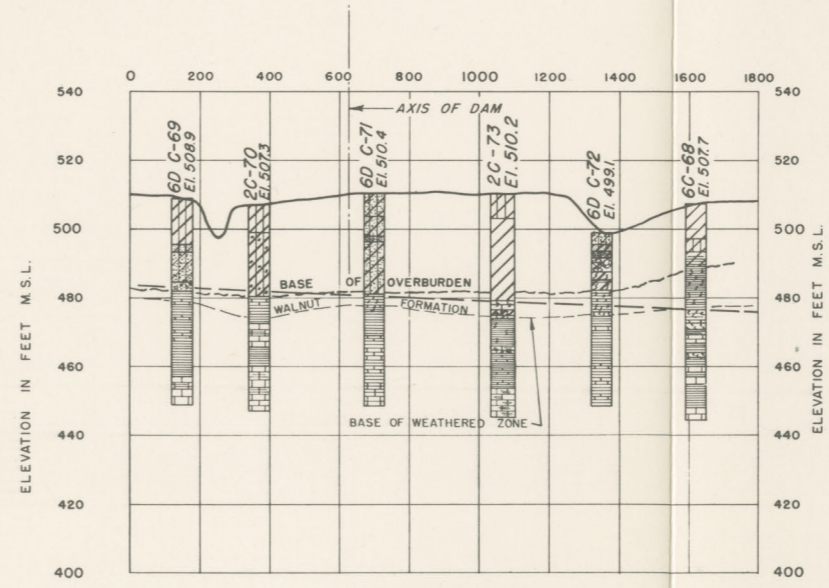
BRAZOS RIVER BASIN, TEXAS
 BELTON RESERVOIR
 LEON RIVER, TEXAS
CORE BORINGS
 GEOLOGIC SECTIONS
 DEFINITE PROJECT SITE
 SCALE AS SHOWN
 GALVESTON DISTRICT, GALVESTON, TEXAS
 TO ACCOMPANY DEFINITE PROGRESS REPORT
 FILE BRAZ 503-203 APPENDIX III PLATE 3

Analysis of the geological profiles shown on plates 3 and 4 reveal that the dip of the primary formations is towards the east at a rate of about 35 feet per mile. The geological profiles on plates 2 and 3 show that the contact between the Comanche Peak and Edwards formation outcrops on the right abutment about 5 feet higher than on the left abutment. The profiles indicate that the main portion of the dam axis nearly parallels the strike of the primary formations.

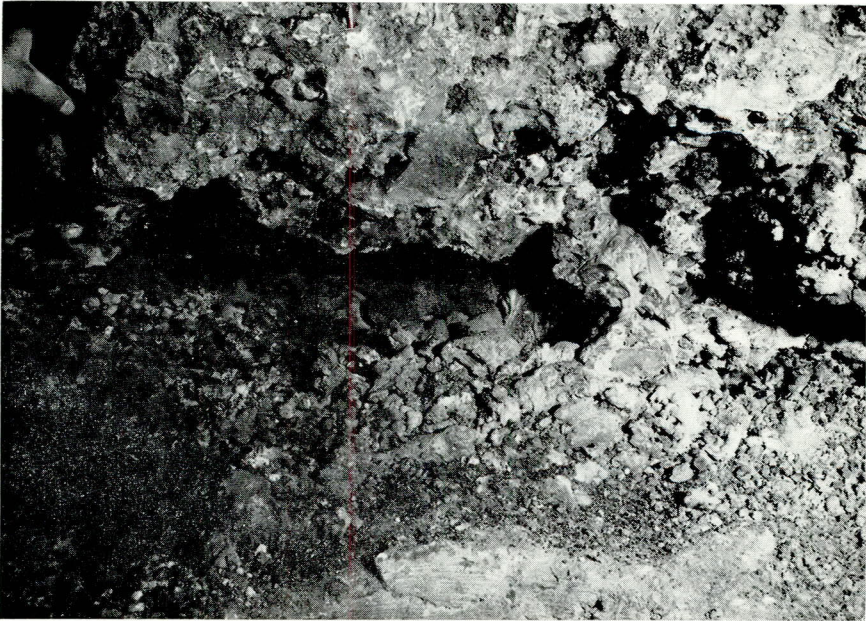
Boring No. 30C-1 was drilled where unusually poor foundation conditions were indicated by water-pressure and grout tests. A cavern was reached in this boring at an elevation of 580 feet, which extended downward to an elevation of 576.8 feet. The opening was partially filled with clay and grout as well as typical calcareous cavern deposits. The boring was continued from an elevation of 576.8 feet to 552 feet with a 6-inch bit and the core showed grout filled cavities from elevations of 563.2 feet to 558.3 feet, indicating the zone of grout penetration in the grout test on boring No. 2C-61. Borings 30C-2 and 30C-3 were drilled 100 feet south and west, respectively, of boring 30C-1 and reached the cavernous zone at approximately the same elevation as in boring 30C-1. The cavernous zone was explored by cleaning out cavern deposits for a distance of 100 feet southwest from 30C-1. At this point, the cavern branched to the south and west for a distance of at least 50 feet in each direction. Examination of the cavern upon completion of clearing operation revealed that numerous small solution channels and openings lead off from the main opening. These laterals were observed to extend a considerable distance from the main cavern. All observations in the areas indicate that the openings are irregular, extensive, and inter-connected, and that a large amount of leakage would take place through the strata in which solution has taken place. Smoke generated at the bottom of boring No. 30C-1 vented from both the other 30-inch borings. Views of the cavernous condition of the foundation encountered in boring 30C-1 are shown on plates 20 and 21.

Fig. 1. Exposed cavern in wall of core boring 30C-1 at elevation 577.0 in left abutment.

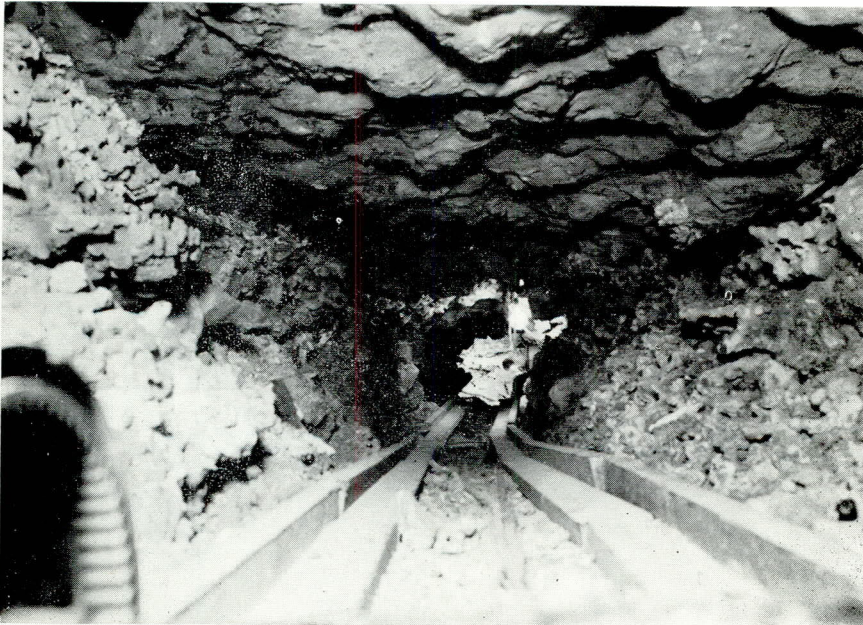
Fig. 2. Mucked-out cavern (total length about 100 feet) extending southwesterly from boring 30C-1.

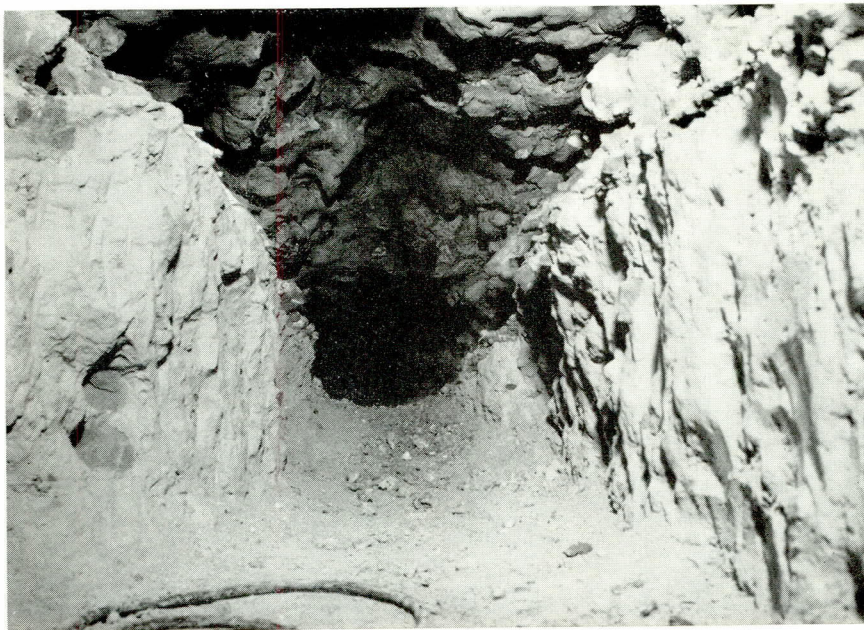
Fig. 1. End of mucked-out cavern beyond which two solution channels extend approximately 50 feet.

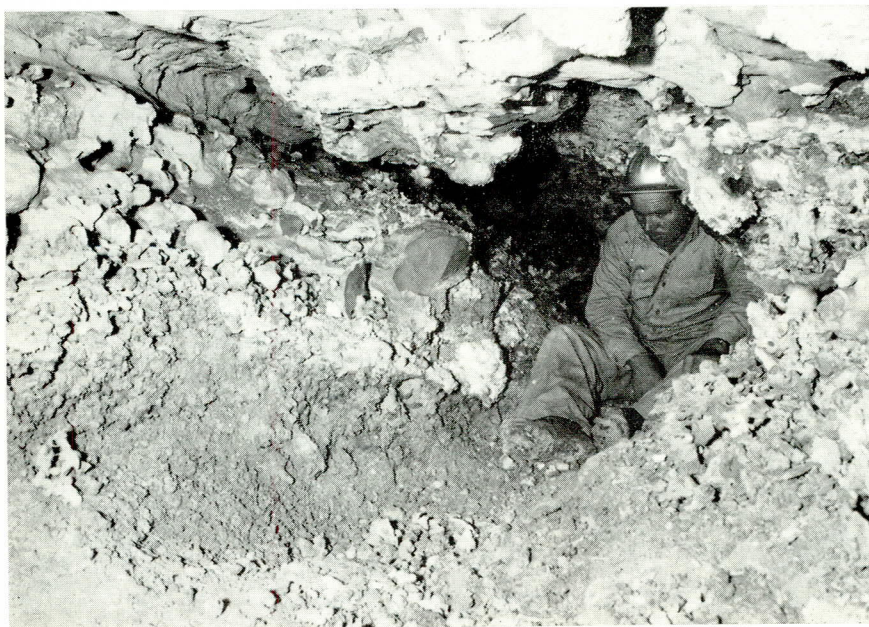
Fig. 2. Partly mucked-out solution channel at end of mucked-out cavern.
