# EMERGING TECHNOLOGIES

## Infrared Inspection

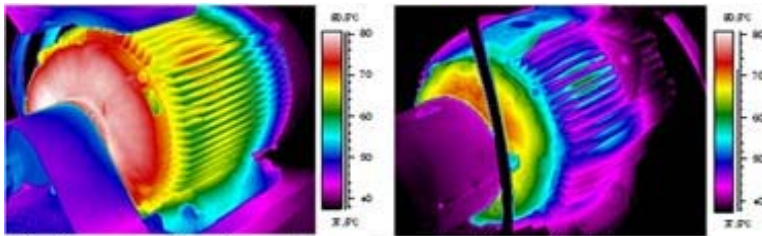
When comparing these two motors, the thermal patterns are similar, but the motor on the left has a markedly higher overall temperature. *Image courtesy of the Academy of Infrared Thermography*

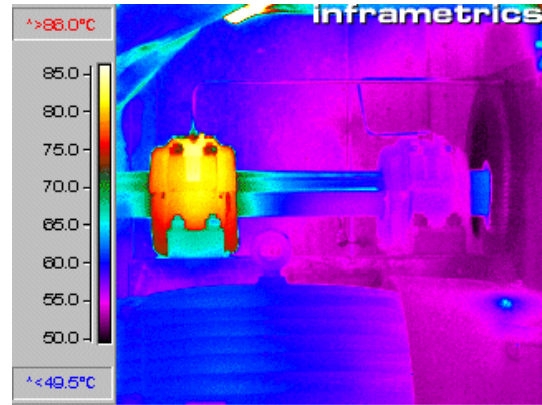
Two bearings under the same load conditions. One bearing is significantly warmer (~30 degrees Celsius) than the other. *Image Courtesy of Snell and Inframetrics*

Excessive heat and bearing failure is caused by friction due to misalignment, improper lubrication, lack of lubrication, contamination of lubrication, or excessive loading.

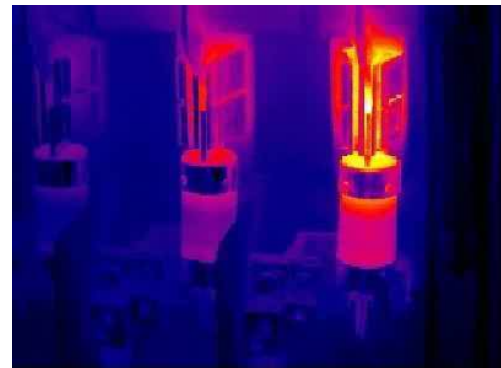
Overheated fuse. Could be caused by a poor connection or the fuse failure. *Image courtesy of the Academy of Infrared Thermography.*

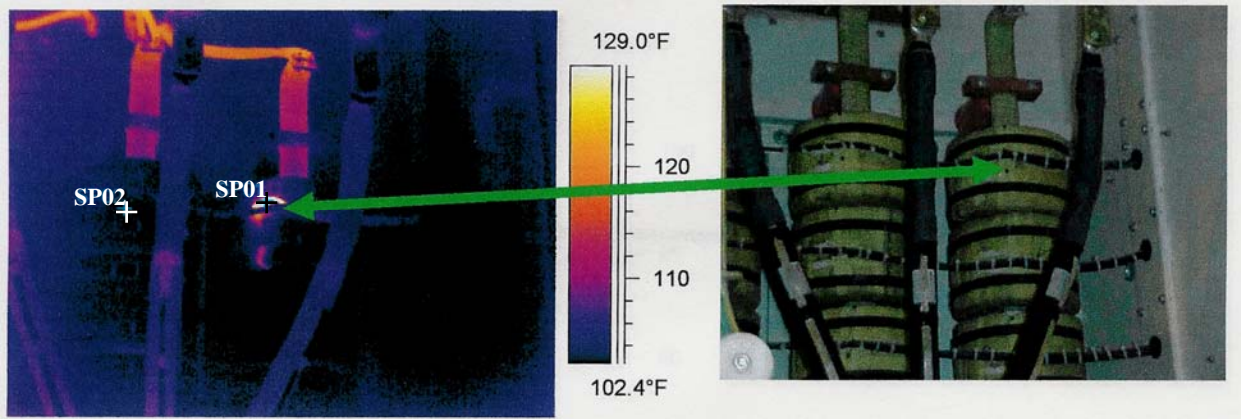
### Anomaly 1. Hot “A” phase CT connection

Anomaly on a hot “A” phase CT connection. The arrow indicates the same spot on both images for reference. These images were obtained from an MWD infrared inspection report. The temperature scale between the images is set by the report writer and does not represent the full range of temperatures in the infrared image.

The first anomaly was found in the main connection panel for one of the pump motors. An infrared camera was used to inspect the panel. The anomaly, labeled as SP01, can be seen in the figure above. It was identified by comparing the two pieces of similar equipment at the same approximate location (SP01 and SP02 in the figure). The temperature at SP01 is 161.9°F and the temperature at SP02 is 102.3°F (differential of 59.6°F). The temperature differential was significant enough to warrant a recommendation of “Should be repaired as soon as possible.” In a priority scale of A-D where priority A warrants immediate repairs, this is a priority B.

According to Mr. Putnam, if this CT connection were to fail the motor would continue to be operational. However, it would have to be operated manually without the variable frequency drive. Since the problem was identified before any damage occurred, the CT connection can be cleaned and retested when the motor is out of scheduled operation (during the off-season) and probably will not need to be replaced.

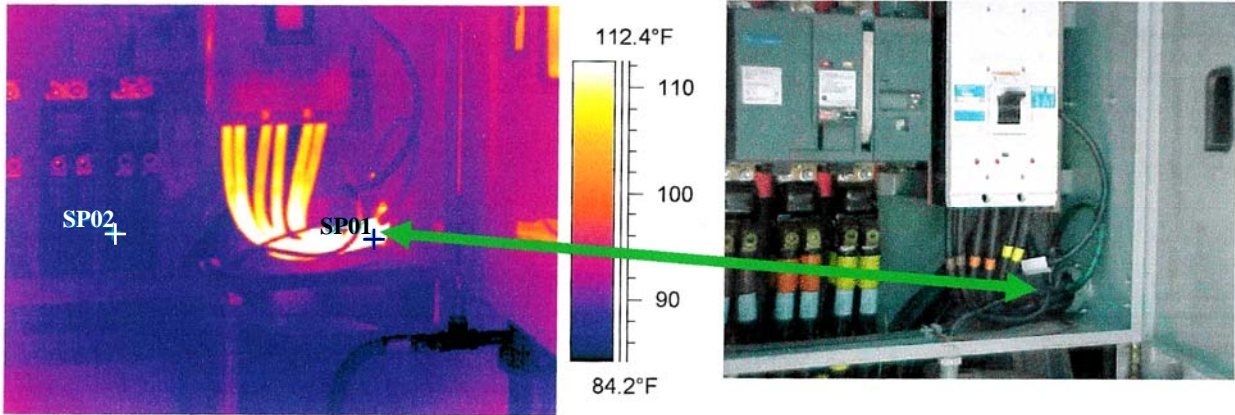
### Anomaly 2. Possibly undersized cables to load bank.

Possibly undersized cables in a main breaker panel. The arrow indicates the same spot on both images for reference. These images were obtained from an MWD infrared inspection report. The temperature scale between the images is set by the report writer and does not represent the full range of temperatures in the infrared image.

breaker panel are significantly hotter than the rest of the panel. In this case the investigator did not have similar equipment with which to compare the anomaly. Instead, the anomaly was compared to a spot in the panel. In this case, as in many others, it is difficult to determine if the heat generated in the cables is normal under the load. The temperature of SP01 was 141.3°F and SP02 was 87.2°F (differential of 54.1°F).

Because these cables are on an emergency stand-by generator, the problem may never escalate because the generator may never be used. However, if it is necessary to use the

generator and the cables fail, the result would be catastrophic. All equipment using this generator would also fail. Further damage, besides the cables melting, would be likely to occur. Fire or excessive heat could damage much of the equipment in the main breaker panel, as well as creating a risk of human injury.

Nevertheless, the experienced investigator set a repair priority of B (Should be repaired as soon as possible), with a recommendation that the cable sizes be verified for the load requirement and replaced if necessary.

Because of preventative maintenance, the cables will be further inspected and replaced if necessary with no downtime to the facility and without replacing any other equipment in the main panel.

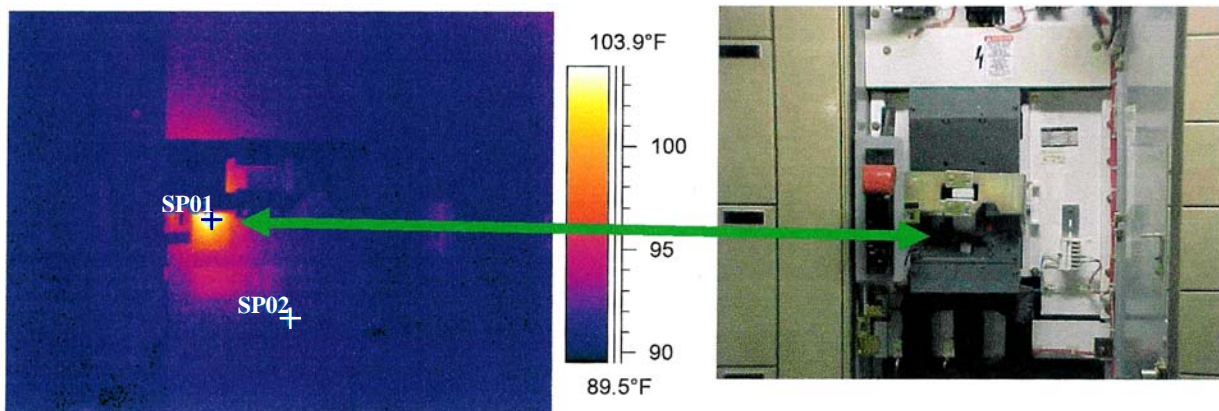
### **Anomaly 3. Warm “A” phase breaker contact.**

The figure below shows a breaker contact that was warmer than the surrounding equipment. SP01 had a temperature of 104.3°F

Warm breaker connection. The arrow indicates the same spot on both images for reference. These images were obtained from an MWD infrared inspection report. The temperature scale between the images is set by the report writer and does not represent the full range of temperatures in the infrared image.

and SP02 had a temperature of 91.7°F (differential of 12.6°F). In this case the breaker contact was faulty and warranted replacement of the breaker. Because of the relatively small temperature differential, the investigator gave a repair priority of C (Should be attended to at first priority).

If this problem were not repaired, over time the connection would continue to increase in temperature, possibly damaging additional equipment and hampering the effectiveness of the breaker itself. Instead, the breaker can be replaced at the facility's scheduled downtime without difficulty.

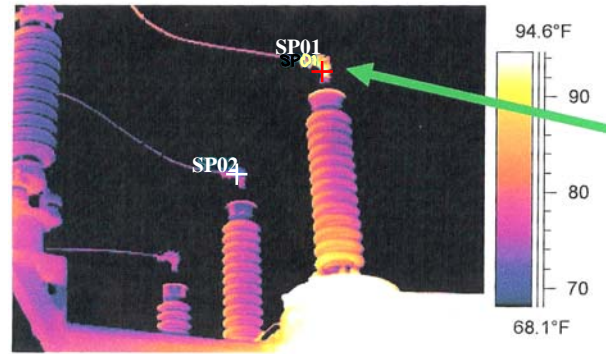
#### **Anomaly 4. Warm "A" phase cable-to-bushing connection.**

The final anomaly at the facility was on one of the facility's transformers. This is not a typical piece of equipment for a water agency to maintain, but it is interesting how a problem that could potentially be very expensive if allowed to develop could be prevented with early detection and minor cleaning. Most heat anomalies that occur at electrical connections can be solved with very minor, inexpensive maintenance. However, if they are allowed to run their course, the damage could be enormous.

In this case, the connection in the figure at SP01 had a temperature of 93.2°F and the temperature at an identical connection at SP02 was 72.2°F (differential of 21°F). Mr. Putnam estimated that catastrophic damage probably would not have occurred for another 10-15 years because of this problem. The investigator gave a repair priority of C (Should be attended to at first priority), with the recommendation to clean the connection and retest.

If the problem was not repaired, it is possible that the entire transformer could have been damaged, causing tens of thousands of dollars in damage just because of a faulty connection that needed cleaning.

Warm "A" phase cable-to-bushing connection on main transformer. This image was obtained from an MWD infrared inspection report. The temperature scale is set by the report writer and does not represent the full range of temperatures in the infrared image.
