# Bulli Pass Landslide Risk Management Part 1 - Hazard Assessment

# BULLI PASS LANDSLIDE RISK MANAGEMENT PART 1 - HAZARD ASSESSMENT

#### Andrew Hunter<sup>1</sup>, Phil Flentje<sup>2</sup> and Alan Moon<sup>3</sup>

<sup>1</sup>GHD, Sydney; <sup>2</sup>University of Wollongong ; <sup>3</sup>Engineering Geologist, Adelaide https://doi.org/10.56295/AGJ5735

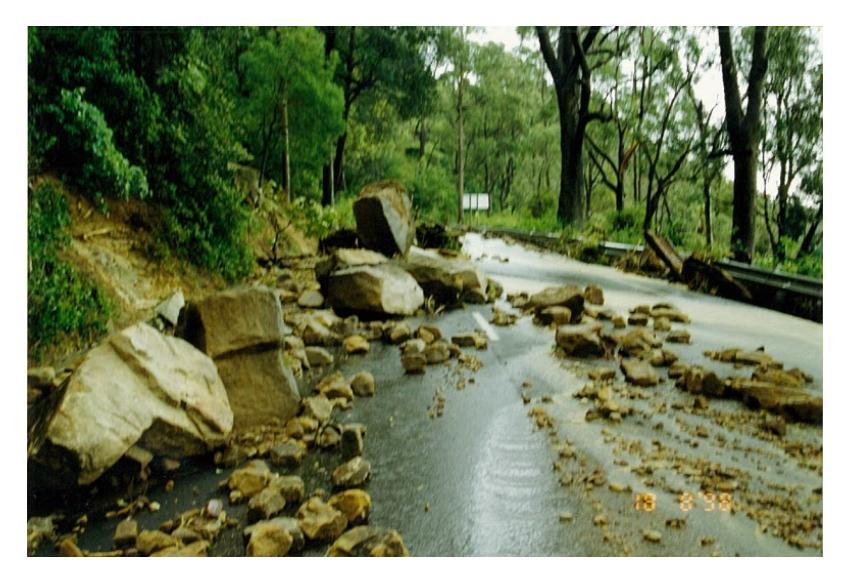
The debris flows also led to side fill failures of the road downslope of the pavement due to scouring and overland flow of channelled water. Several sections of the downslope guard rail were left hanging in the air due to the loss of the shoulder. Numerous rock falls also occurred, some of which impacted vehicles. The largest of the rock falls had dimensions of up to about 2 m across. The rock falls directly impacted many vehicles, including an ambulance, smashing windscreens and windows. Remarkably, these incidents did not result in any loss of life. Because the road was impassable, people had to be rescued on foot, with some people found clinging to the rooves of vehicles. The pass was closed by about 7 pm on 17 August and did not reopen for a number of days, whilst all the debris was removed and new guard rails were installed.

Figure 14: Bulli Pass early morning of 18 August 1998 (TfNSW)

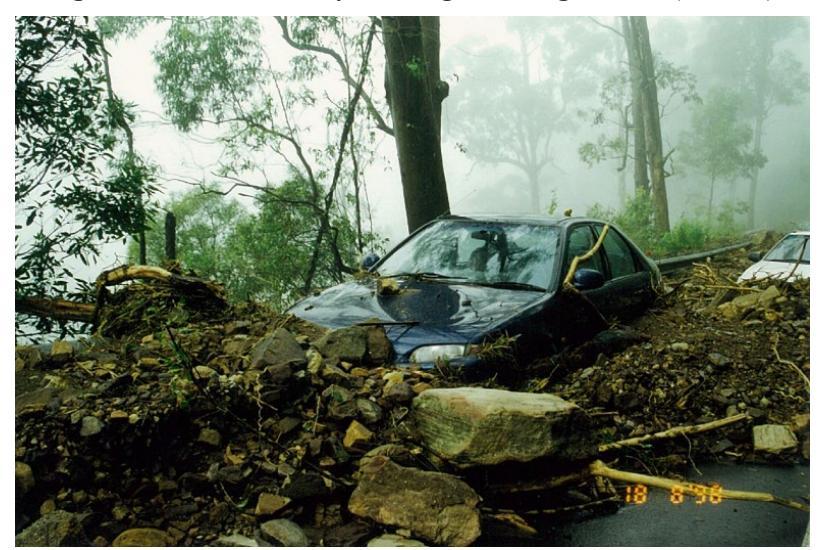
Figure 15: Bulli Pass early morning of 18 August 1998, two inundated and abandoned cars (TfNSW)

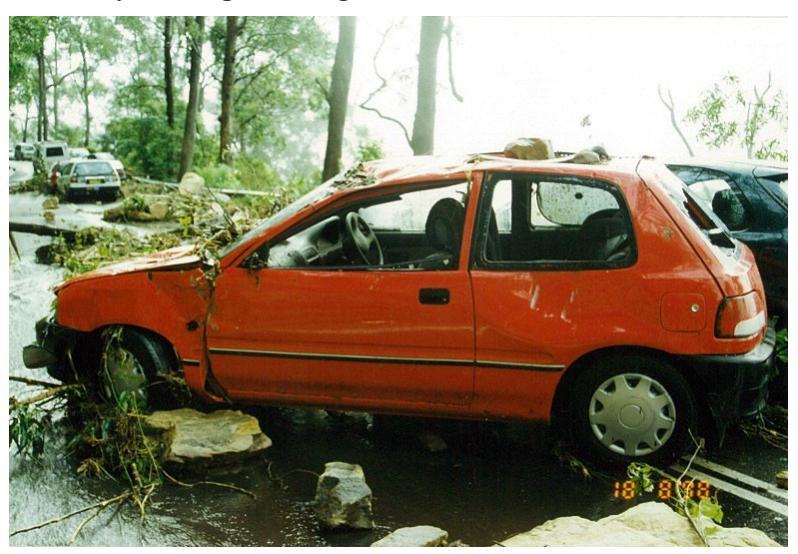
Figure 16: Bulli Pass early morning of 18 August 1998, note smashed car windows, rocks on roof and stranded vehicles in distance (TfNSW)

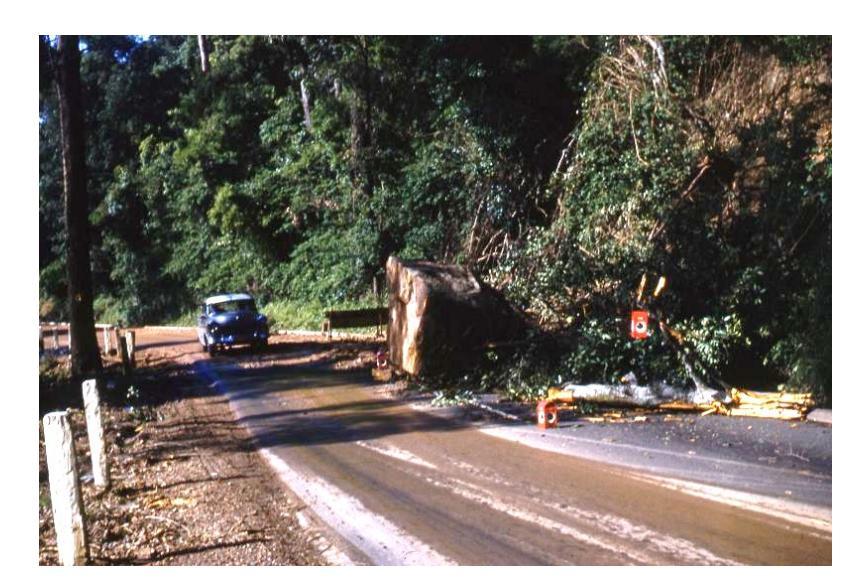
Figure 17: 'Large' sized rockfall, November 1961 (Wollongong City Libraries)

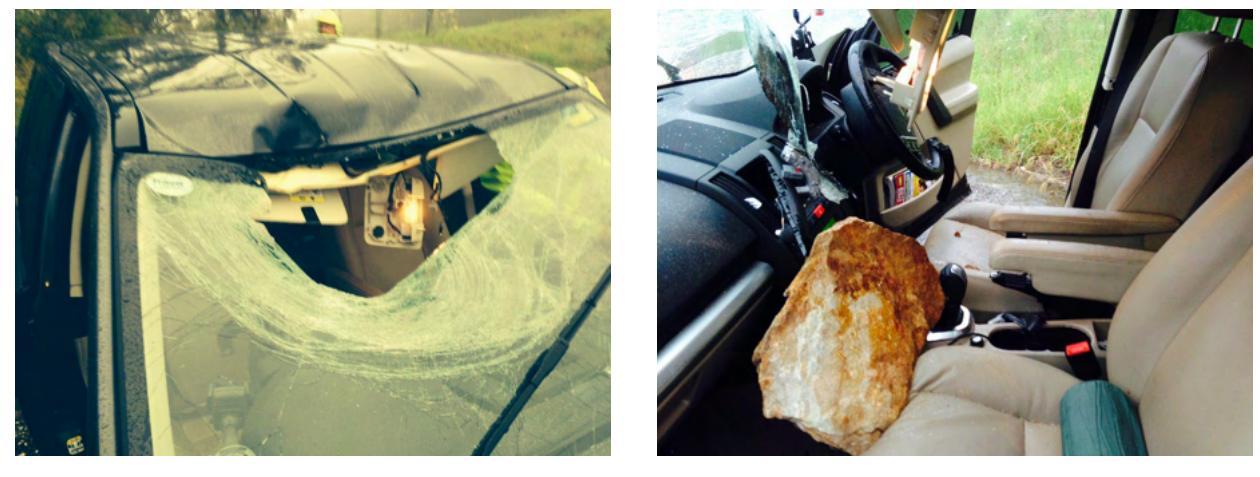
Figure 18: (a) Windscreen and roof damage to vehicle from 'Very Small' 28 January 2015 rockfall, (b) Damage to vehicle interior and subject rock.
