Damage localization on CFRP composites by electrical impedance tomography

Helena Rocha^{a,b,*}, Christophe Fernandes^c, Nelson Ferreira^c, Ugo Lafont^d, João P. Nunes^a

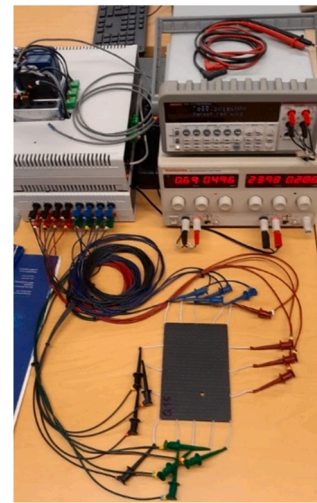
Fig. 3. Electrical impedance tomography equipment.

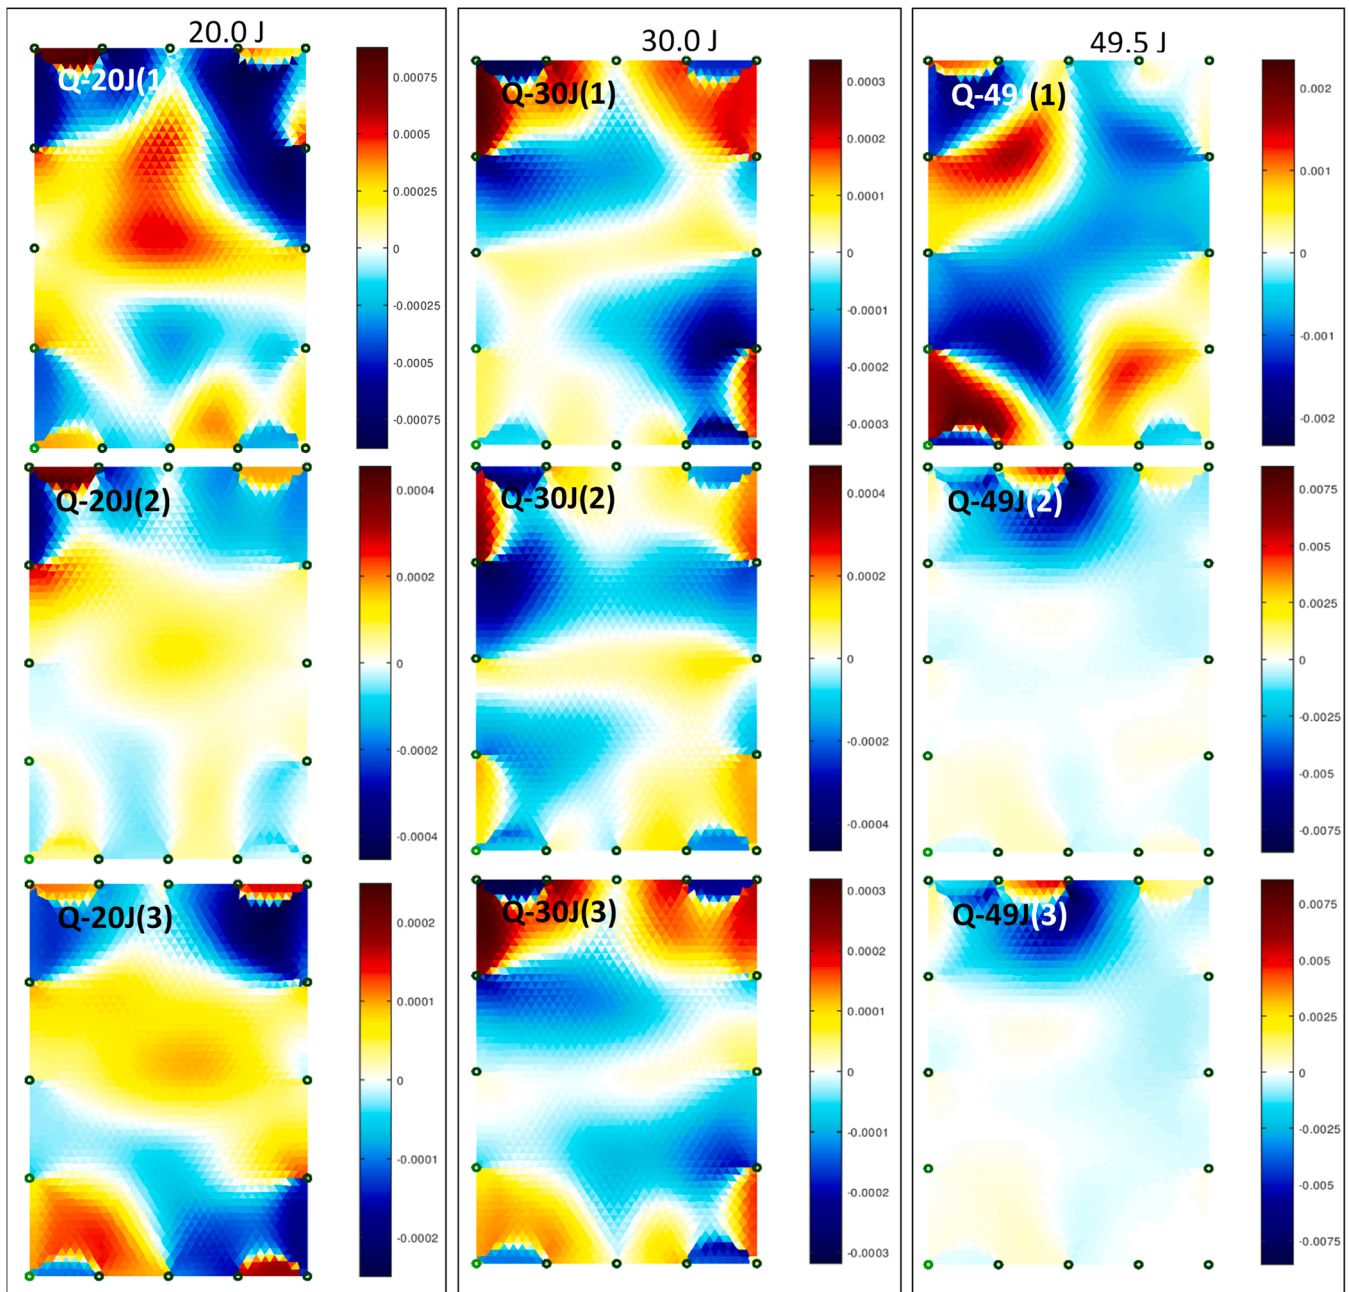
Fig. 7. Reconstructed EIT images using GN algorithm of different quasi-isotropic composite specimens exposed to drop-weight impact events with impact energies of 20.0 J (left), 30.0 J (middle), and 49.5 J (right). The green dots represent the connection points of each electrode.

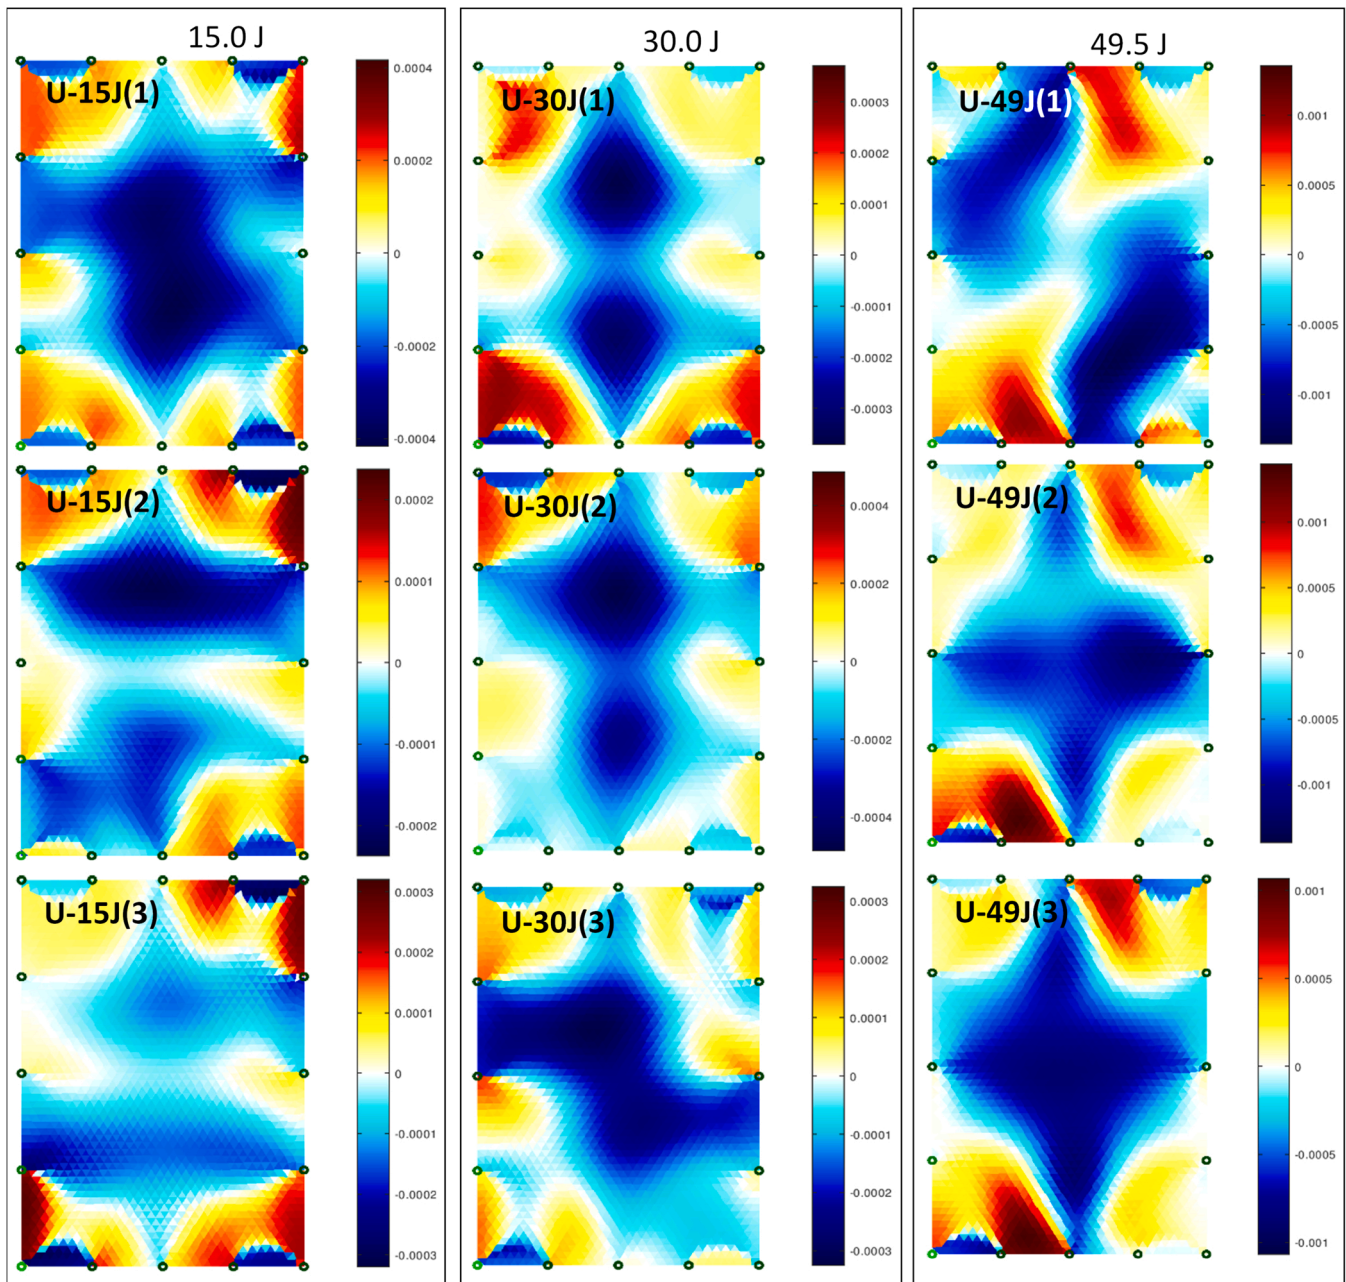
Fig. 8. Reconstructed EIT images using GN algorithm of different unbalanced composite specimens exposed to drop-weight impact events with impact energies of 15.0 J (left), 30.0 J (middle), and 49.5 J (right). The green dots represent the connection points of each electrode.

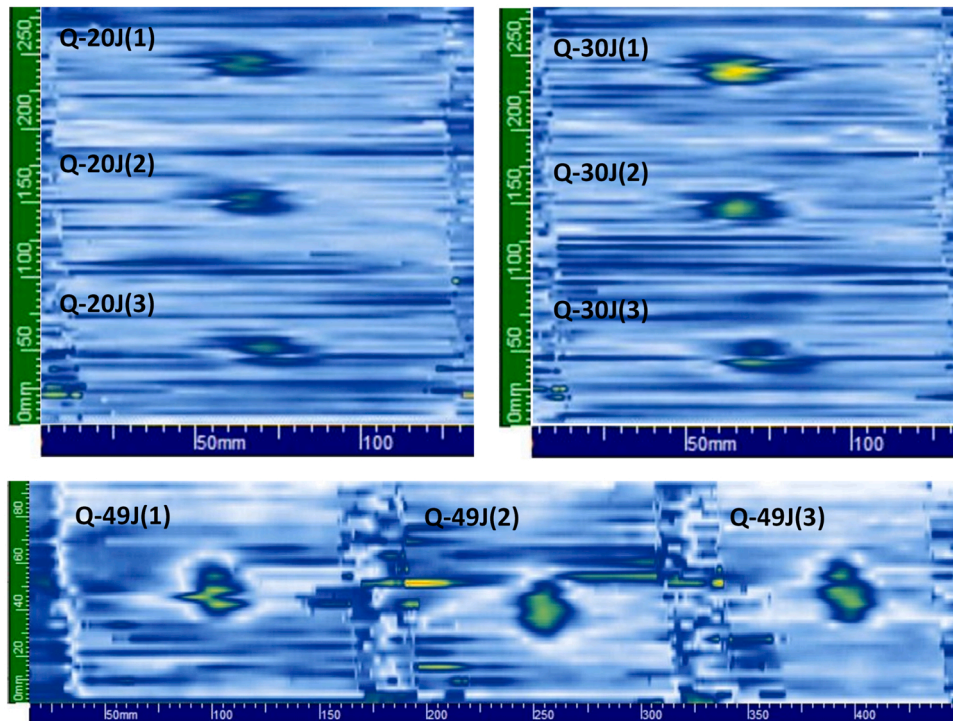
Fig. 9. Ultrasonic C-scan inspection of quasi-isotropic composite specimens exposed to drop-weight impact events with impact energies of 20.0 J (top left), 30.0 J (top right), and 49.5 J (bottom).

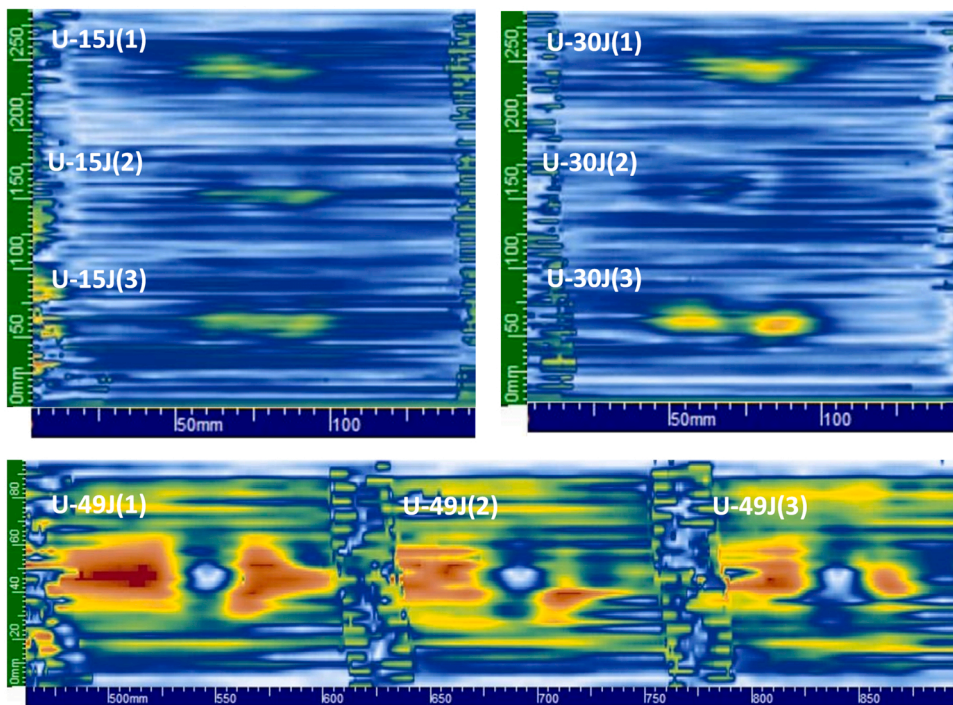
Fig. 10. Ultrasonic C-scan inspection of unbalanced composite specimens exposed to drop-weight impact events with impact energies of 15.0 J (top left), 30.0 J (top right), and 49.5 J (bottom).
