# IOMAC'13

5<sup>th</sup> International Operational Modal Analysis Conference 2013 May 13-15 Guimarães - Portugal

# EXPERIMENTAL MODAL IDENTIFICATION OF AN EXISTENT EARTHEN RESIDENTIAL BUILDING

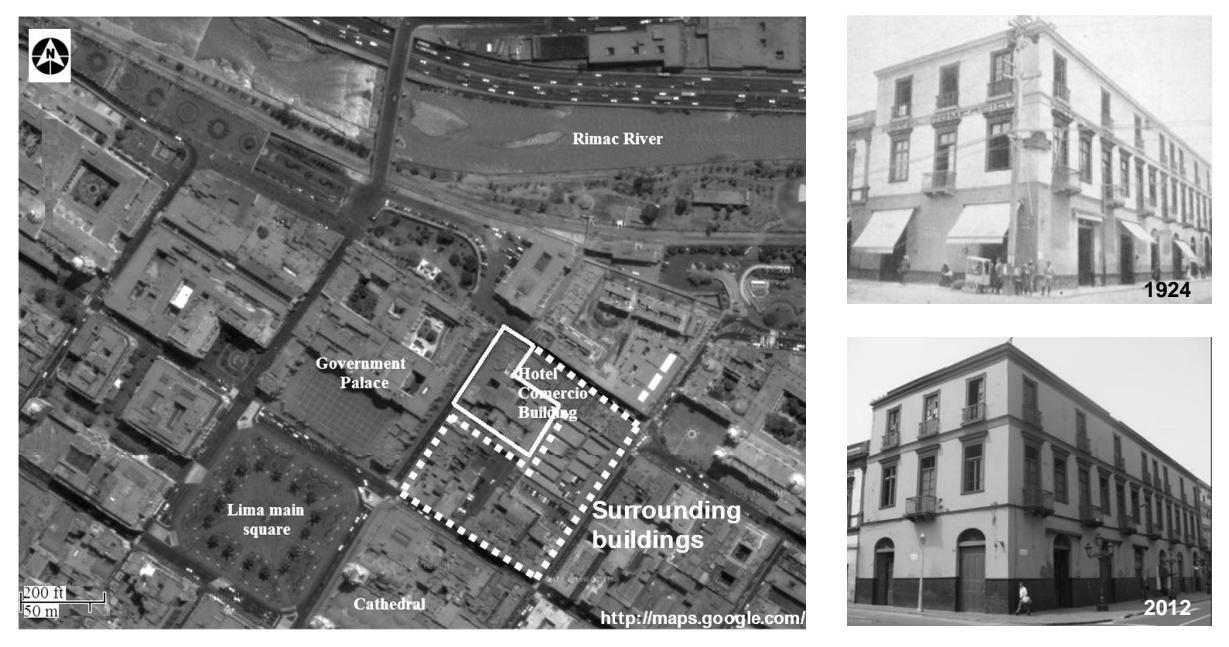
Figure 1 Location and general views of the Hotel

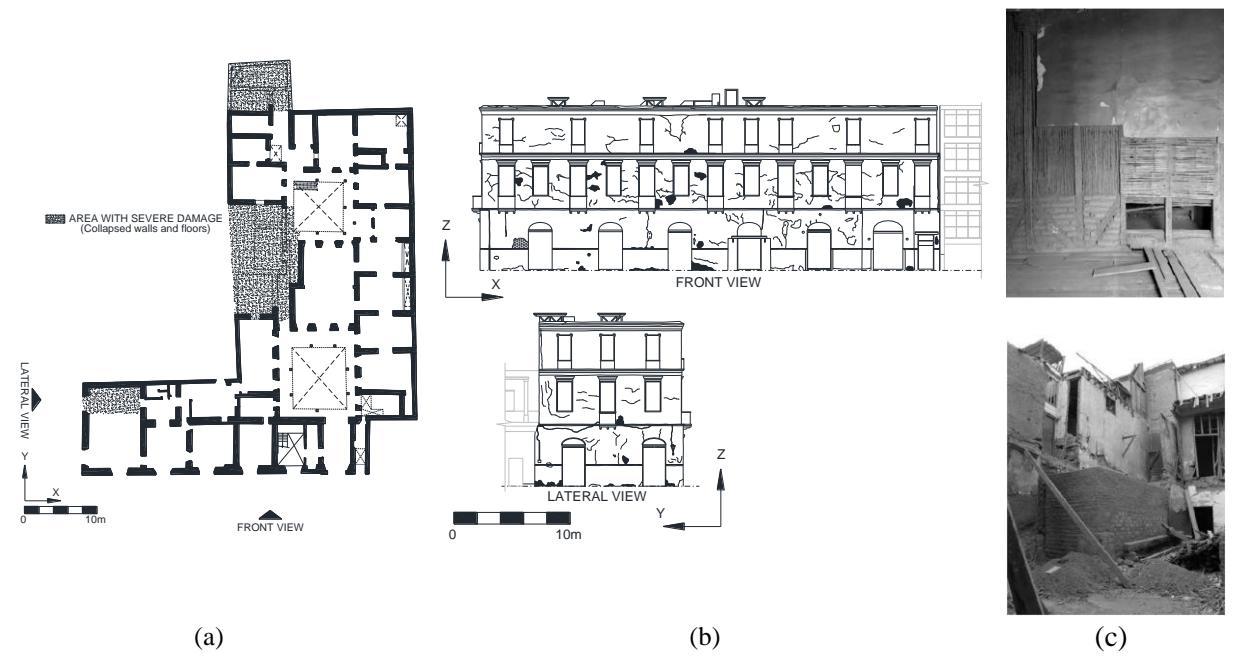
In the last years, severe damage has evidenced in the building due to the occurrence of small-medium earthquakes, the unused condition, and the lack of conservation and preservation works. Figure 2 presents a general overview of the damage condition of the building. As shown, even in the façade walls, which receive a continuous treatment of re-plastering and re-painting for the aesthetic of the Lima's Historical Centre, light pattern of cracks and some humidity marks are visible (see Figure 2b). The condition of these walls does not reflect the actual situation of the building since inside there are zones with collapsed walls, floors, corridors, and stairs (see Figure 2a and Figure 2c). In general, the plaster of large zones of walls inside is in bad condition (some walls has not plaster any more) which causes problems of humidity in the walls, and deterioration of the wood and canes.

Figure 3 Damage condition of the building: (a) plant view of the first floor [adapted from 2]; (b) elevation view of the front façades [adapted from 2]; and (c) interior of the building

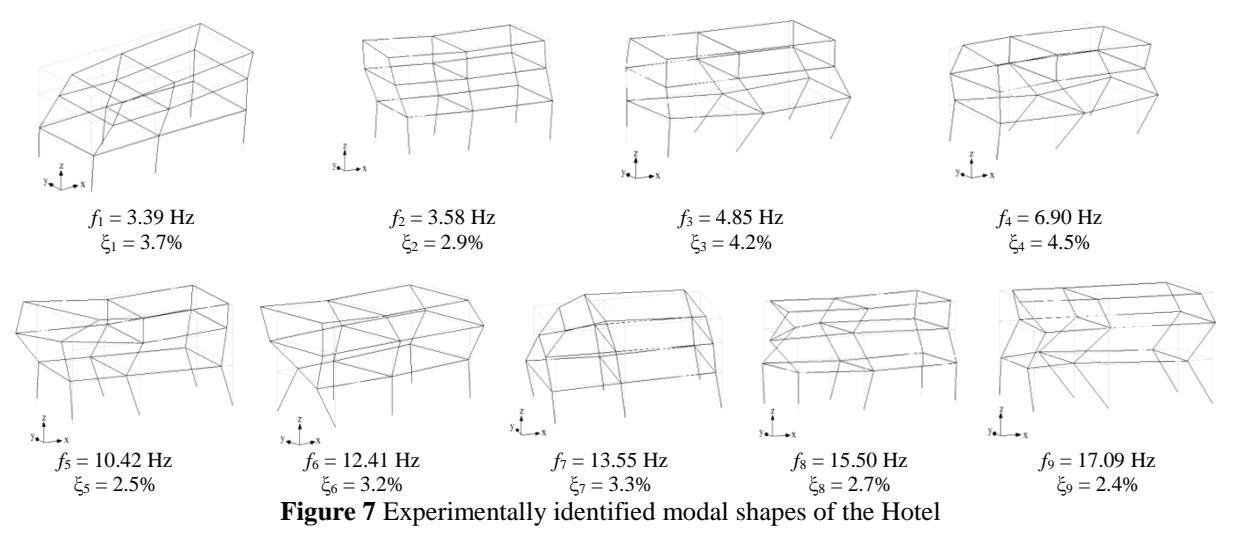
The modal shape results are presented in Figure 7. These results evidence the complexity of the structure and confirm the fact that the existent damage affects the behaviour of the whole system. The first two mode shapes seem global translational modes parallel to the façades Y-Y and X-X, respectively (see Figure 4). In these modes, it is evidenced the effect of the neighbouring constructions, and the different behaviour of the first Adobe floor (rigid part with almost no movement) and the others second and third Quincha levels (which shows high flexibility). The third and fourth mode shapes indicates an unexpected behaviour since the façade wall parallel to the Y-Y side is not moving in consistency to the back part. This phenomenon may indicate that the diaphragms conformed by the floors of the building are not properly connecting the walls. The results of the fifth to the ninth mode corroborate this effect and shows mainly complex modes of the façade. The results

of the tests evidence a structural problem that should be studied in detail in further studies. In these studies, in addition to the solutions for repairing the areas with evident damage, it should be studied the condition of the façade wall parallel to the Y-Y axis in Figure 4.
