FINAL REPORT ~ FHWA-OK-22-02

A SYSTEMS APPROACH FOR DESIGN, CONSTRUCTION, AND MAINTENANCE OF BRIDGES AND ADJACENT ROADWAYS

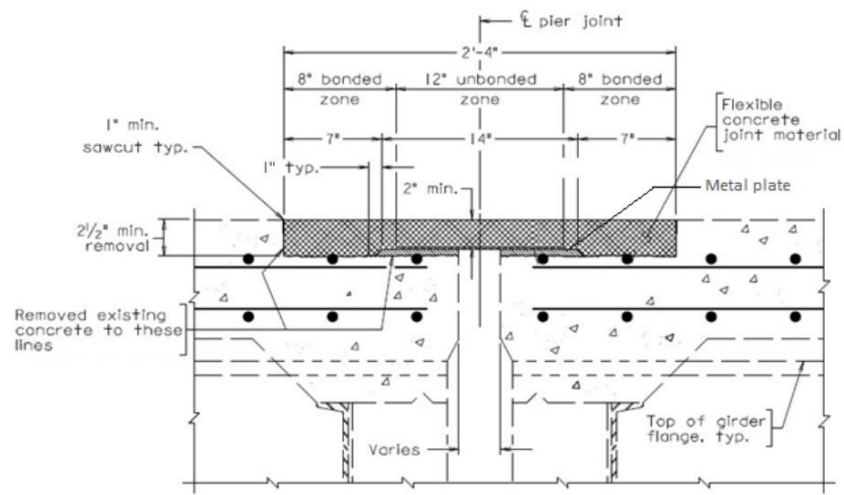
Figure 1. Elastomeric Concrete Plug Joint (Balakumaran et al. 2018)

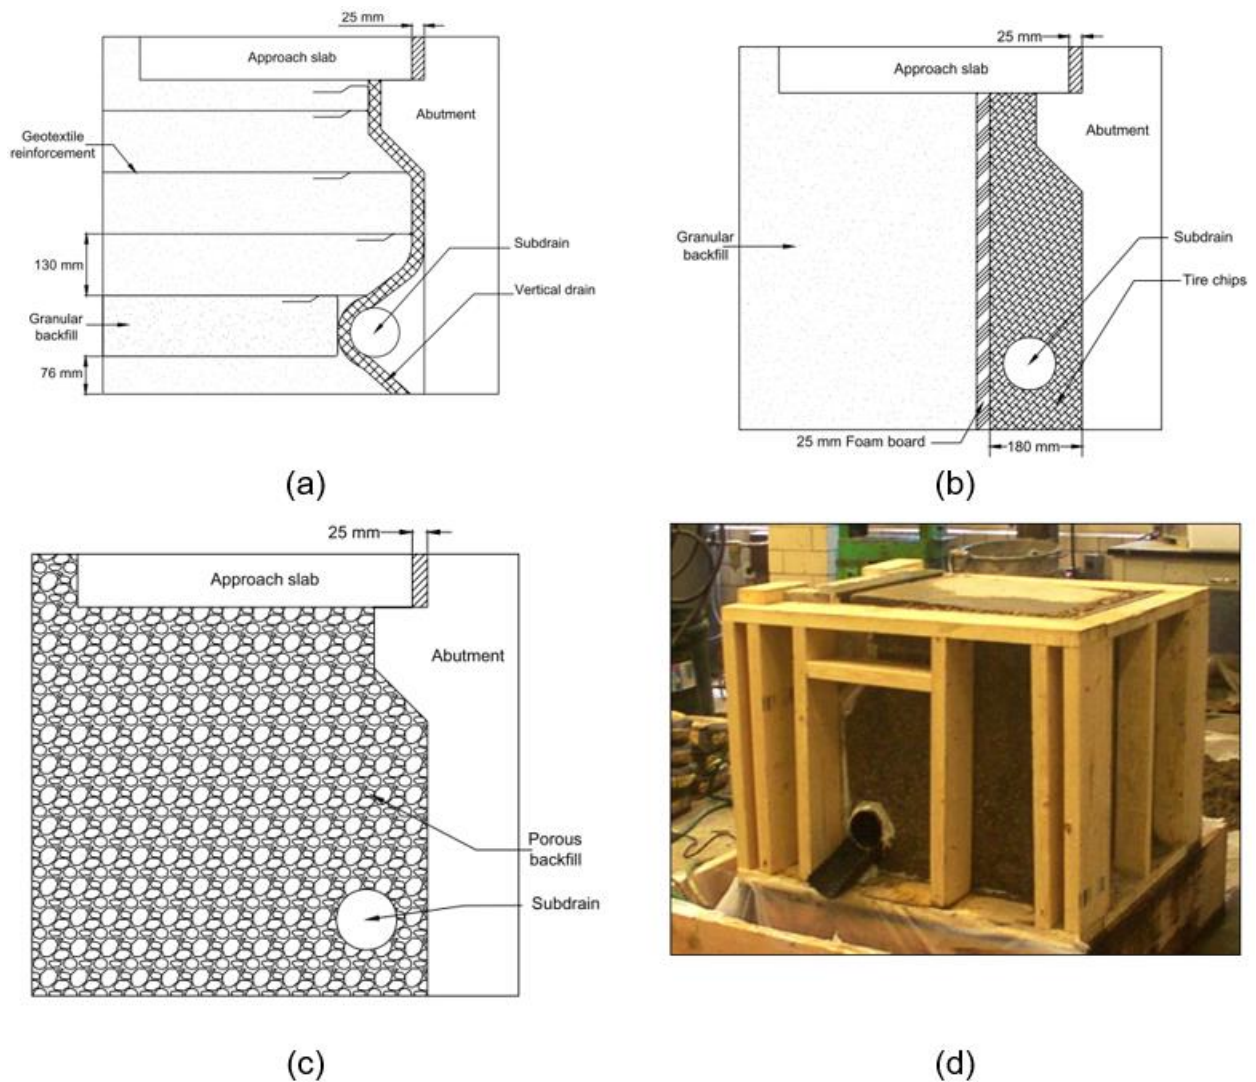
Figure 2. Backfill Drainage Systems a) Geosynthetic Vertical Drain; b) Tire Chips; c) Porous Backfill; d) Laboratory Model for the Porous Backfill System (from Mekkawy et al. 2005)

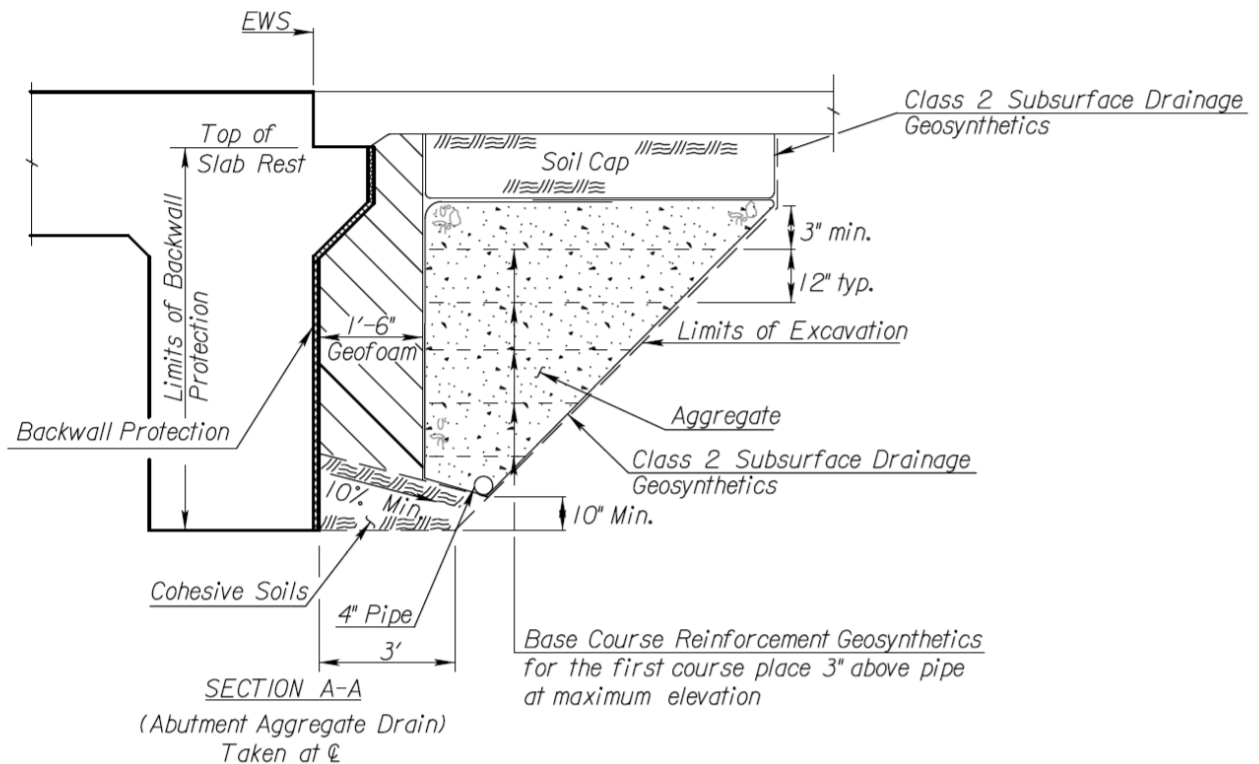
Figure 3. Kansas DOT Backfill Drain with Geofoam Spacer

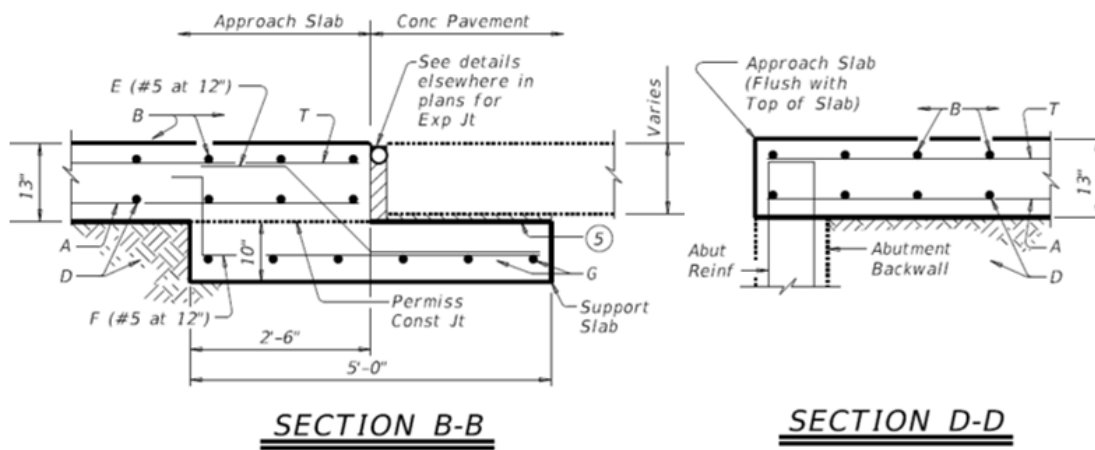
Figure 4. Texas DOT Approach Slab Details: Section B-B Approach Slab/Approach Pavement Interface, Section D-D Abutment/Approach Slab Interface

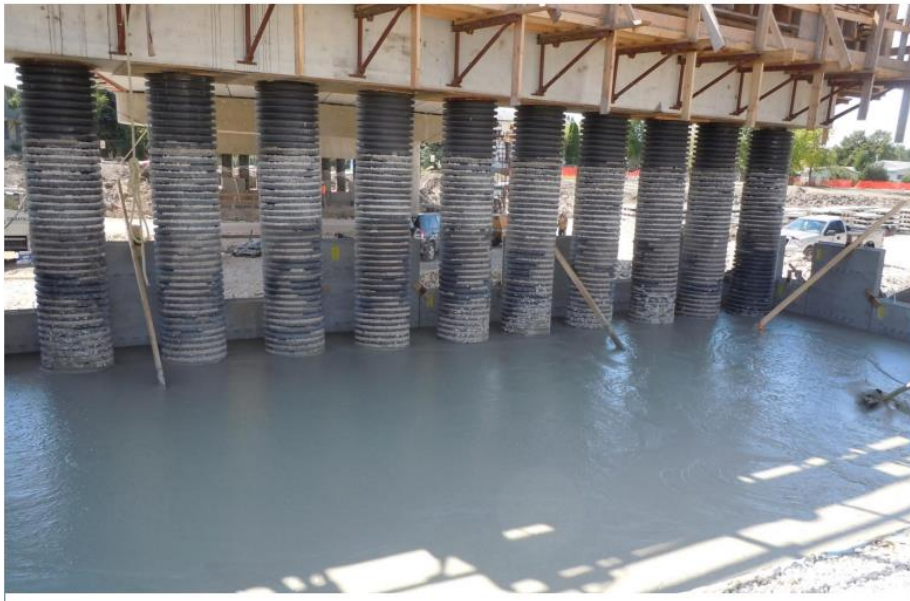
Figure 7. Backfill Construction with LDCC (from Loewen et al. 2012)

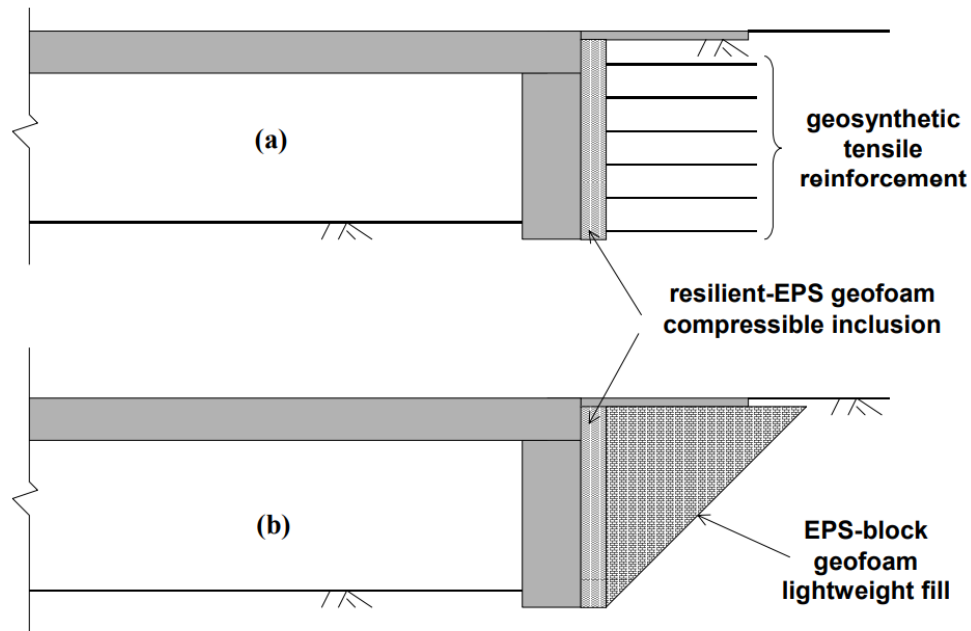
Figure 10. Proposed IAB Design Alternatives (Horvath 2005)

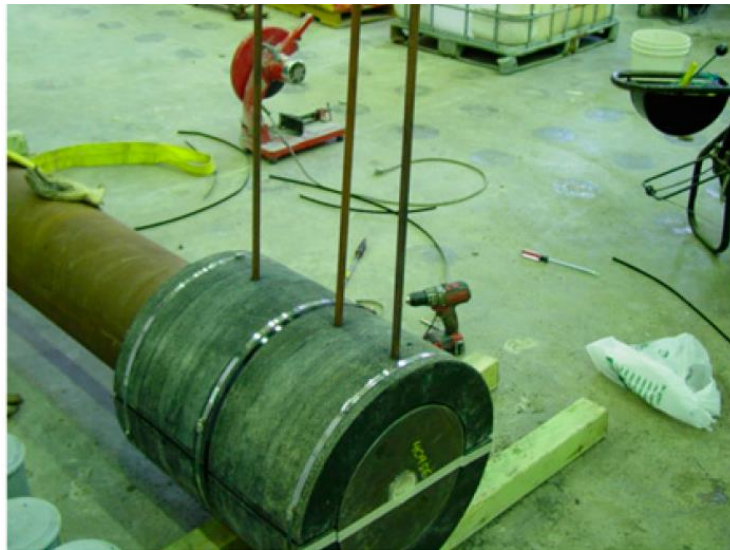
Figure 11. Moment Break at Pile Top (from Sherafati and Azizinami 2014)

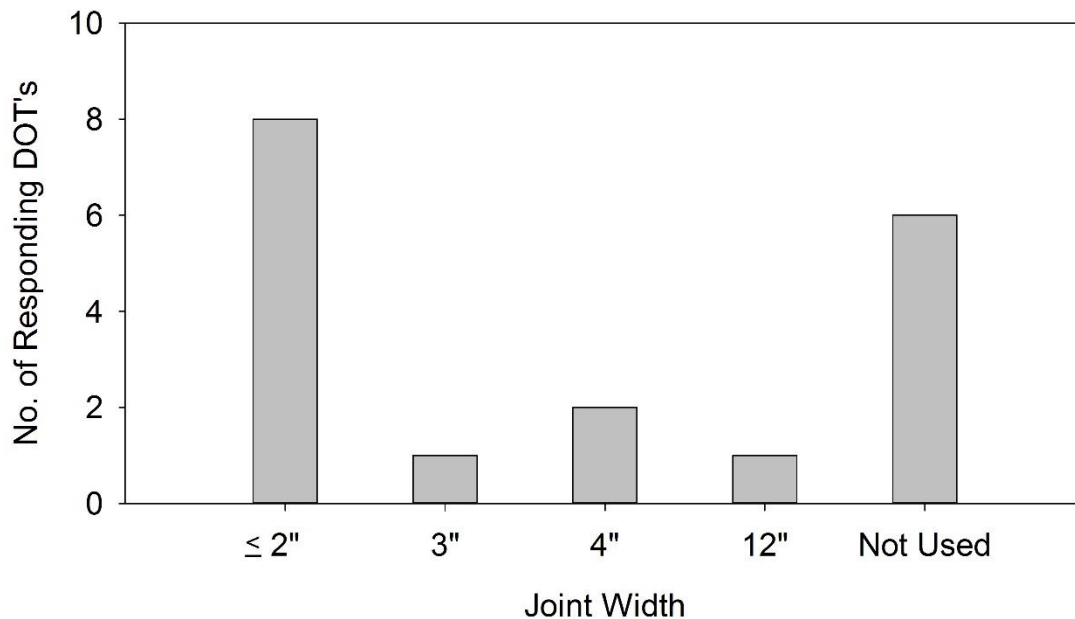
Figure 13. Pressure Relief Joint Width - New Construction

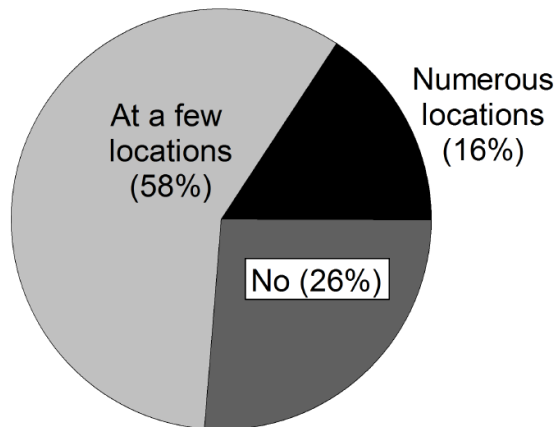
Figure 15. Prevalence of Excessive Pavement Pressure Problems

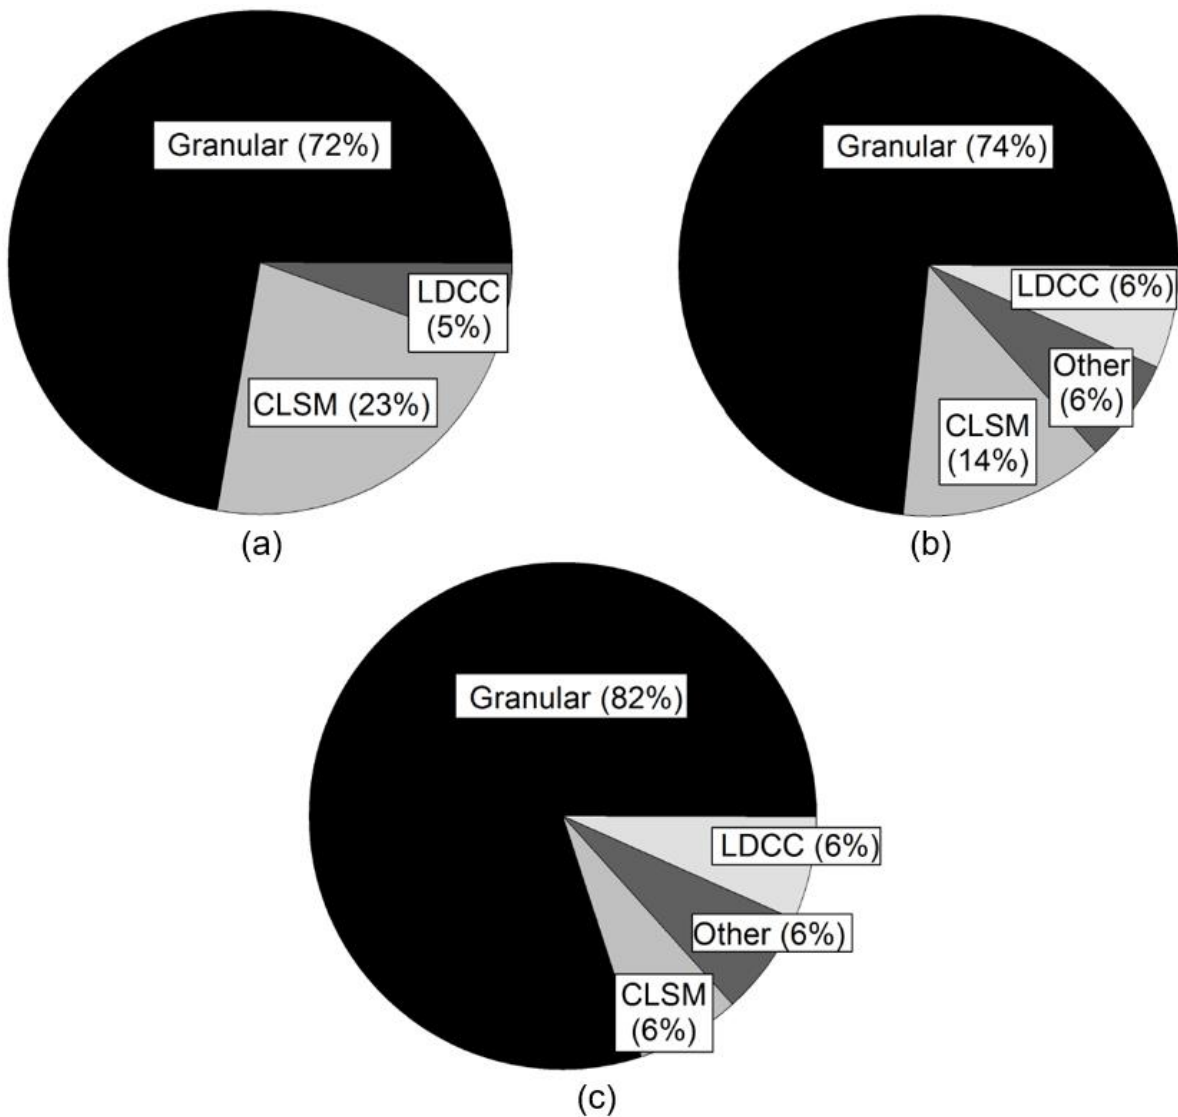
Figure 22. Backfill Distribution: (a) Conventional Bridges, (b) Integral Bridges, and (c) Semi-Integral Bridges

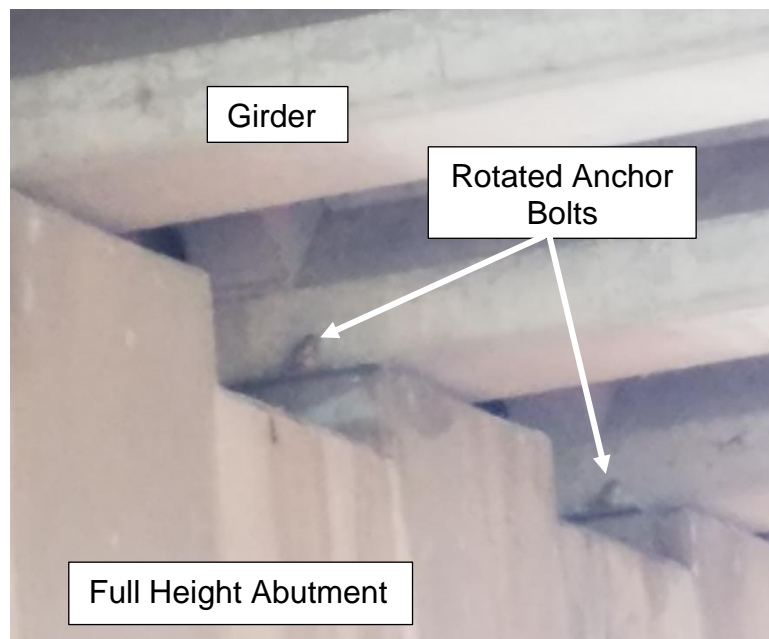
Figure 25. Shields Boulevard over the Oklahoma River: North Abutment

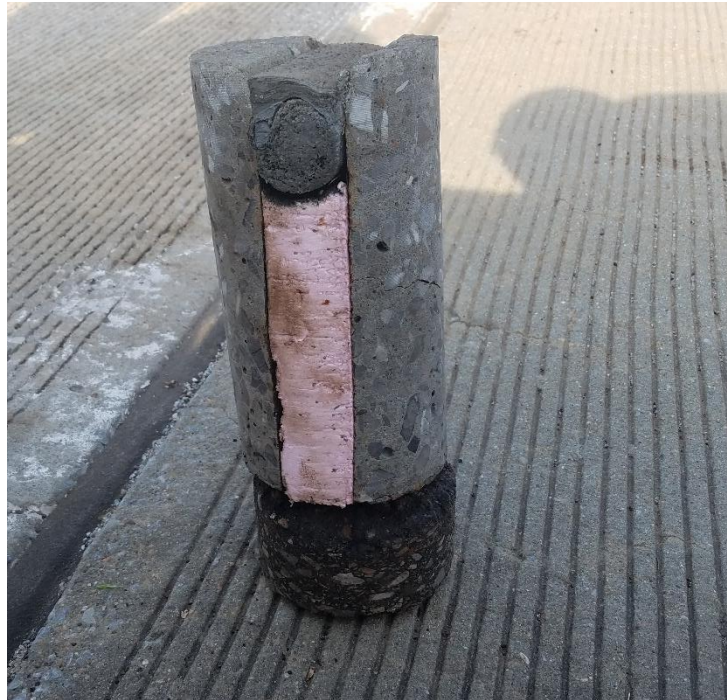
Figure 26. Shields Boulevard over I-40: Expansion joint pavement core

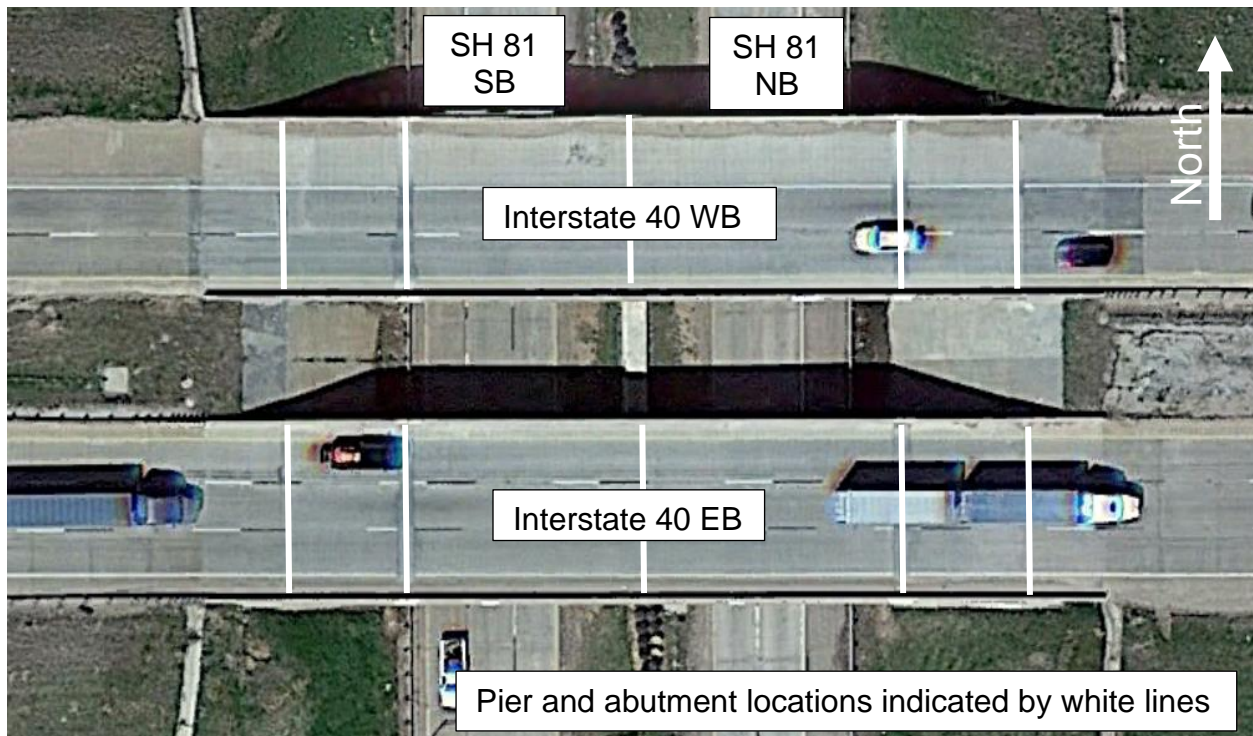
Figure 32. I-40 over SH-81, El Reno

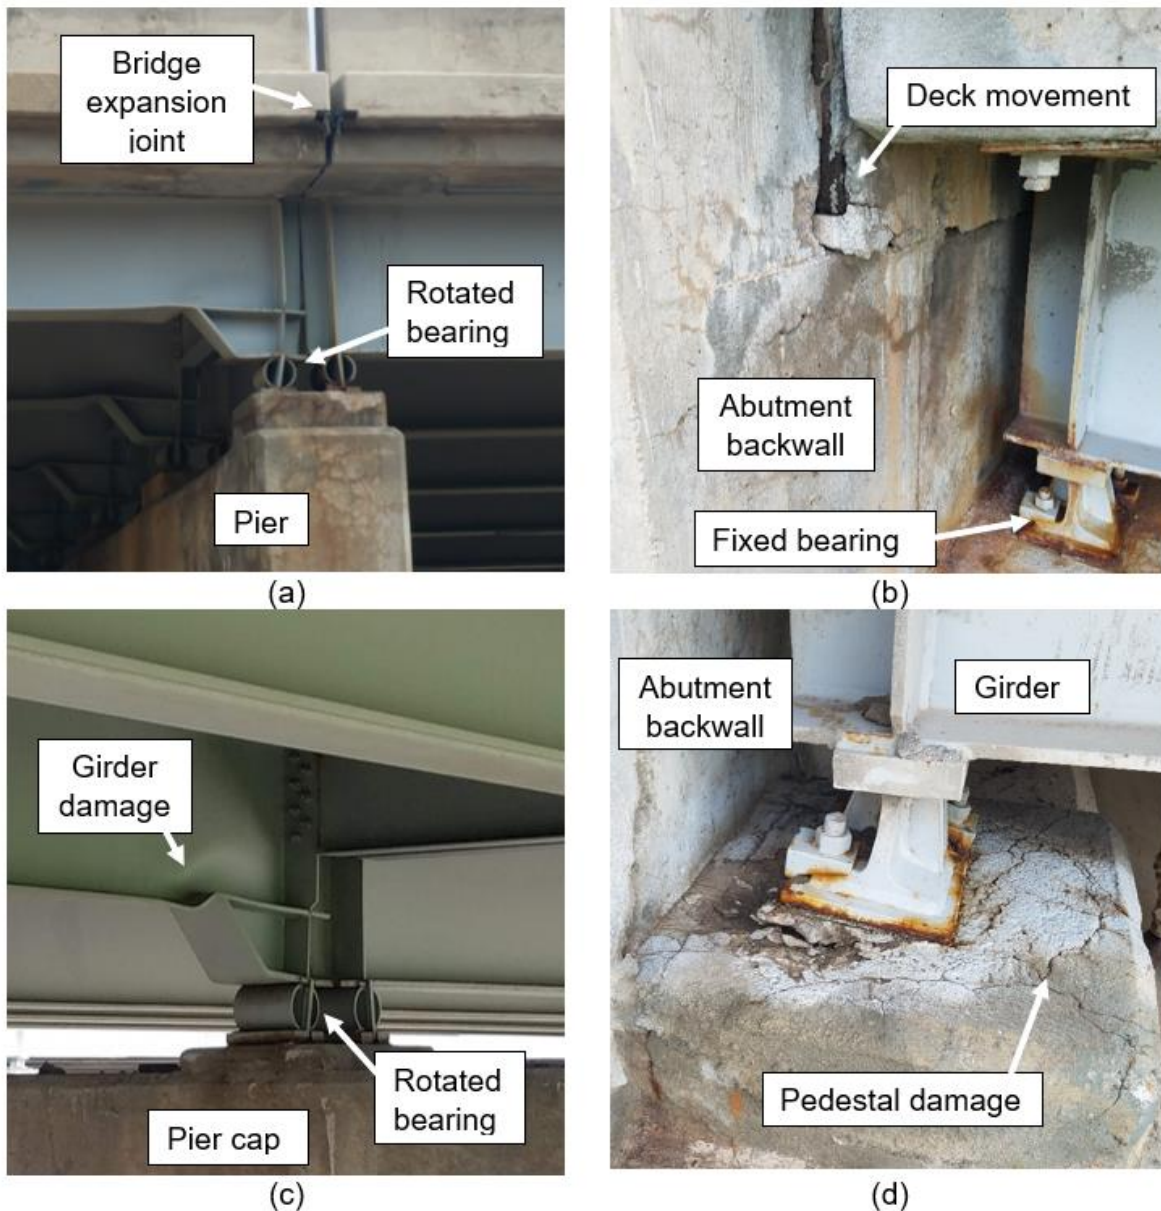
Figure 33. I-40 over SH-81: (a) closed expansion joint, (b) deck shoving, (c) rotated bearing, (d) pedestal damage

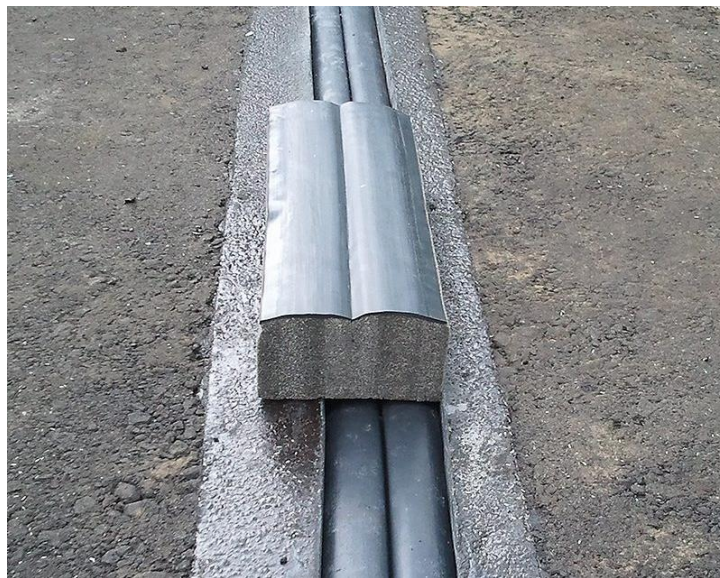
Figure 34. EMSEAL® BEJS, courtesy of EMSEAL®

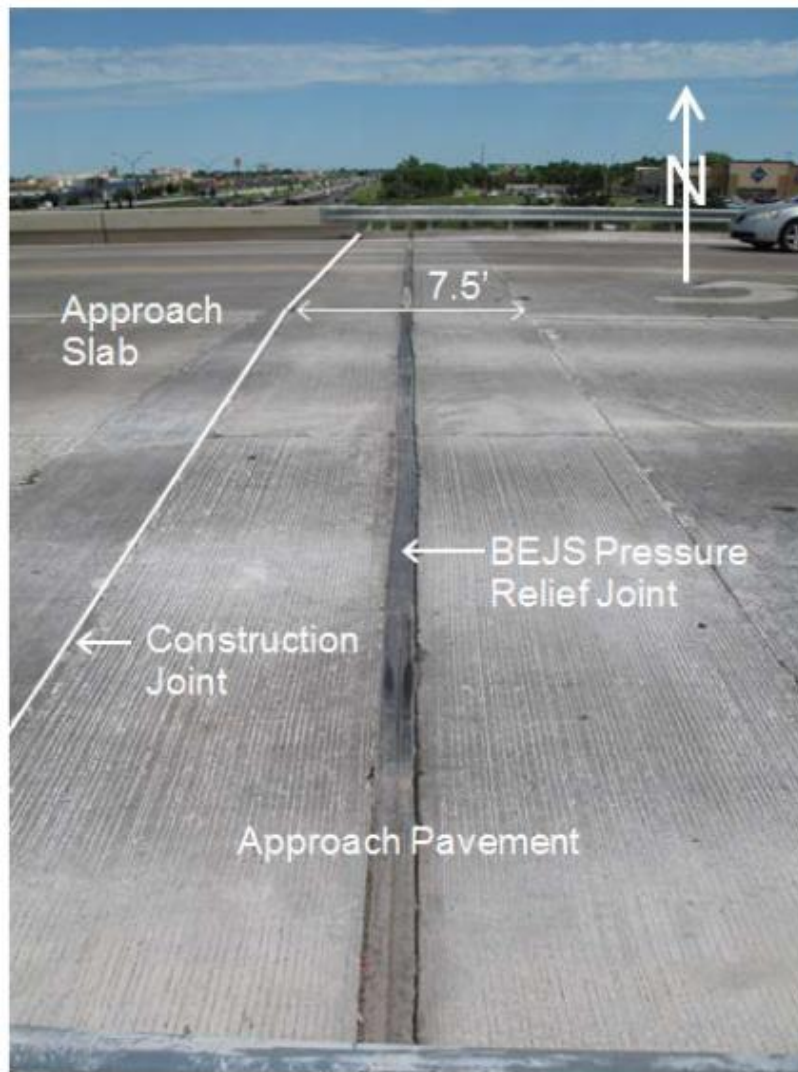
Figure 40. 19th Street over I-35: Pressure relief joint installed in 2016

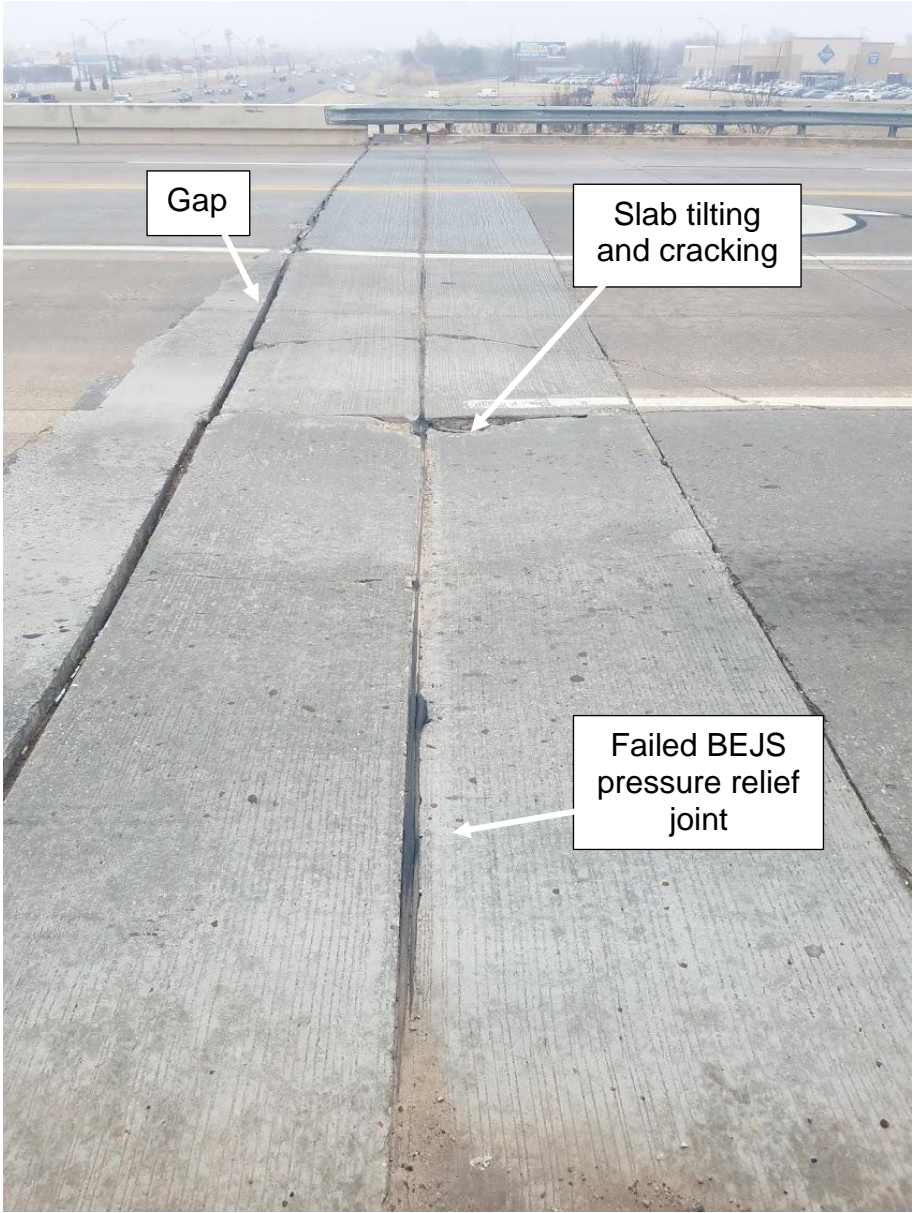
Figure 41. 19th Street over I-35: Pressure relief joint in 2019

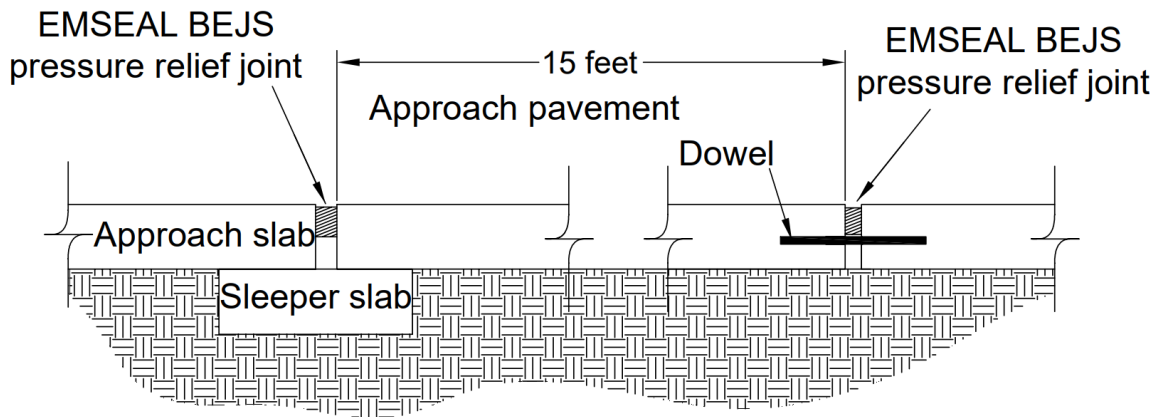
Figure 45. 19th Street over I-35: Locations of pressure relief joints

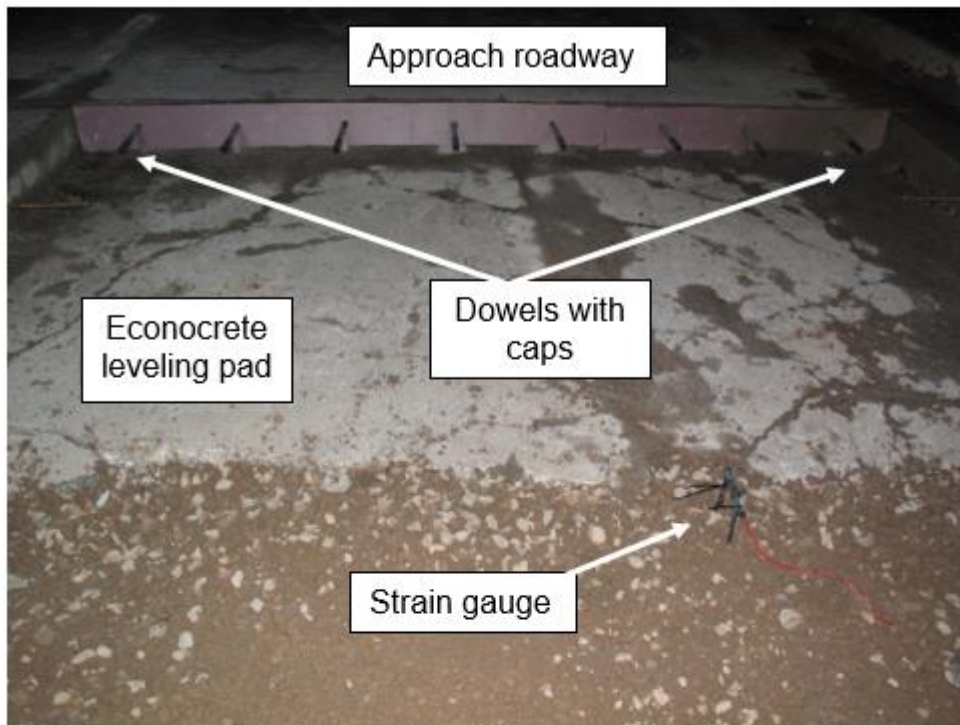
The east and west side panels were replaced on the nights of September 21, 22, 23, and 24, 2020. A 2-inch gap was left on each side of the new panels for a pressure relief joint to later be installed. The gap was temporarily filled with foam board and sealed with silicone. A representative from OU was onsite during the construction on the nights of September 21 and 24, 2020. A strain gauge was embedded in the concrete of the outside driving lane in each direction on both sides of the bridge for a total of four concrete embedded strain gauges. Photographs showing the construction and placement of the strain gauges are shown in Figure 46. A portion of the new panels are underlain by an existing layer of Econocrete. The Econocrete, shown in Figure 46, was used as a leveling pad when the bridge was originally constructed. Photographs showing the panels completed are shown in Figure 47.

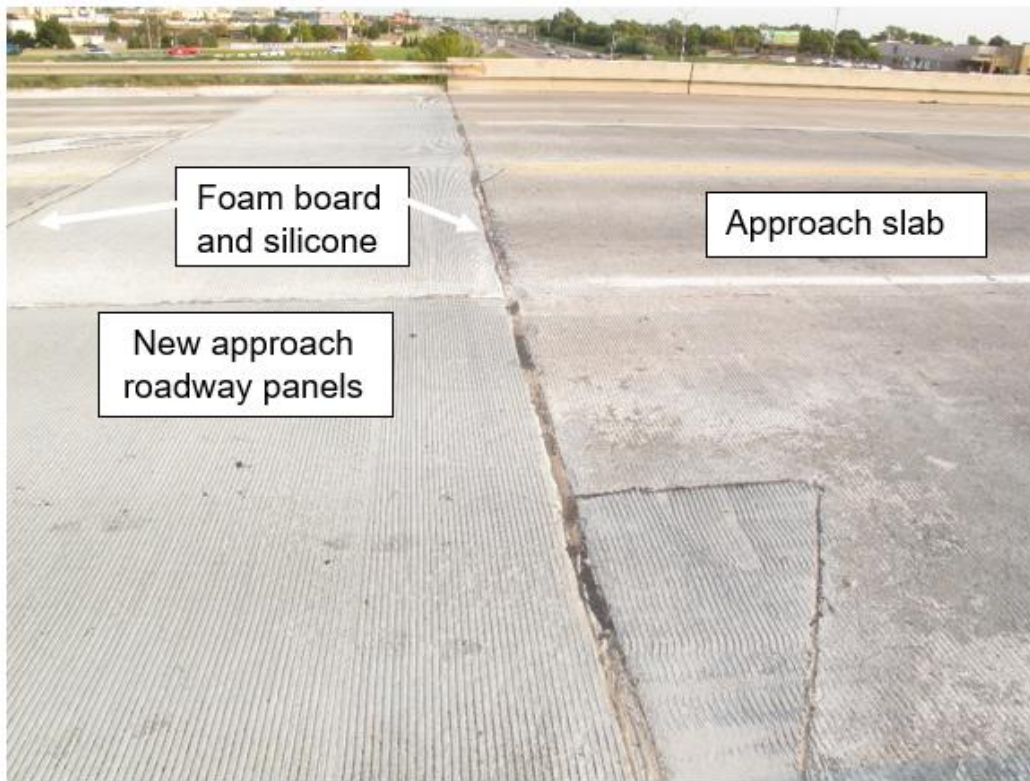
Figure 46. 19th Street over I-35: Approach roadway replacement (a) facing approach roadway, (b) facing approach slab

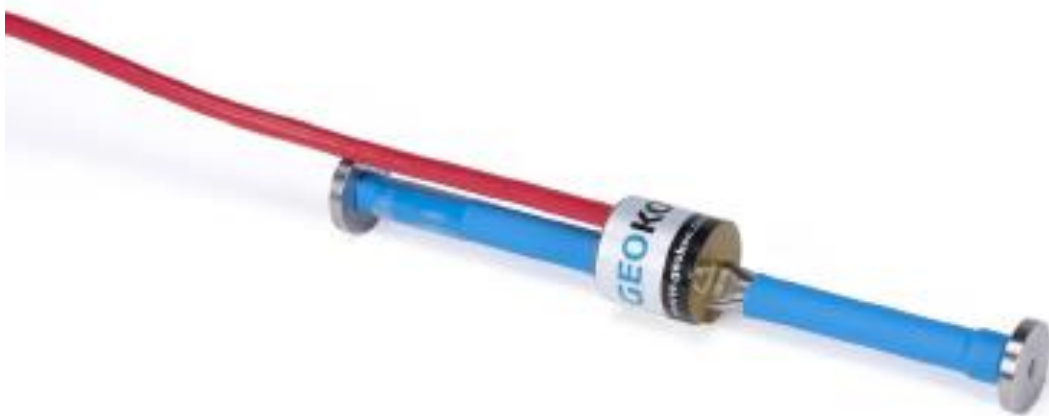
Figure 51. Geokon model 4200 vibrating wire strain gauge (Geokon 2019)

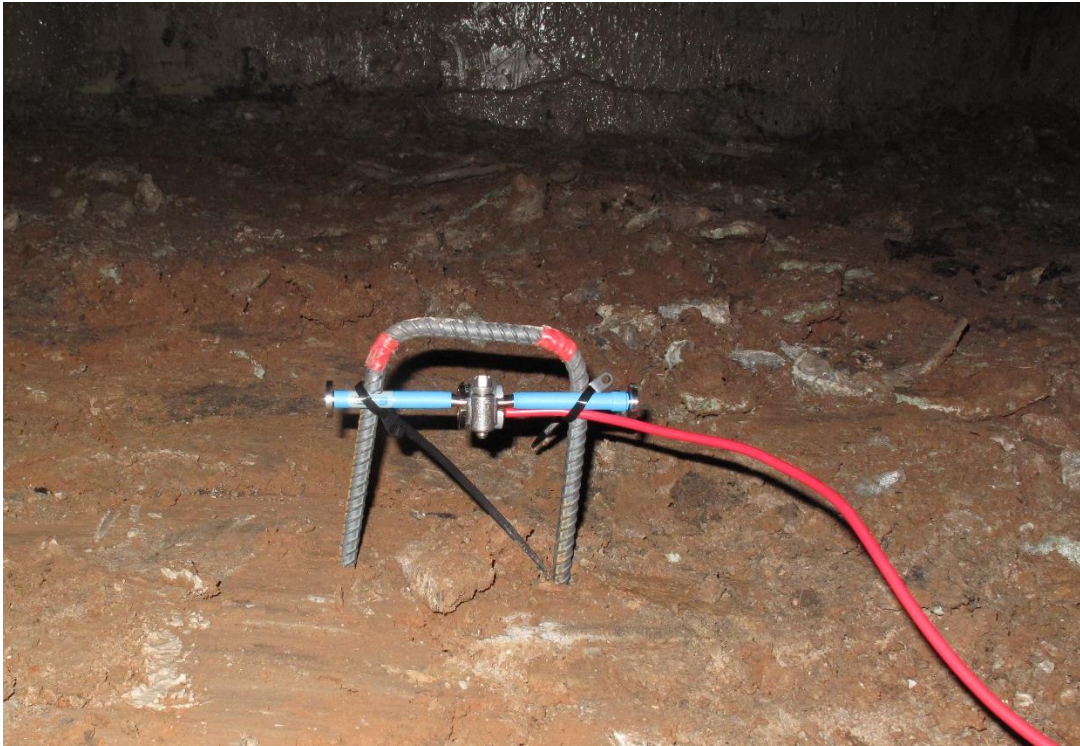
Figure 52. Mounting bracket with Geokon strain gauge

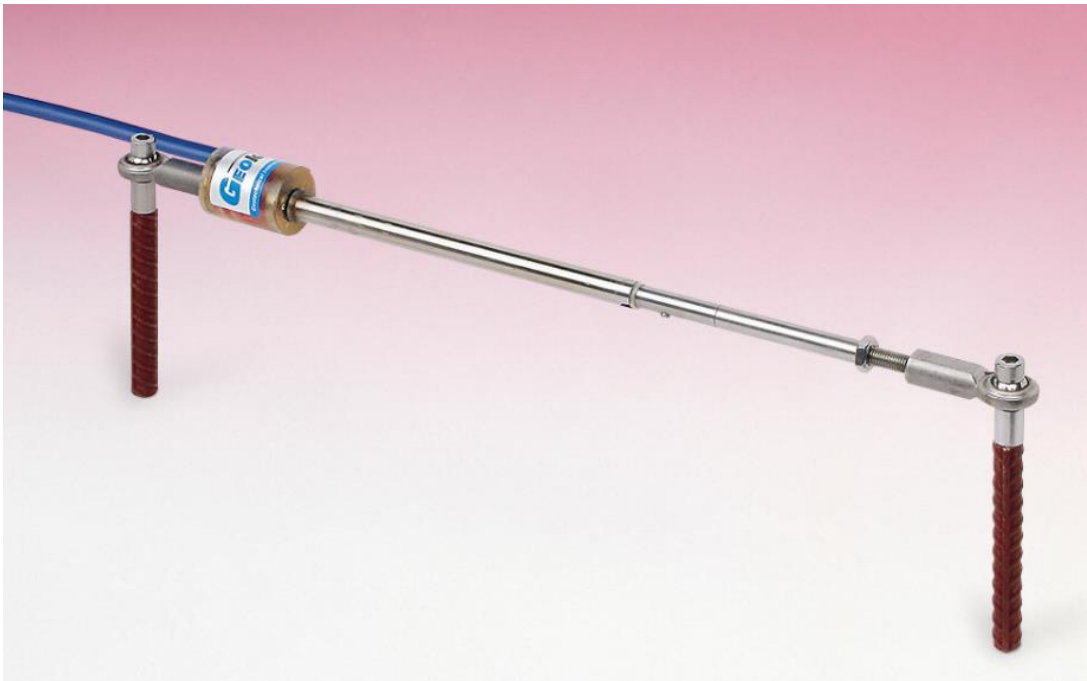
Figure 53. Geokon model 4420 crackmeter shown with mounting brackets (Geokon 2020)

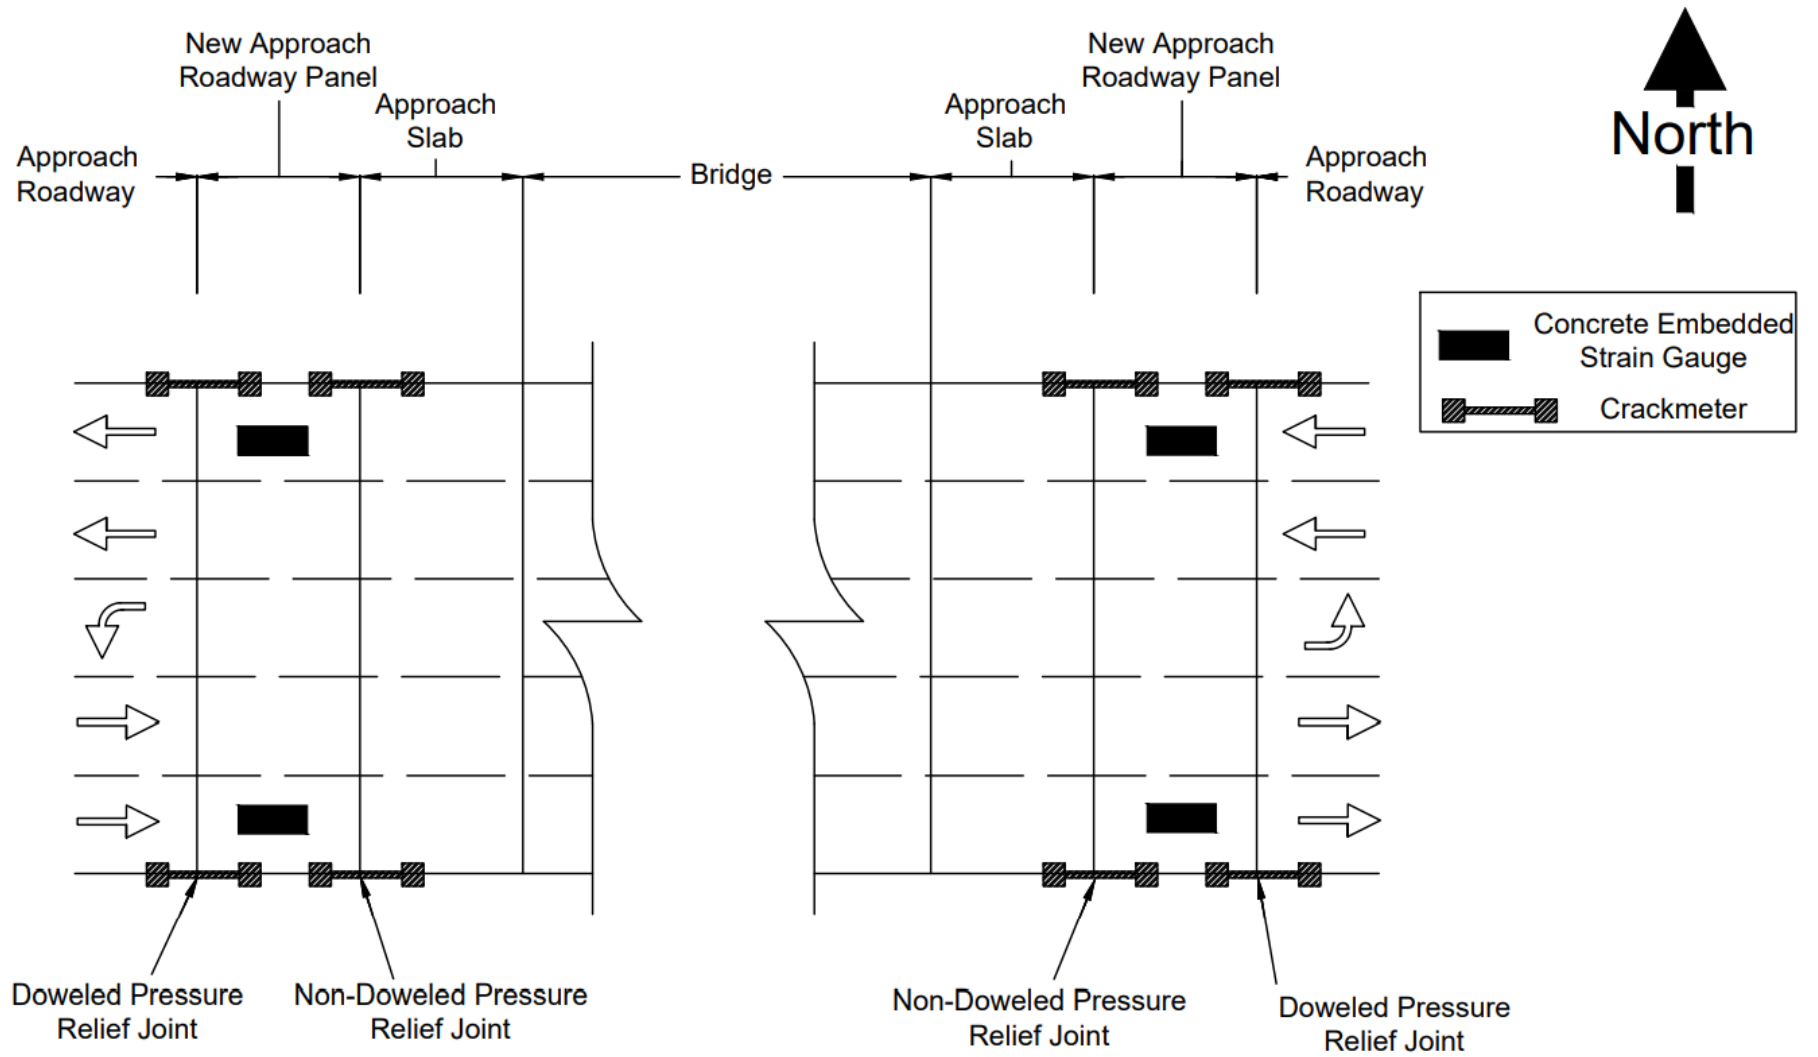
Figure 54. 19th Street over I-35 instrument locations

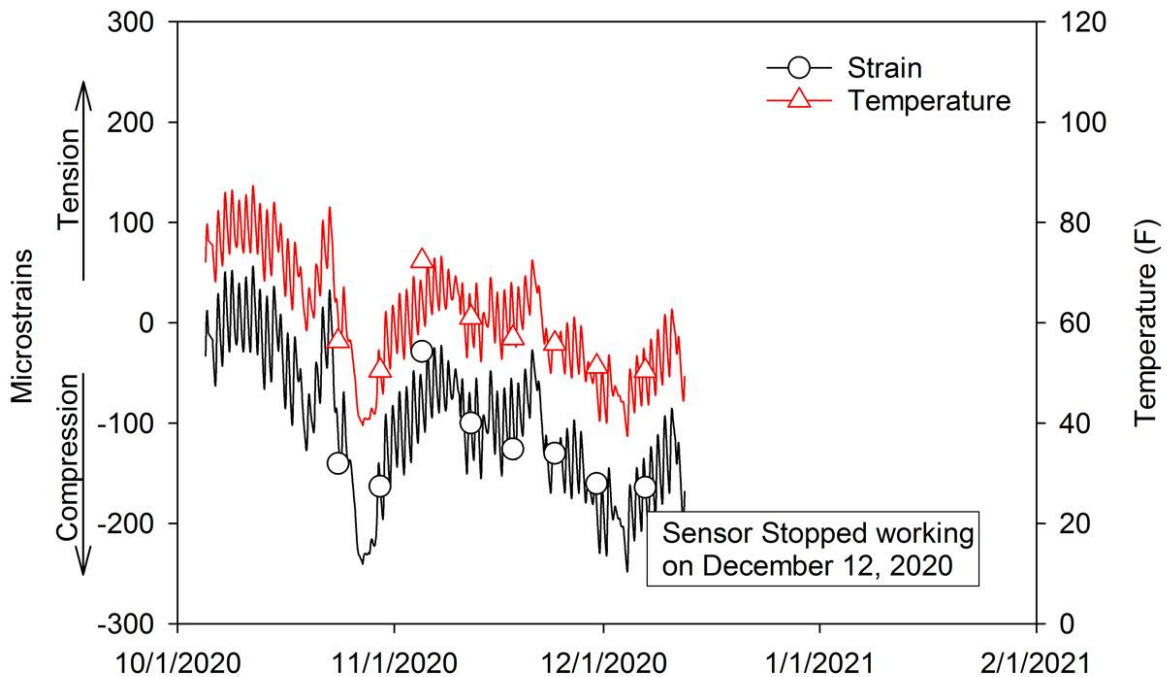
**Figure 55. 19th Street over I-35 concrete strain:
East approach roadway south lane**

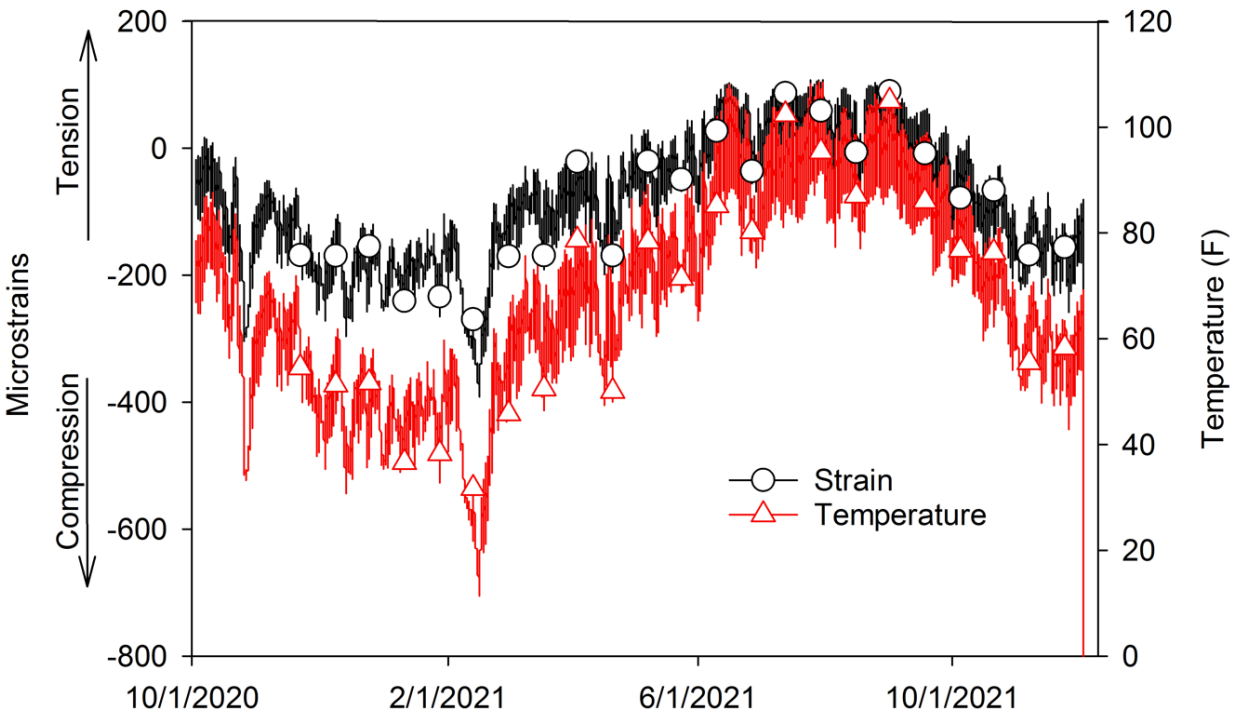
**Figure 57. 19th Street over I-35 concrete strain:
West approach roadway north lane**

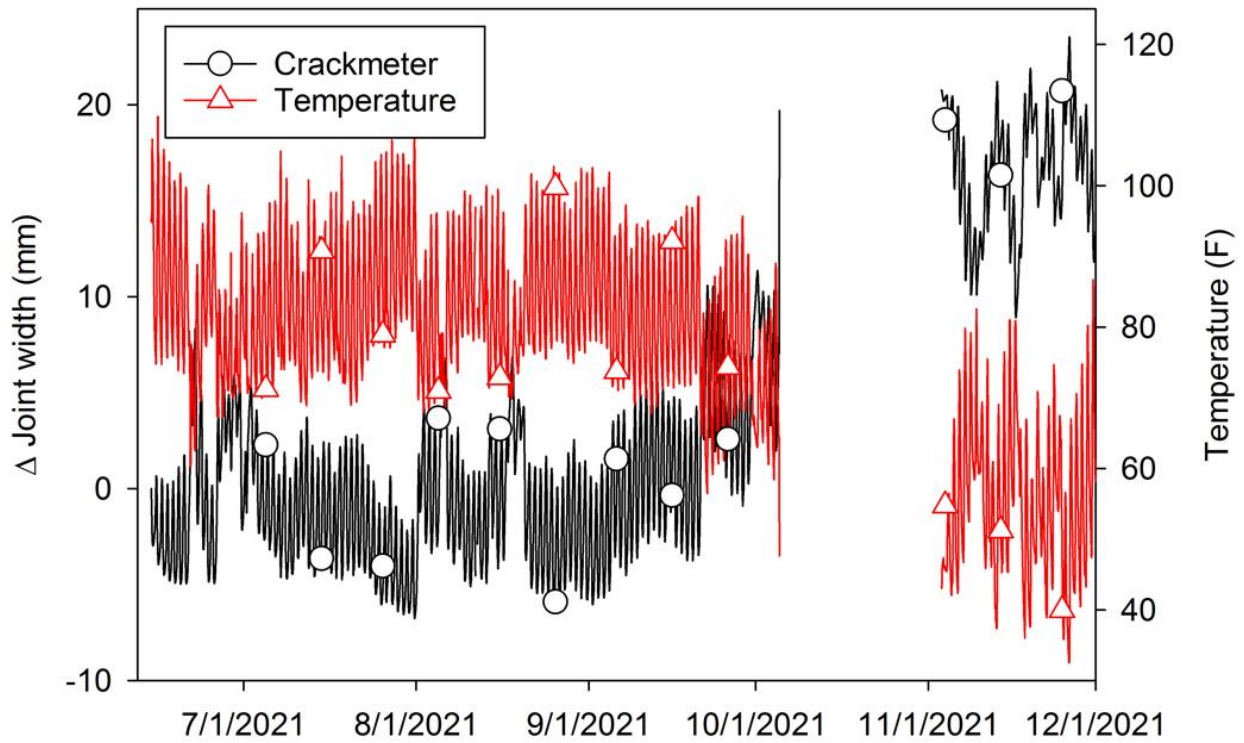
**Figure 58. 19th Street over I-35 pressure relief joint width:
East approach south non-doweled joint**

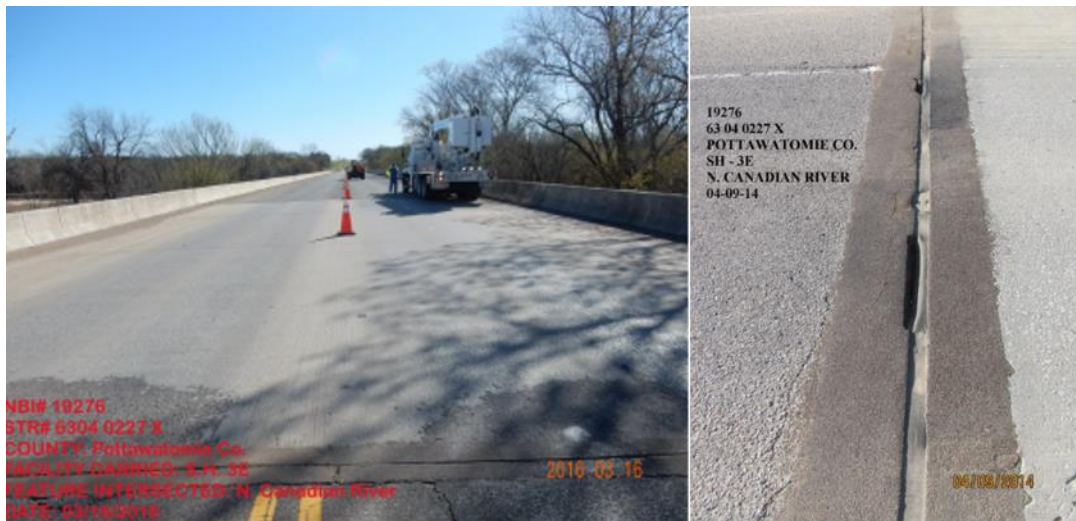
**Figure 66. SH-3 bridge over N. Canadian River (left)
and expansion joint to be replaced (right)**

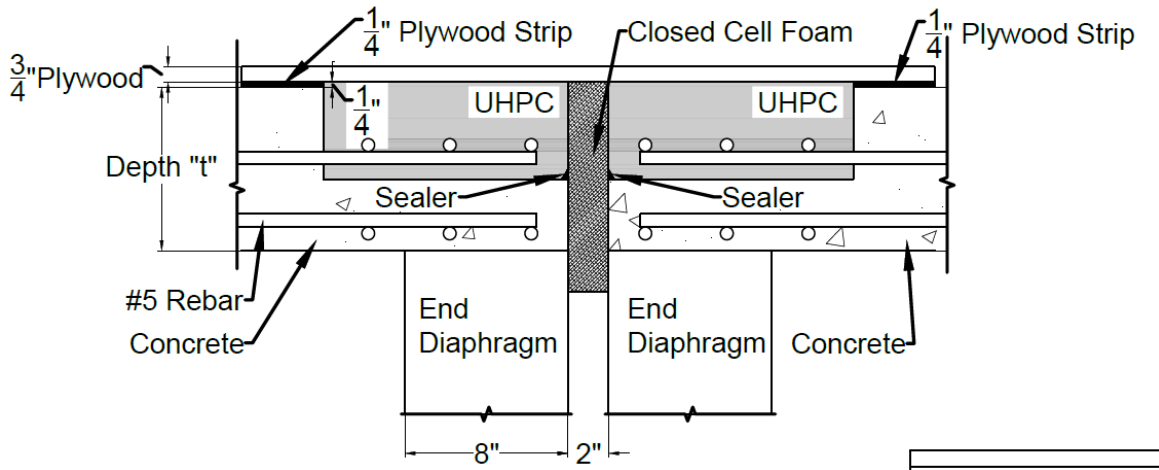
Figure 68. Details of the UHPC expansion joint headers including formwork
