FINAL REPORT ~ FHWA-OK-22-02

A SYSTEMS APPROACH FOR DESIGN, CONSTRUCTION, AND MAINTENANCE OF BRIDGES AND ADJACENT ROADWAYS

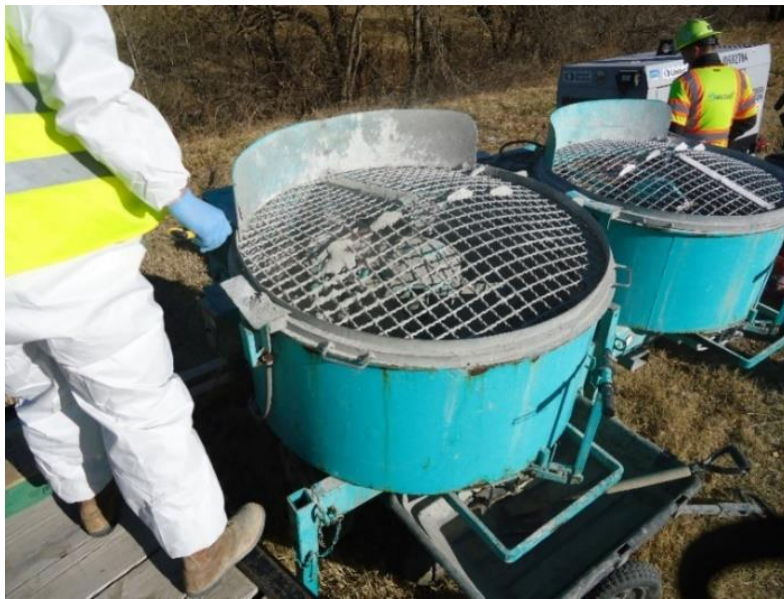
Figure 69. High shear mixers used for mixing UHPC

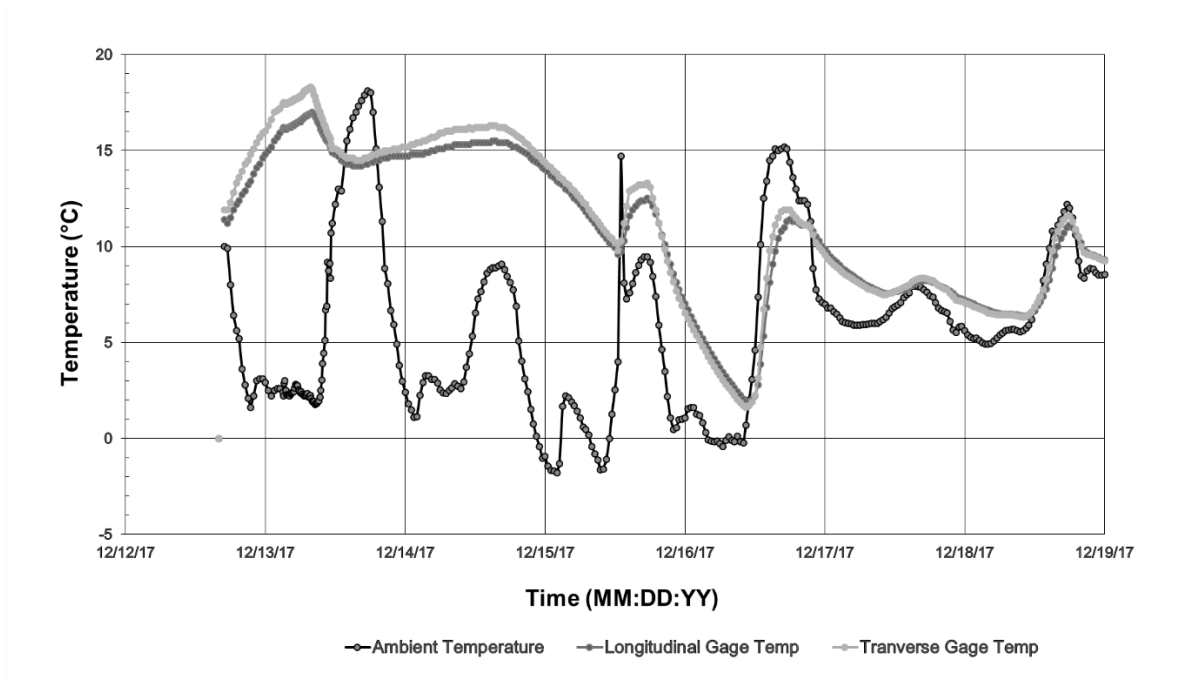
Figure 72. UHPC temperature over the first week after casting

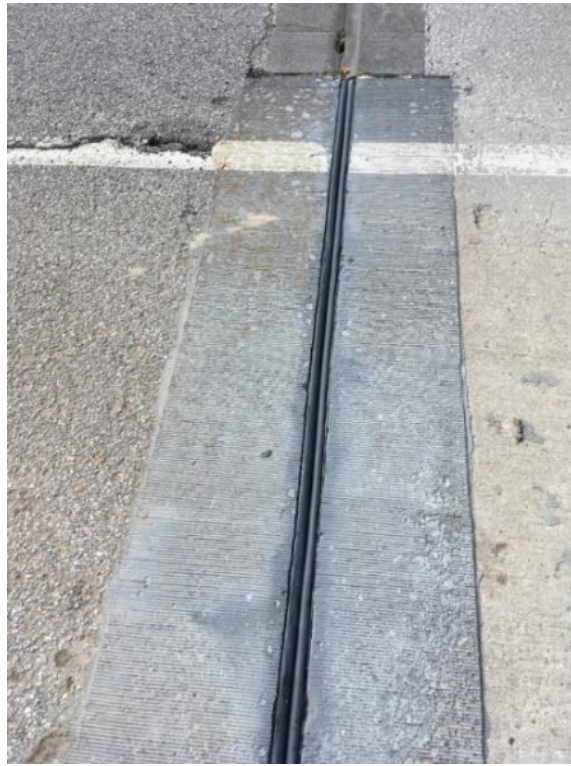
Figure 77. UHPC joint headers on SH-3E bridge immediately after BEJS material was placed

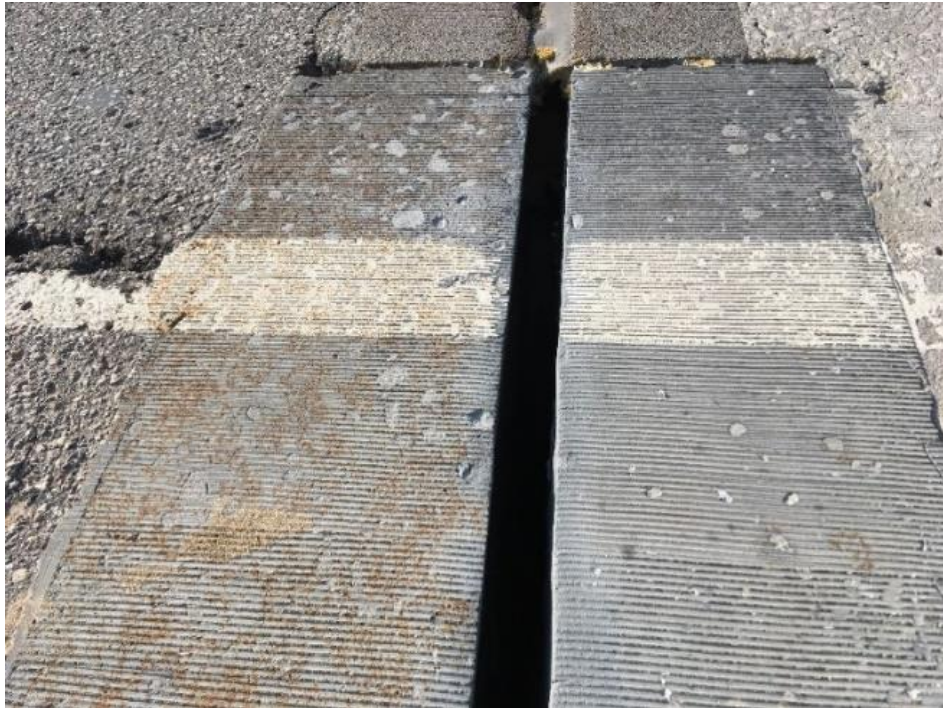
Figure 79. UHPC joint headers on SH-3E bridge before joint sealant was placed and showing surface rusting of the exposed steel fibers

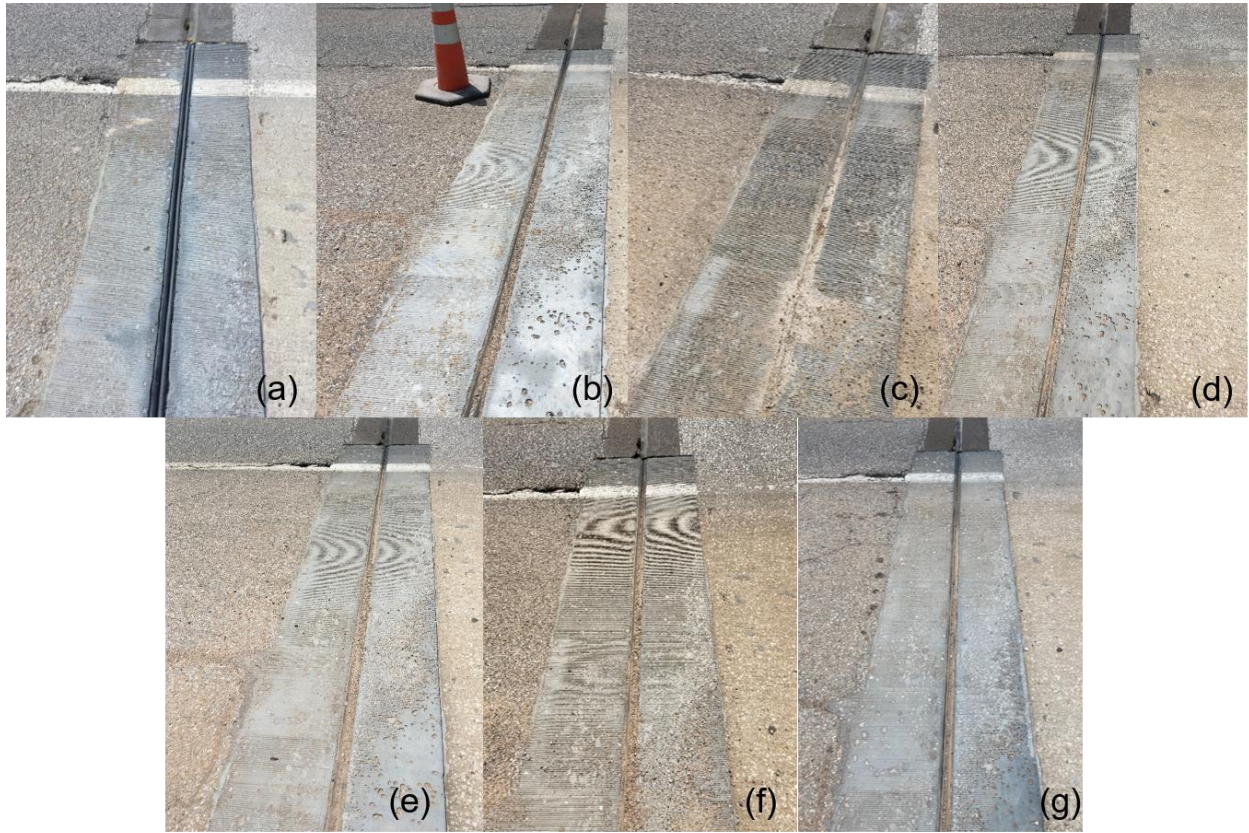
Figure 80. Photos of the UHPC joint on the SH-3E bridge over the North Canadian River (a) immediately after BEJS placement, on March 29, 2018 3 months after casting, (b) 7 months after casting, (c) 14 months after casting, (d) 21 months after casting, (e) 29 months after casting, (f) 33 months after casting, and (g) 45 months after casting

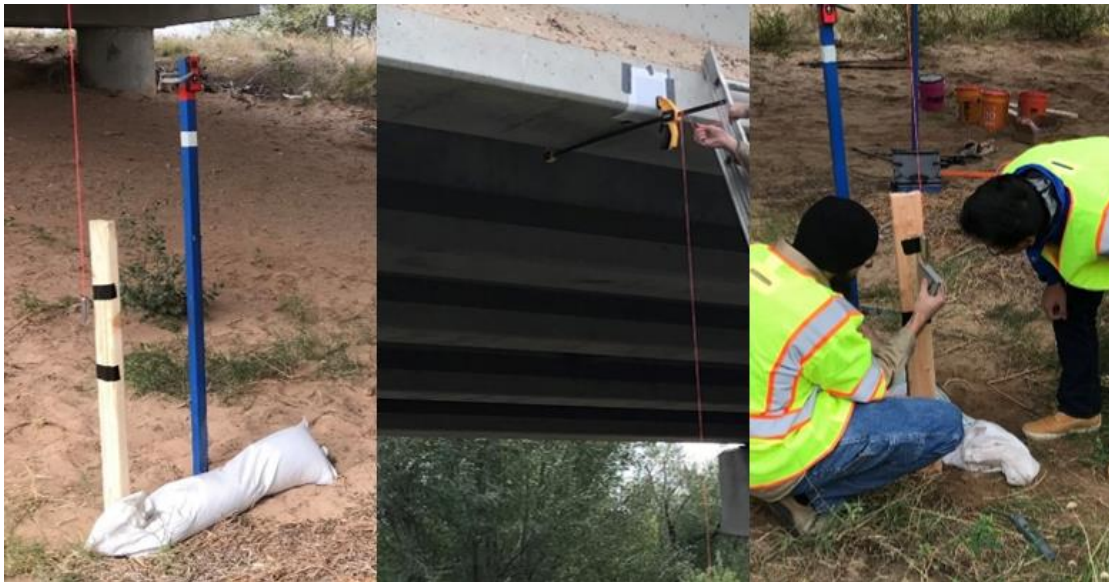
Figure 86. Laser measurer and plumb bob setup (left), clamp on the girder bottom (middle), and method used for measurement with the plumb bob (right)

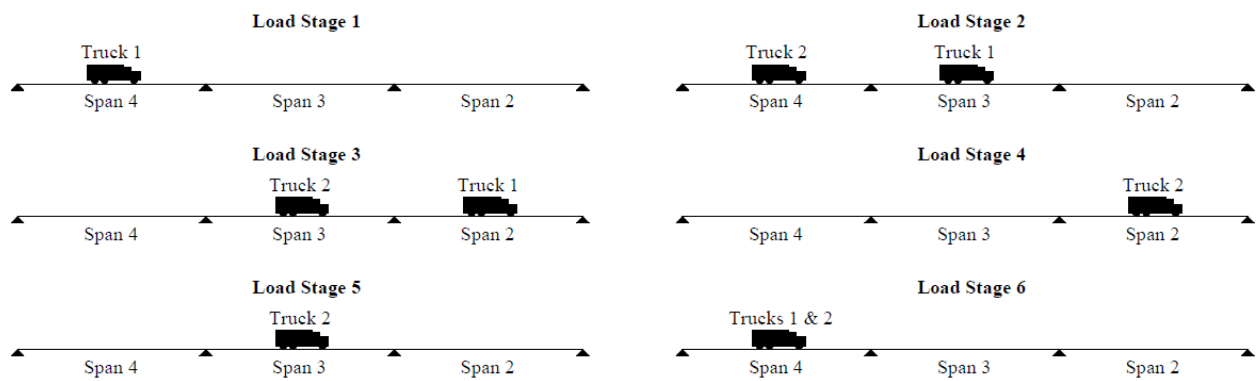
Figure 87. Truck locations for each load stage

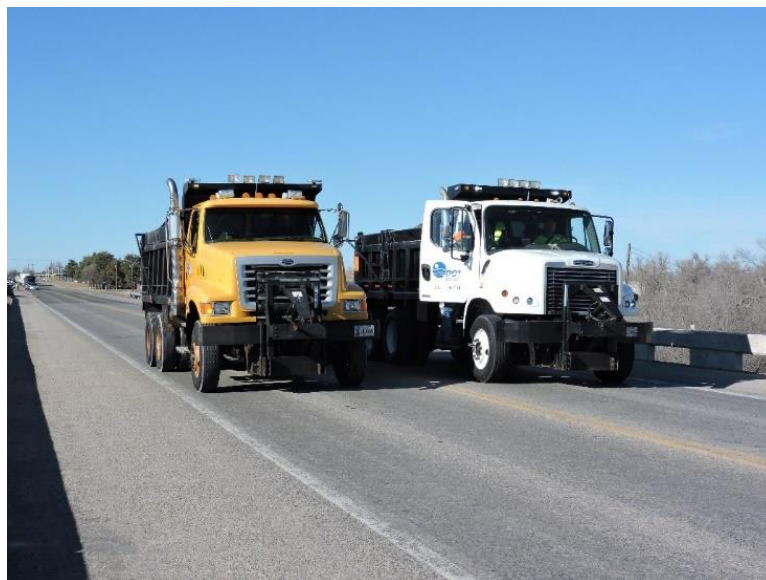
Figure 88. Trucks located for Load Stage 6

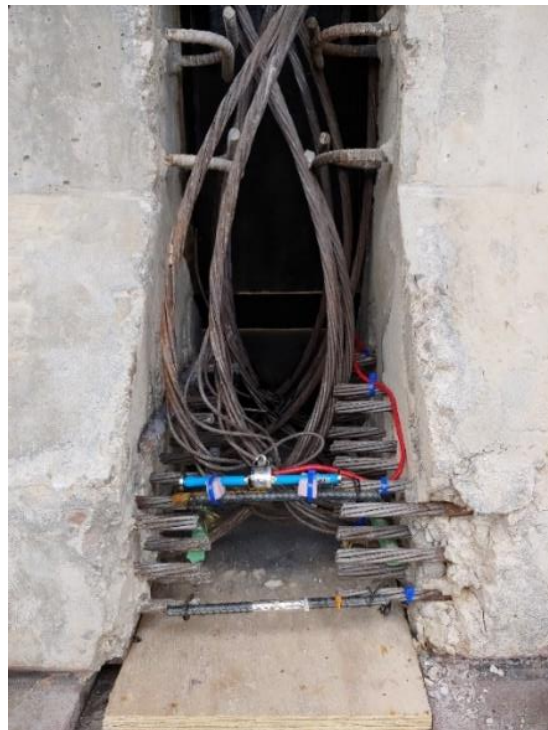
Figure 89. Strain gauge placement in the joint

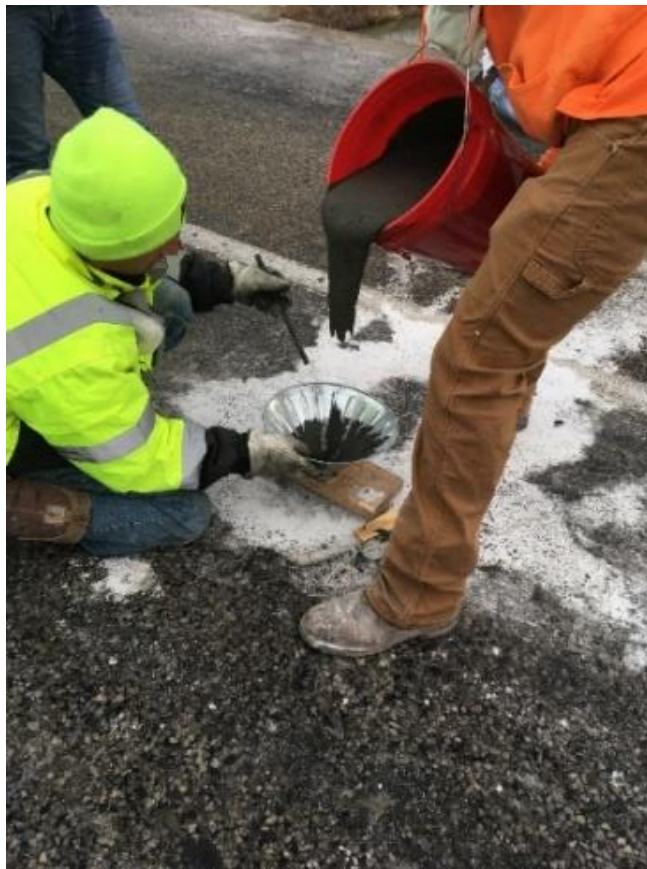
Figure 92. Placement of UHPC into fill hole in the bridge deck

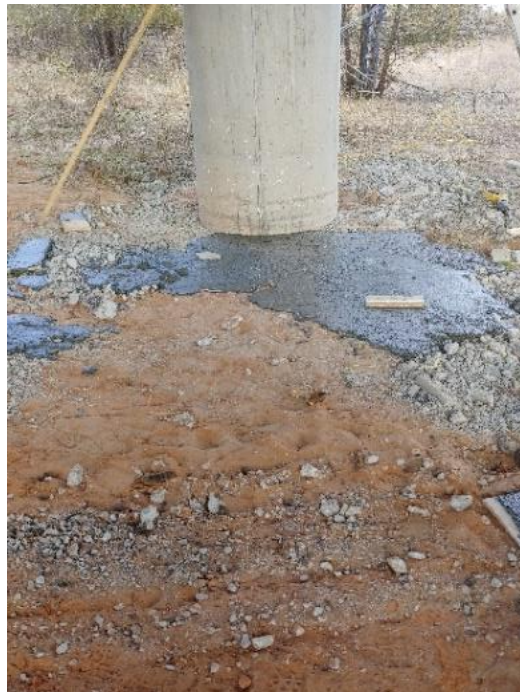
Figure 93. UHPC from failed formwork

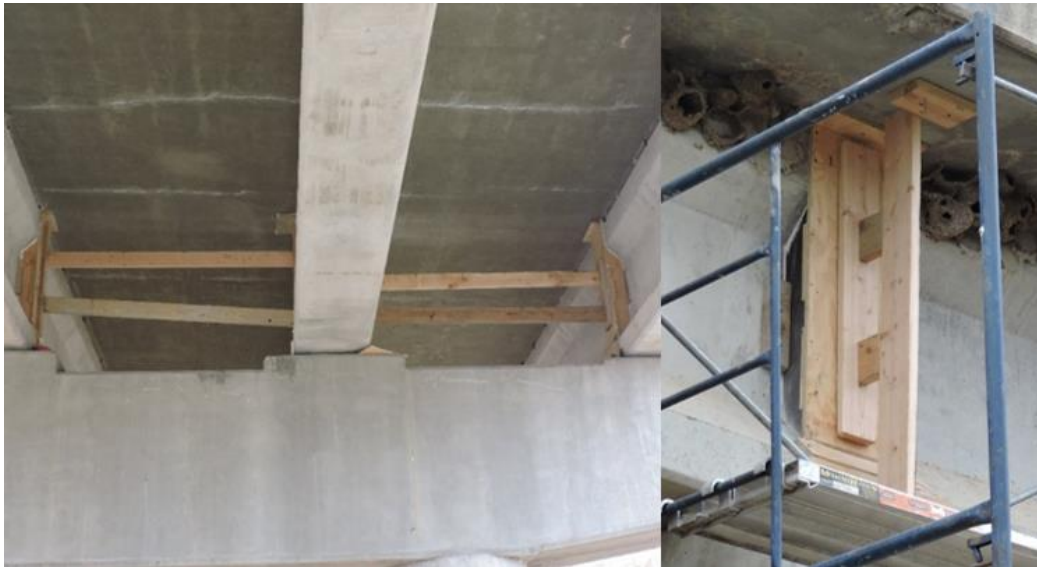
Figure 94. Final joint forms after adding bracing

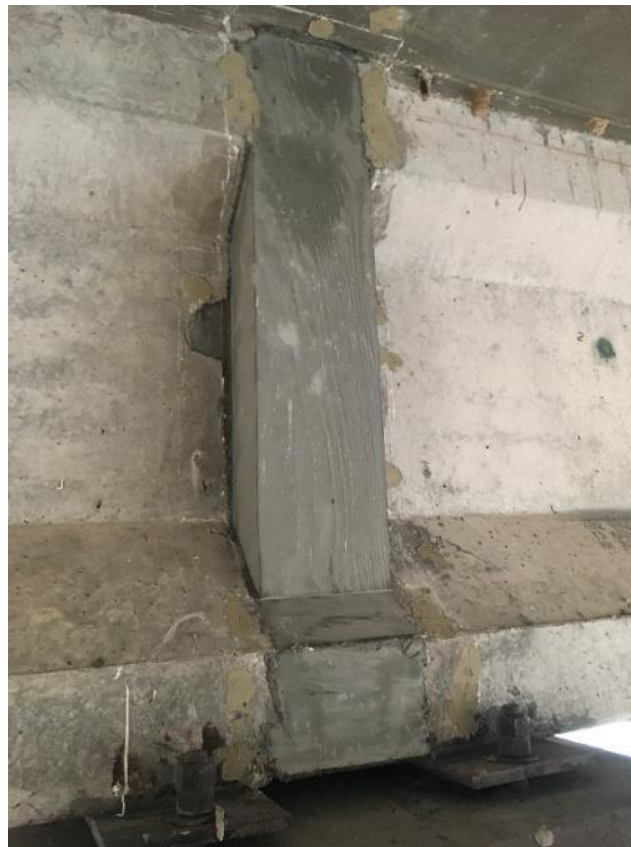
Figure 95. Completed UHPC continuity joint after form removal

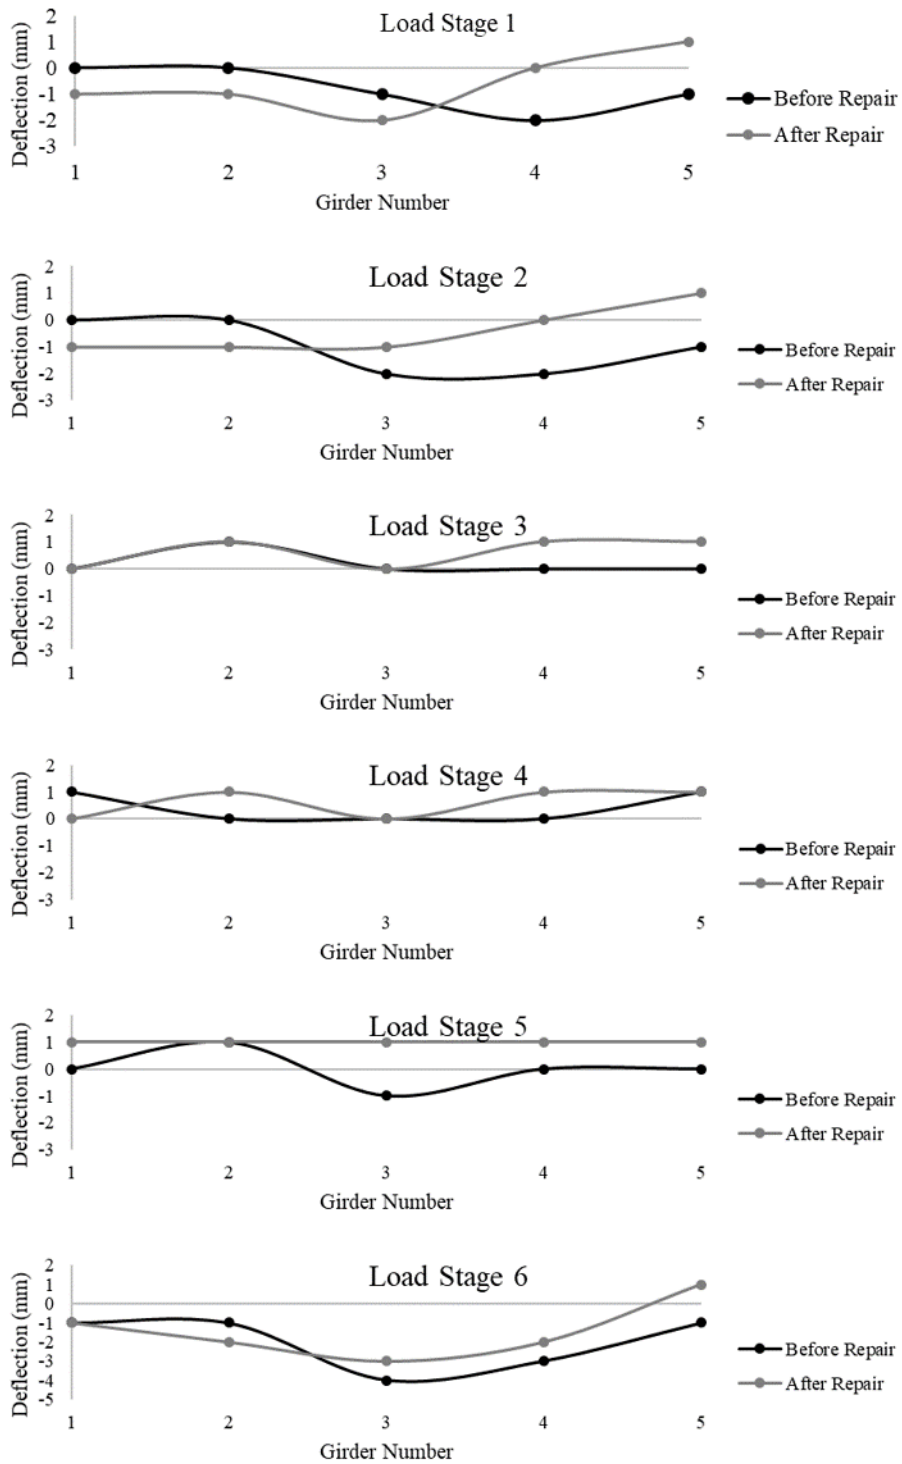
Figure 97. Span 4 midspan deflections during each of the six load stages

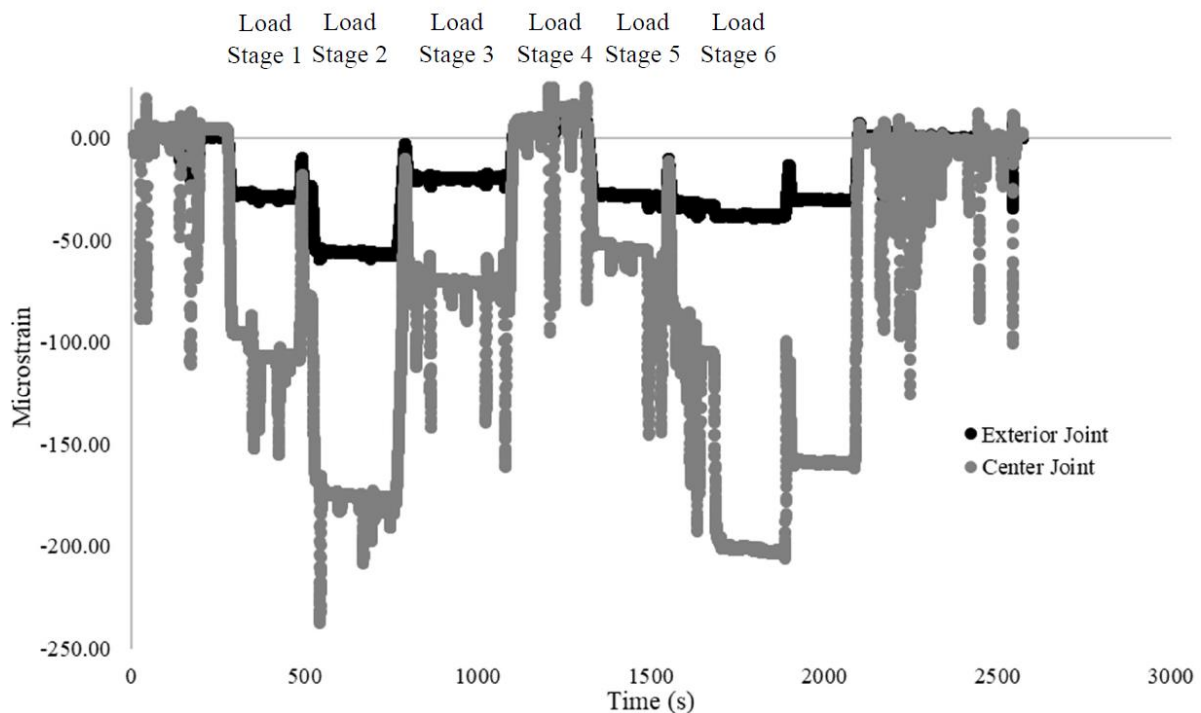
Figure 98. Foil strain gauge data for post-repair load test

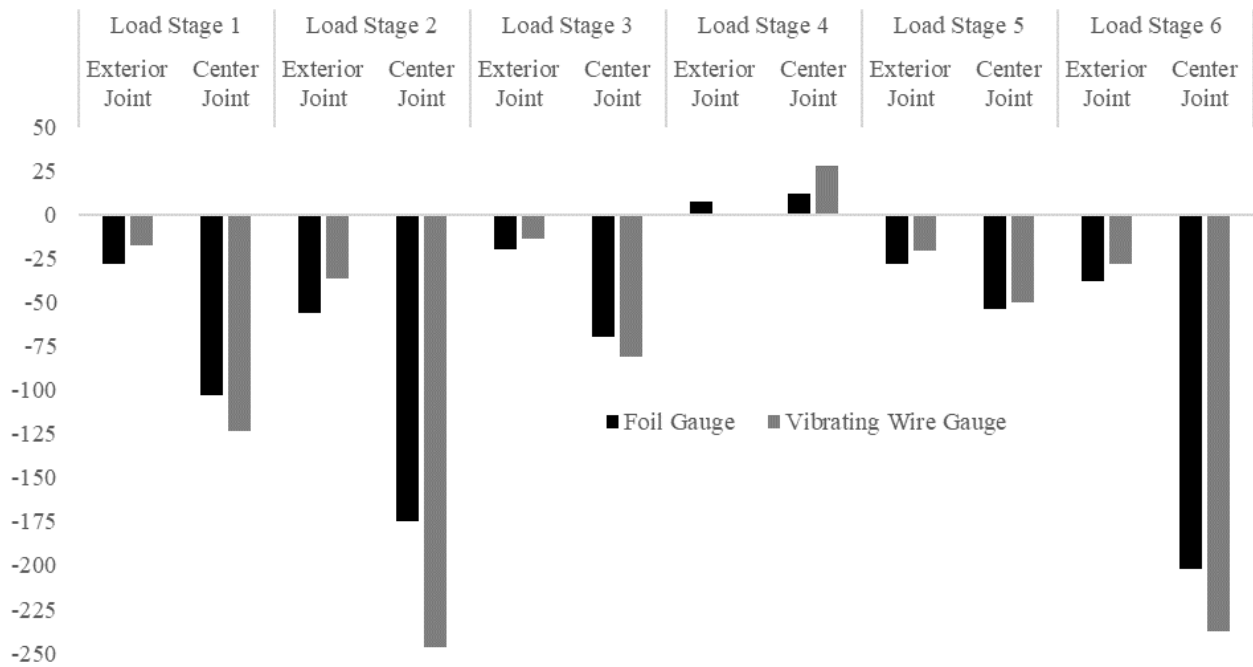
Figure 99. Collected average strain gauge readings

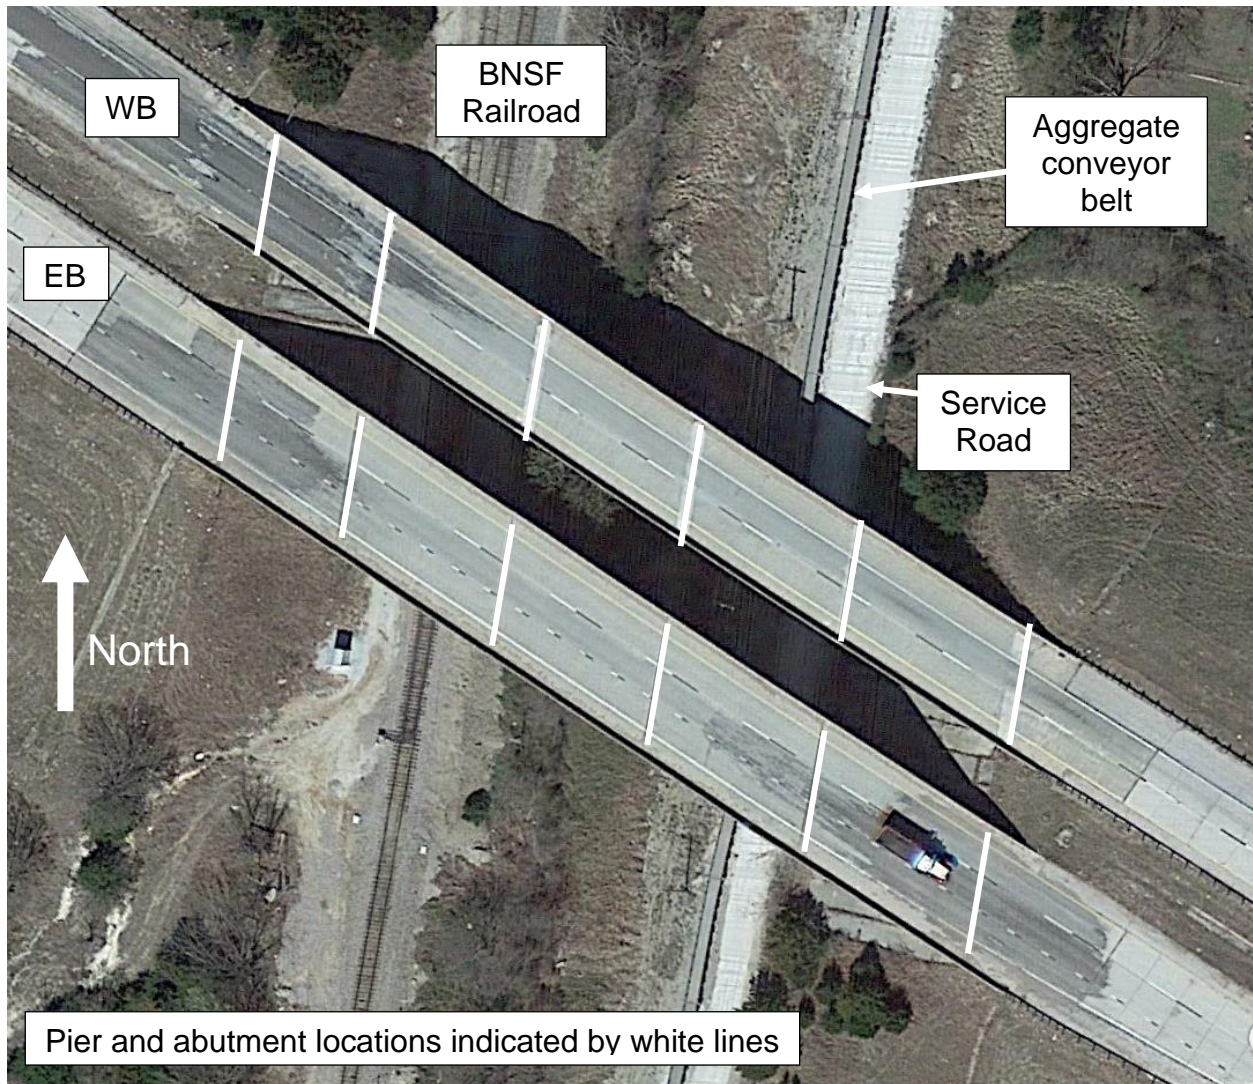
Figure 100. SH-3 over BNSF Railroad; aerial overview

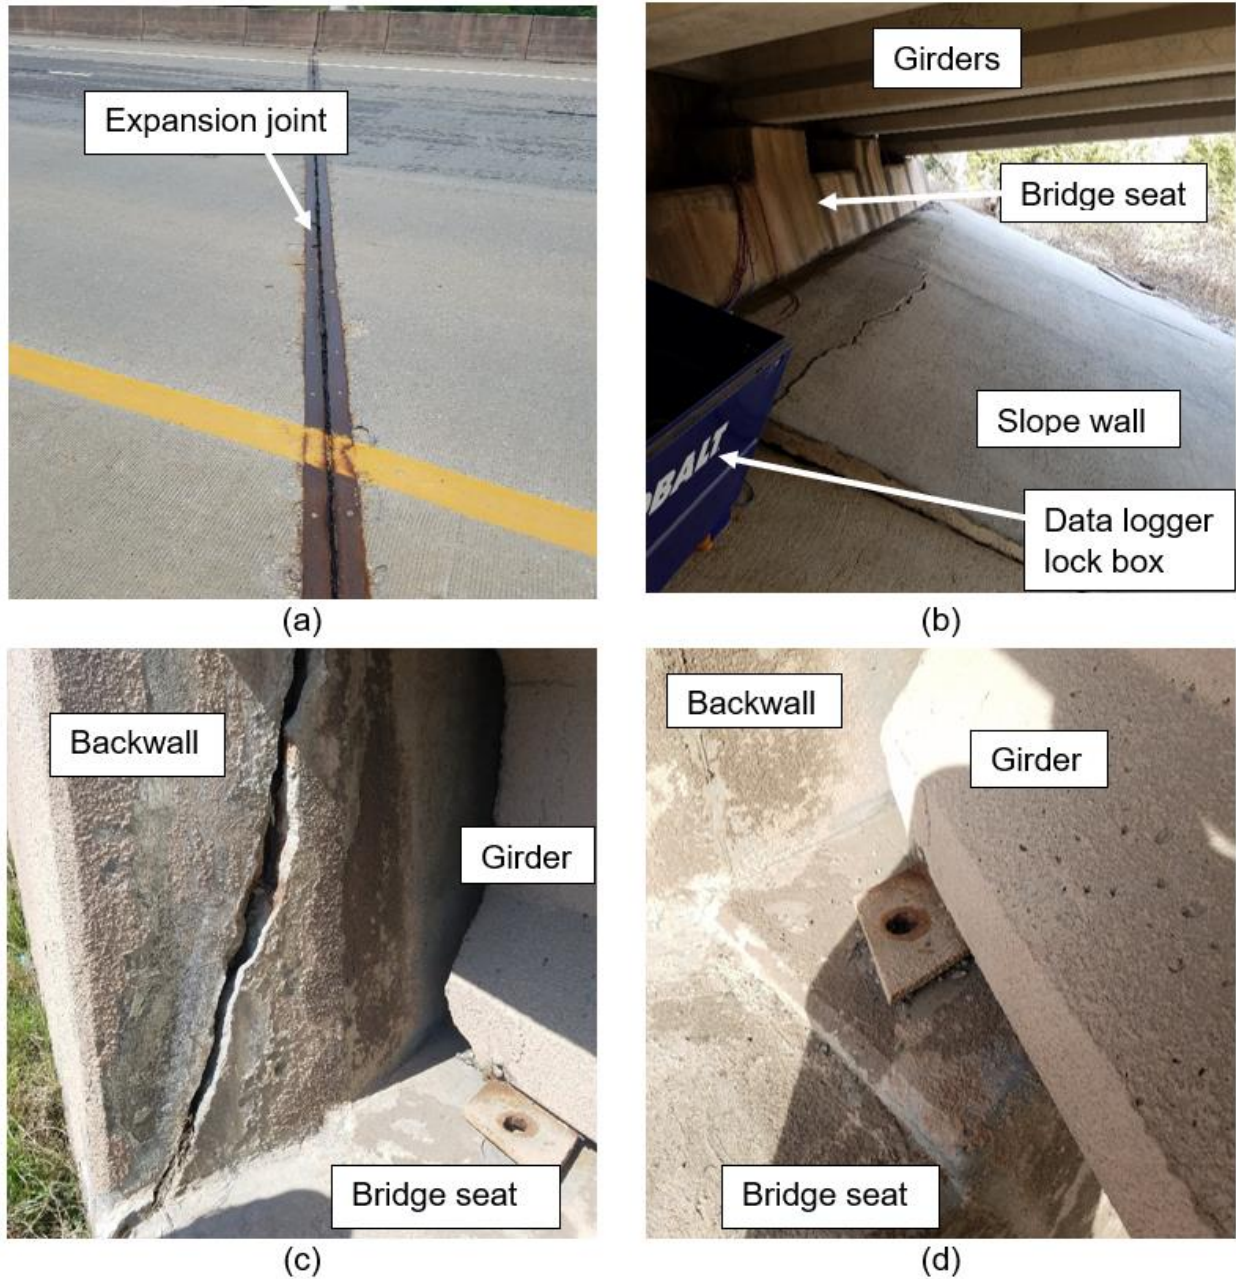
Figure 101. SH-3 over BNSF: Bridge distress (a) closed expansion joint, (b) buckled slope wall, (c) cracked backwall, (d) sheared anchor bolt

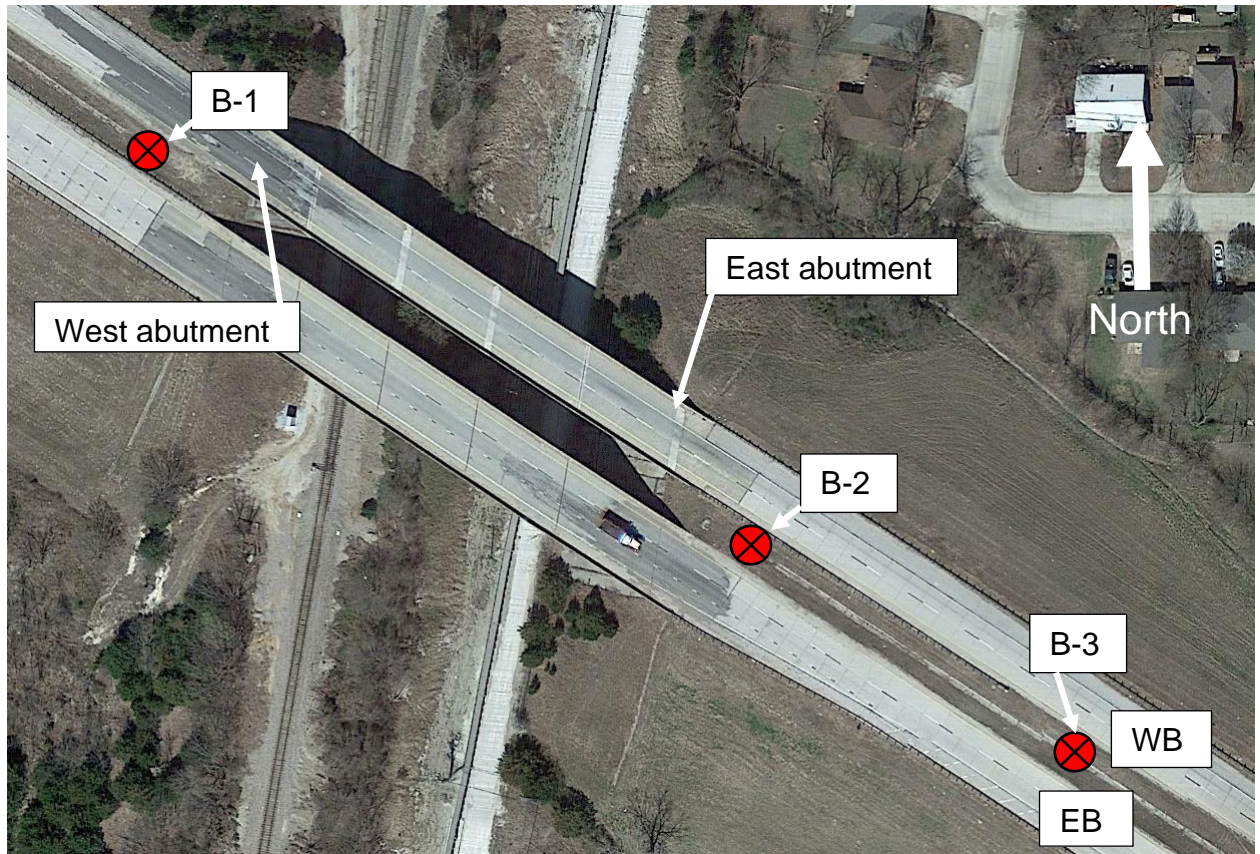
Figure 102. SH-3 over BNSF: Boring locations

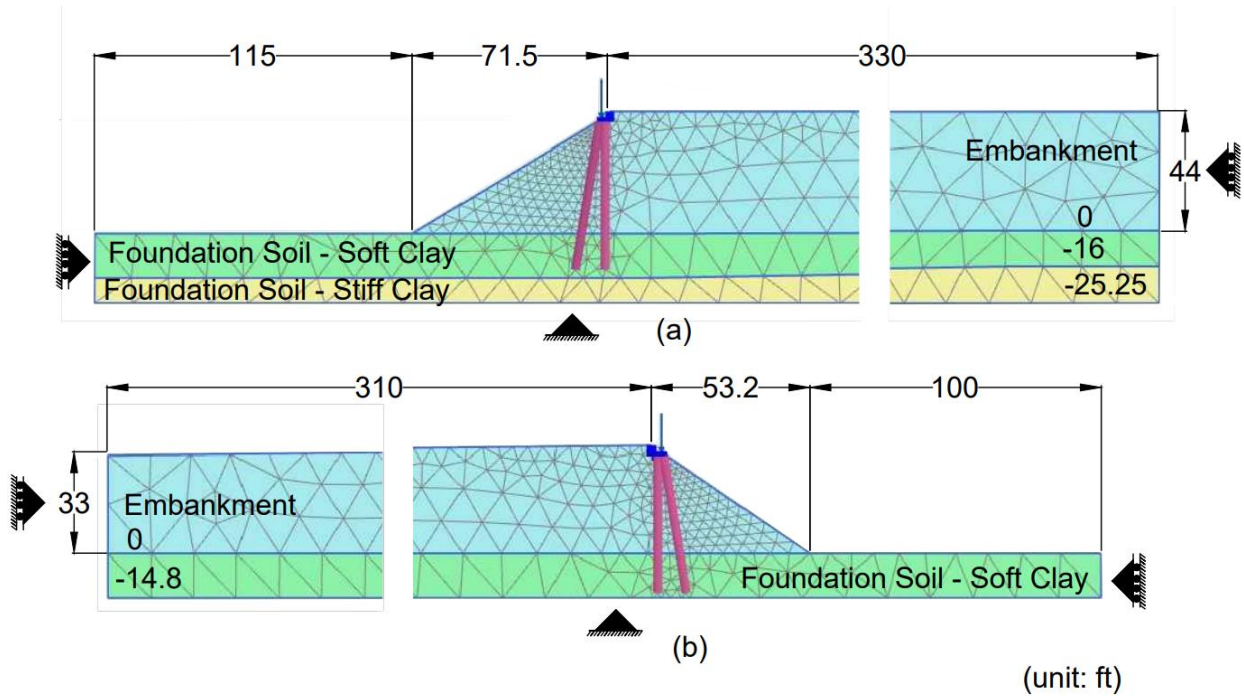
**Figure 104. SH-3 over BNSF Railroad: Finite element mesh
(a) east embankment, (b) west embankment**

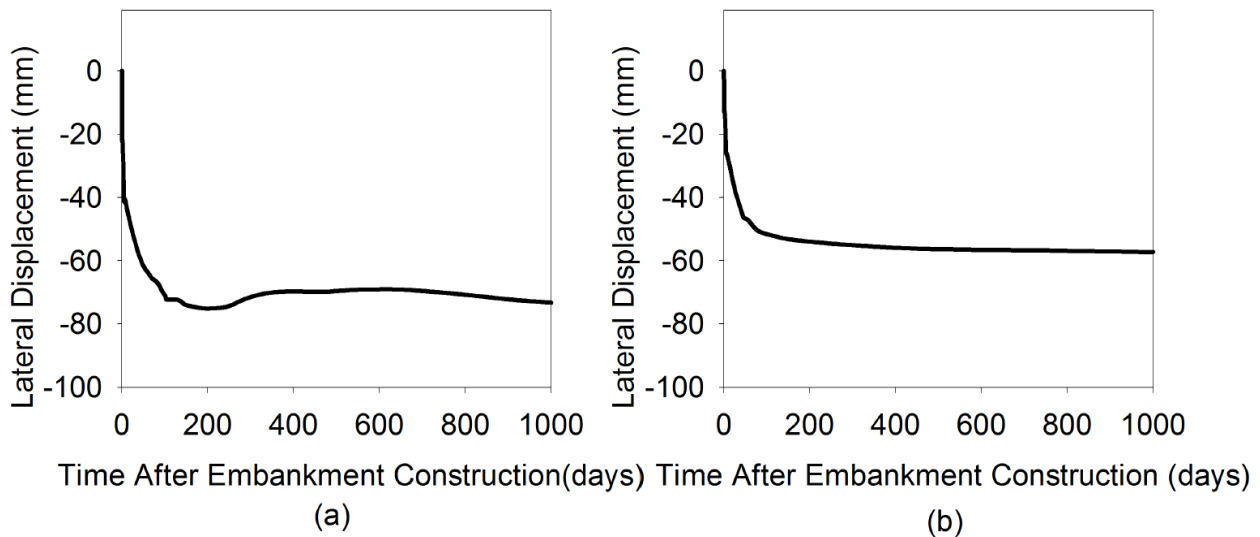
**Figure 106. SH-3 over BNSF Railway: simulated lateral displacement
(a) east embankment, (b) west embankment**

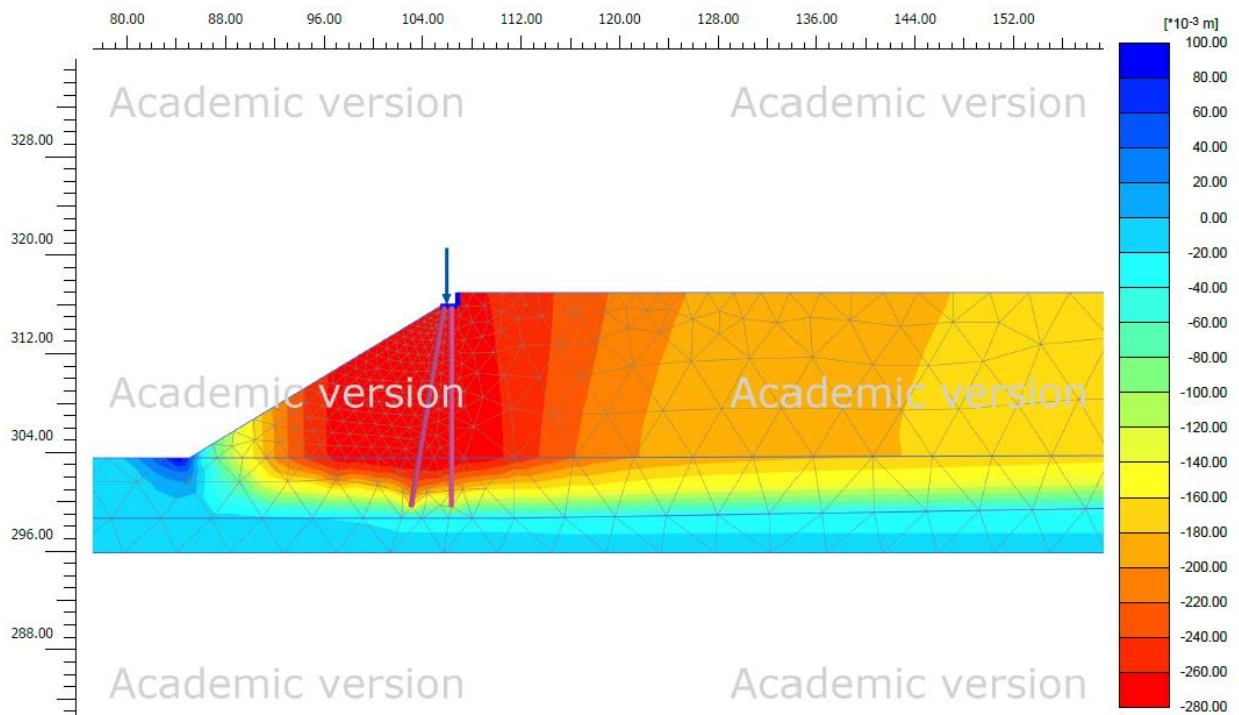
Figure 107. SH-3 over BNSF Railroad: Settlement isochrones – east embankment

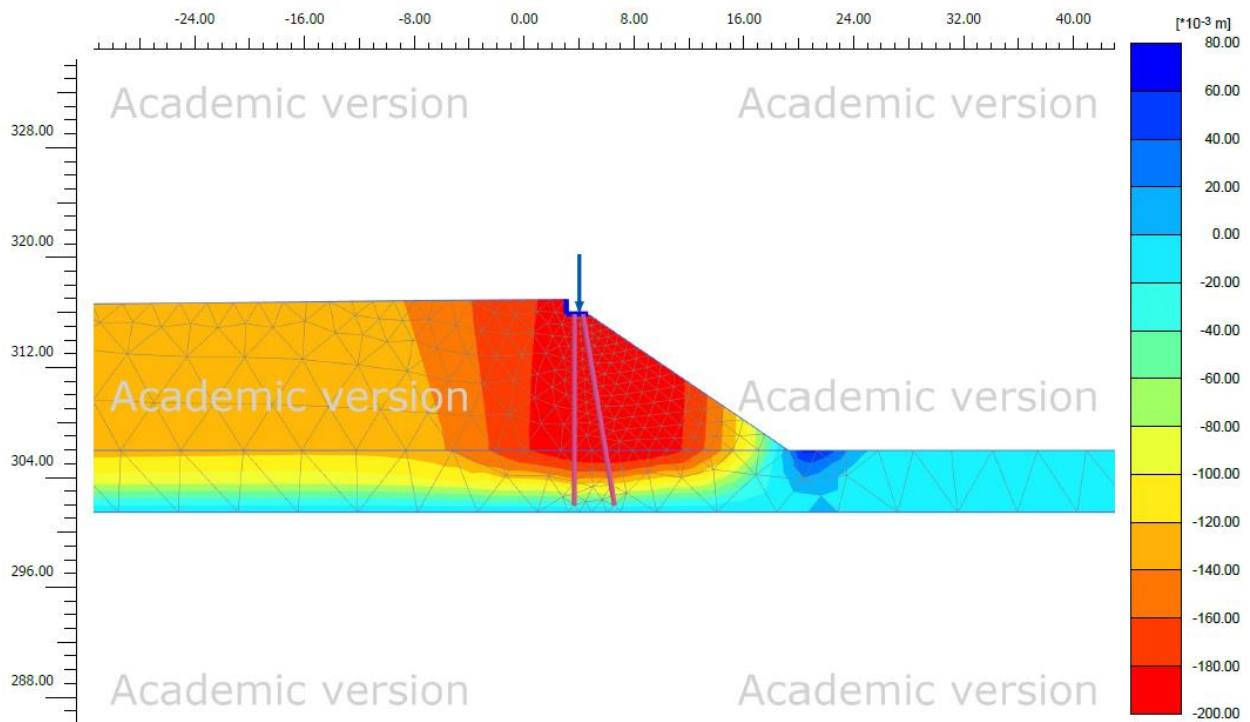
Figure 108. SH-3 over BNSF Railroad: Settlement isochrones – west embankment

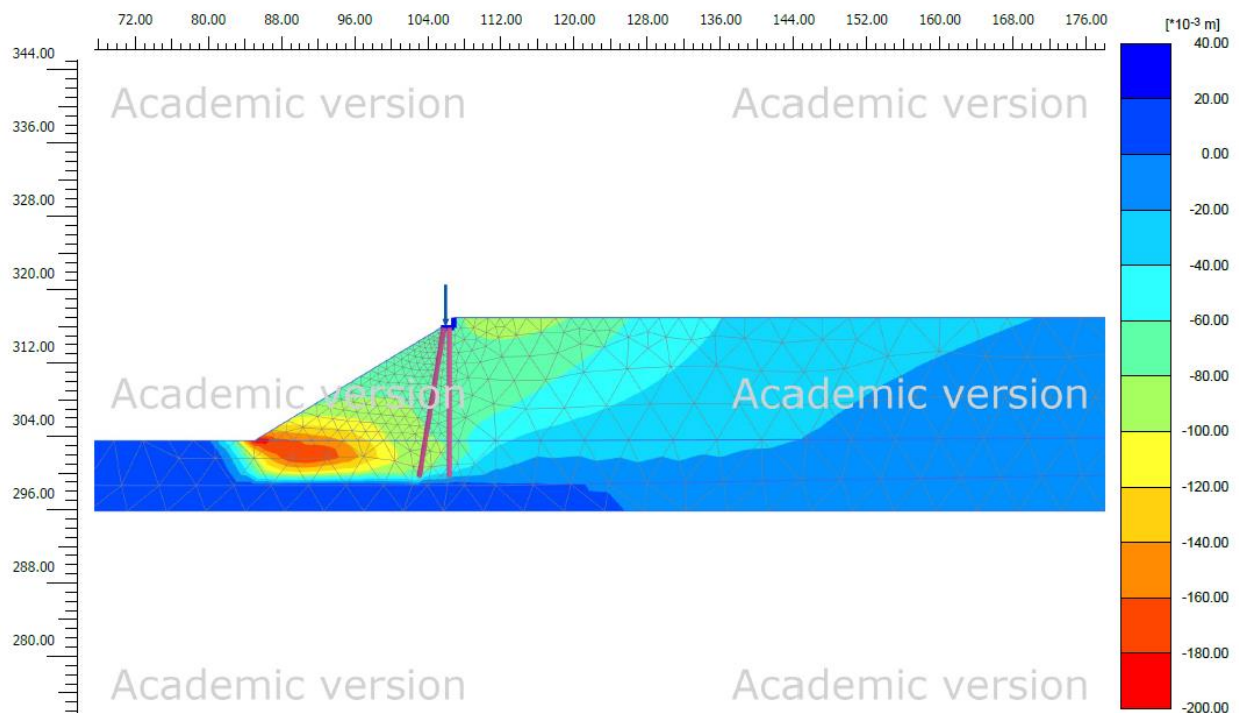
Figure 109. SH-3 over BNSF Railroad: Lateral deformation isochrones – east embankment

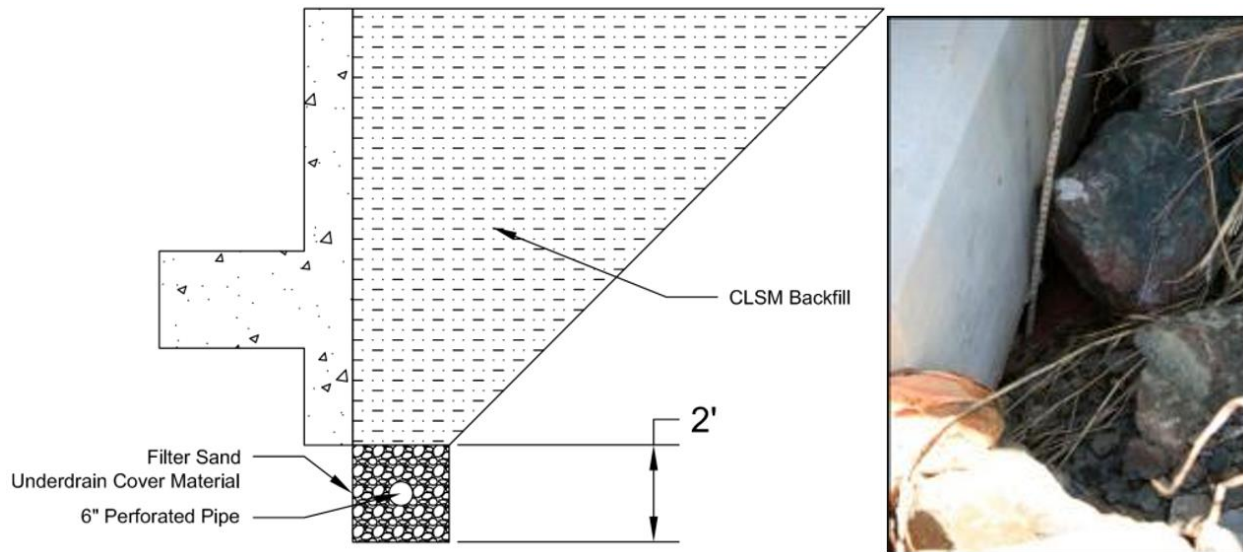
Figure 113. Underdrain design, after ODOT Proposed Plan for S.H. 3W over Big Creek

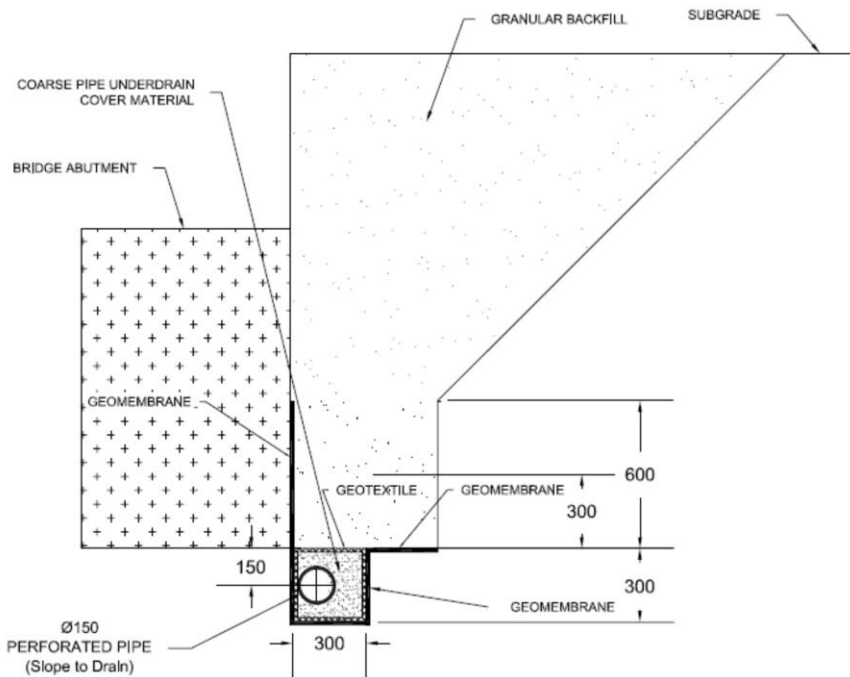
Figure 120. Proposed Abutment Backfill Drainage System, Depressed with Geomembrane and Geotextile Filter (units in mm: 300 mm≈12 inches) (from Miller et al. 2013)

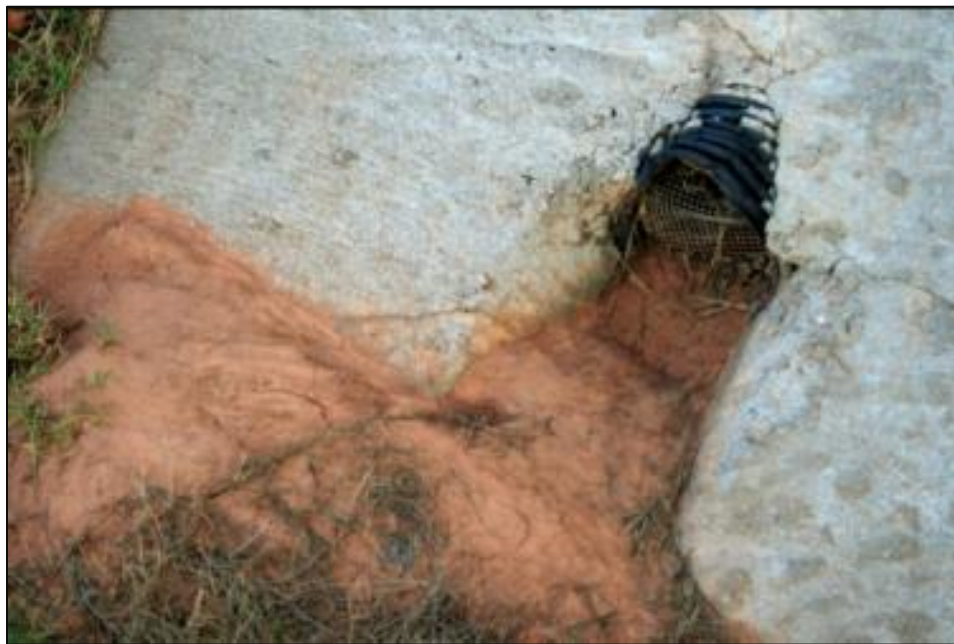
Figure 121. Soil flowing out of underdrain outlet.

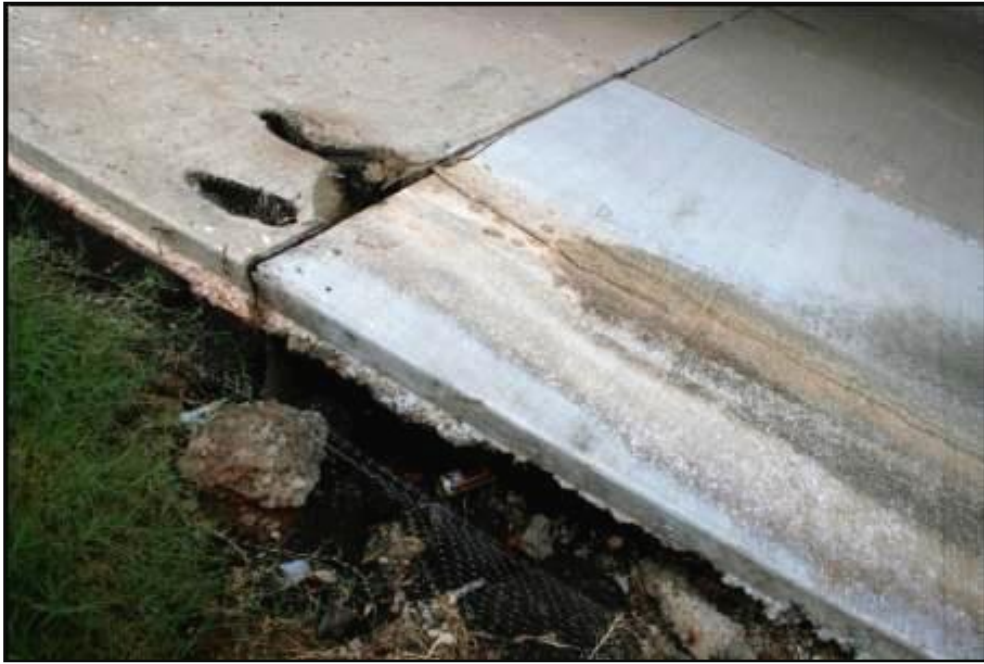
Figure 122. Water flowing from underdrain outlets onto slope wall, Tecumseh Rd. over I-35. (note large void under slope wall)
