FINAL REPORT ~ FHWA-OK-22-02

A SYSTEMS APPROACH FOR DESIGN, CONSTRUCTION, AND MAINTENANCE OF BRIDGES AND ADJACENT ROADWAYS

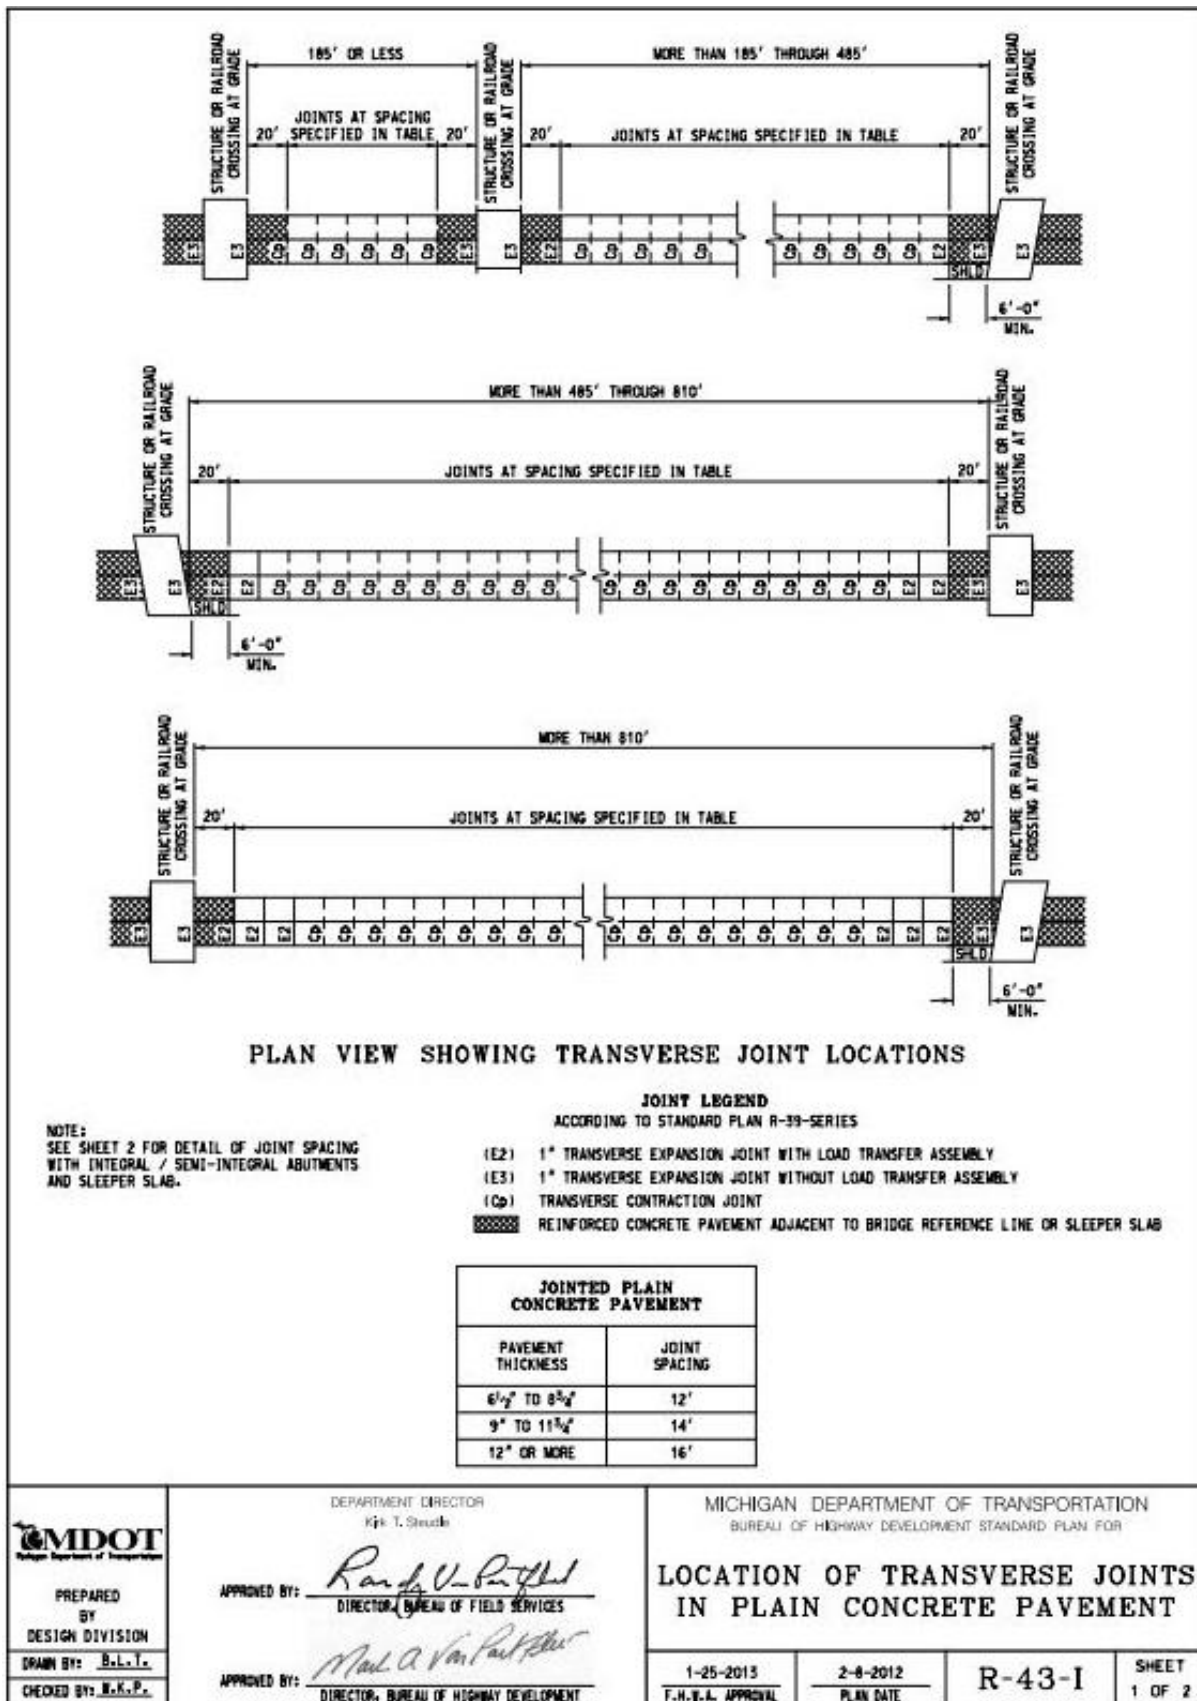
Figure 123. Michigan DOT pressure relief joint spacing standard drawing (from MDOT)

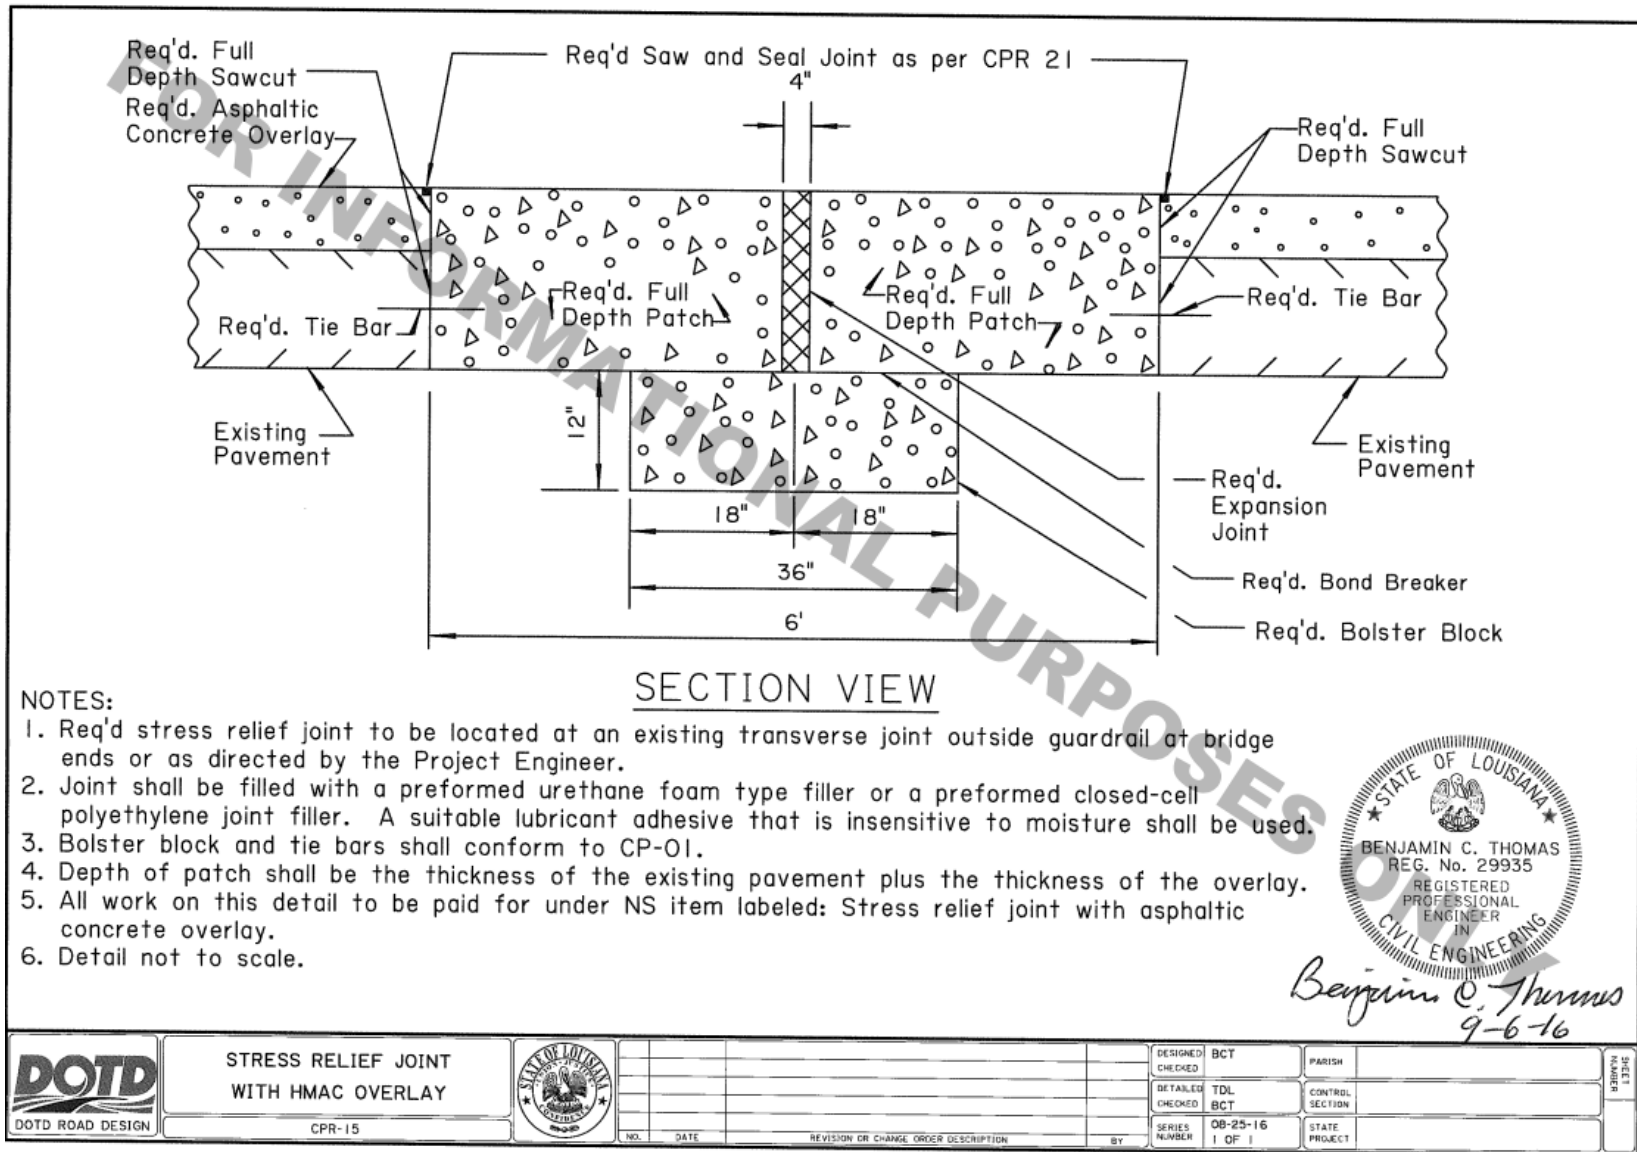
Figure 124. Louisiana DOTD pressure relief joint retrofit standard (from Louisiana DOTD)

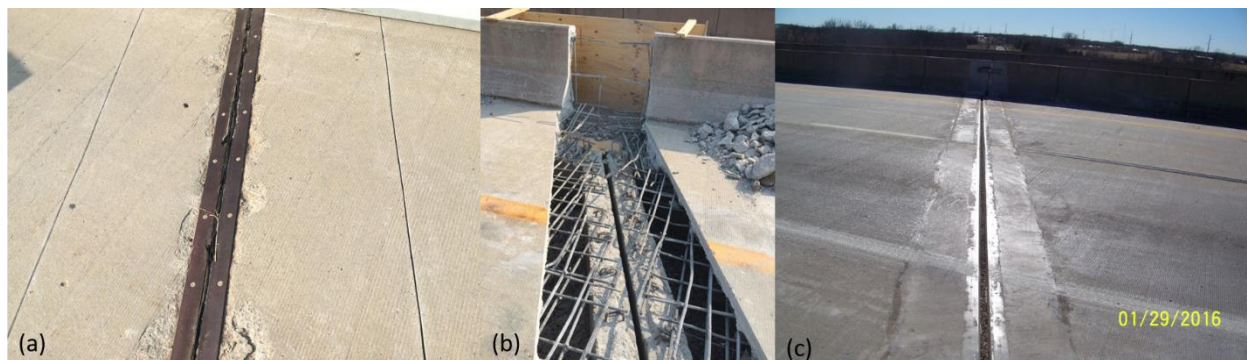
Figure 126. Retrofit of bridge deck expansion joint using conventional concrete (a) before retrofit, (b) after demolition, and (c) after retrofit completion

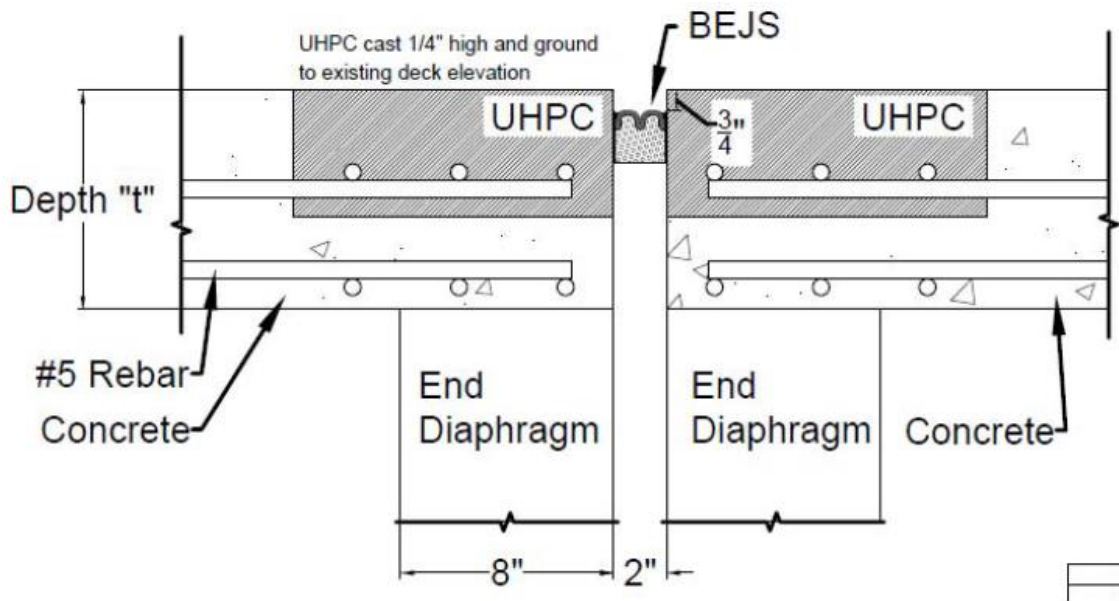
Figure 127. Recommended general detail for UHPC expansion joint headers

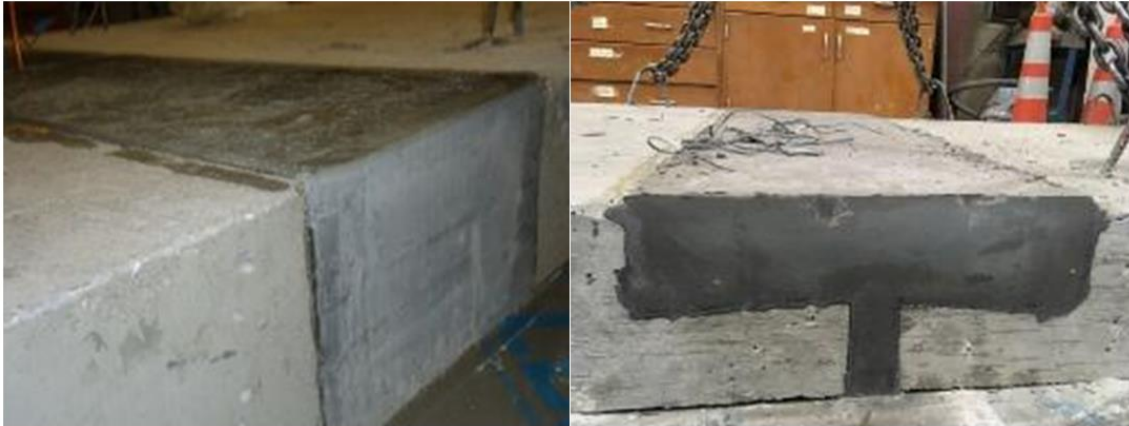
Figure 128. Full-depth (left) and half-depth (right) UHPC connections intended for removal of expansion joints in bridge deck slabs

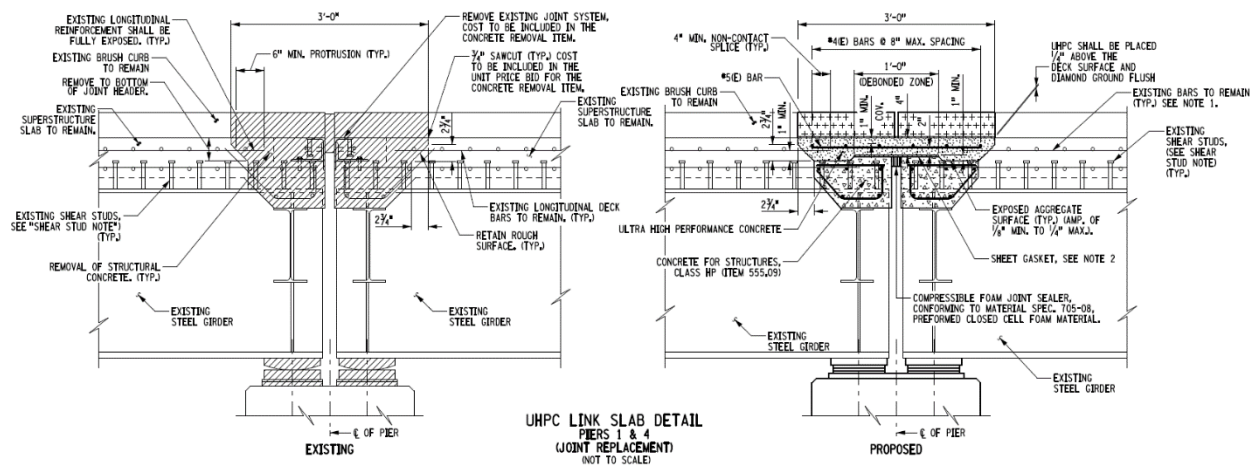
Figure 129. Typical detail for retrofit of an existing expansion joint using a UHPC link slab (NYSDOT)

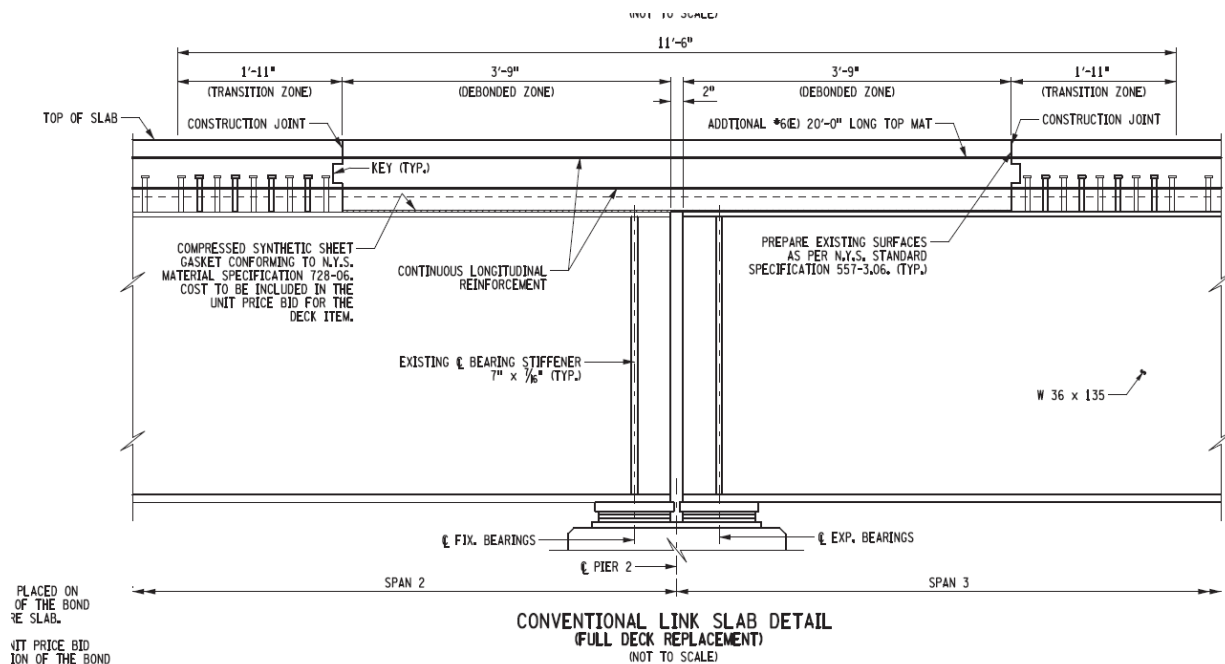
Figure 130. Conventional concrete link slab detail for full-depth deck replacement (NYSDOT)

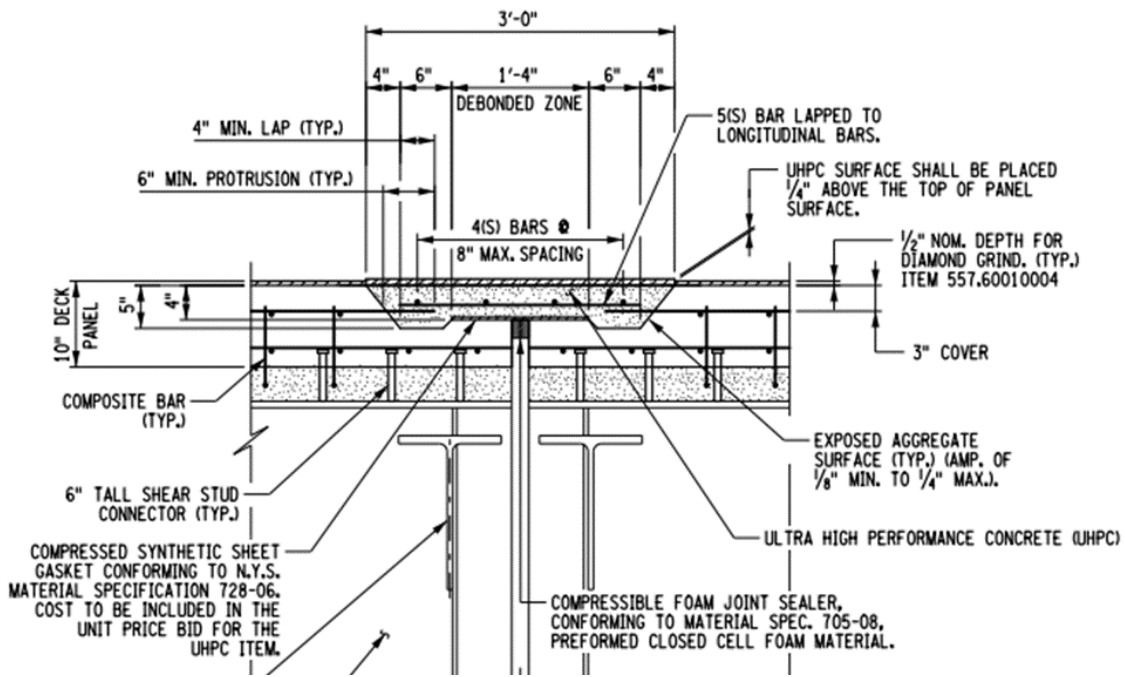
Figure 131 UHPC link slab detail for new construction (NYSDOT)

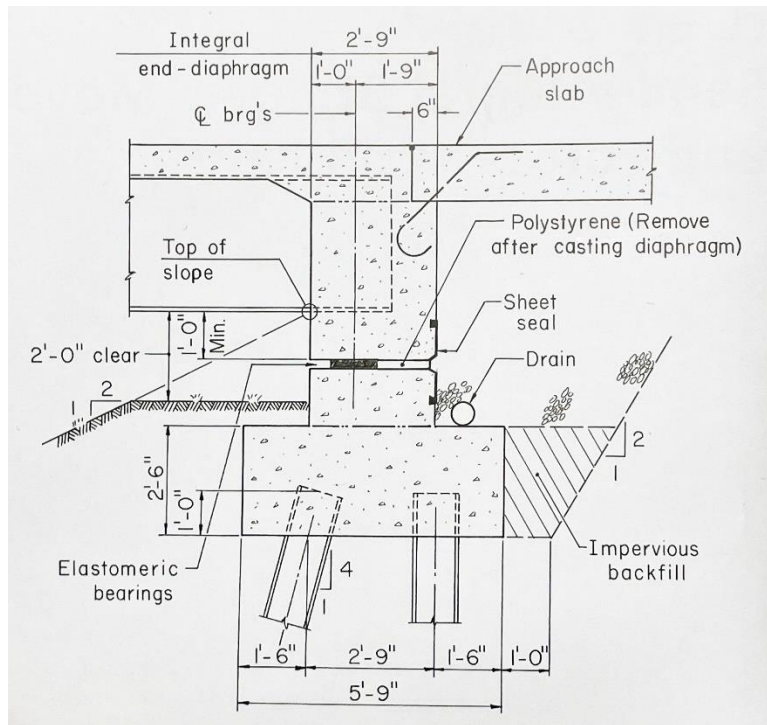
Figure 134. Semi-Integral Abutment Detail (Burke 2009)

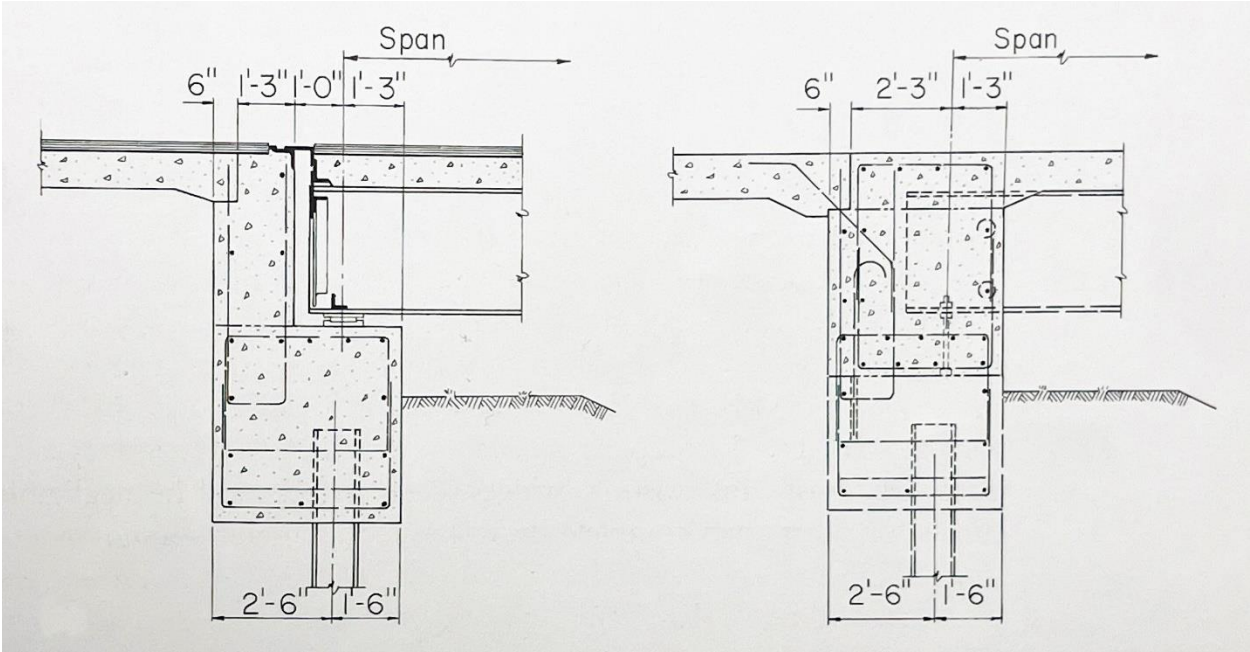
Figure 135 Integral Abutment Conversion: Before (l) and After (r) (Burke 2009)

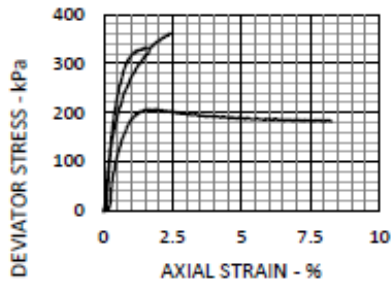
| SAMPLE NO. | 1 | 2 | 3 |

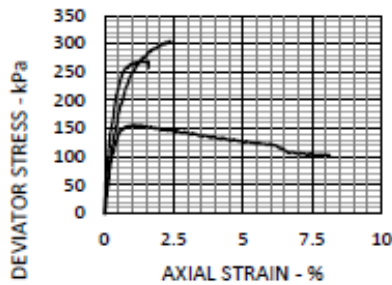
| SAMPLE NO. | 1 | 2 | 3 |

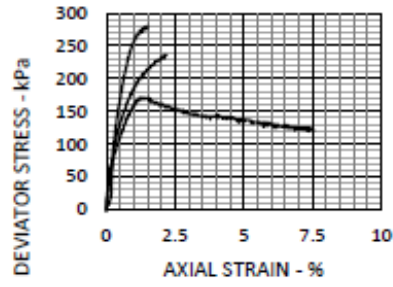
| SAMPLE NO. | 1 | 2 | 3 |

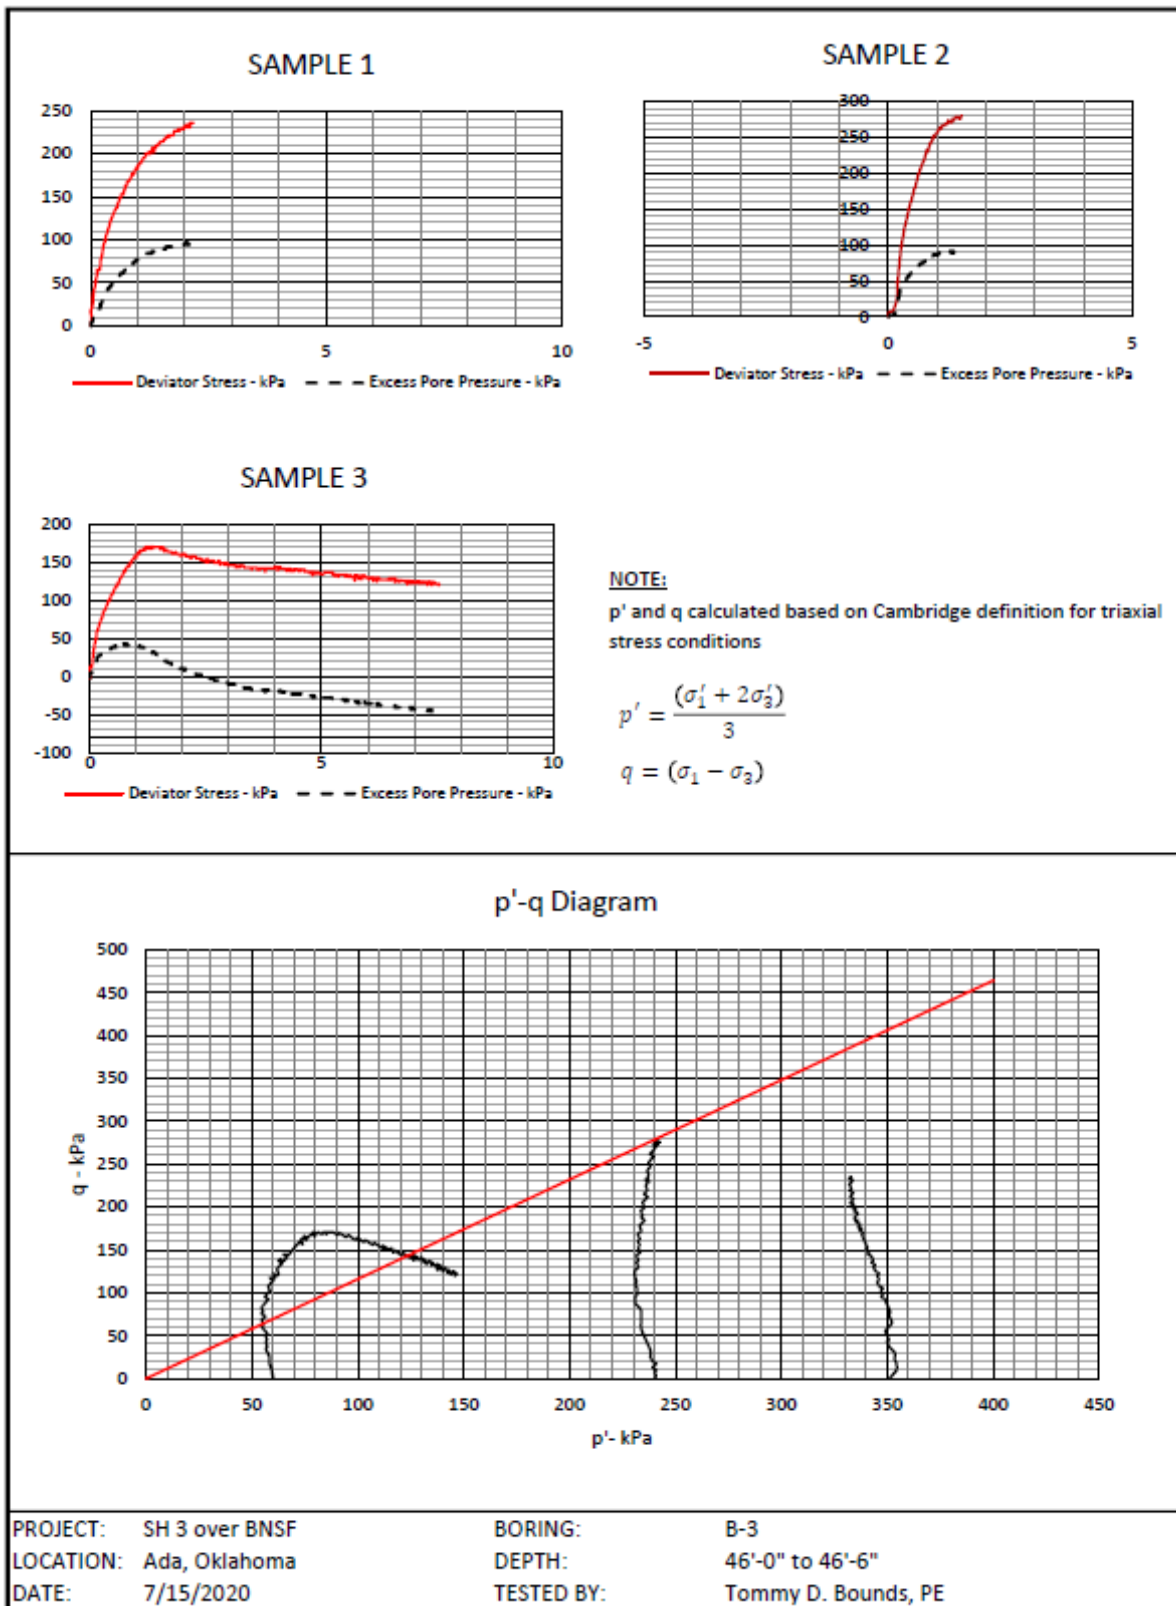
D.3 Triaxial Extension Results

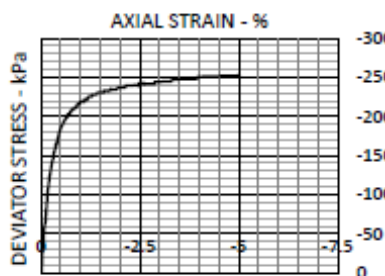
| SAMPLE NO. | 1 | 2 | 3 |
