DIAGNOSTIC AND ANALYSIS OF SELECTED MASONRY RAILWAY BRIDGES ON SLOVAK RAILWAYS

Abstract. The paper presents an overview of the current state of railway masonry arch bridges that are in operation on Slovak Railways. The material of the vault is either stone or brick. It also presents the current possibilities of diagnostics, monitoring and evaluation of failures, the method of measuring selected material characteristics of masonry elements (especially the determination of compressive strength). Within the cooperation of our department and the Research and Development Institute of ŽSR, applications of diagnostic measurements and evaluation of the current state of these bridges are presented on selected bridge structures.

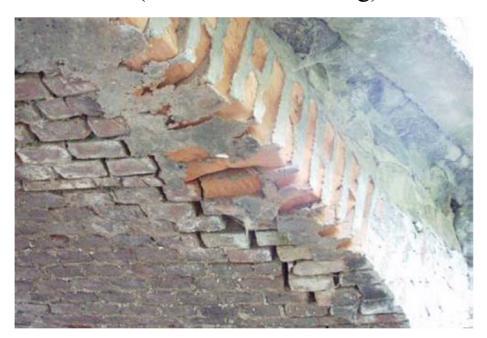
Fig. 2: Opening and falling mortar from joints in a brick vault.

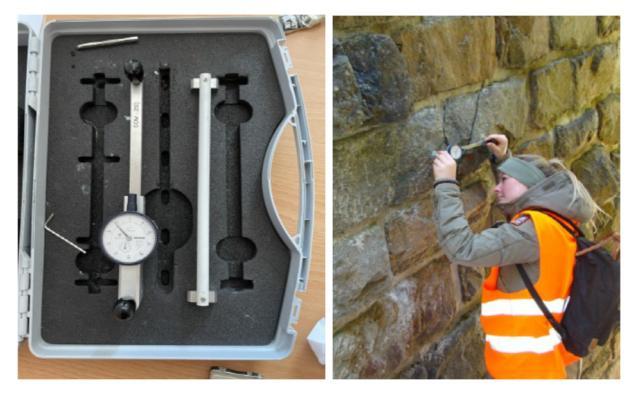
Fig. 3: Deformeter SDM 250/10 and a practical example of measuring the width of the monitored crack.

Faults formed by vertical cracks and fissures in the pillars of the building have been repeatedly measured on the bridge structure since August 2021 [4]. For their comprehensive analysis, measuring points were installed in the aggregate. At these points, the crack width was measured using an SDM 250/10 strain gauge (Fig. 3). The measurement accuracy is determined by a value of 1/100 mm, which is calibrated on the basis of data provided by the Railway Research and Development Institute [4].

The bridge has a long-term non-functional drainage, which causes water to flow into the mortar joints and aggregates through the supporting structure of the bridge, in which local cracks and calcium incrustations subsequently appear. The recorded cracks are located on the north side of the bridge, which is in the shade all year round. On the other hand, the south side is exposed to sunlight all year round and thus it dries out even in winter. Due to the falling temperature and water freezing in the bridge structure, the cracks widen in the winter. On the contrary, crack closure was recorded as temperatures increased.

Whether the cracks are demonstrably widening in the long run will be seen in a longer-term measurement, in which the crack width values are compared throughout the year. In the long run, underestimating the non-functional drainage will lead to further disruption of the stone cladding of the pillars, leakage of vaults and gradual loss of mortar in the joints, which may lead to a reduction of the active area for normal stresses and thus to reducing the load capacity of the bridge. The assessment of the condition of the viaduct, taking into account failures and degradation of materials, must prove a static calculation.

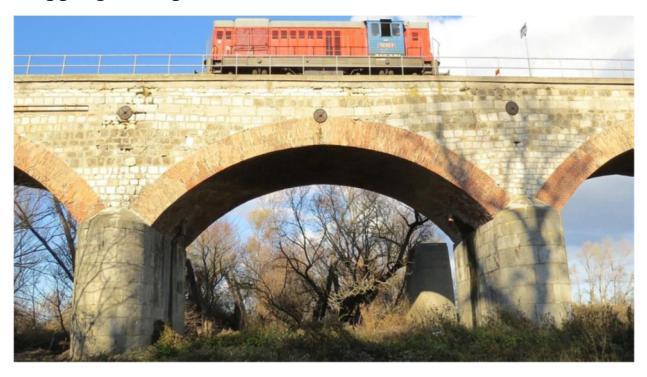
On the bridge object in the vaulted part, the defects are mainly formed by longitudinal cracks in the vaulted ceiling. As part of the diagnostics, crack targeting and mapping were performed.

Fig. 6: Position of the vehicle at the critical point of the vault.

At the same time, a static load test was performed. The position of the vehicle at the critical point of the vault is shown in Fig. 6.

Given the results of diagnostics and static analysis of the bridge, it is necessary:

- operate a bridge with a maximum axle load of 20 tonnes (load category C3),
- operate the bridge at a maximum speed of 70 km / h,
- replace the expansion device (its vertical movement

when passing the individual axles of the trains shows a dynamic excitation on the vault) [5].

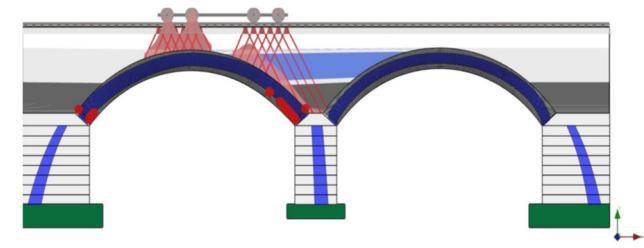
Fig. 7: Model of the arch part of the bridge in the LimitState Ring program.

The static assessment of the bridge was performed in the software LimitState RING (Fig. 7).
