Imperial College London

Mechanical Engineering PhD Thesis

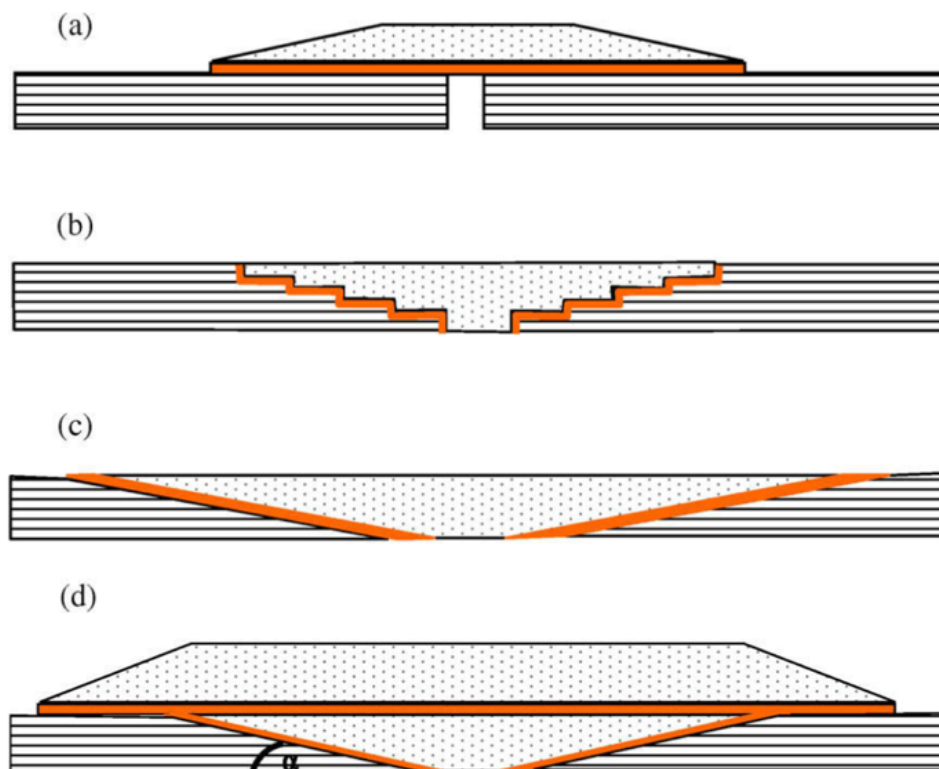
Figure 2-1. Repair configurations discussed by Rider et al. (a) patch repair, (b) stepped scarf repair, (c) scarf repair and (d) scarf and patch repair [2].

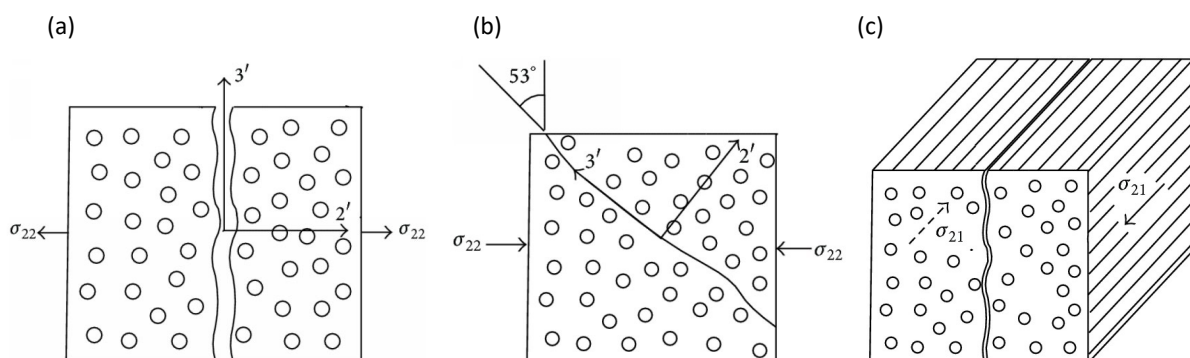
Figure 2-2. Matrix cracking in composite laminates under (a) tension, (b) compression, and (c) shear loading [14].

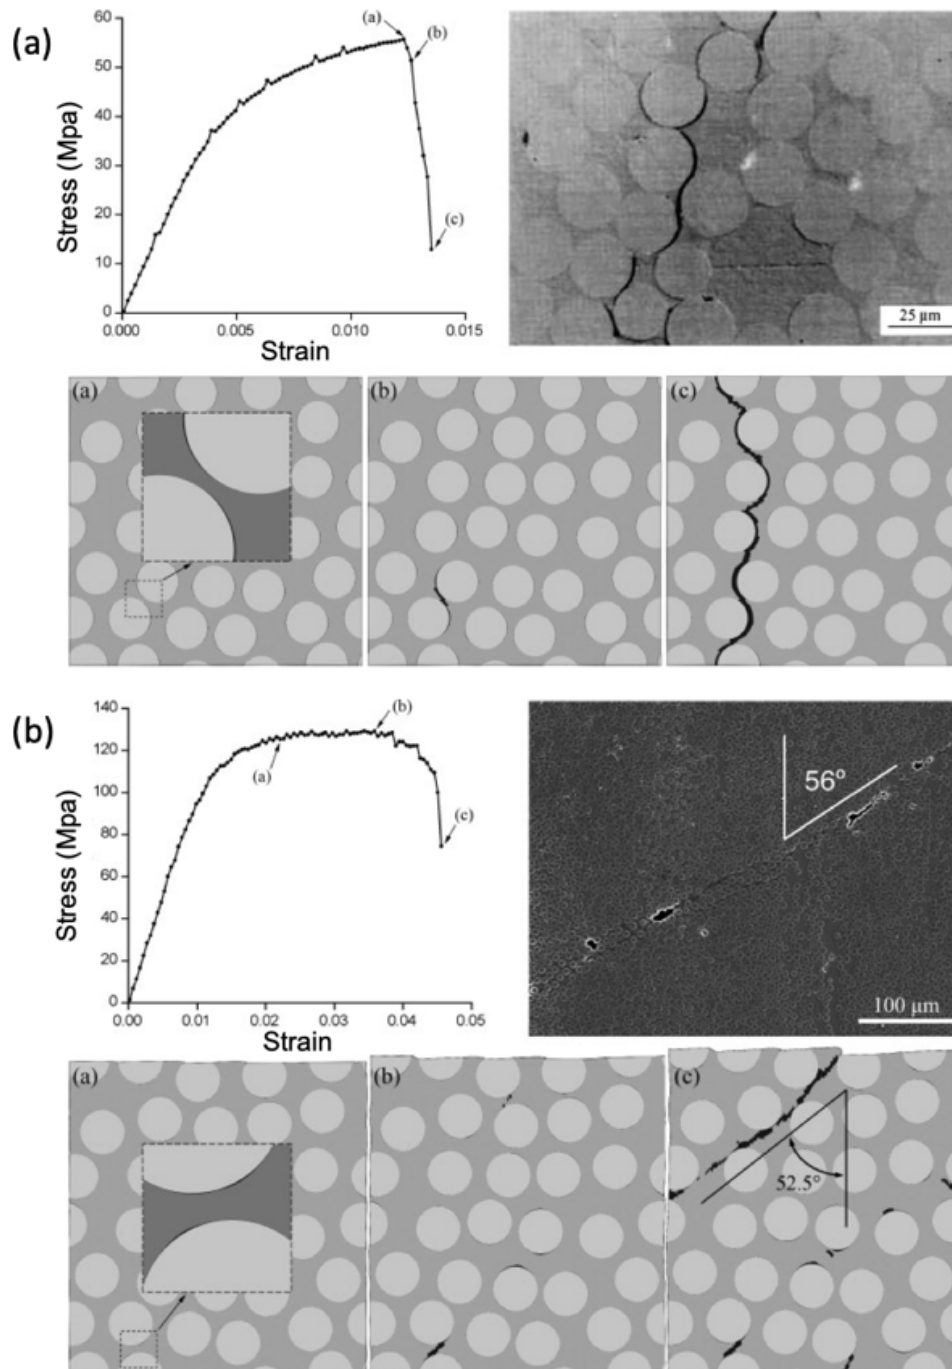
Figure 2-3. Fibre and matrix de-bonding leading to matrix cracking in a fibre reinforced composite loaded under (a) tension, and (b) compression [16].

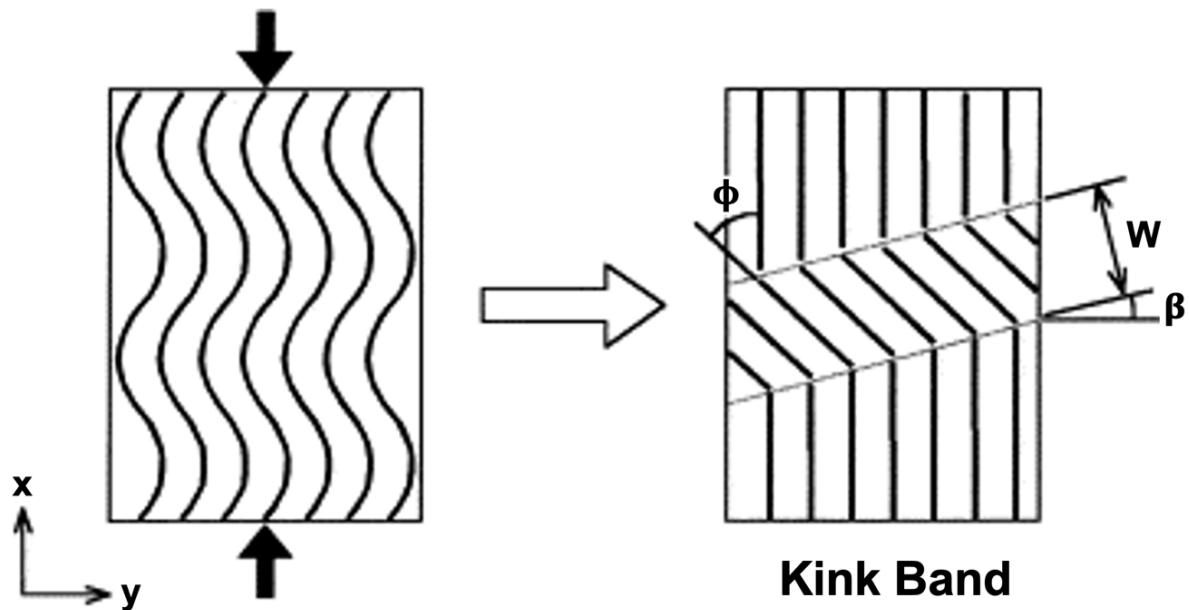
Figure 2-4. Diagram of a kink band [17].

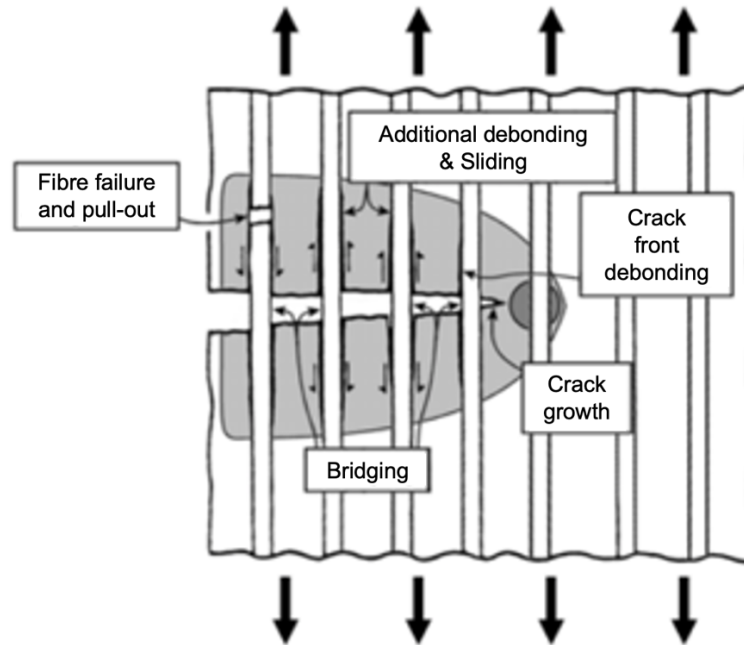
Figure 2-5. Fibre failure mechanisms under tension [29].

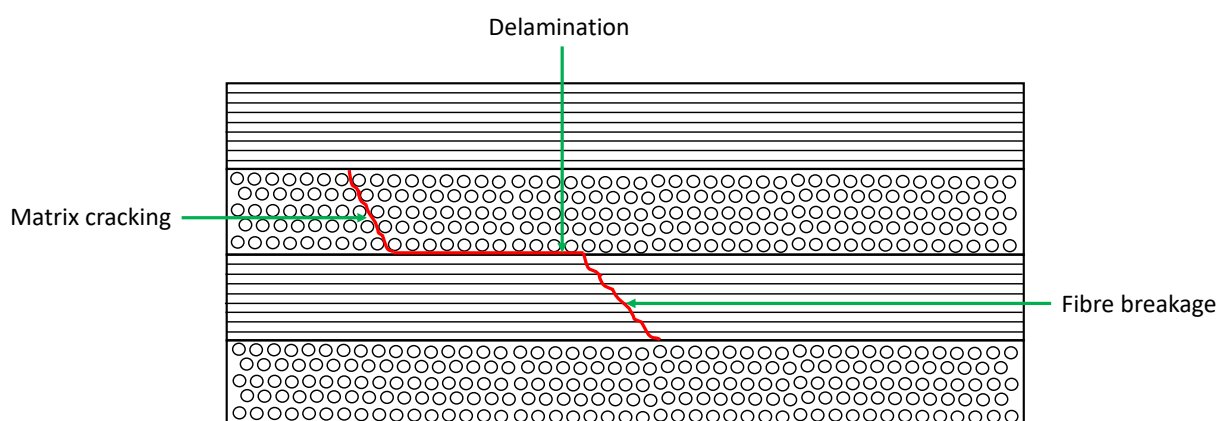
Figure 2-6. Diagram of the damage path in a cross-ply composite panel

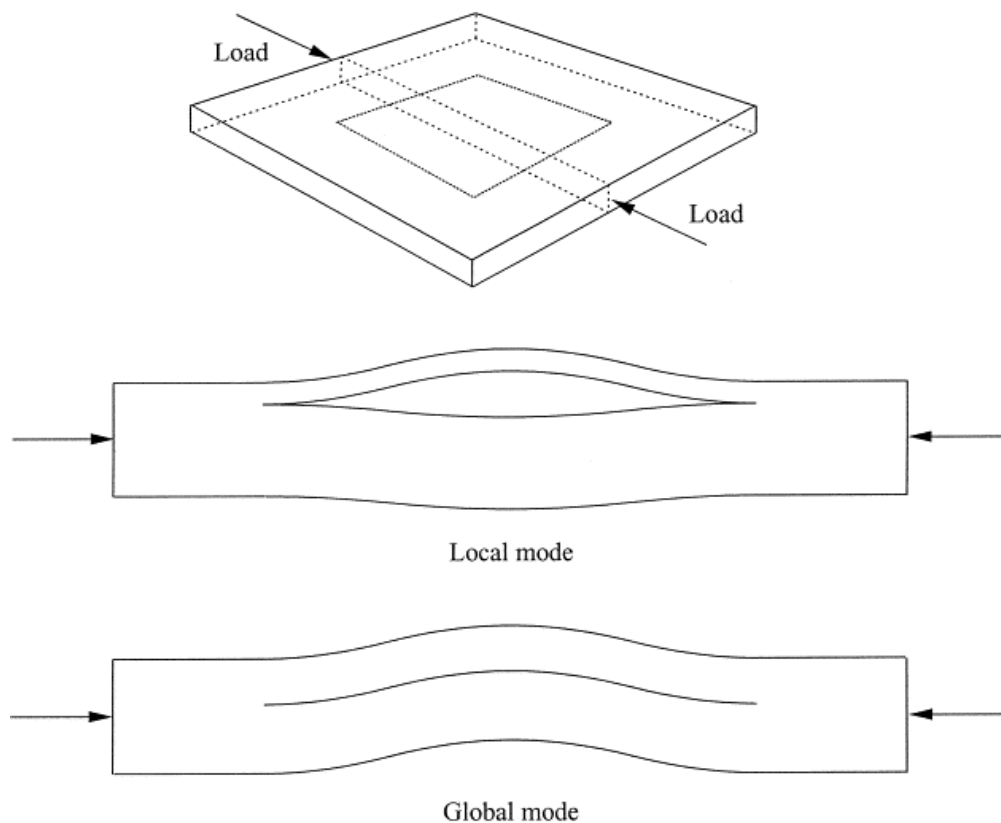
Figure 2-7. Modes of buckling caused by delaminations: (a) local mode when the delamination is large and near the surface of the laminate, and (b) global mode when the delamination is smaller and further down in the laminate [30].

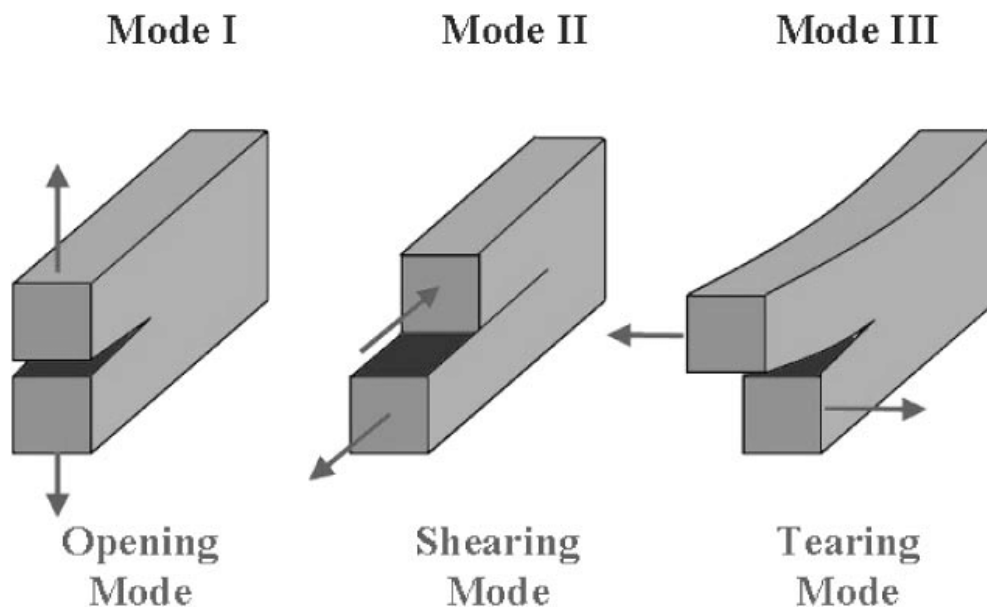
Figure 2-8. Loading conditions that can cause delaminations to grow: (a) Mode I - opening mode, (b) Mode II - sliding mode, and (c) Mode III - Tearing mode [38].

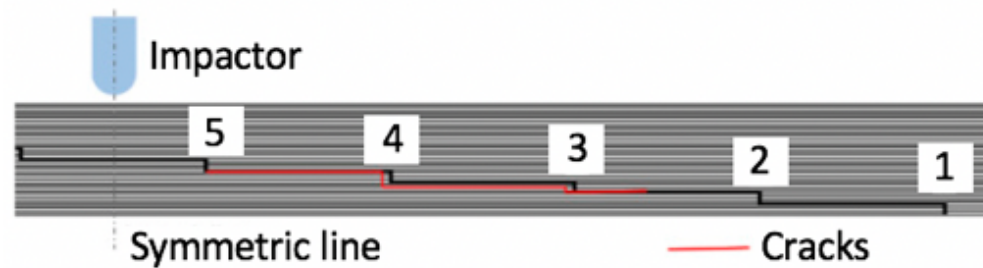
Figure 2-9. Location of cracks from 10 J impact done by Liu et al. [40]

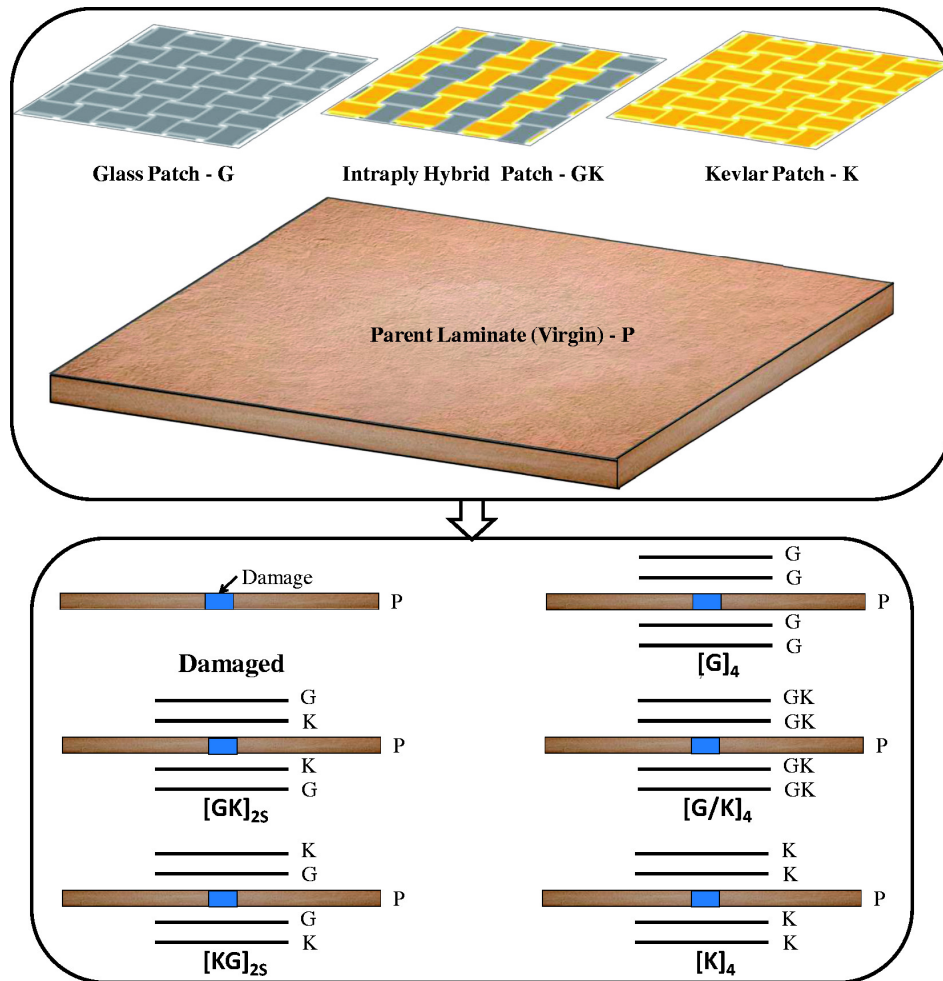
Figure 2-10. Woven glass, kevlar and hybrid patch configurations used by Andrew et al. [45]

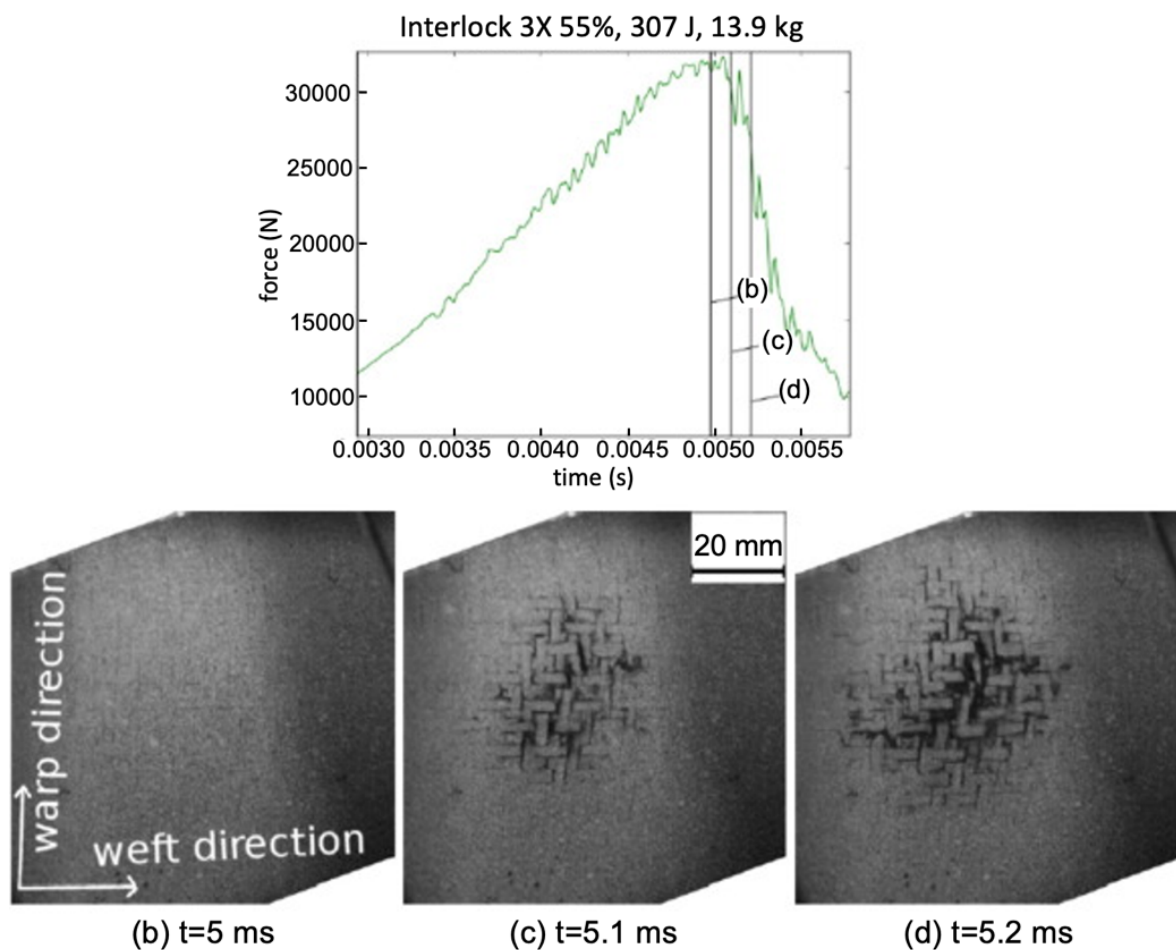
Figure 2-11. Damage progression in a CFRP woven panel with an epoxy matrix at an impact energy of 307 J by Dau et al. [51]

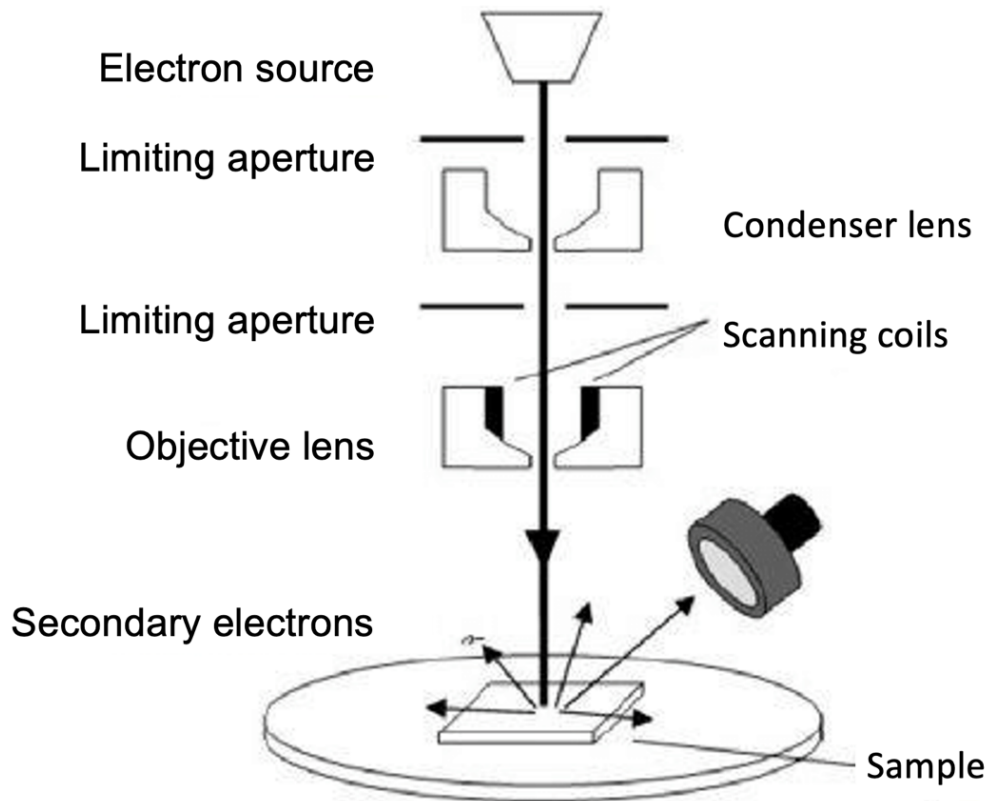
Figure 2-13. Diagram of the set-up of a scanning electron microscope [73].

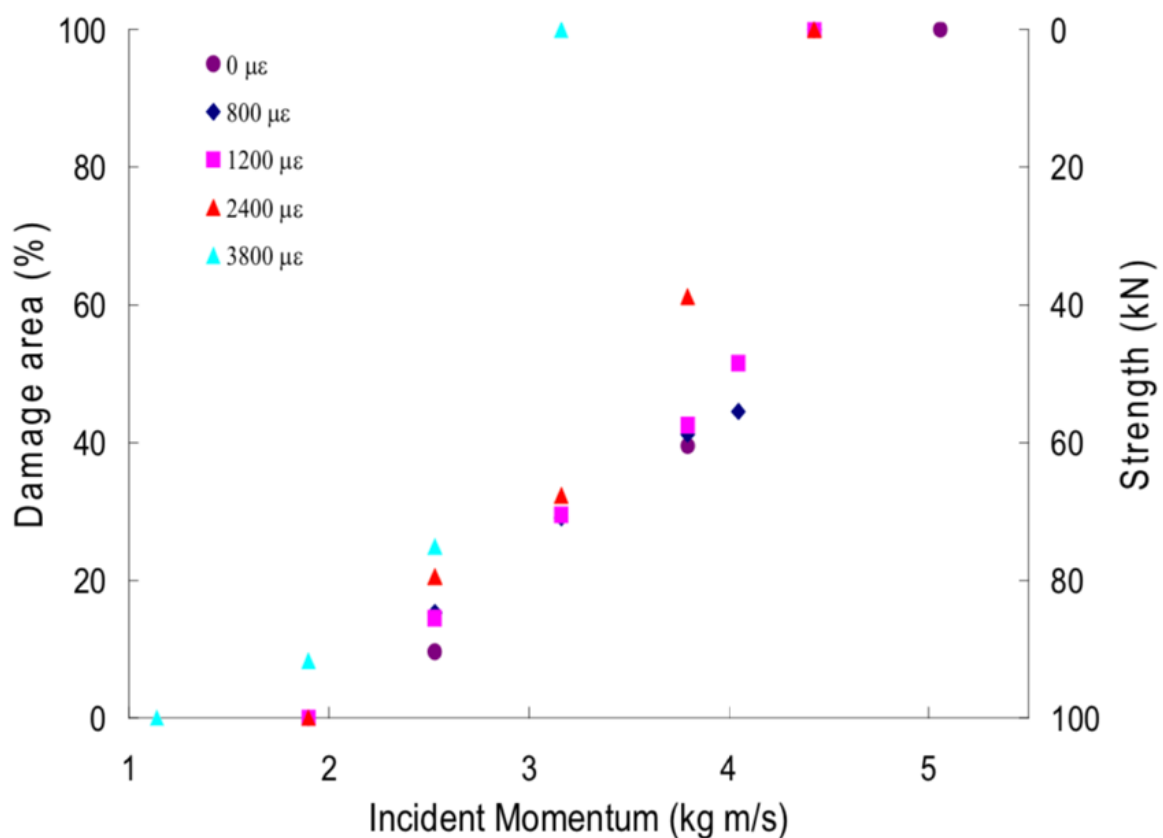
Figure 2-14. Relationship between damage area, strength and incident momentum of scarf repaired composites by Herszberg et al. [43]

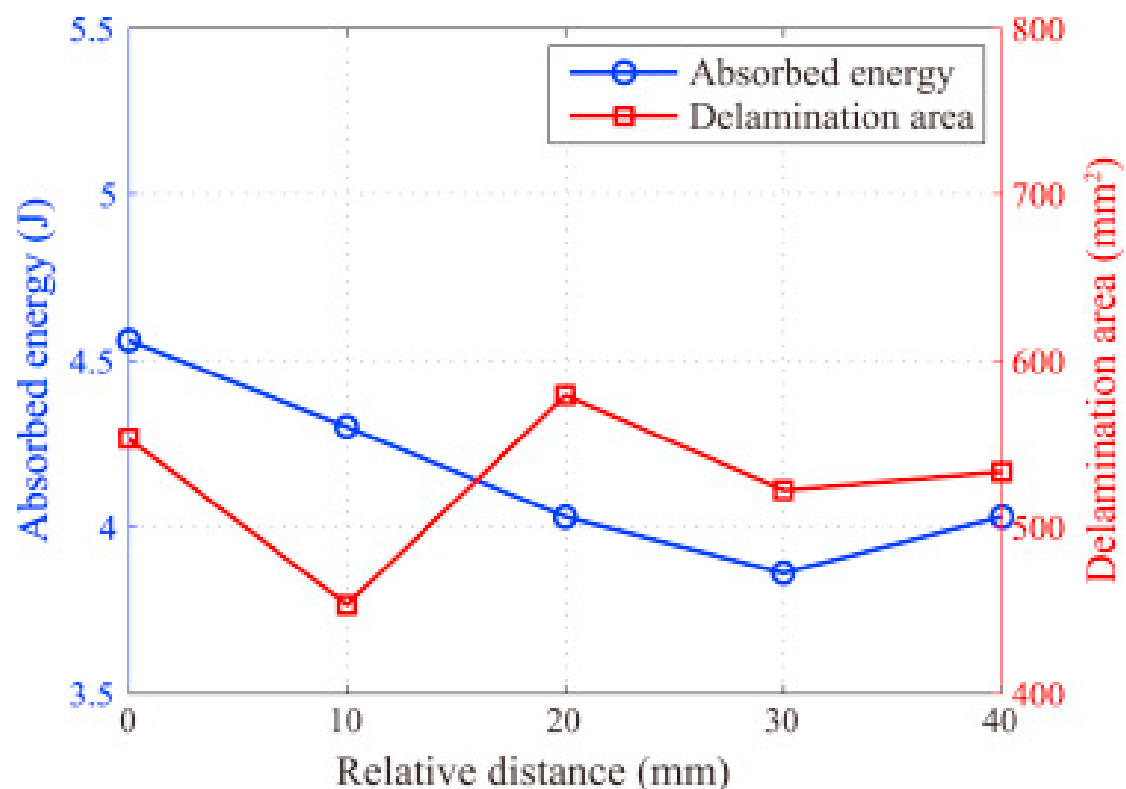
Figure 2-15. Absorbed energy and delamination area of impacts at different distances from the repair by Hou et al. [49]

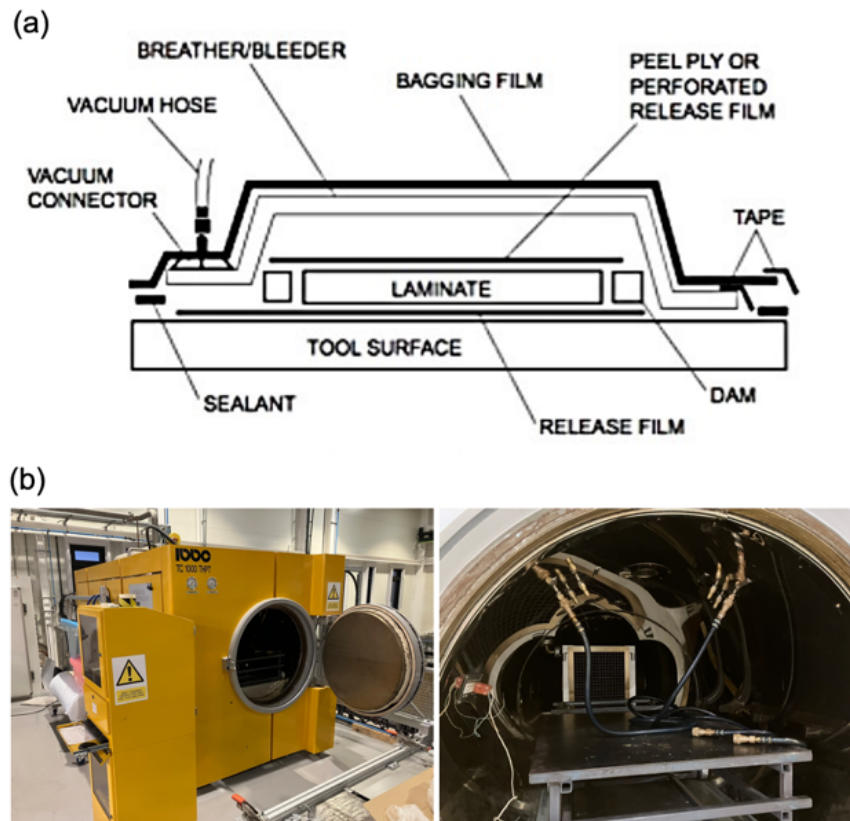
Figure 3-1. (a) Diagram of the curing process to produce laminates from the prepreg [85] and (b) the autoclave used to cure the prepreg and make panels.

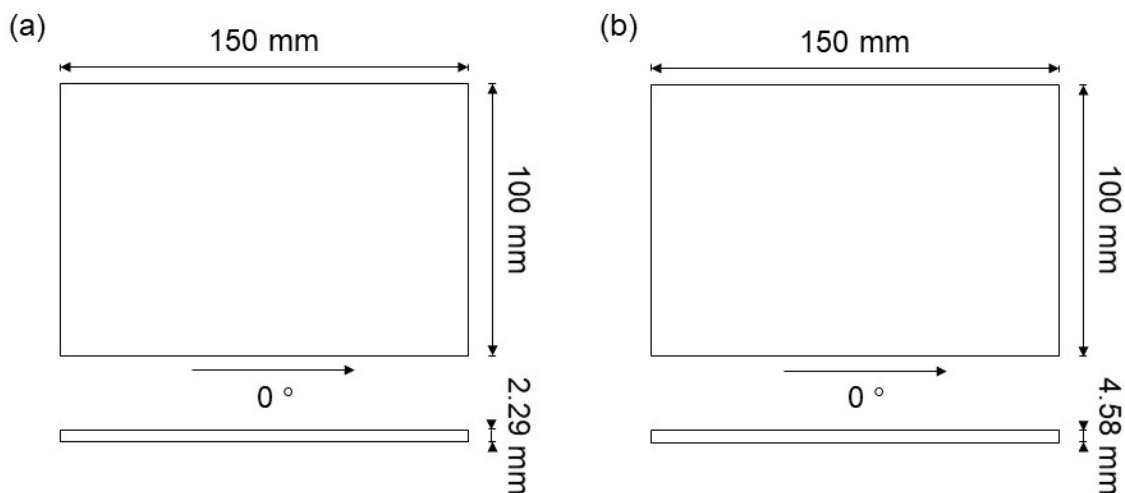
Figure 3-2. Plan- and side-views of (a) a thinner panel and (b) a thicker panel

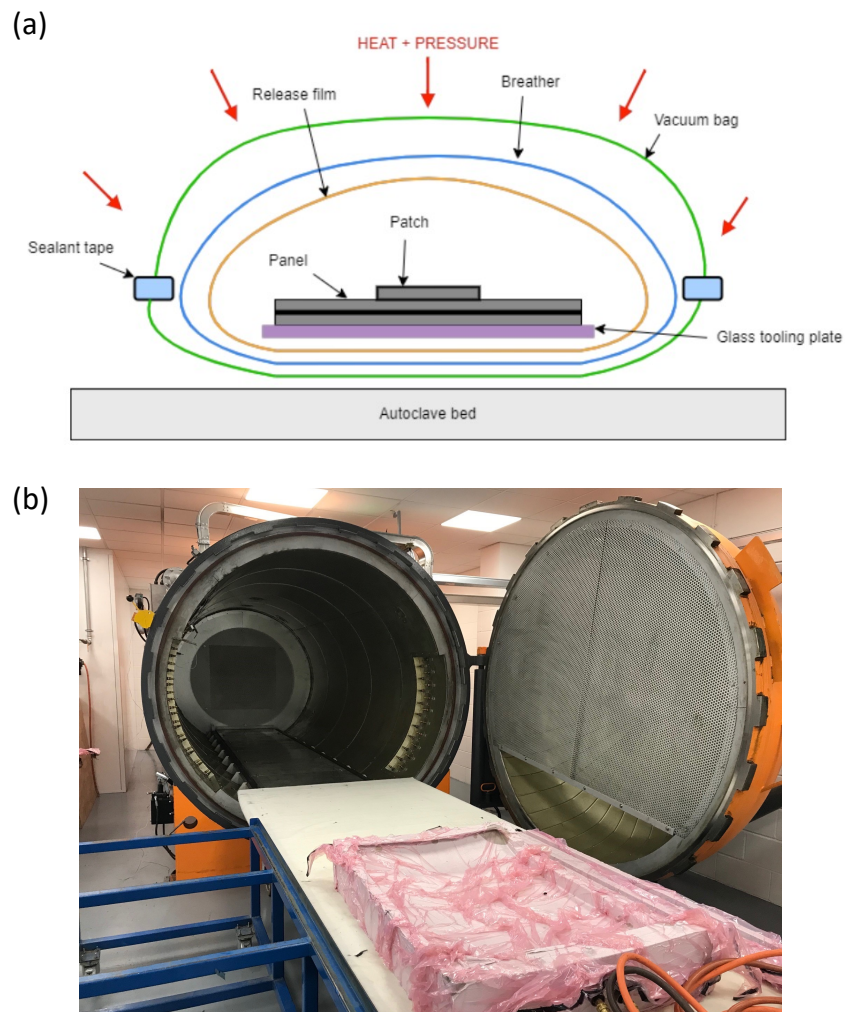
Figure 3-3. (a) Diagram of the curing process to produce repairs [85] and (b) the autoclave used to cure the adhesive for repairs.

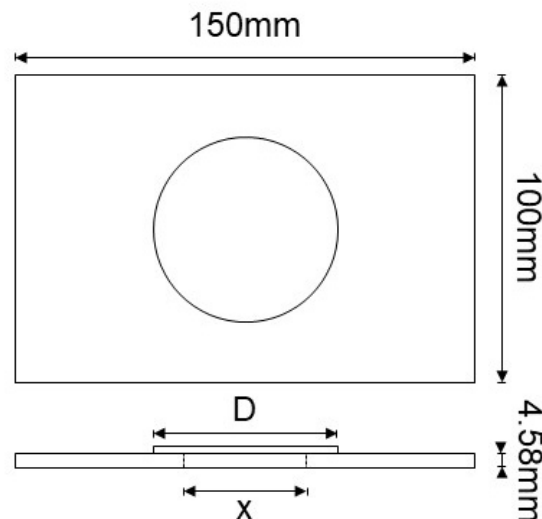
Figure 3-4. Plan- and side-views of a repaired panel

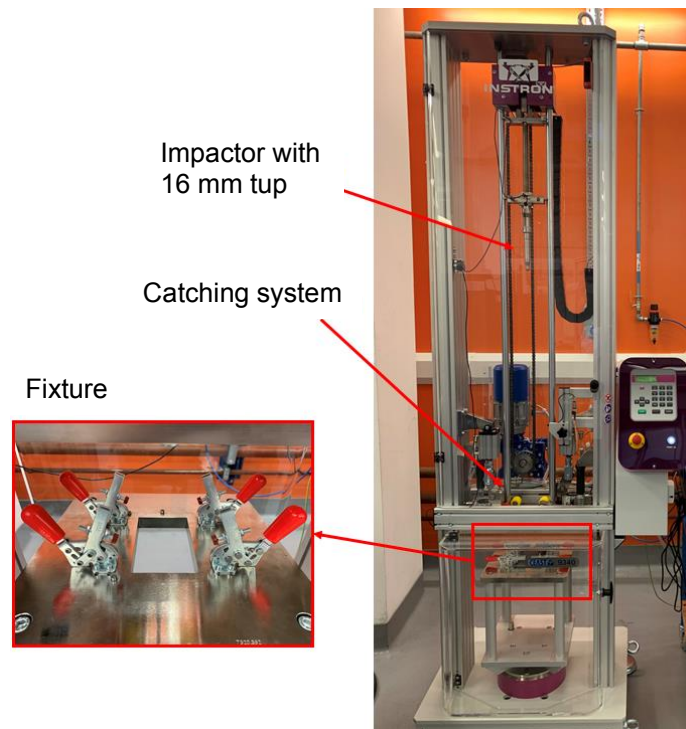
Figure 3-5. Drop-weight tower set-up.

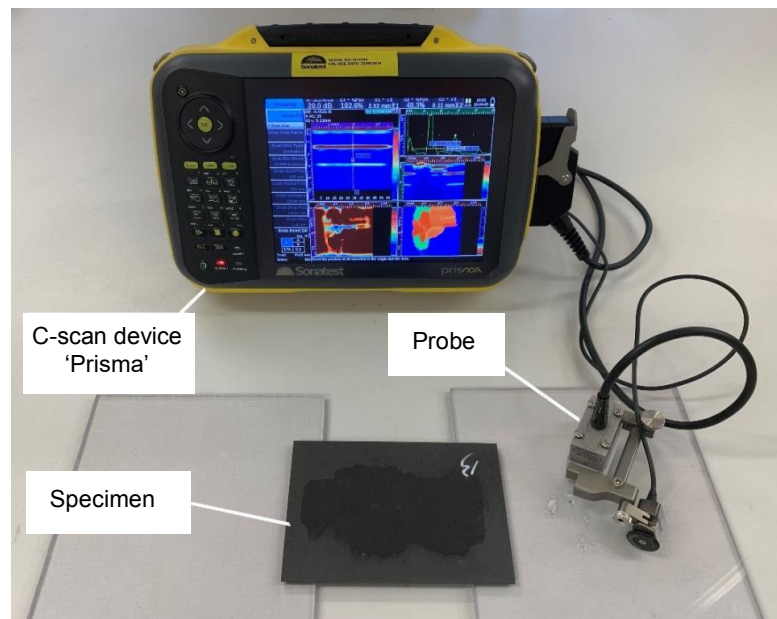
Figure 3-6. Ultrasonic C-scan equipment set-up.

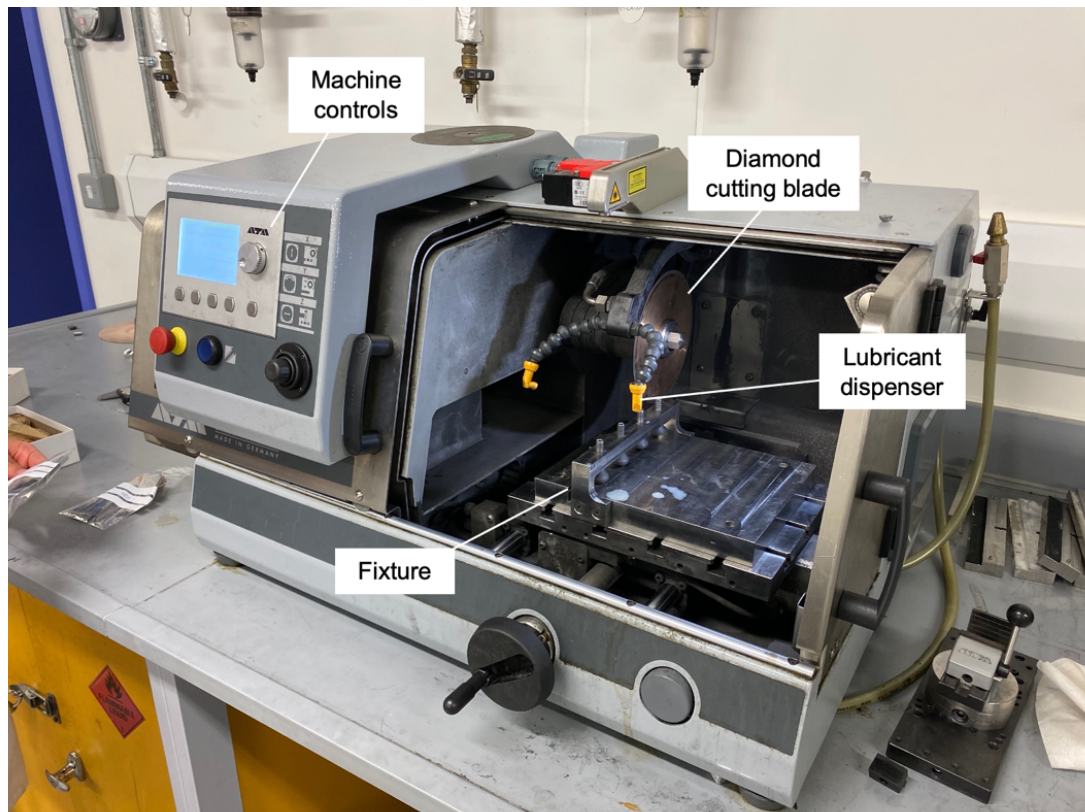
Figure 3-7. Diamond-bladed circular saw used to cut samples through the damage area in preparation for analysis via optical microscopy.

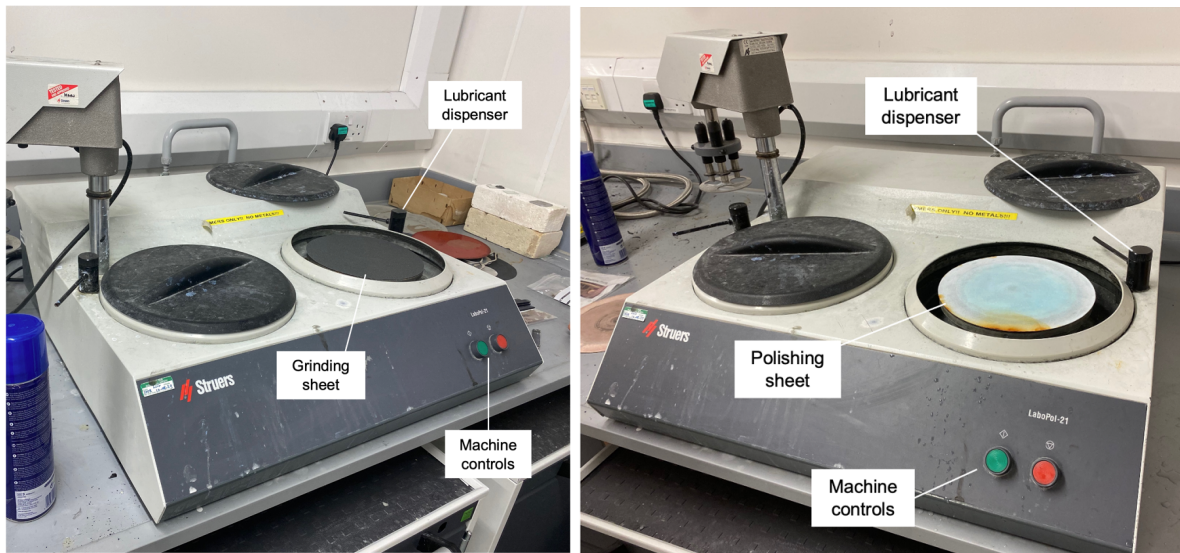
Figure 3-8. Grinding and polishing equipment with a sheet of silicon carbide grinding paper attached (left) and a polishing cloth sprayed with suspension fluid attached (right).

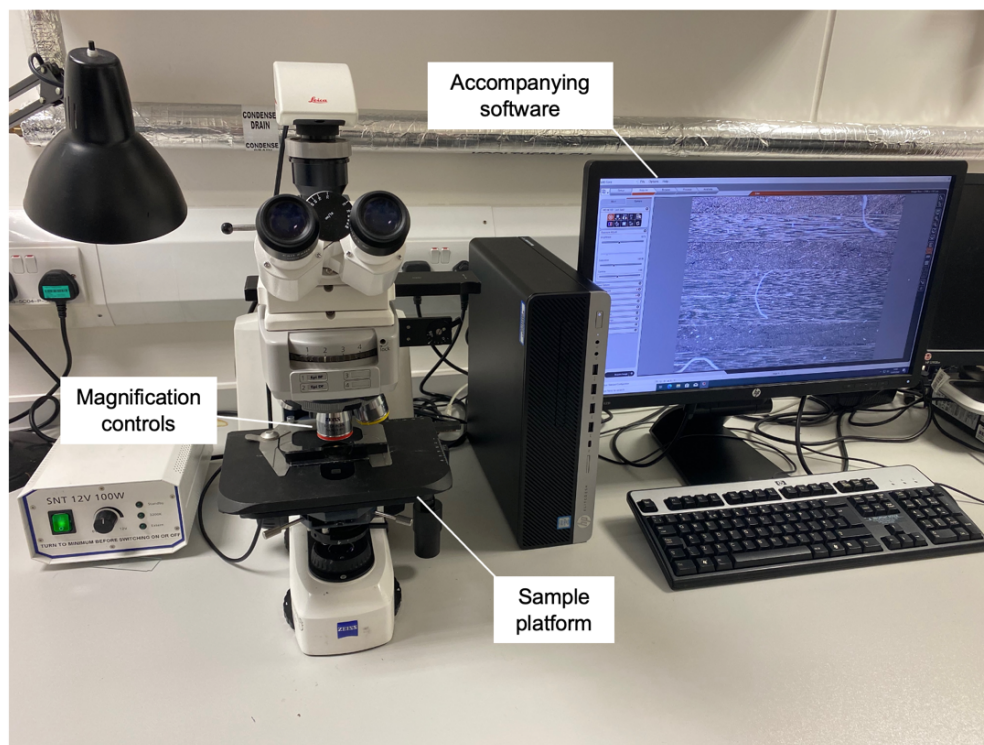
Figure 3-9. Optical microscope and accompanying software used to view damage mechanisms within composite panels after impact.

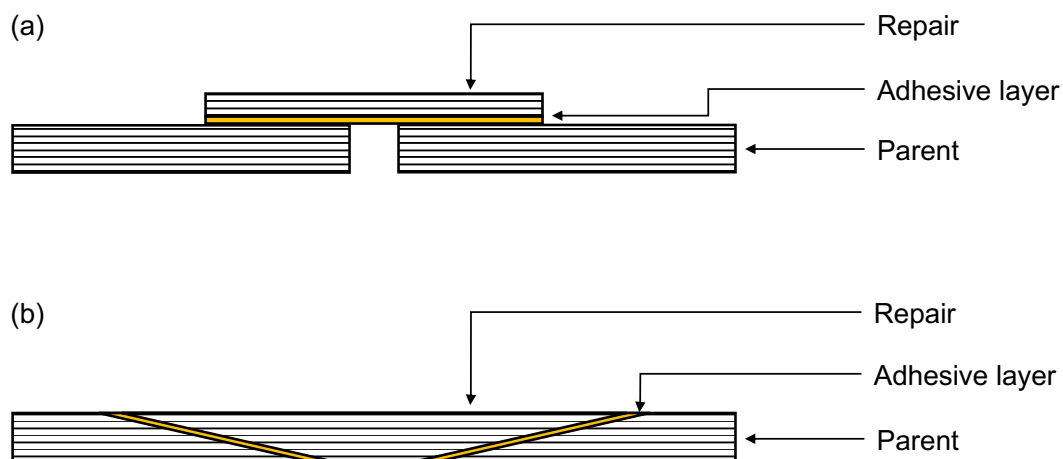
Figure 4-1. Schematic of the two main types of repair configurations: (a) patch repair and (b) scarf repair.

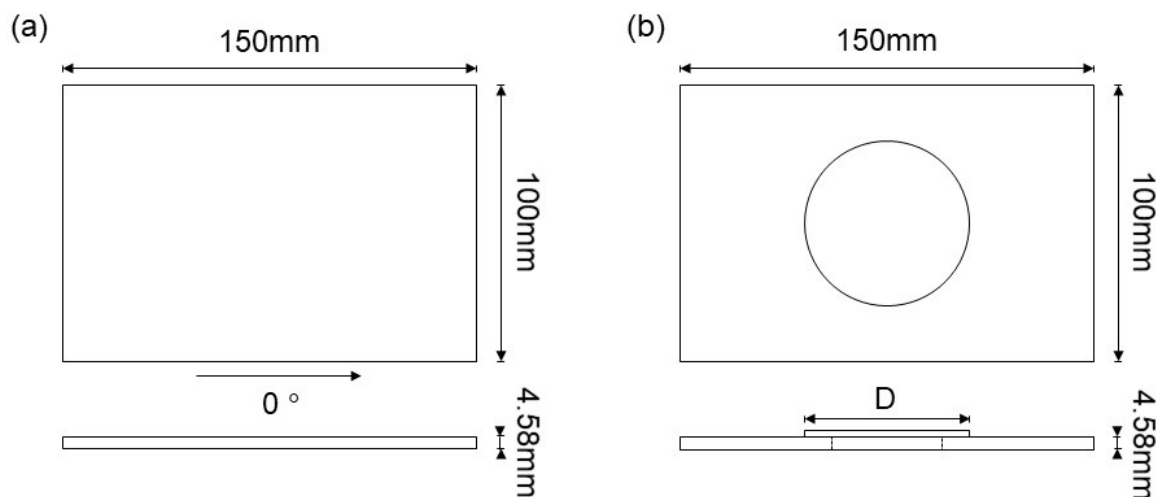
Figure 4-2. Plan- and side-views of (a) the pristine panel and (b) the patch-repair CFRP panel.

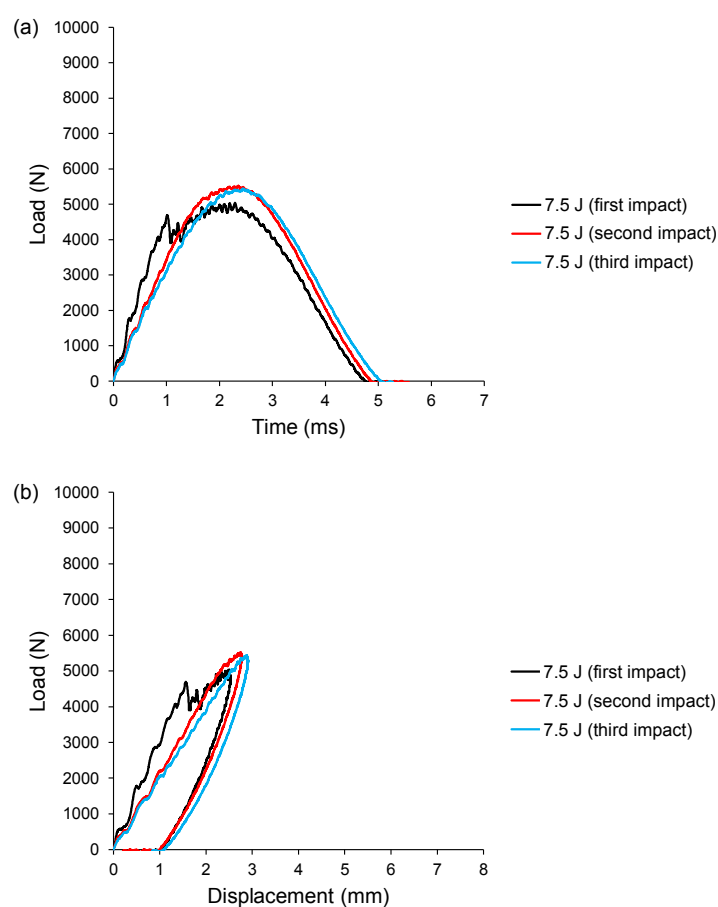
Figure 4-3. Load traces for repeated, i.e., multiple, impacts on a pristine QIT CFRP panel at 7.5 J: (a) load versus time traces and (b) load versus displacement traces.

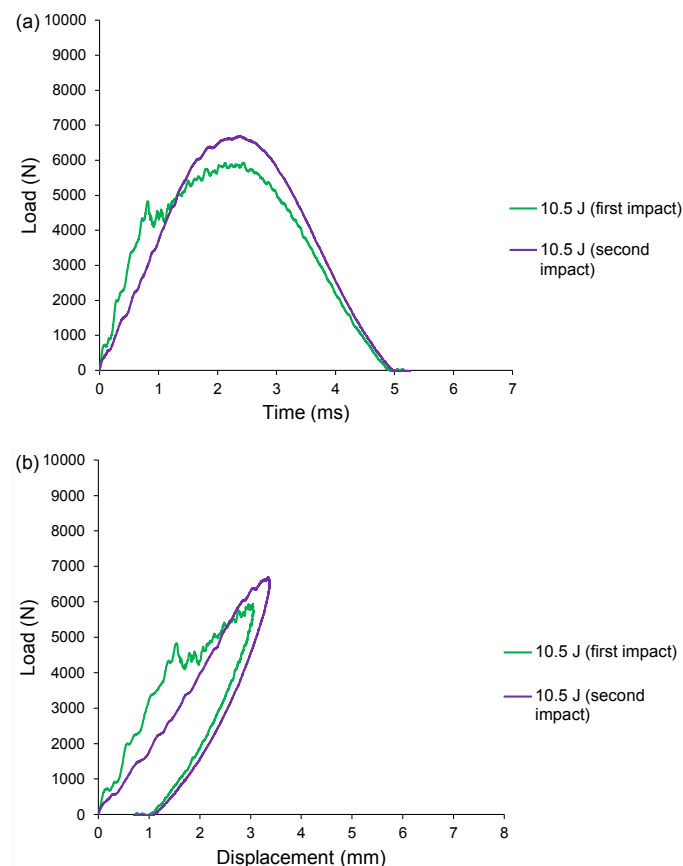
Figure 4-4. Load traces for repeated, i.e., multiple, impacts on a pristine QIT CFRP panel at 10.5 J: (a) load versus time traces and (b) load versus displacement traces.

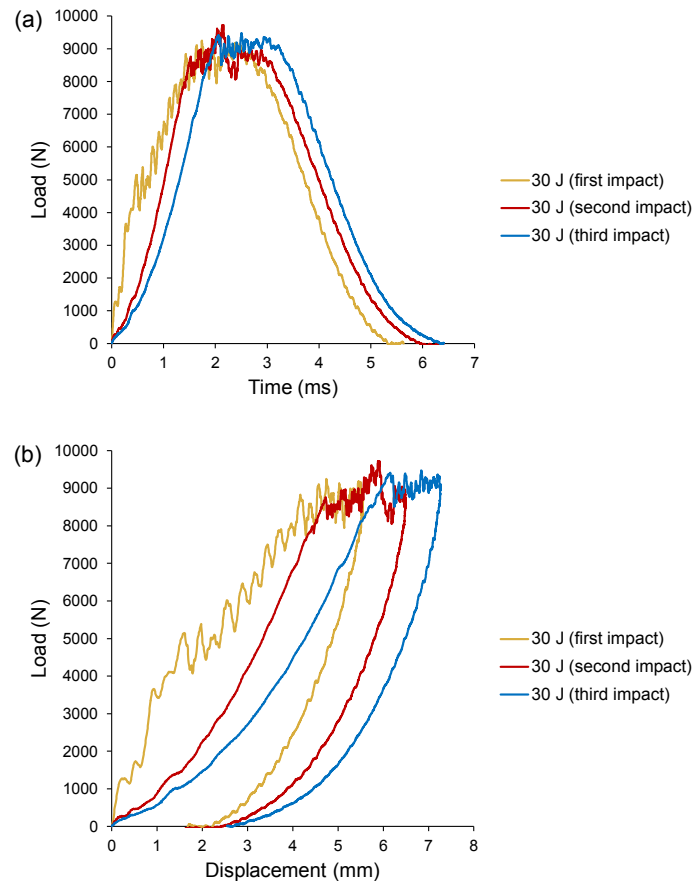
Figure 4-5. Load traces for repeated, i.e., multiple, impacts on a pristine QIT CFRP panel at 30 J: (a) load versus time traces and (b) load versus displacement traces.

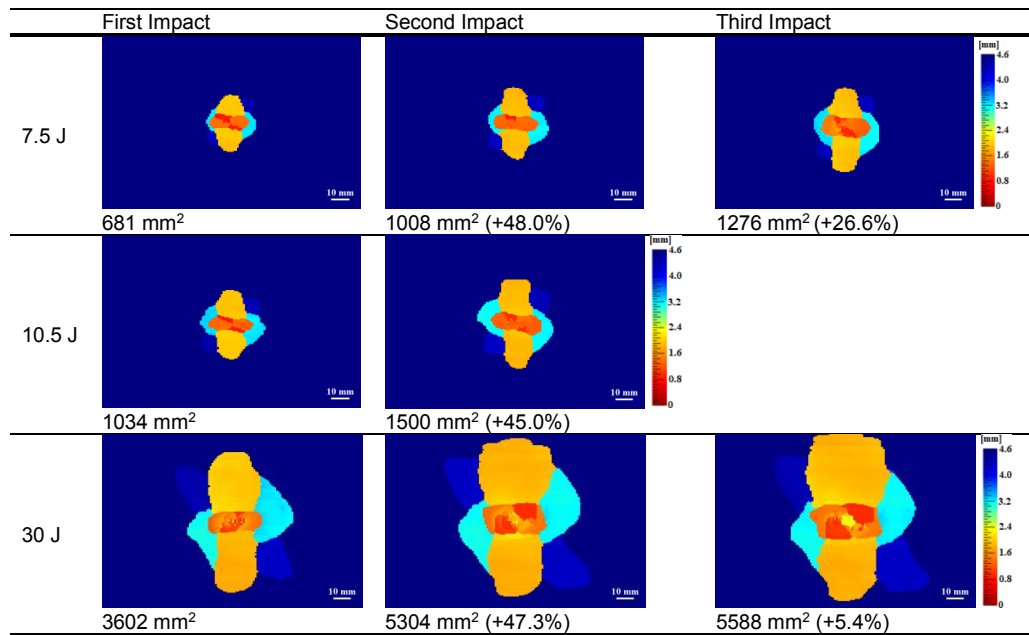
Figure 4-6. C-scan images taken from the top (impacted) surface for repeated, i.e., multiple, impacts on pristine QIT CFRP panels at various impact energies. (The scales show the depth of the different locations of the interlaminar damage. The percentage value, in brackets, is relative to the preceding impact).

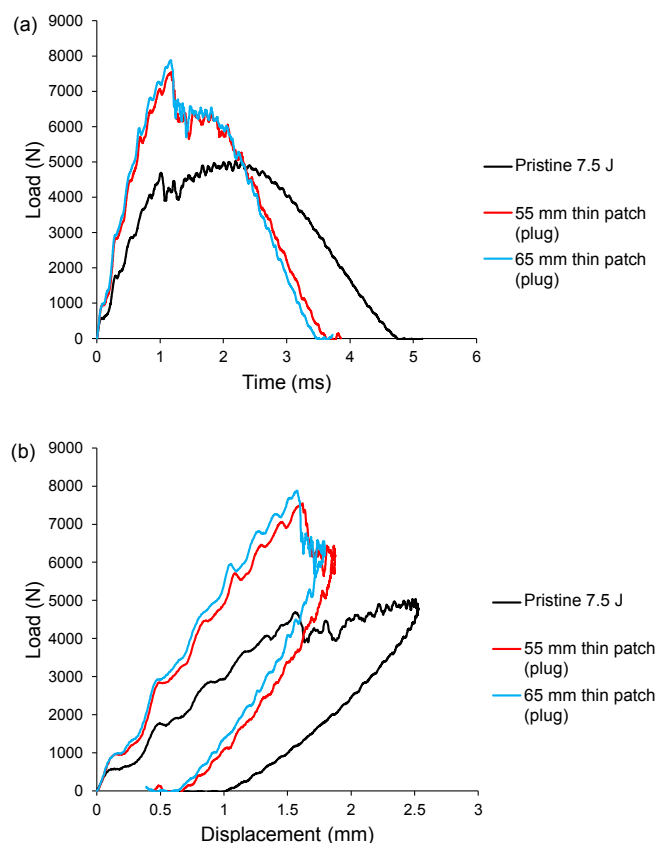
Figure 4-7. Load traces for a pristine QIT CFRP panel and 55 mm diameter and 65 mm patch-repair panels, with a QIT CFRP plug, impacted at 7.5 J. The thickness, t , of the parent and the plug QIT CFRP was 4.58 mm and the thickness, $0.5t$, of the patch was 2.29 mm. Shown are the: (a) load versus time traces and (b) load versus displacement traces.

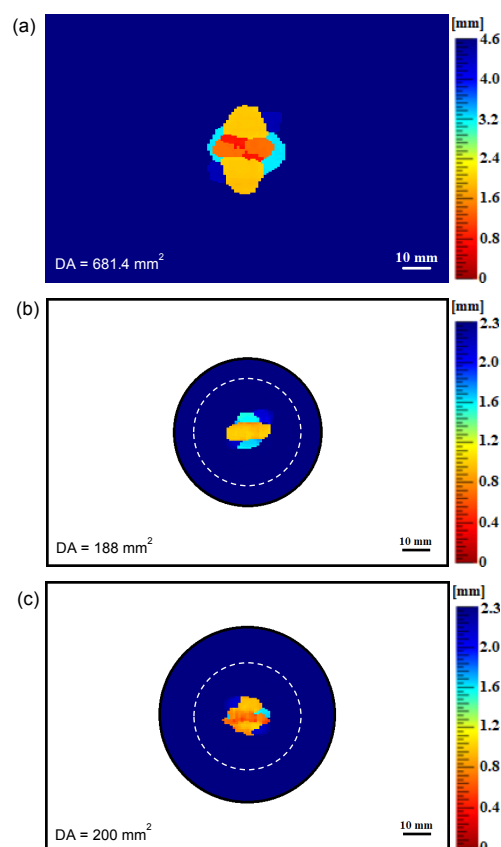
Figure 4-8. C-scan images taken from the top (impacted) face after a 7.5 J impact for: (a) the pristine QIT CFRP panel (of thickness, t , of 4.58 mm), (b) the 55 mm patch-repair QIT CFRP panel (of patch thickness, $0.5t$, of 2.29 mm, with a plug) and (c) the 65 mm patch-repair QIT CFRP panel (of patch thickness, $0.5t$, 2.29 mm, with a plug). The plug was 4.58 mm thick, i.e., the same thickness as the parent QIT CFRP. (The white-dashed line represents the 40 mm diameter hole that was initially cut out in the parent panel).

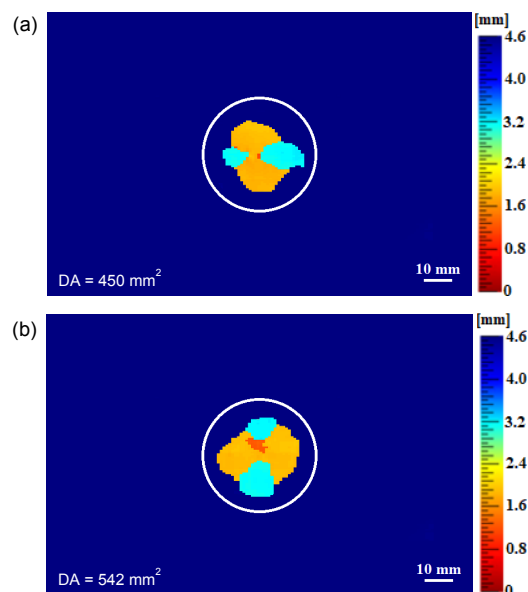
Figure 4-9. C-scan images of the plug and surrounding parent composite taken from the rear (non-impacted) face of the panel after a 7.5 J impact of: (a) the 55 mm patch-repair panel (of thickness, 0.5t, of 2.29 mm, with a plug) and (b) the 65 mm patch-repair panel (of thickness, 0.5t, of 2.29 mm with a plug). The plug was 4.58 mm thick, i.e., the same thickness as the parent QIT CFRP. (The solid-white line is 40 mm in diameter and represents the boundary between plug and the parent QIT CFRP panel).

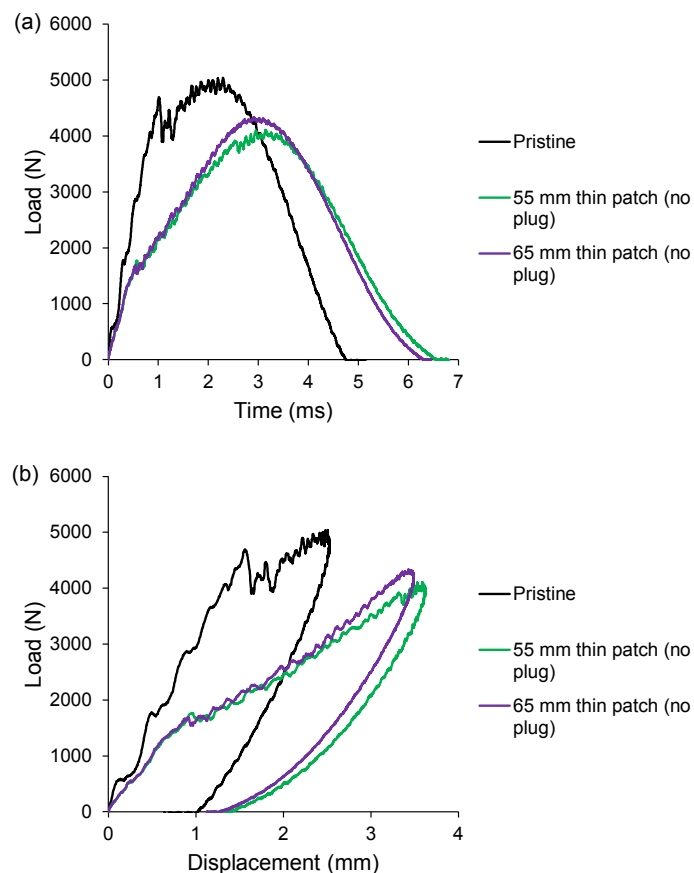
Figure 4-10. Load traces for a pristine QIT CFRP panel and 55 mm diameter and a 65 mm patch-repair panels, with no QIT CFRP plug, impacted at 7.5 J. The thickness of the parent was 4.58 mm and the thickness of the patch was 2.29 mm. Shown are the: (a) load versus time traces and (b) load versus displacement traces.
