Imperial College London

Mechanical Engineering PhD Thesis

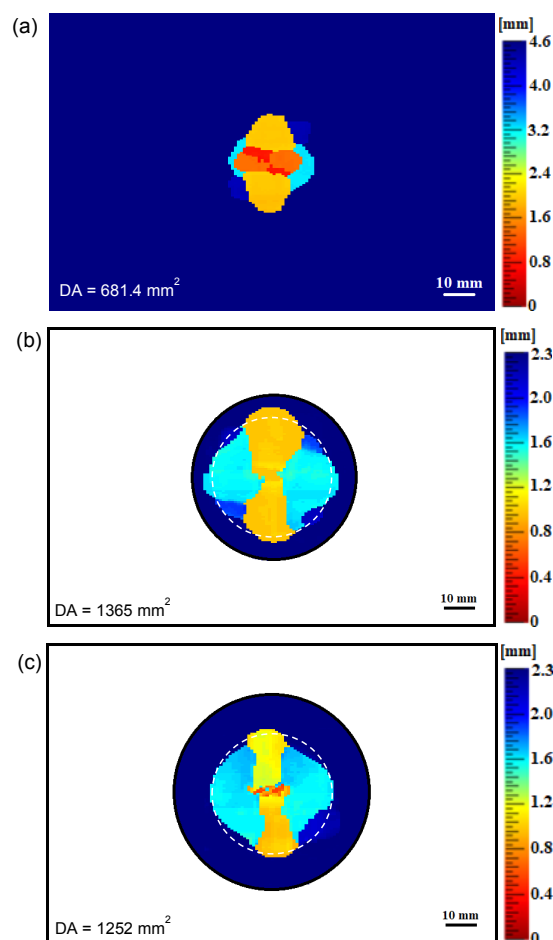
Figure 4-11. C-scan images taken from the top (impacted) face after a 7.5 J impact for: (a) the pristine QIT CFRP panel (of thickness, t , of 4.58 mm), (b) the 55 mm patch-repair panel (of patch thickness, $0.5t$, of 2.29 mm, with no plug) and (c) the 65 mm patch-repair QIT CFRP panel (of patch thickness, $0.5t$, 2.29 mm, with no plug). The thickness, t , of the parent QIT CFRP was 4.58 mm. (The white-dashed line represents the 40 mm diameter hole that was initially cut out in the parent panel).

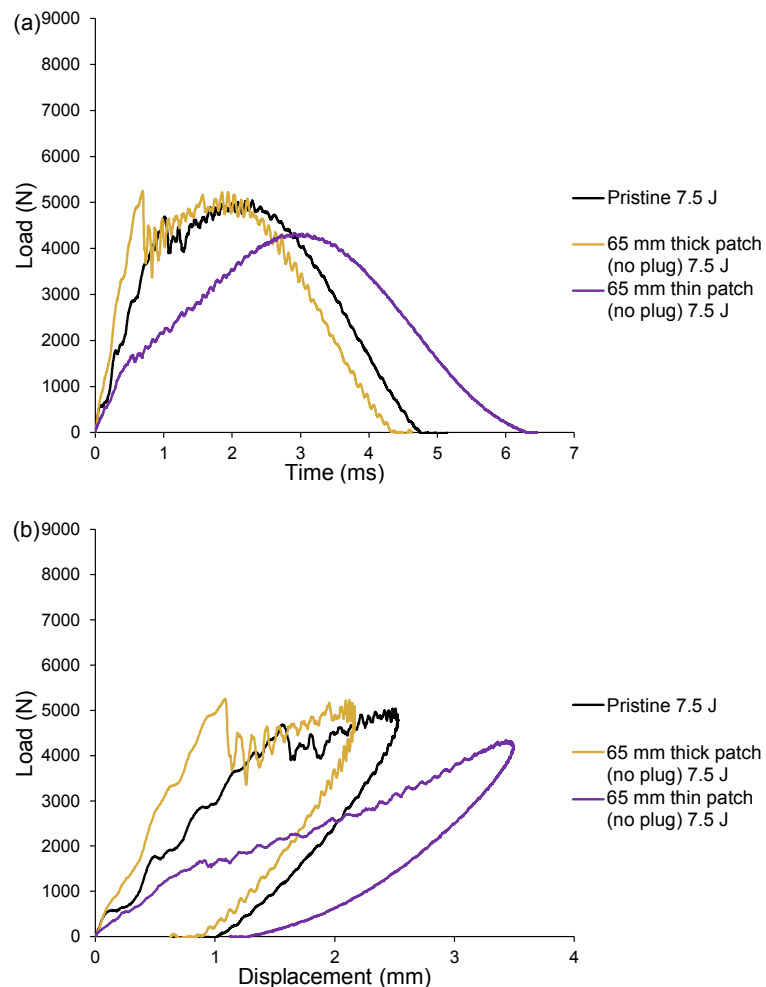
Figure 4-12. Load traces for a pristine panel, a 65 mm patch-repair QIT CFRP panel (of patch thickness, t , of 4.58 mm, with no plug) and a 65 mm patch-repair QIT CFRP panel (of patch thickness, $0.5t$, of 2.29 mm, with no plug). Both patch-repair panels were impacted at 7.5 J. Shown are the: (a) load versus time traces and (b) load versus displacement traces.

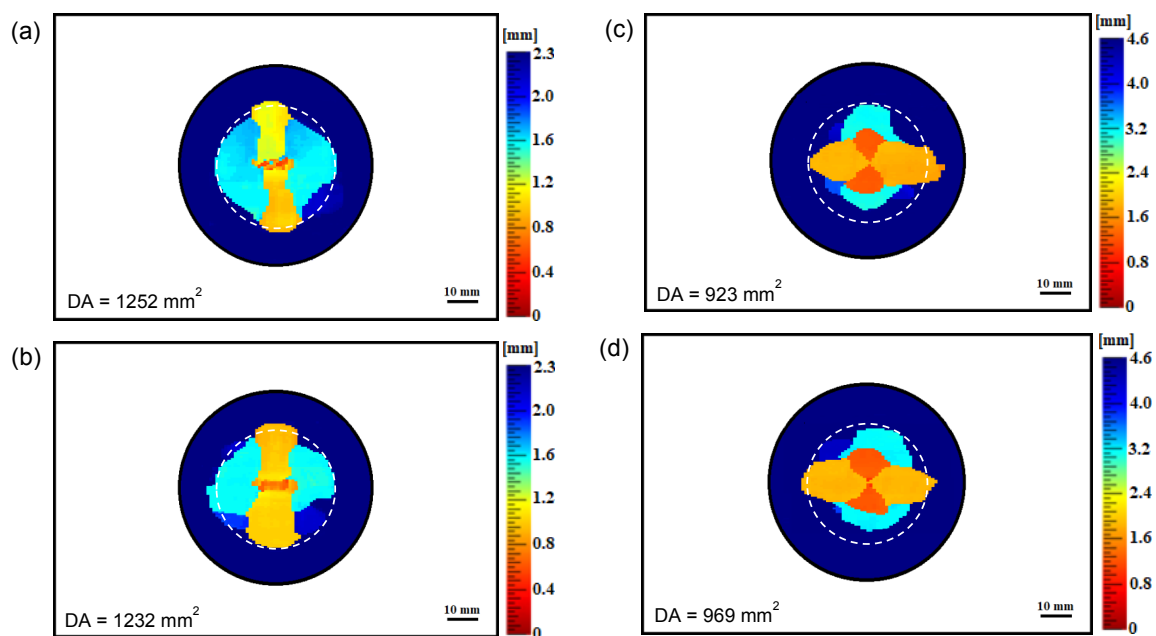
Figure 4-13. C-scan images of patch-repair QIT CFRP panels with no plugs taken from the top (impacted) face after a 7.5 J impact for: (a) the 65 mm thin ($0.5t = 2.29$ mm) patch repair – Test 1, (b) the 65 mm thin ($0.5t = 2.29$ mm) patch repair – Test 2, (c) the 65 mm thick ($t = 4.58$ mm) patch repair – Test 1, and (d) the 65 mm thick ($t = 4.58$ mm) patch repair – Test 2. (Tests 1 and 2 are duplicate tests. The white-dashed line represents the 40 mm diameter hole that was initially cut-out in the parent panel).

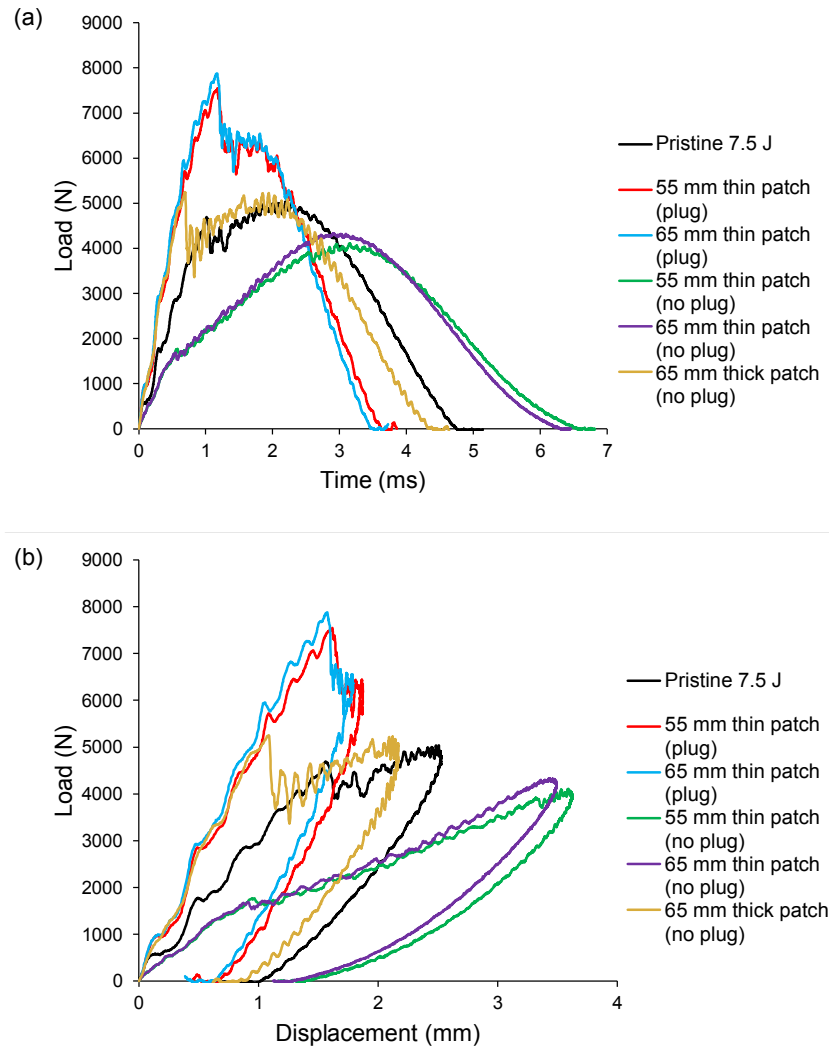
Figure 4-14. Load traces for the pristine panel, the 55 mm diameter thin ($0.5t = 2.29$ mm) patch-repair panel with a plug, the 65 mm diameter thin ($0.5t = 2.29$ mm) patch-repair panel with a plug, the 55 mm thin ($t = 2.29$ mm) patch-repair panel with no plug, the 65 mm thin ($0.5t = 2.29$ mm) patch-repair panel with no plug and the 65 mm thick ($t = 4.58$ mm) patch-repair panel with no plug. All impacted at 7.5 J: (a) load versus time traces and (b) load versus displacement traces.

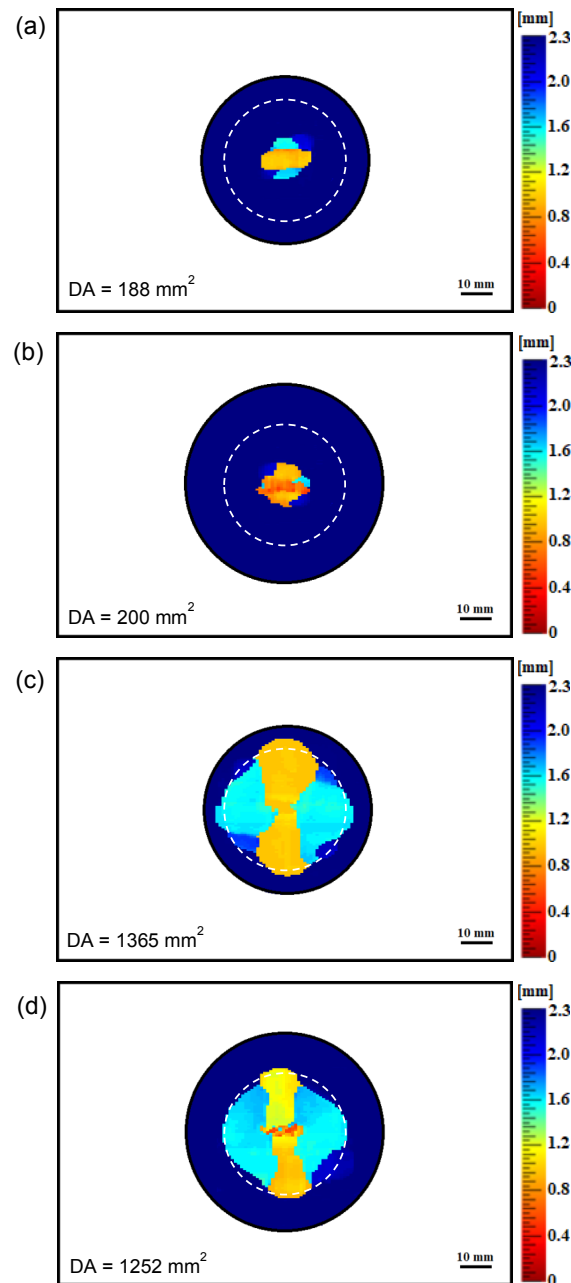
Figure 4-15. C-scan images of patch-repair QIT CFRP panels taken from the top (impacted) face after 7.5 J impact for: (a) the 55 mm diameter thin ($0.5t = 2.29$ mm) patch-repair CFRP panel with a plug present, (b) the 65 mm diameter thin ($0.5t = 2.29$ mm) patch-repair QIT CFRP panel with a plug present, (c) the 55 mm diameter thin ($0.5t = 2.29$ mm) patch-repair QIT CFRP panel with no plug present and (d) the 65 mm diameter thin ($0.5t = 2.29$ mm) patch-repair QIT CFRP panel with no plug present. (The white-dashed line represents the 40 mm diameter hole that was initially cut out in the parent panel).

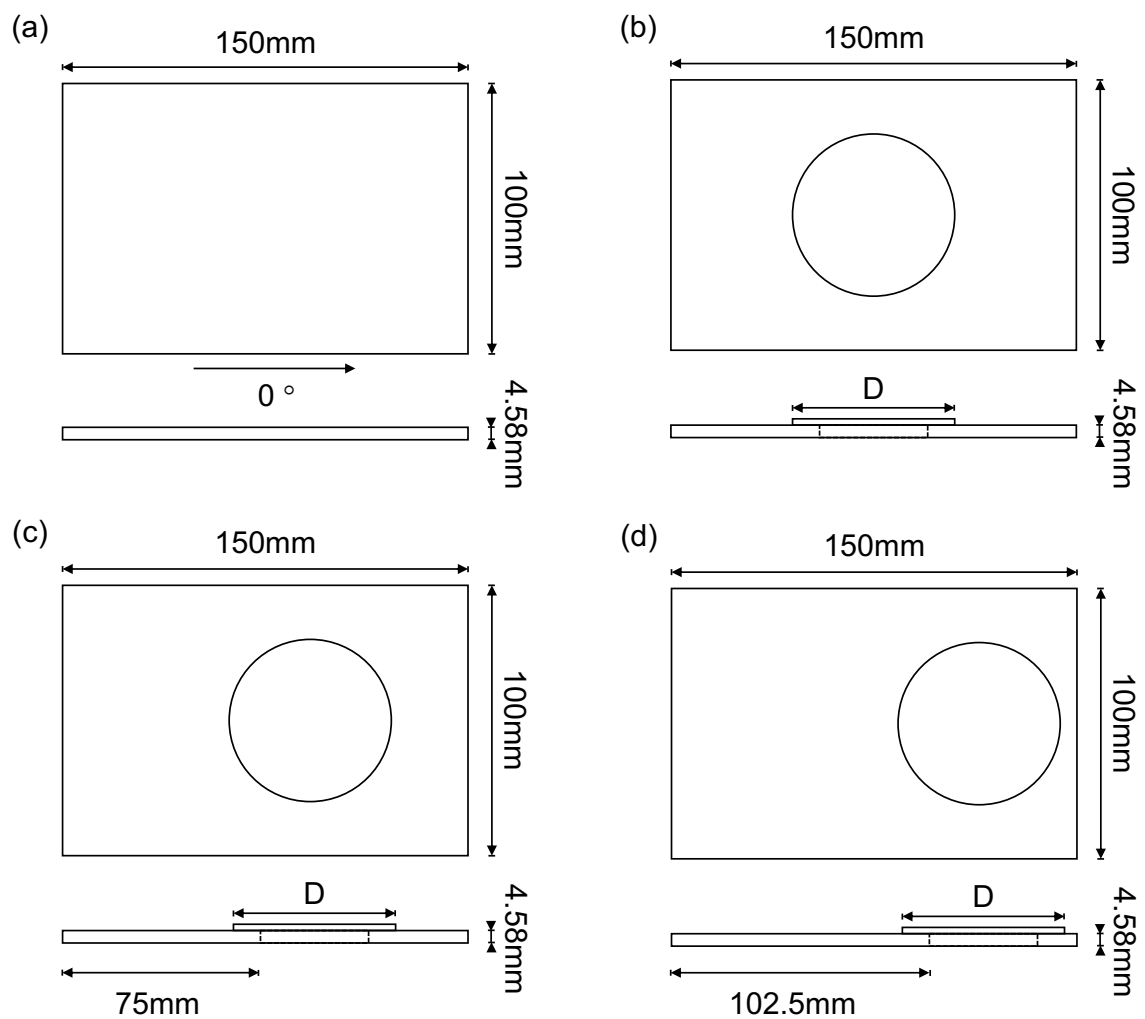
Figure 5-1. Plan- and side-views of (a) the pristine panel, (b) the central patch-repair panel, (c) the edge of hole patch-repair panel and (d) the 15 mm offset patch-repair panel.

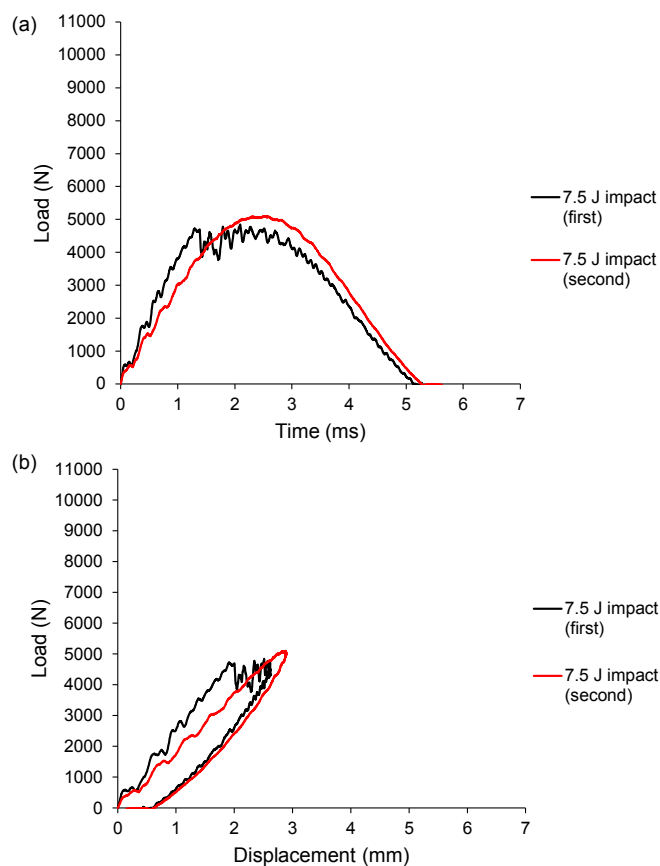
Figure 5-2. Load traces for repeated, i.e., multiple, impacts on a pristine cross-ply CFRP panel at 7.5 J: (a) load versus time traces and (b) load versus displacement traces.

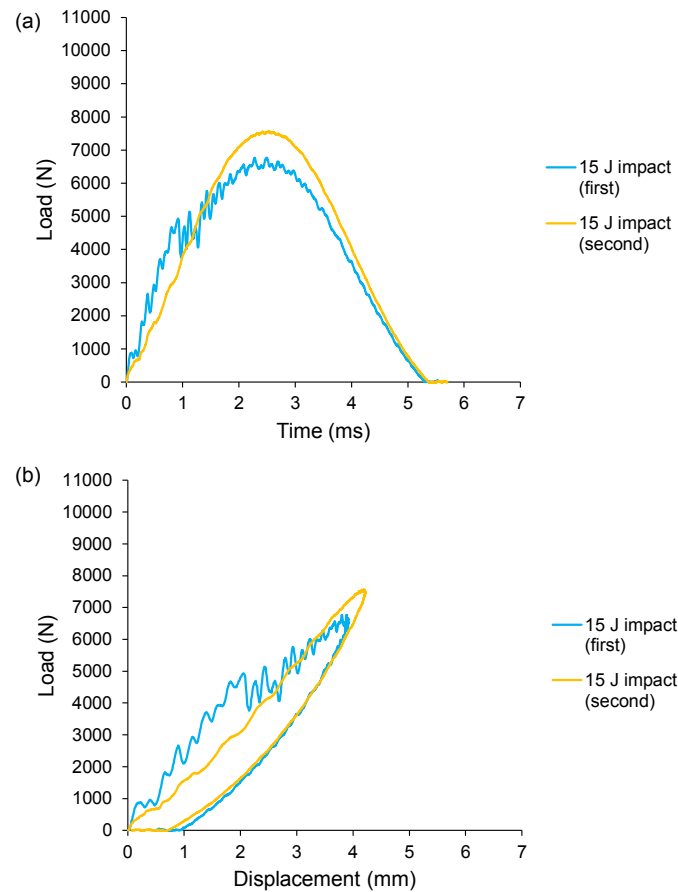
Figure 5-3. Load traces for repeated, i.e., multiple, impacts on a pristine cross-ply CFRP panel at 15 J: (a) load versus time traces and (b) load versus displacement traces.

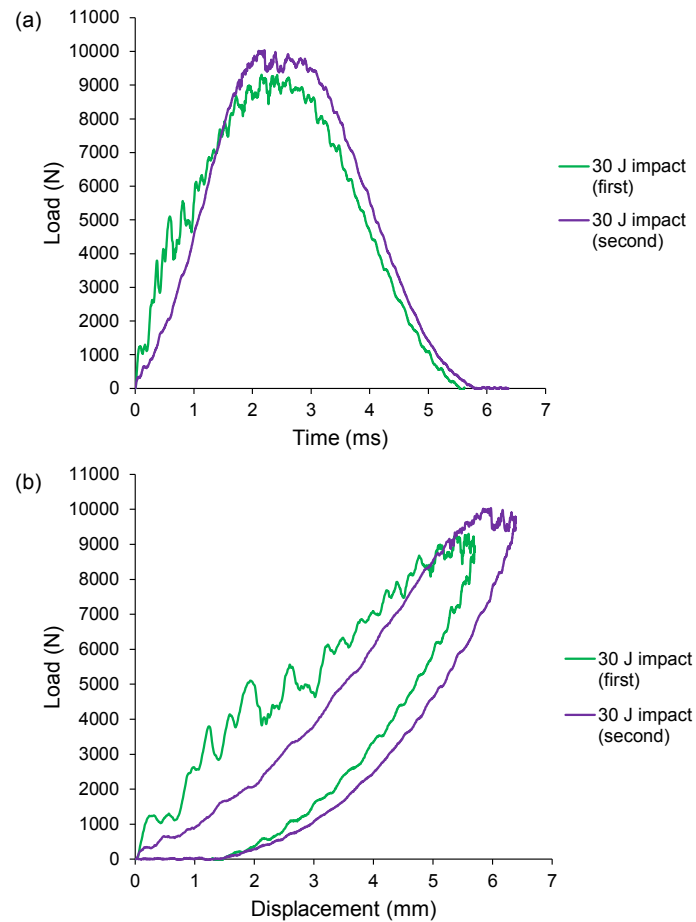
Figure 5-4. Load traces for repeated, i.e., multiple, impacts on a pristine cross-ply CFRP panel at 30 J: (a) load versus time traces and (b) load versus displacement traces.

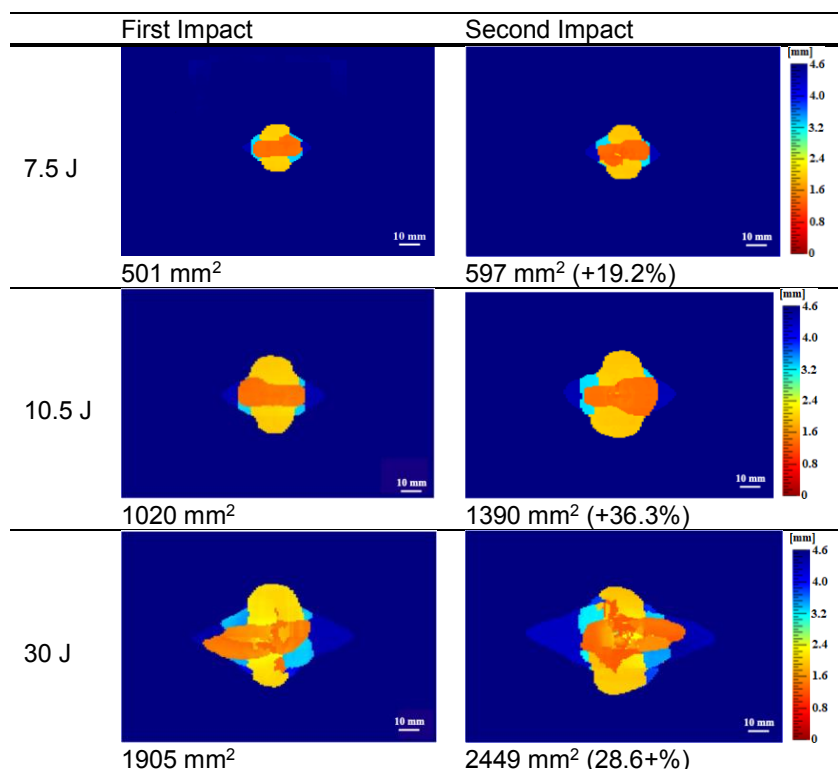
Figure 5-5. C-scan images taken from the top (impacted) surface for repeated, i.e., multiple, impacts on pristine cross-ply CFRP panels at various impact energies. (The scales show the depth of the different locations of the interlaminar damage. The percentage value, in brackets, is relative to the preceding impact).

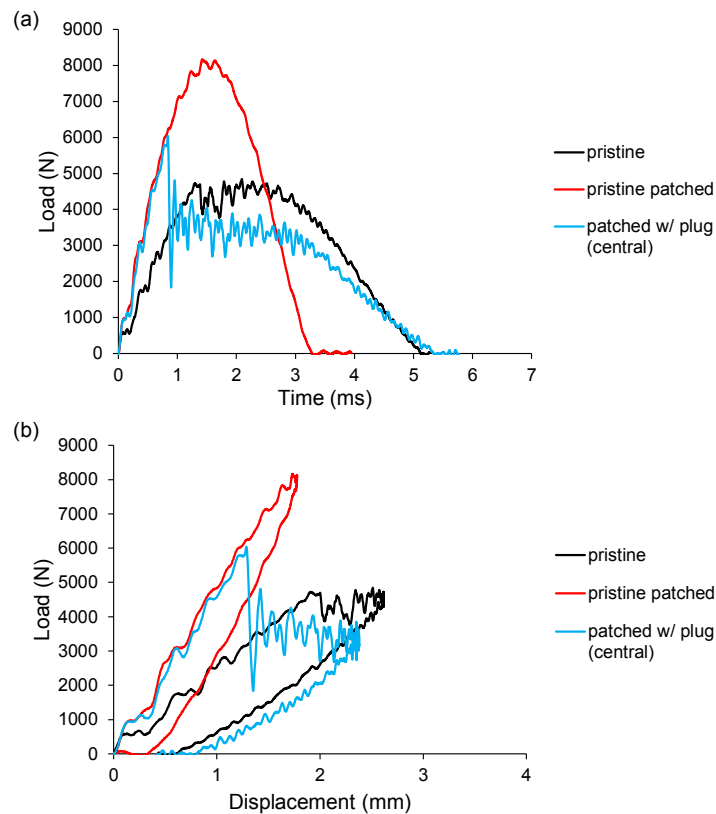
Figure 5-6. Load traces for a pristine cross-ply CFRP panel and pristine patched and central plugged repair panels, impacted at 7.5 J. The thickness, t , of the parent and the plug cross-ply CFRP was 4.58 mm and the thickness, $0.5t$, of the patch was 2.29 mm. Shown are the: (a) load versus time traces and (b) load versus displacement traces.

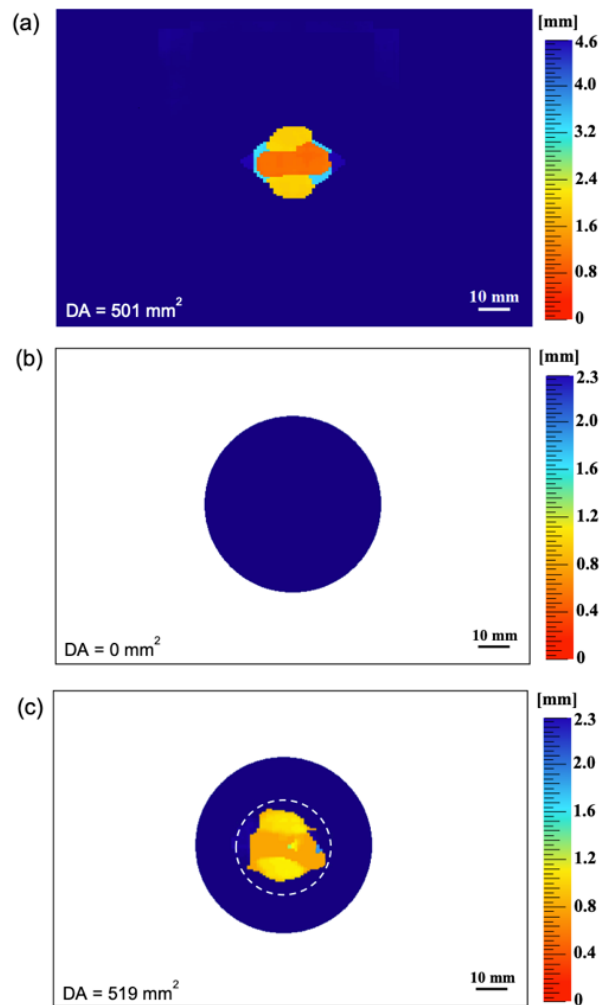
Figure 5-7. C-scan images taken from the top (impacted) face after a 7.5 J impact for: (a) the pristine cross-ply CFRP panel (of thickness, t , of 4.58 mm), (b) the pristine patched cross-ply CFRP panel (of patch thickness, $0.5t$, of 2.29 mm) and (c) the central patch-repair cross-ply CFRP panel (of patch thickness, $0.5t$, 2.29 mm, with a plug). The plug was 4.58 mm thick, i.e., the same thickness as the parent cross-ply CFRP. (The white-dashed line represents the 30 mm diameter hole that was initially cut out in the parent panel).

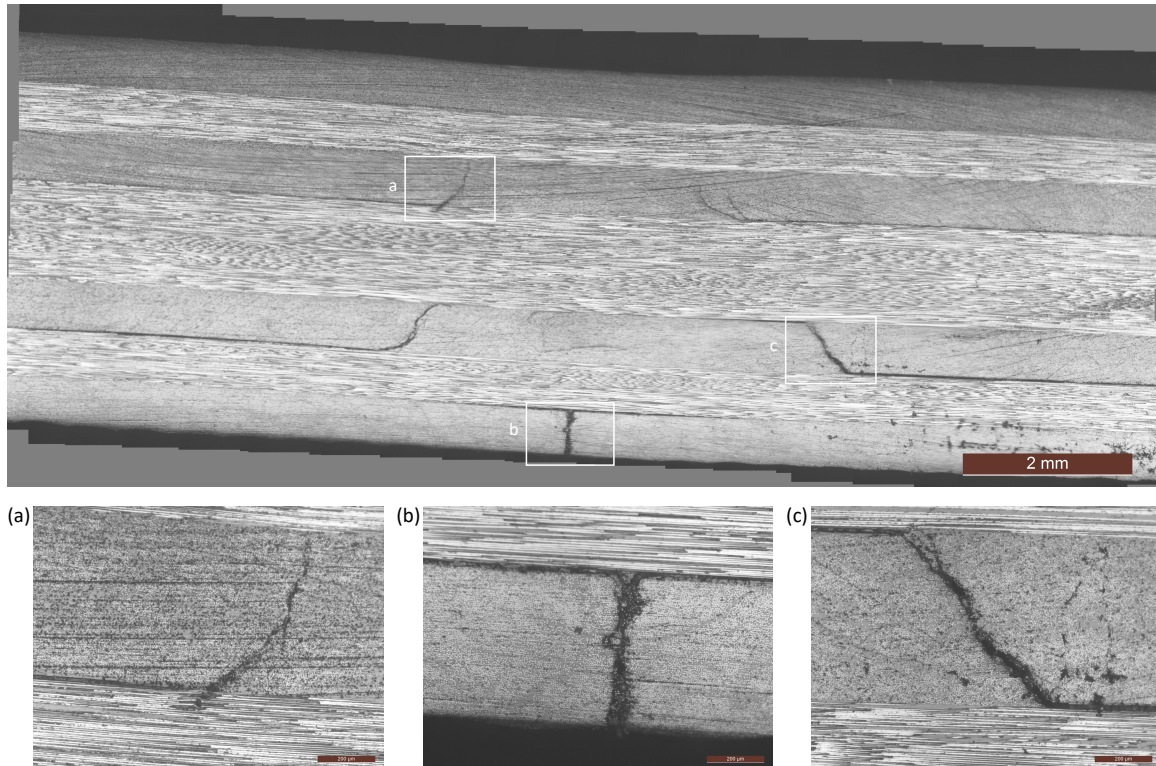
Figure 5-8. Optical microscopy images of a pristine cross-ply CFRP panel after a 7.5 J impact, with key features highlighted by white boxes shown in images (a), (b) and (c).

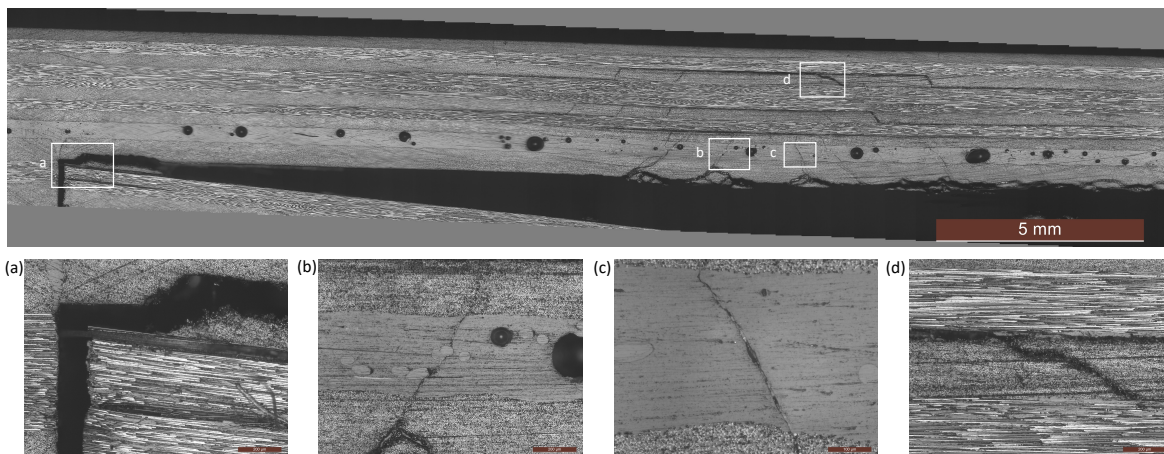
Figure 5-9. Optical microscopy images of a central patch-repair cross-ply CFRP panel with a plug after a 7.5 J impact, with key features highlighted by white boxes shown in images (a), (b), (c) and (d).

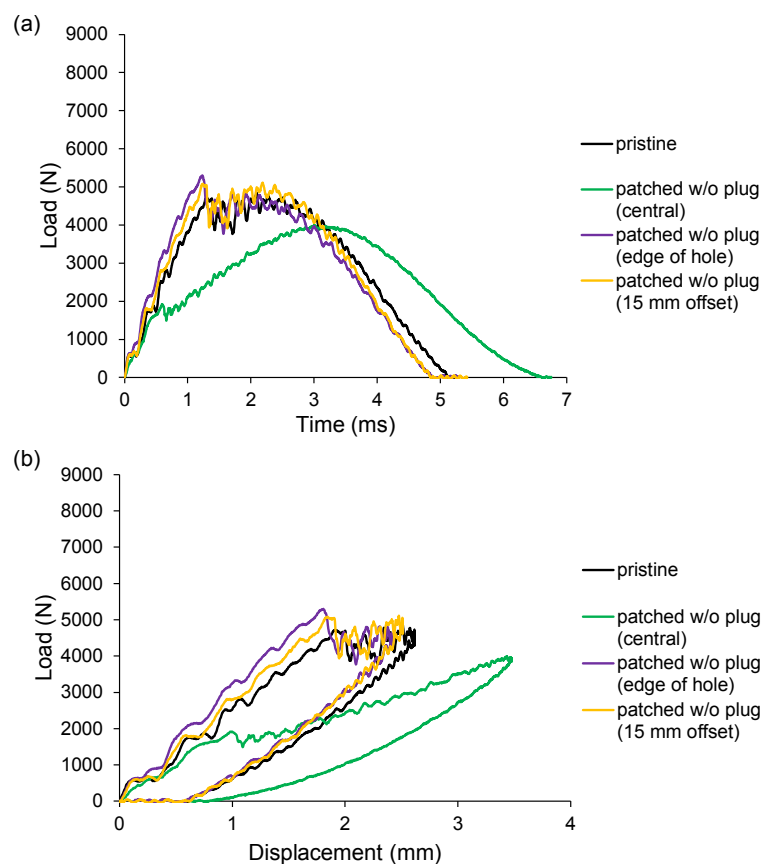
Figure 5-10. Load traces for a pristine cross-ply CFRP panel and central, edge of hole and 15 mm offset patch-repair panels, without plugs, impacted at 7.5 J. The thickness, t , of the parent cross-ply CFRP was 4.58 mm and the thickness, $0.5t$, of the patch was 2.29 mm. Shown are the: (a) load versus time traces and (b) load versus displacement traces.

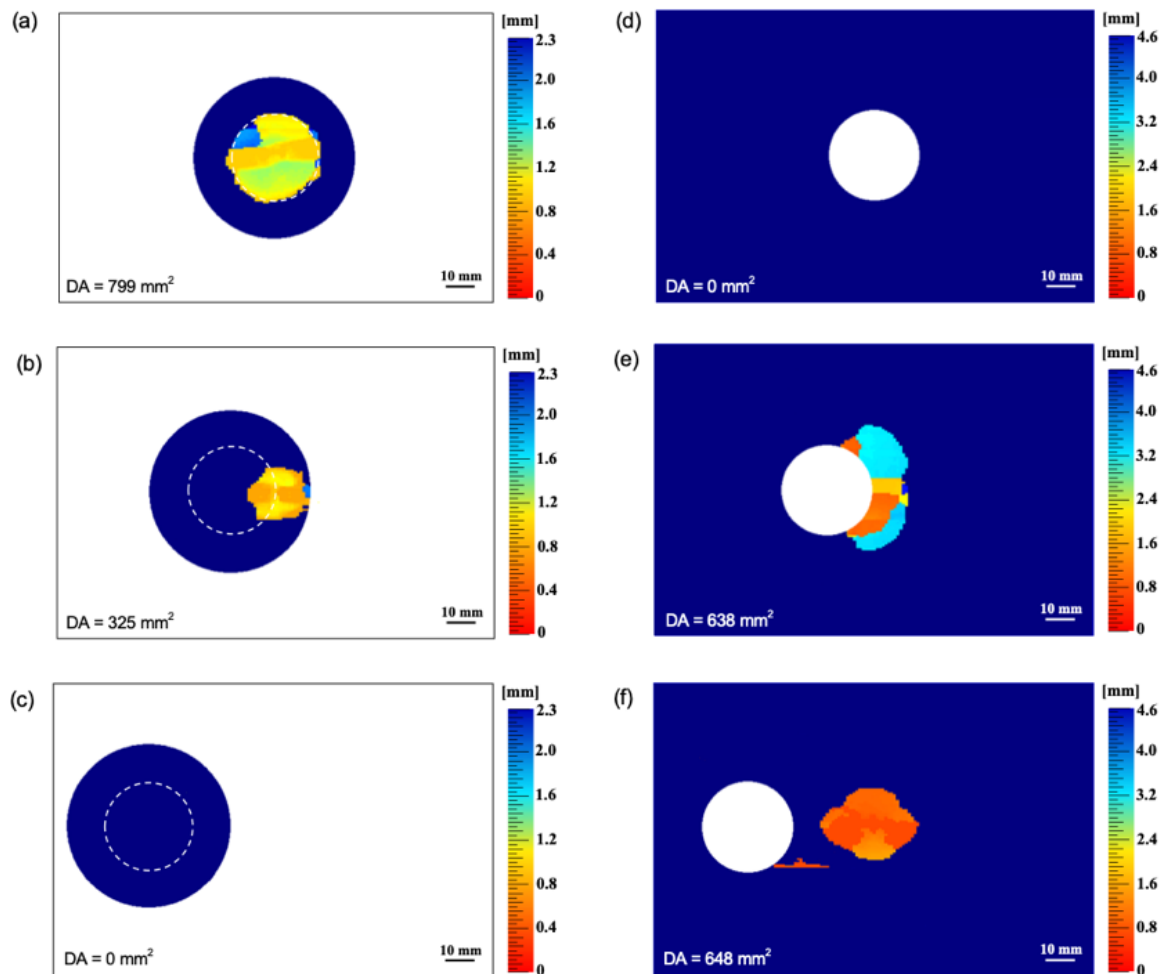
Figure 5-11. C-scan images taken from the top (impacted) face after a 7.5 J impact for: (a) the central patch-repair cross-ply CFRP panel (of patch thickness, $0.5t$, 2.29 mm), (b) the edge of hole offset patch-repair cross-ply CFRP panel (of patch thickness, $0.5t$, 2.29 mm) and (c) the 15 mm offset patch-repair cross-ply CFRP panel (of patch thickness, $0.5t$, 2.29 mm), all without plugs. And c-scan images taken from the bottom face for the same three panels are shown in (d), (e) and (f), respectively. (The white-dashed line represents the 30 mm diameter hole that was initially cut out in the parent panel).

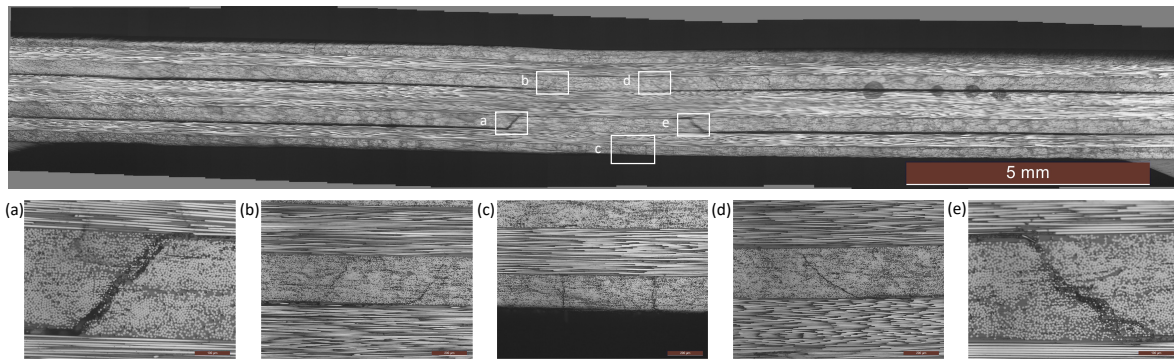
Figure 5-12. Optical microscopy images of a central patch-repair cross-ply CFRP panel without a plug after a 7.5 J impact, with key features highlighted by white boxes shown in images (a), (b), (c), (d) and (e).

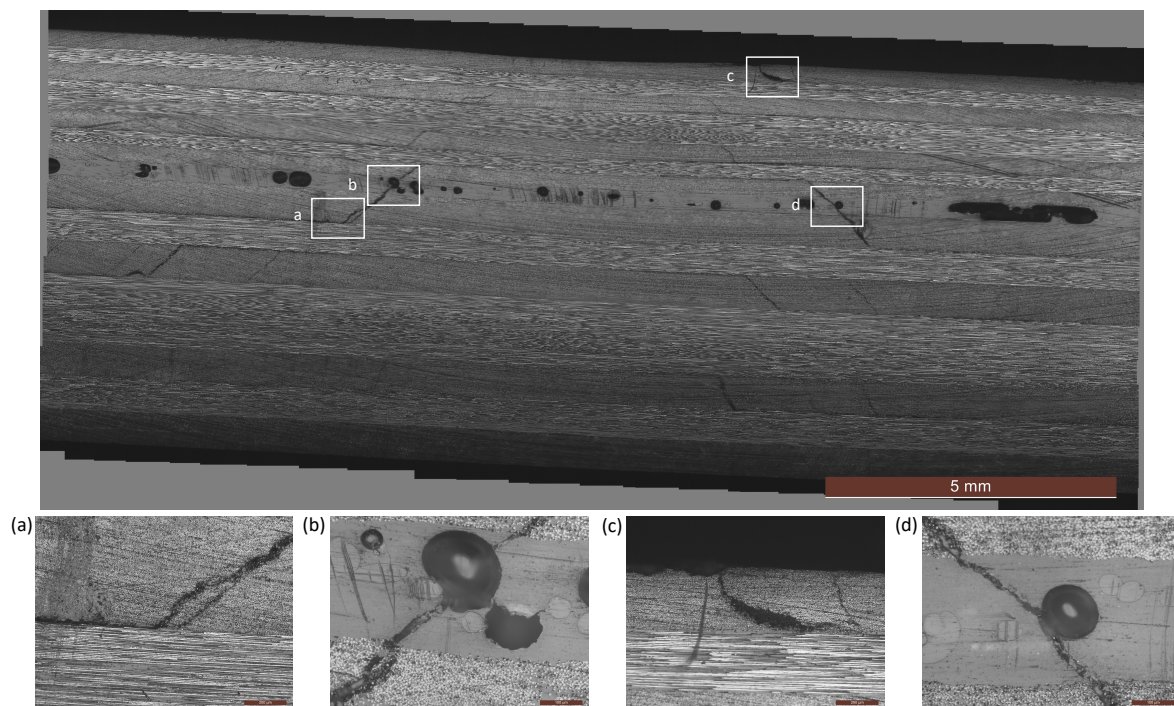
Figure 5-13. Optical microscopy images of an edge of hole offset patch-repair cross-ply CFRP panel without a plug after a 7.5 J impact, with key features highlighted by white boxes shown in images (a), (b), (c) and (d).

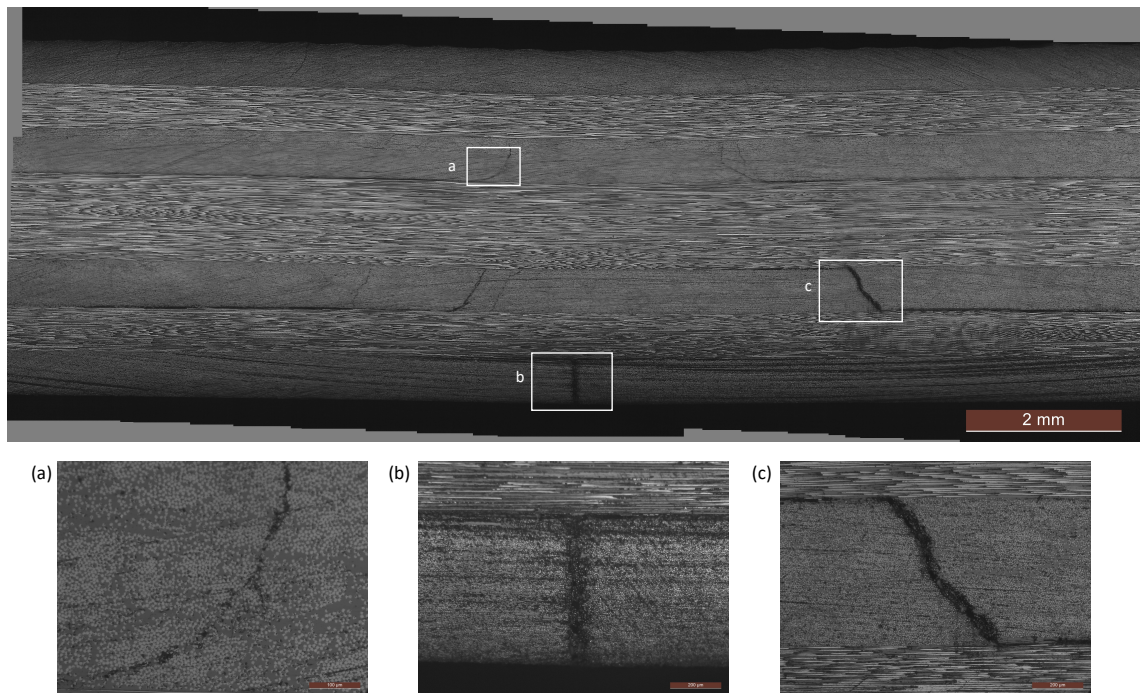
Figure 5-14. Optical microscopy images of a 15 mm offset patch-repair cross-ply CFRP panel without a plug after a 7.5 J impact, with key features highlighted by white boxes shown in images (a), (b) and (c).

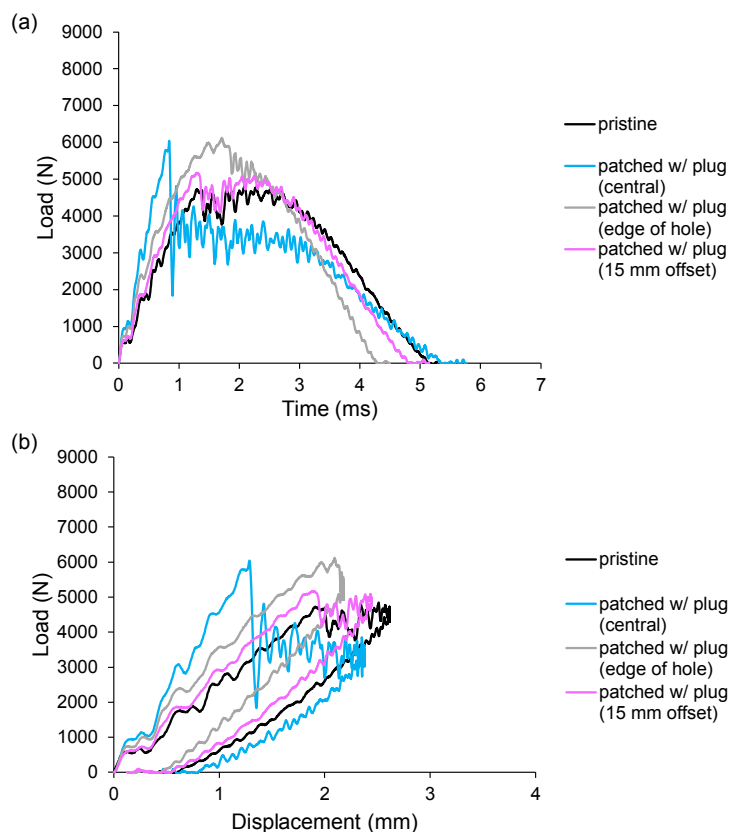
Figure 5-15. Load traces for a pristine cross-ply CFRP panel and central, edge of hole and 15 mm offset patch-repair panels, with cross-ply CFRP plugs, impacted at 7.5 J. The thickness, t , of the parent and the plug cross-ply CFRP was 4.58 mm and the thickness, $0.5t$, of the patch was 2.29 mm. Shown are the: (a) load versus time traces and (b) load versus displacement traces.

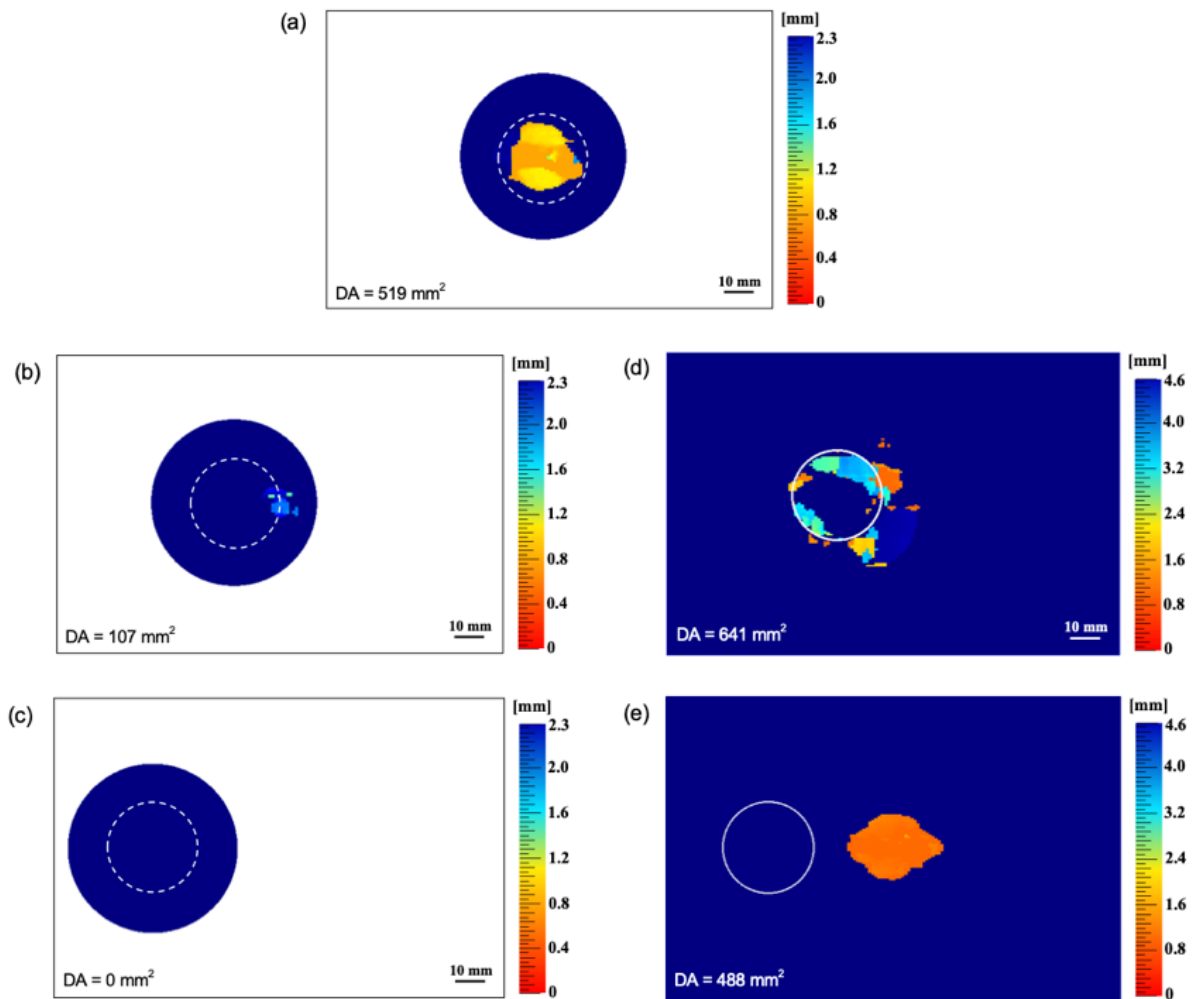
Figure 5-16. C-scan images taken from the top (impacted) face after a 7.5 J impact for: (a) the central patch-repair cross-ply CFRP panel (of patch thickness, 0.5t, 2.29 mm), (b) the edge of hole offset patch-repair cross-ply CFRP panel (of patch thickness, 0.5t, 2.29 mm) and (c) the 15 mm offset patch-repair cross-ply CFRP panel (of patch thickness, 0.5t, 2.29 mm), all with plugs. And c-scan images taken from the bottom face for the latter two panels are shown in (d) and (e), respectively. (The white-dashed line represents the 30 mm diameter hole that was initially cut out in the parent panel and the solid white line depicts the positioning of the plug).

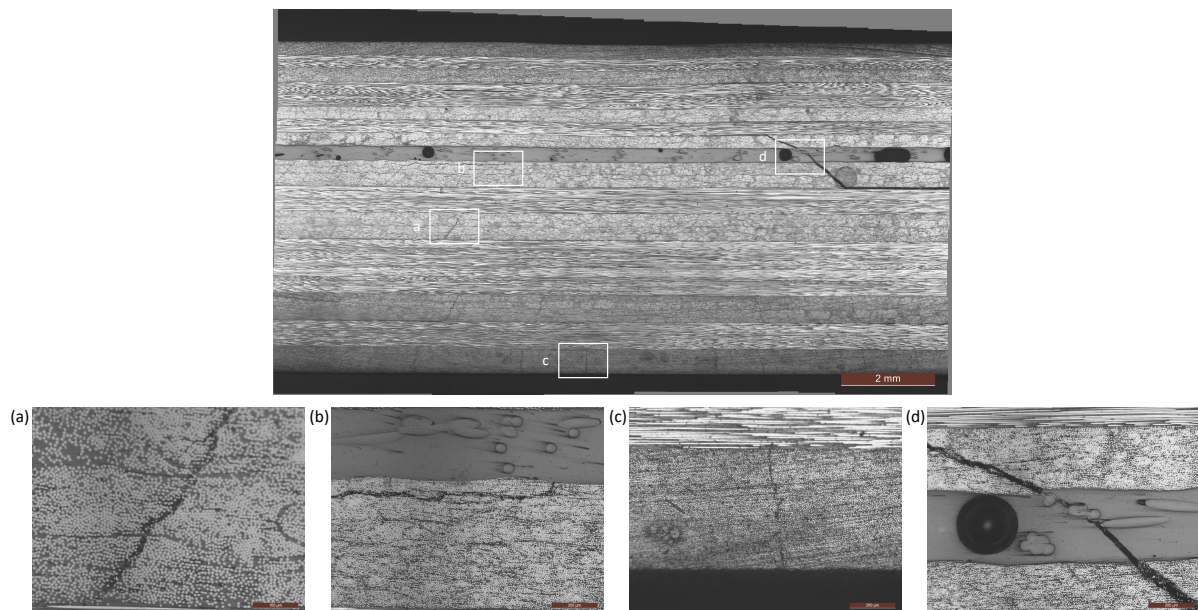
Figure 5-17. Optical microscopy images of an edge of hole offset patch-repair cross-ply CFRP panel with a plug after a 7.5 J impact, with key features highlighted by white boxes shown in images (a), (b), (c) and (d).

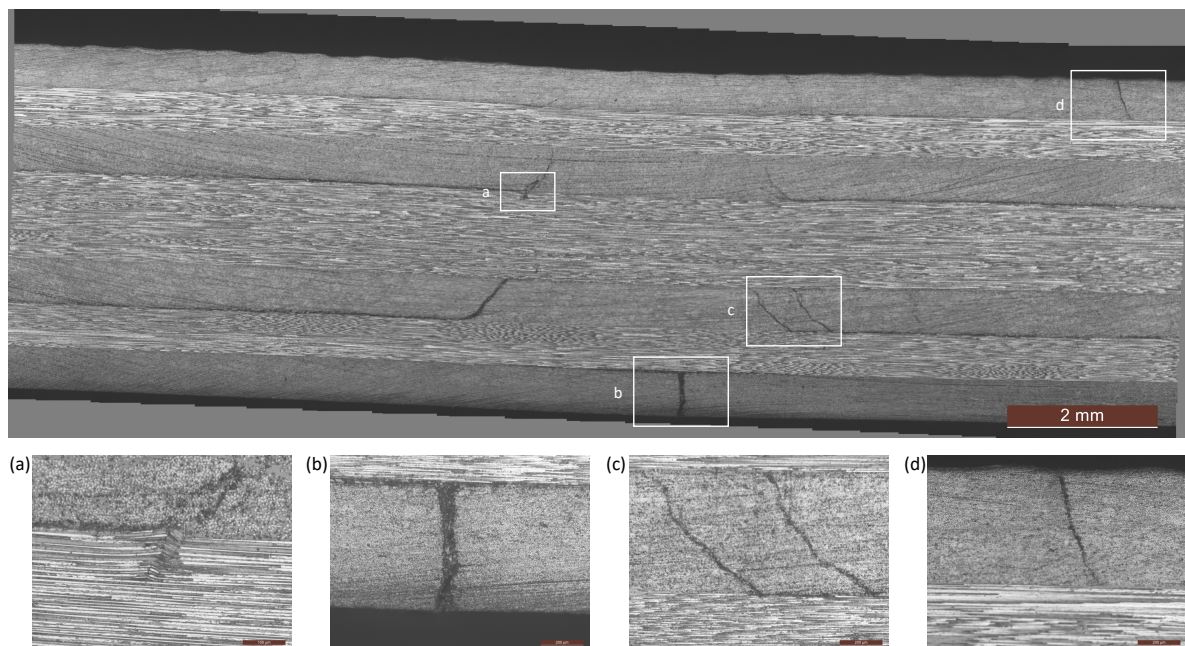
Figure 5-18. Optical microscopy images of a 15 mm offset patch-repair cross-ply CFRP panel with a plug after a 7.5 J impact, with key features highlighted by white boxes shown in images (a), (b), (c) and (d).

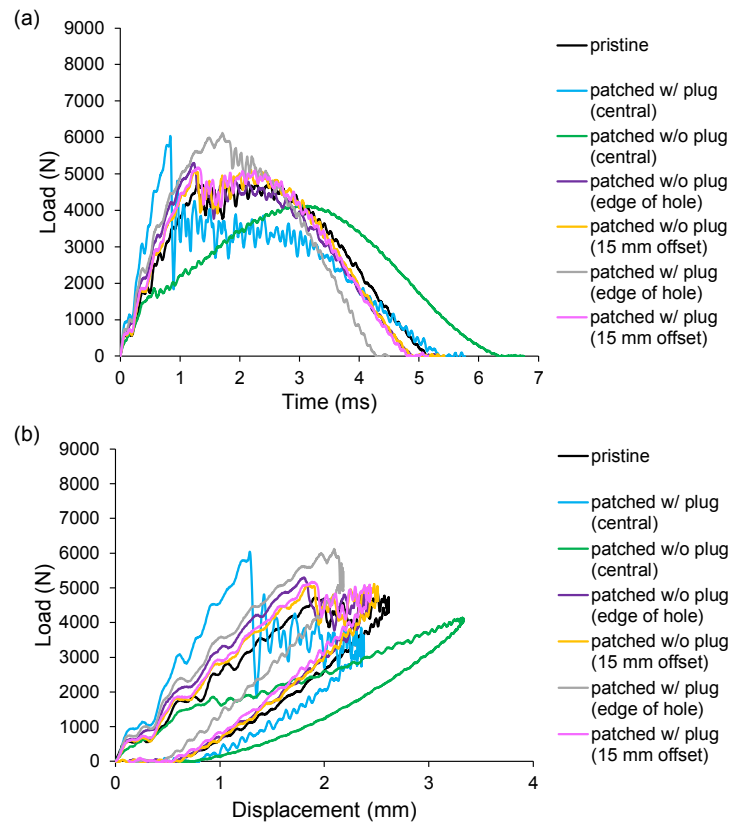
Figure 5-19. Load traces for a pristine cross-ply CFRP panel and central, edge of hole and 15 mm offset patch-repair panels, with and without cross-ply CFRP plugs, impacted at 7.5 J. The thickness, t , of the parent and the plug cross-ply CFRP was 4.58 mm and the thickness, $0.5t$, of the patch was 2.29 mm. Shown are the: (a) load versus time traces and (b) load versus displacement traces.

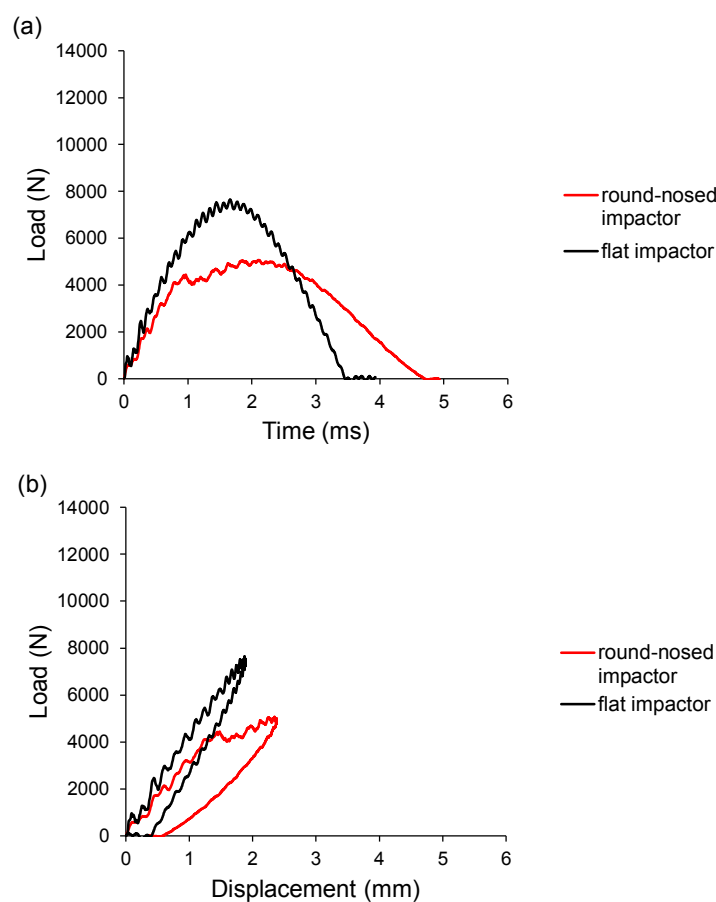
Figure 6-1. Load traces for the pristine panels impacted with a round-nosed impactor (red line) and a flat-ended impactor (black line). Both impacted at 7.5 J: (a) load versus time traces and (b) load versus displacement traces.

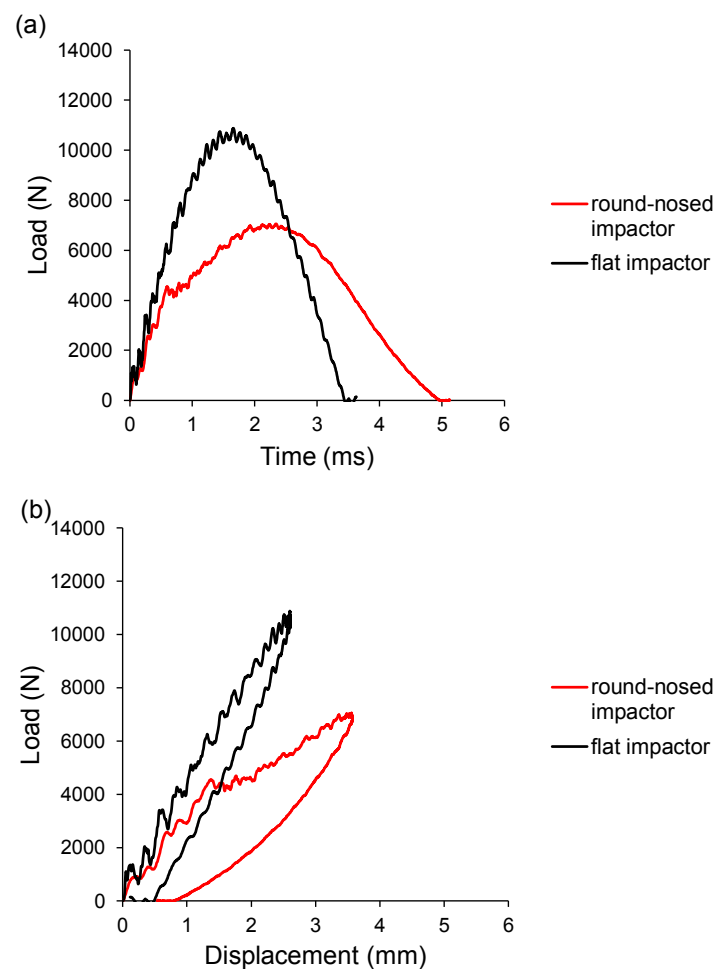
Figure 6-2. Load traces for the pristine panels impacted with a round-nosed impactor (red line) and a flat-ended impactor (black line). Both impacted at 15 J: (a) load versus time traces and (b) load versus displacement traces.

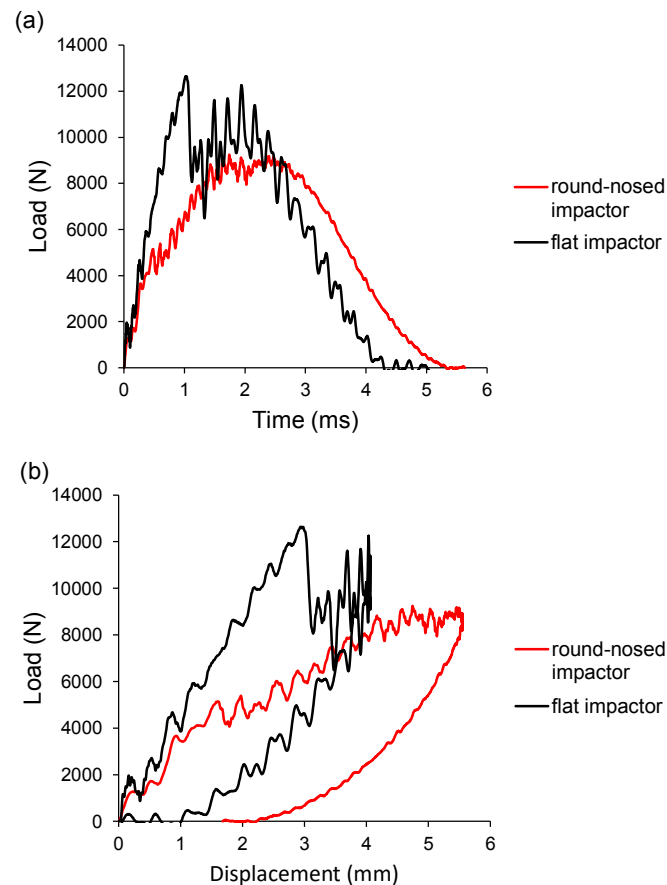
Figure 6-3. Load traces for the pristine panels impacted with a round-nosed impactor (red line) and a flat-ended impactor (black line). Both impacted at 30 J: (a) load versus time traces and (b) load versus displacement traces.

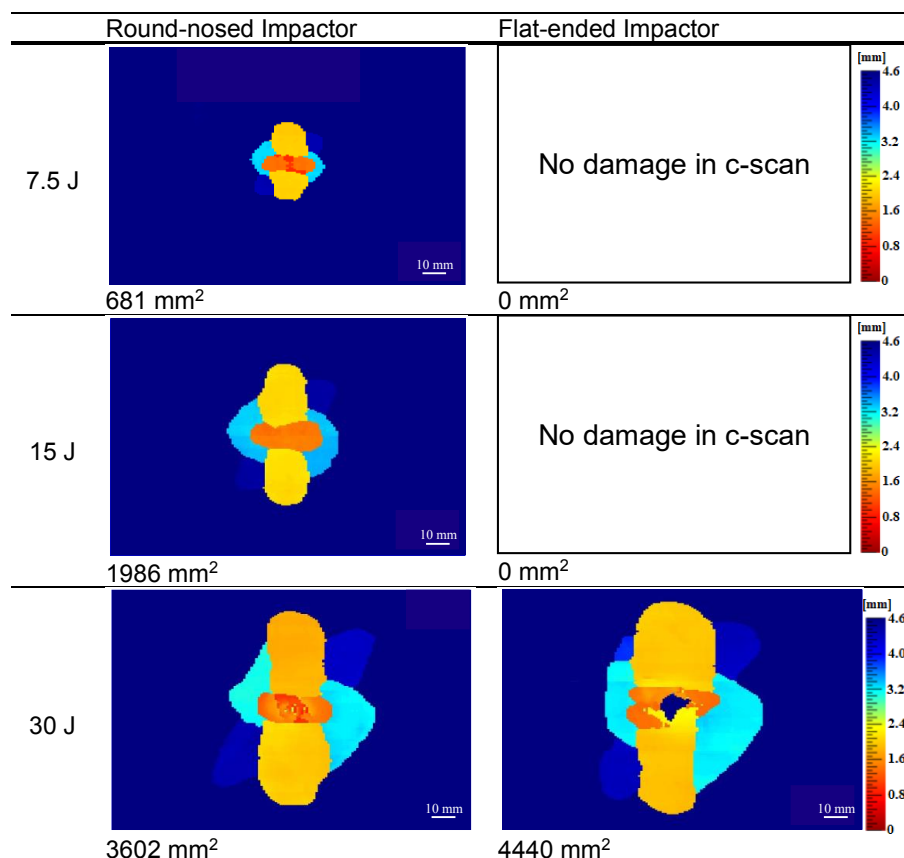
Figure 6-4. C-scan images taken from the top (impacted) surface of pristine CFRP panels impacted with a round-nosed impactor and a flat-ended impactor at various impact energies. The damage area values are given below each image. (The scales show the depth of the different locations of the interlaminar damage).
