Imperial College London

Mechanical Engineering PhD Thesis

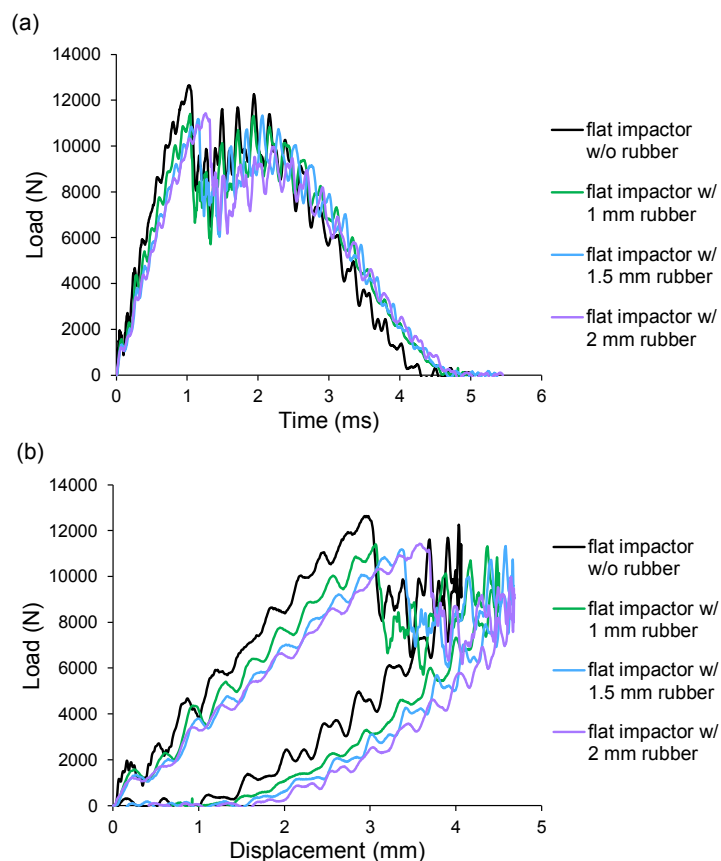
Figure 6-5. Load traces for the pristine panels impacted with a flat-ended impactor without rubber and with rubber disks of 1, 1.5 and 2 mm in thickness adhered to the end. All impacted at 30 J: (a) load versus time traces and (b) load versus displacement traces.

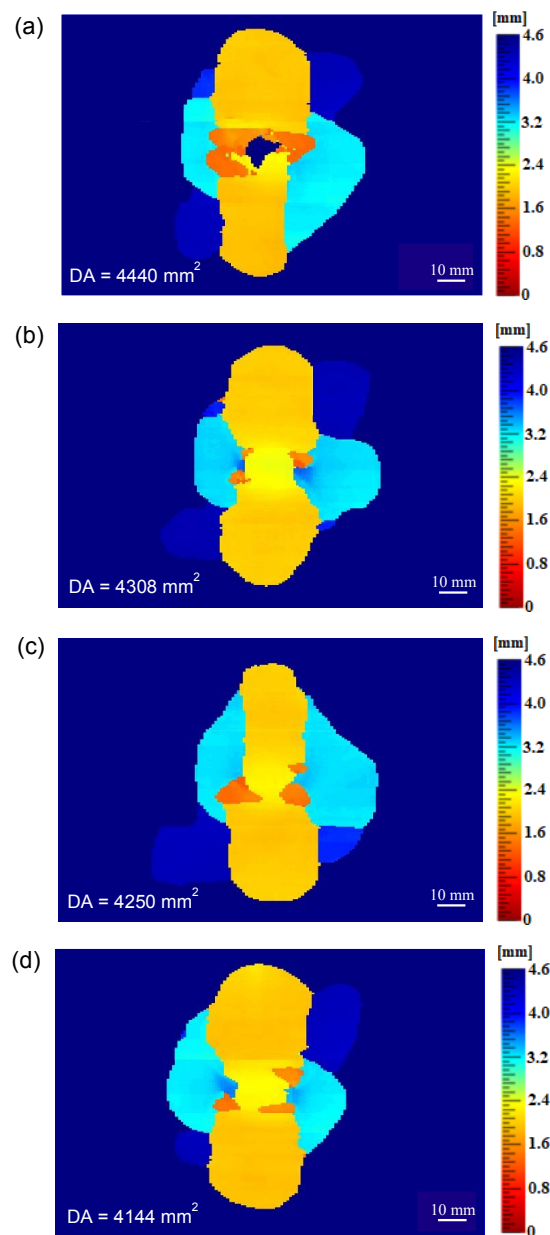
Figure 6-6. C-scan images of pristine CFRP panels taken from the top (impacted) face after 30 J impact for: (a) the panel impacted with a flat-ended impactor, (b) the panel impacted with a flat-ended impactor with a 1 mm thick rubber disk

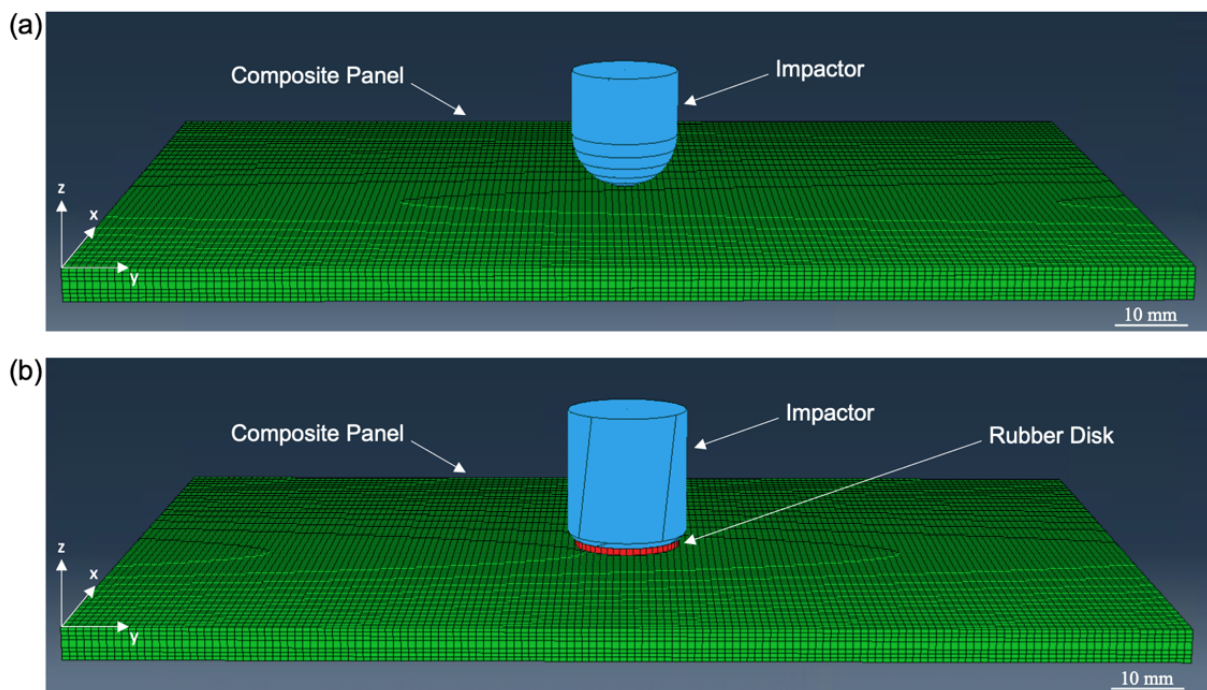
Figure 7-1. Meshed assembly with (a) round-nosed impactor and (b) flat-ended impactor with 1 mm of rubber (the impactor, rubber disk and composite panel are shown in blue, red and green, respectively).

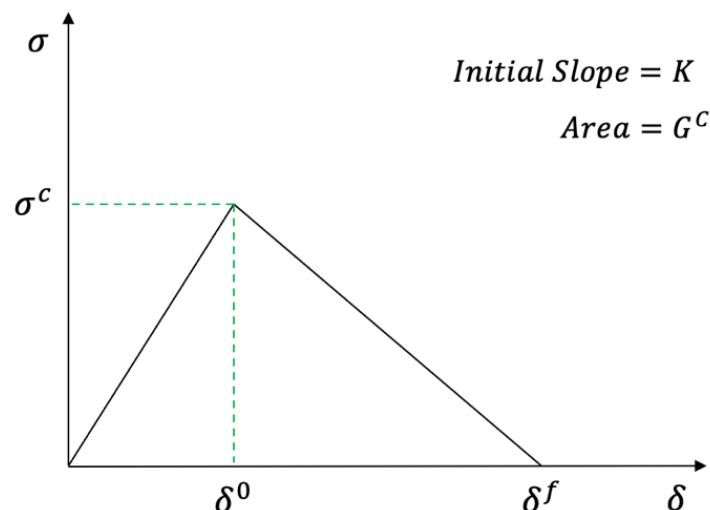
Figure 7-2. Diagram of the bilinear surface cohesive law, where the area under the curve is G_c .

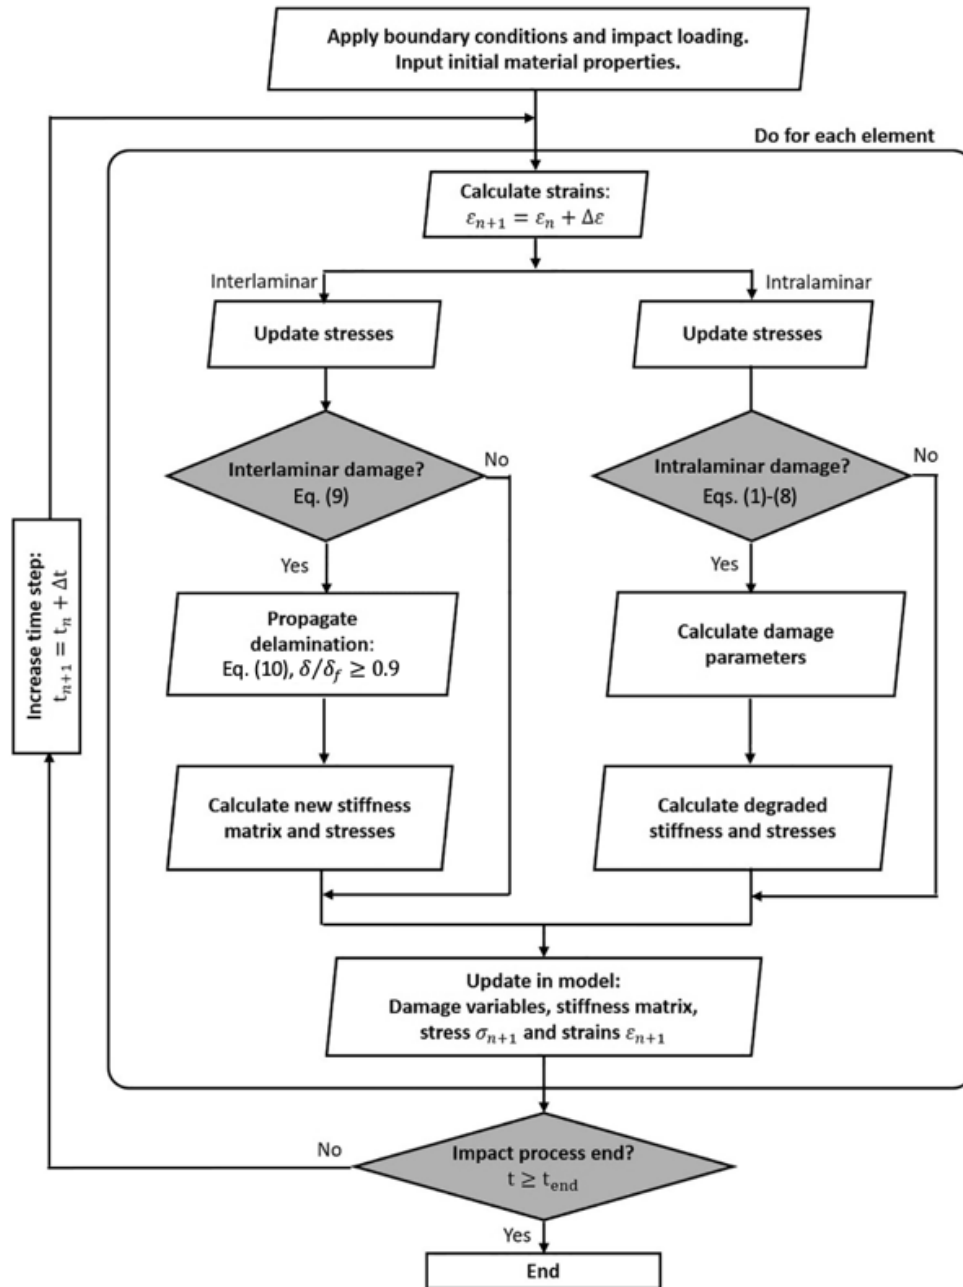
Figure 7-3. Flow chart demonstrating the implementation of Eqs. (1)-(10) to predict the impact response of CFRP panels using 2D Hashin Criteria [52].

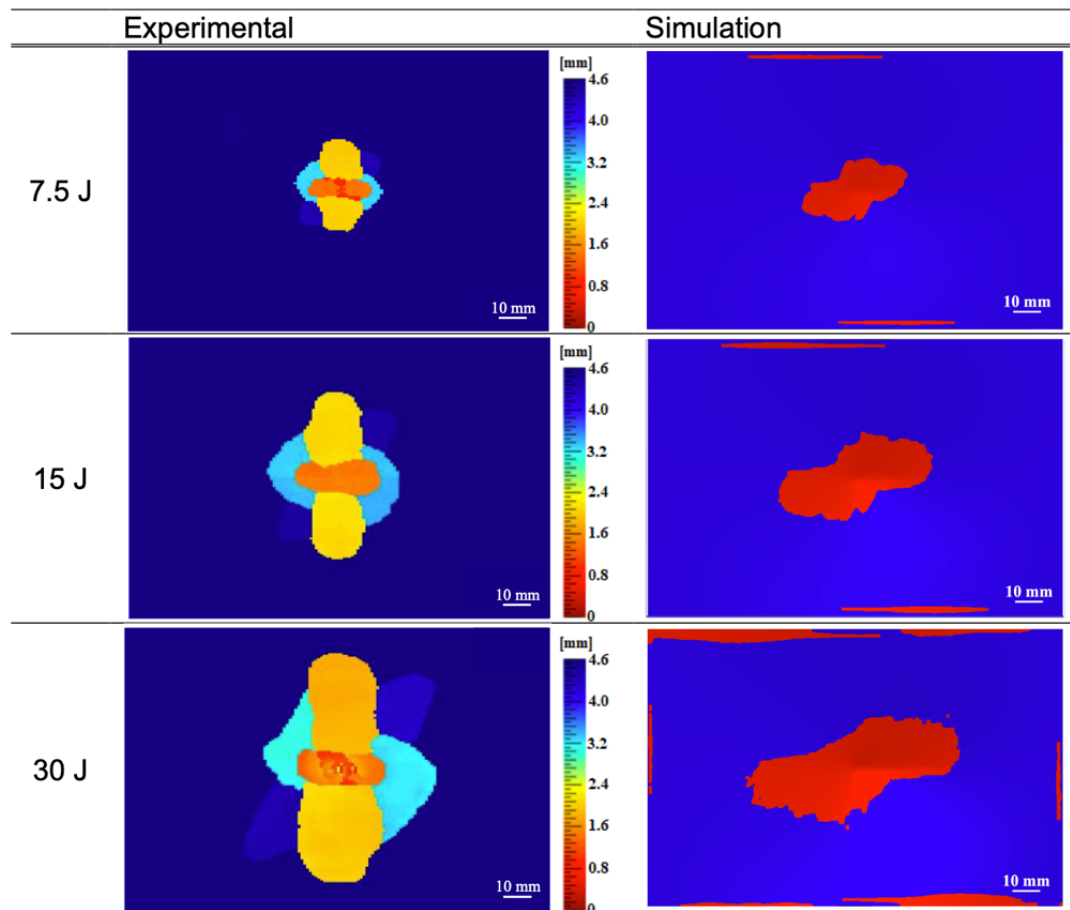
Figure 7-4. Damage maps from experimental testing and numerical simulation for impacts at 7.5, 15 and 30 J (with a damage variable of 0.9 for the numerical modelling).

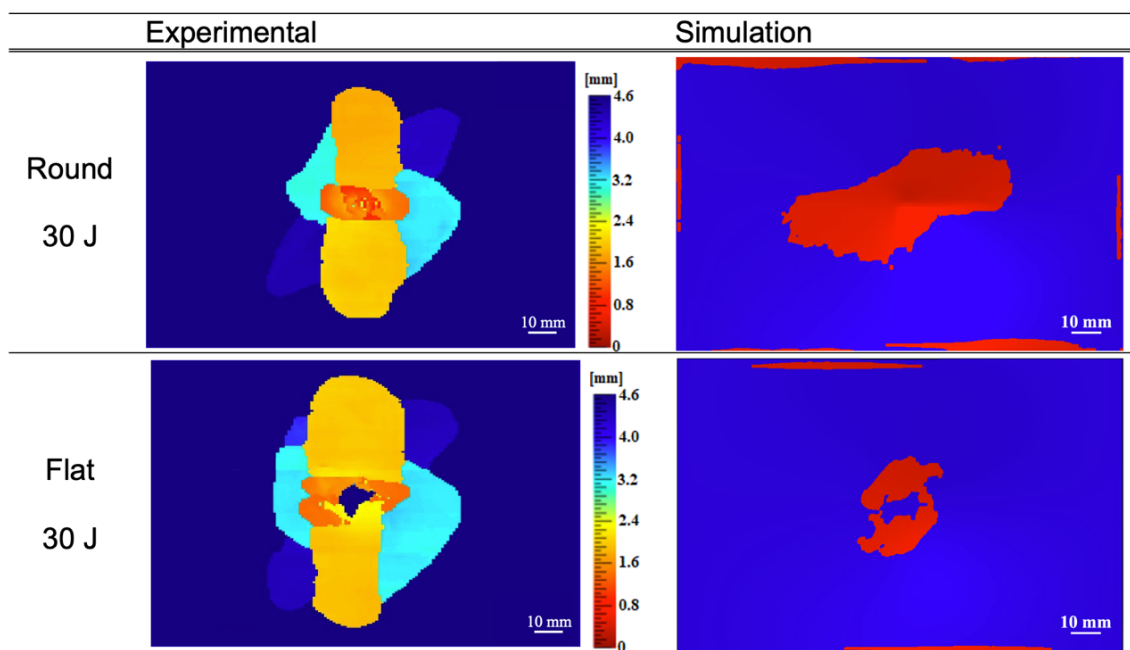
Figure 7-5. Damage maps from experimental testing and numerical simulation for impacts with a round-nosed impactor and a flat-ended impactor at 30 J (with a damage variable of 0.9 for the numerical modelling).

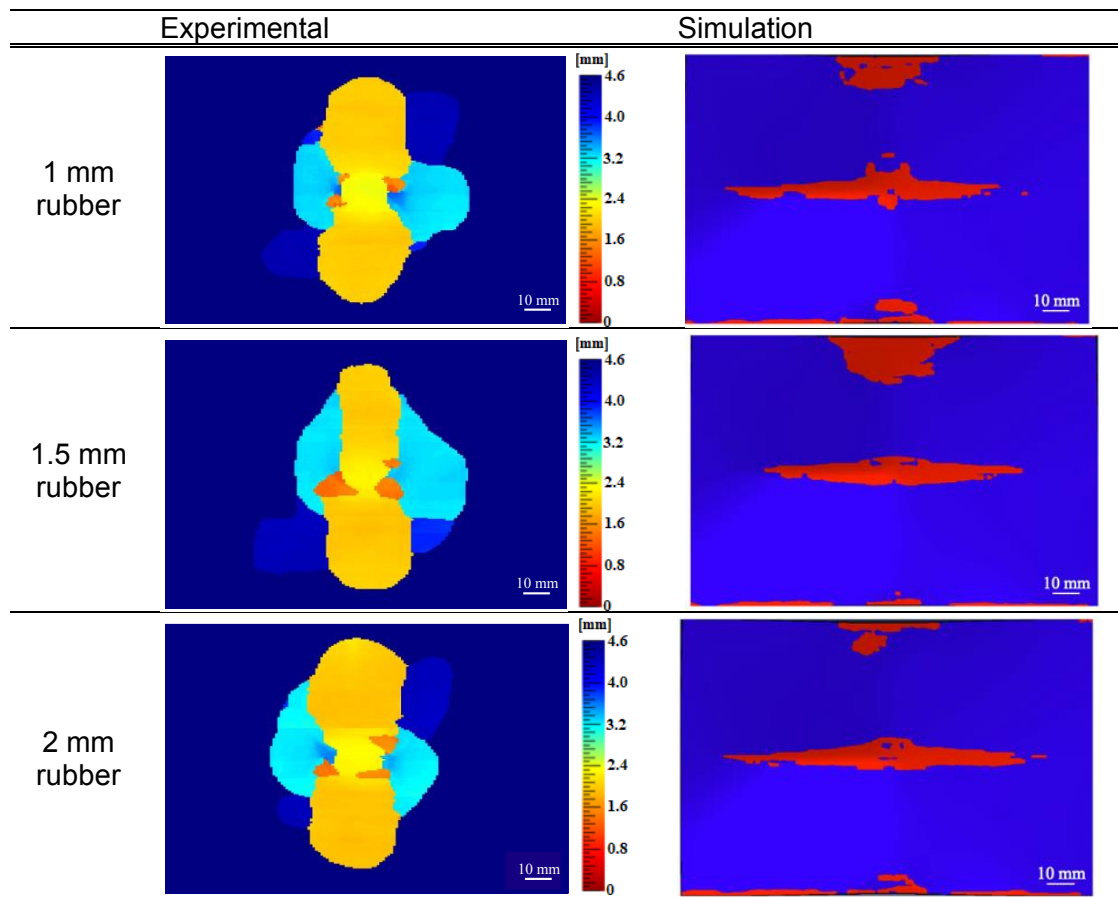
Figure 7-6. Damage maps from experimental testing and numerical simulation for impacts with a flat-ended impactor with 1, 1.5 and 2 mm of rubber at 30 J (with a damage variable of 0.9 for the numerical modelling).

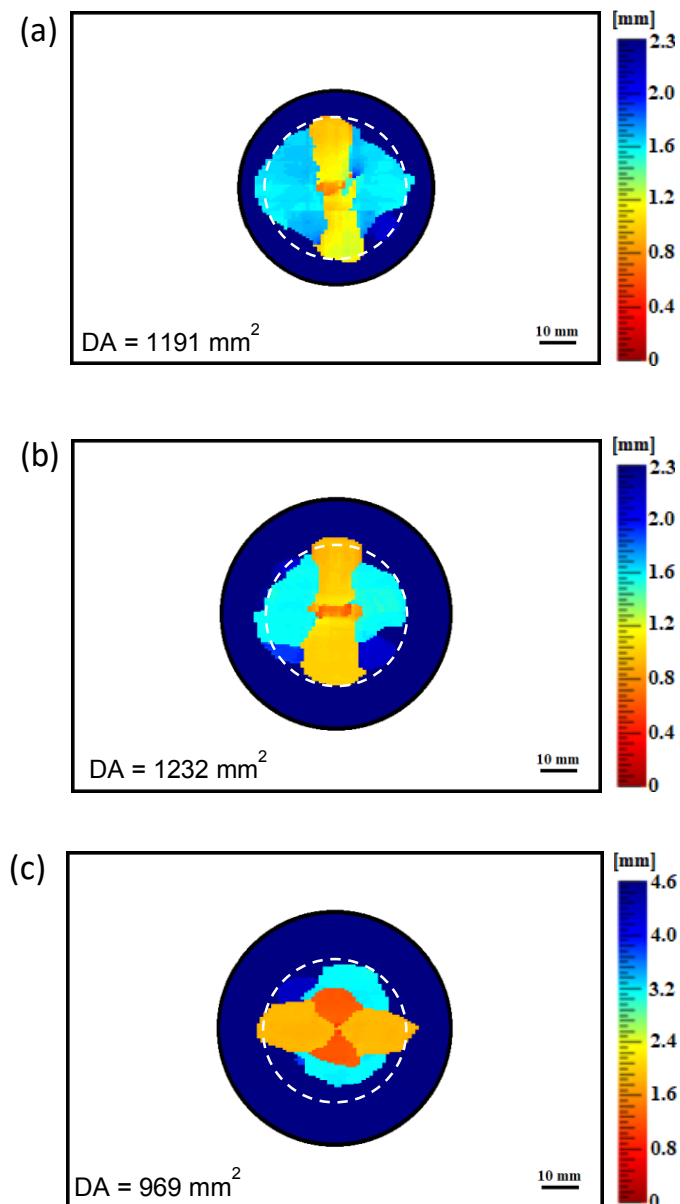
Figure 11-1. C-scan images of patch-repair QIT CFRP panels with no plugs taken from the top (impacted) face after a 7.5 J impact for: (a) the 55 mm thin ($0.5t = 2.29$ mm) patch repair – Test 2, (b) the 65 mm thin ($0.5t = 2.29$ mm) patch repair – Test 2, and (c) the 65 mm thick ($t = 4.58$ mm) patch repair – Test 2. (The white-dashed line represents the 40 mm diameter hole that was initially cut-out in the parent panel).

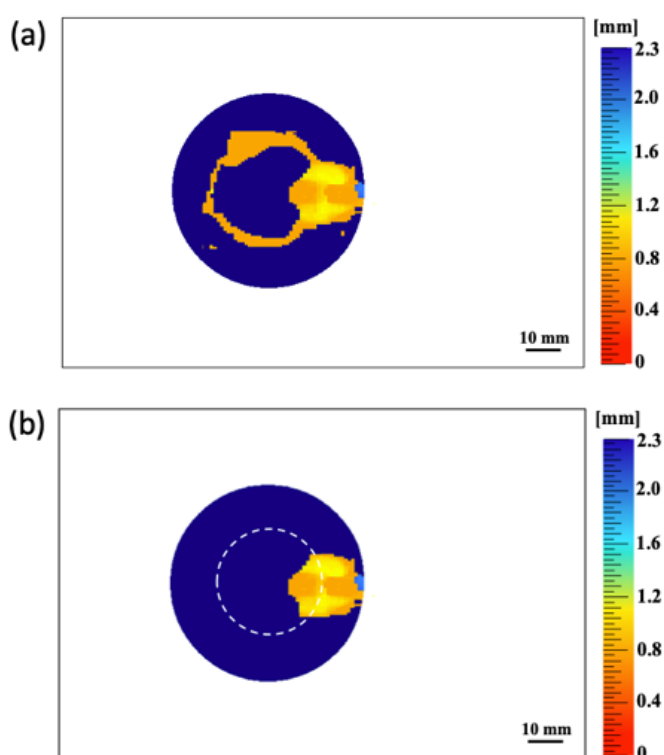
Figure 11-2. C-scan images of an edge of hole offset repaired cross-ply CFRP panel impacted at 7.5 J (a) before and (b) after editing to remove noise from surface impurities. (The white-dashed line represents the 30 mm diameter hole that was initially cut-out in the parent panel).

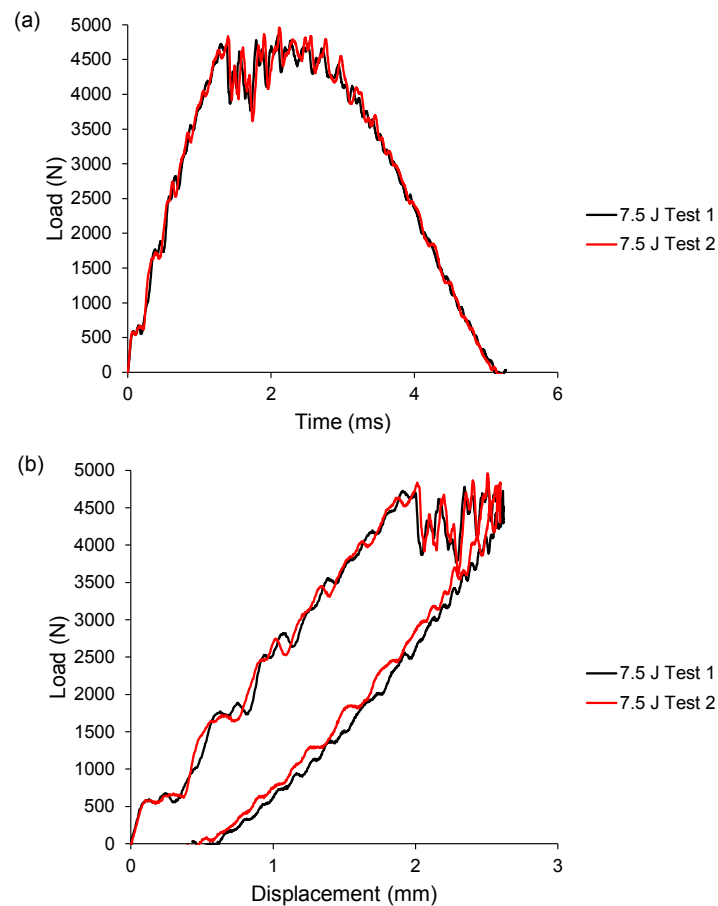
Figure 11-3. Load traces for both pristine cross-ply CFRP panel impacts at 7.5 J, with Test 1 represented by the black line and Test 2, the duplicate case, represented by the red line.

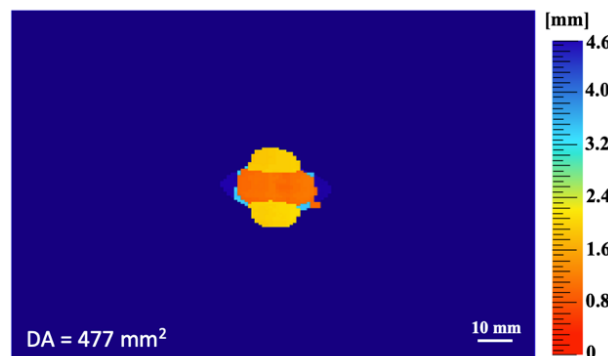
Figure 11-4. C-scan of pristine cross-ply CFRP panel impacted at 7.5 J, Test 2.

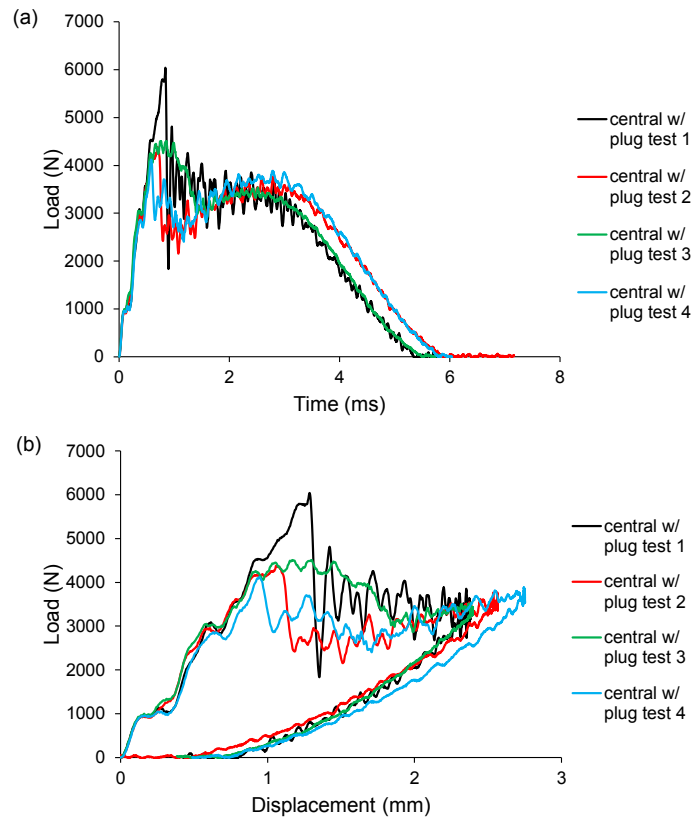
Figure 11-5. Load traces for all four central cross-ply CFRP patch repaired panels with a plug, with Test 1 represented by the black line and Tests 2, 3 and 4, the duplicate cases, represented by the red, green and blue lines, respectively.

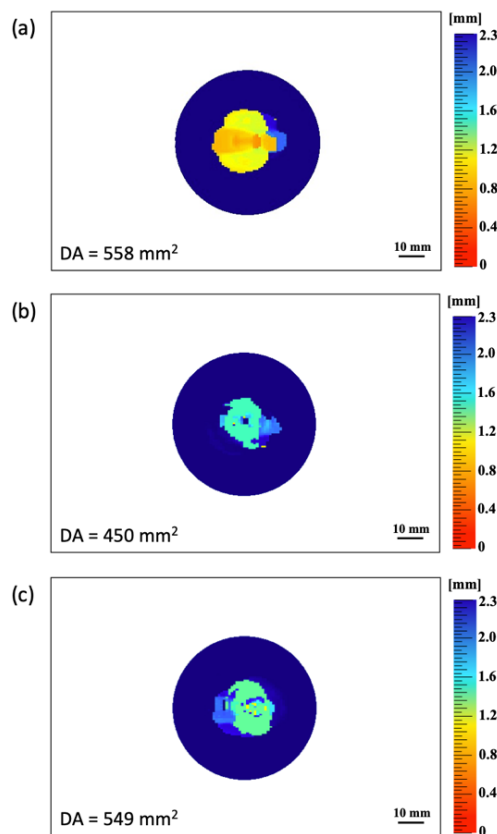
Figure 11-6. C-scans of central cross-ply CFRP patch repaired panels with a plug, (a) Test 2, (b) Test 3, and (c) Test 4.

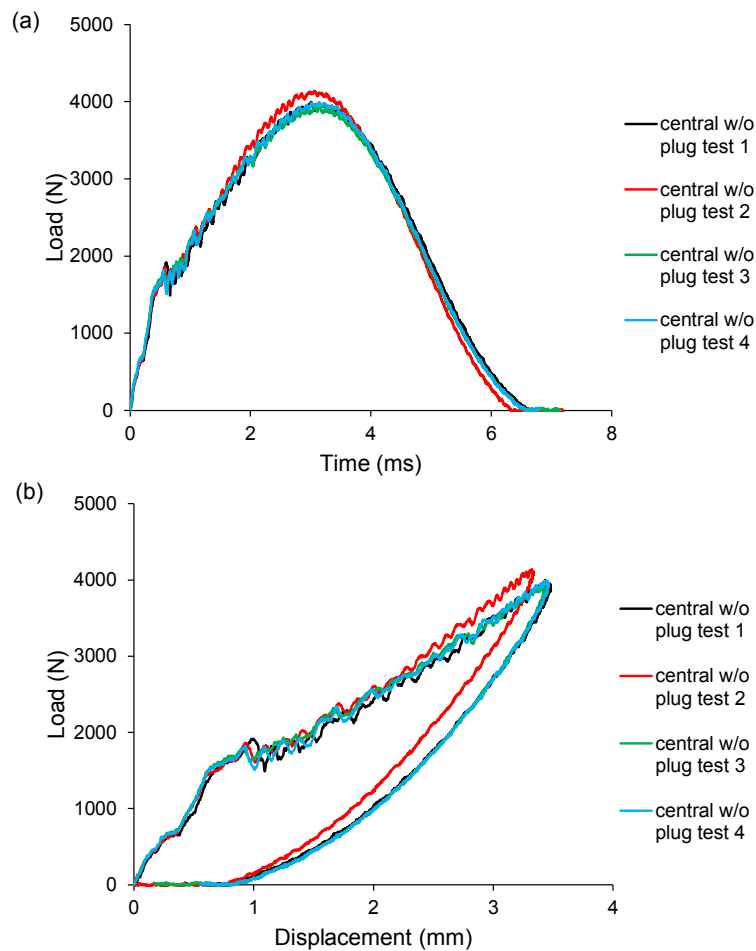
Figure 11-7. Load traces for all four central cross-ply CFRP patch repaired panels without a plug, with Test 1 represented by the black line and Tests 2, 3 and 4, the duplicate cases, represented by the red, green and blue lines, respectively.

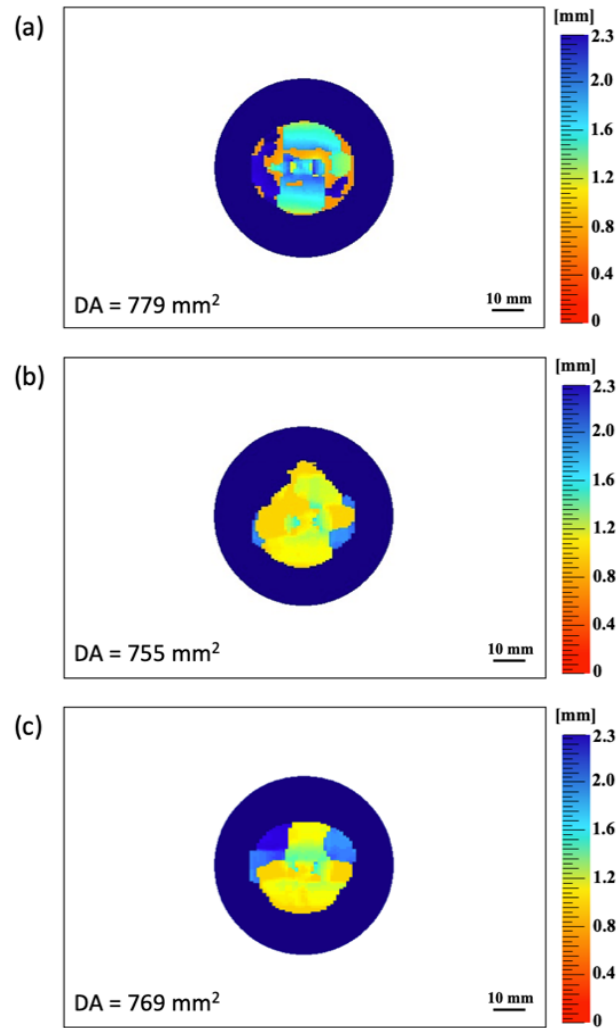
Figure 11-8. C-scans of central cross-ply CFRP patch repaired panels without a plug, (a) Test 2, (b) Test 3, and (c) Test 4.

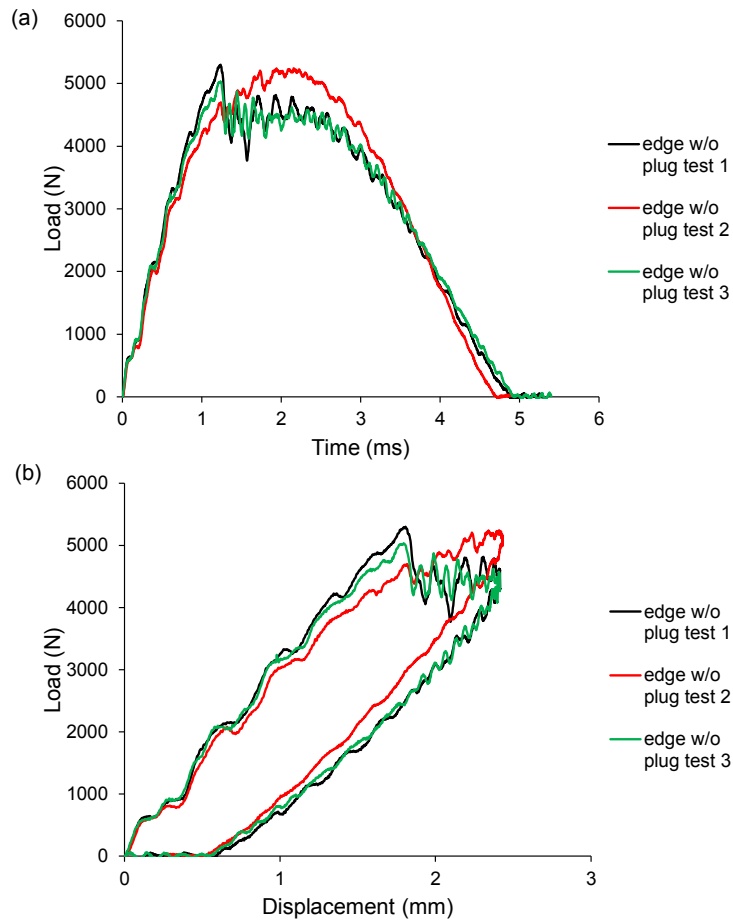
Figure 11-9. Load traces for all three edge of hole offset cross-ply CFRP patch repaired panels without a plug, with Test 1 represented by the black line and Tests 2 and 3, the duplicate cases, represented by the red and green lines, respectively.

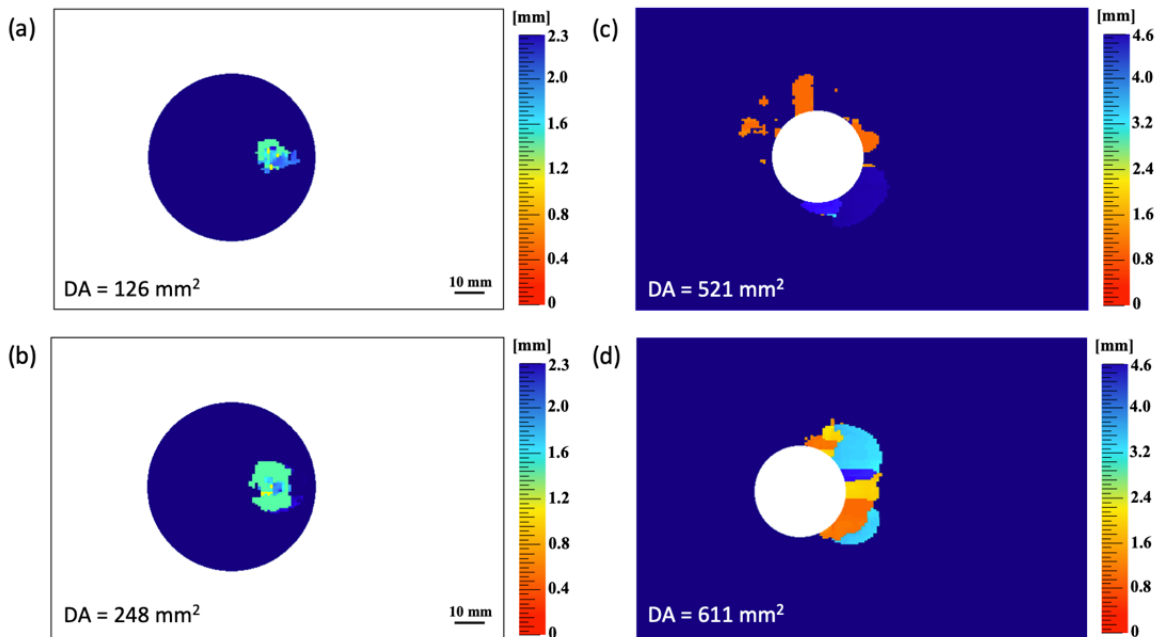
Figure 11-10. C-scans of the edge of hole offset cross-ply CFRP patch repaired panels without a plug, (a) Test 2 patch, (b) Test 3 patch, (c) Test 2 parent panel, and (d) Test 3 parent panel.

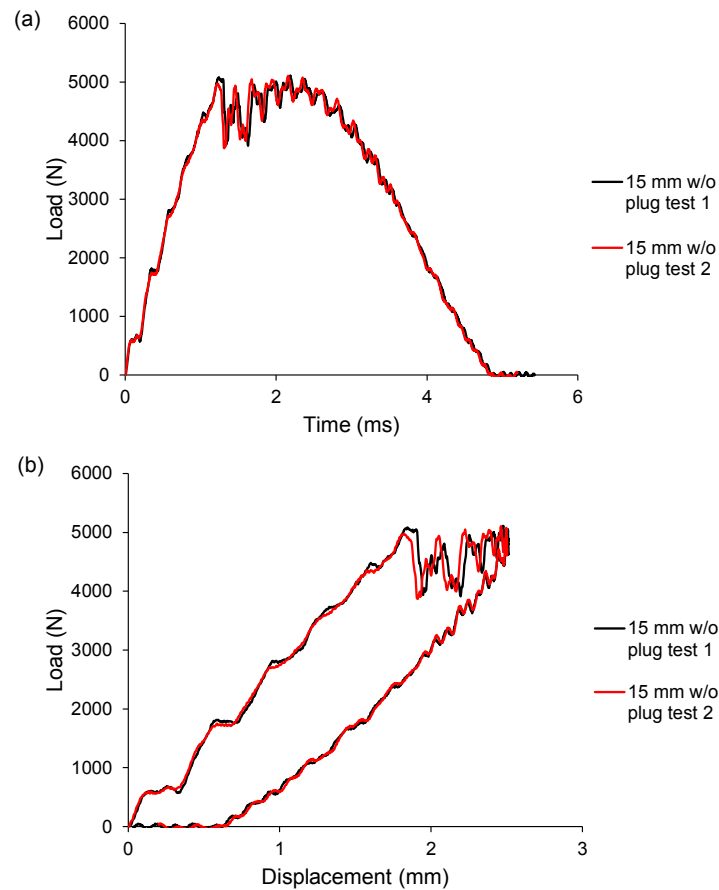
Figure 11-11. Load traces for both 15 mm offset cross-ply CFRP patch repaired panels without a plug, with Test 1 represented by the black line and Test 2 represented by the red line.

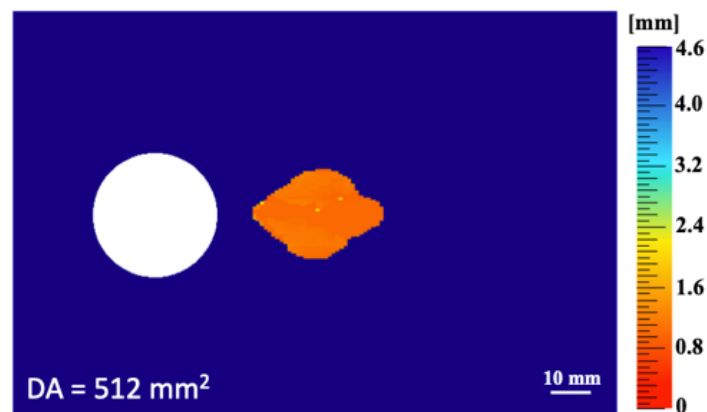
Figure 11-12. C-scan of a 15 mm offset cross-ply CFRP patch repaired panel without a plug, Test 2.

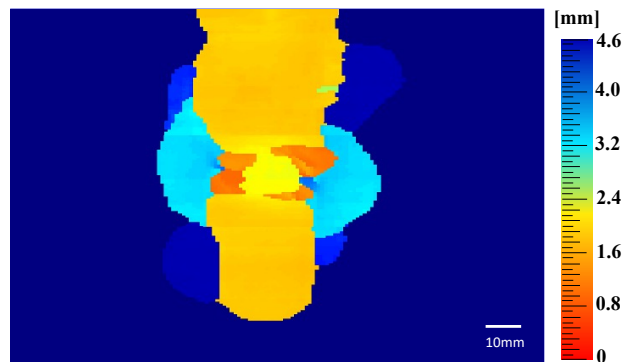
Figure 11-13. C-scan of a panel impacted with a flat-ended impactor with a 1 mm thick rubber disk adhered to the end, Test 1.

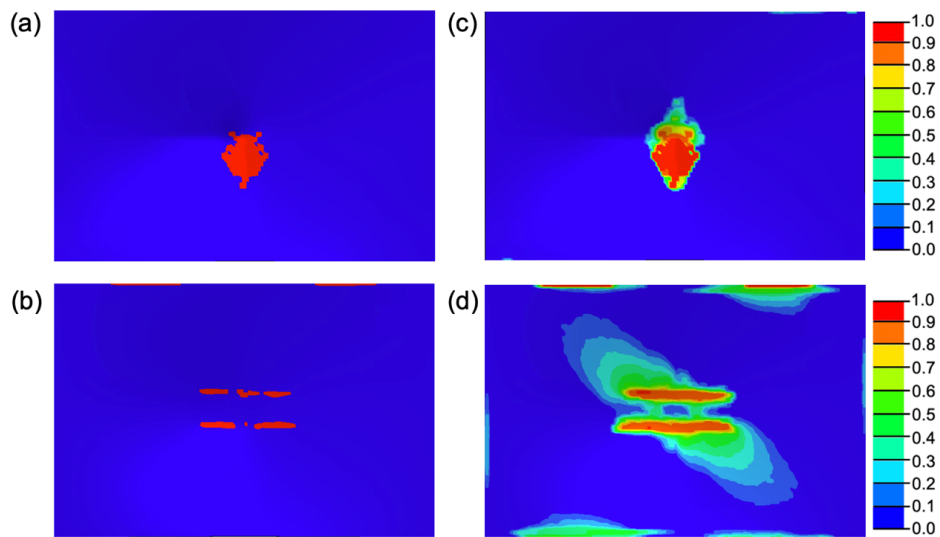
Figure 11-17. Damage maps from 30 J impacts using the preliminary model with damage variables above 0.85 shown in red for (a) round-nosed and (b) flat-ended impactors, and with damage variables according to the scale bar on the right for (c) round-nosed and (d) flat-ended impactors.

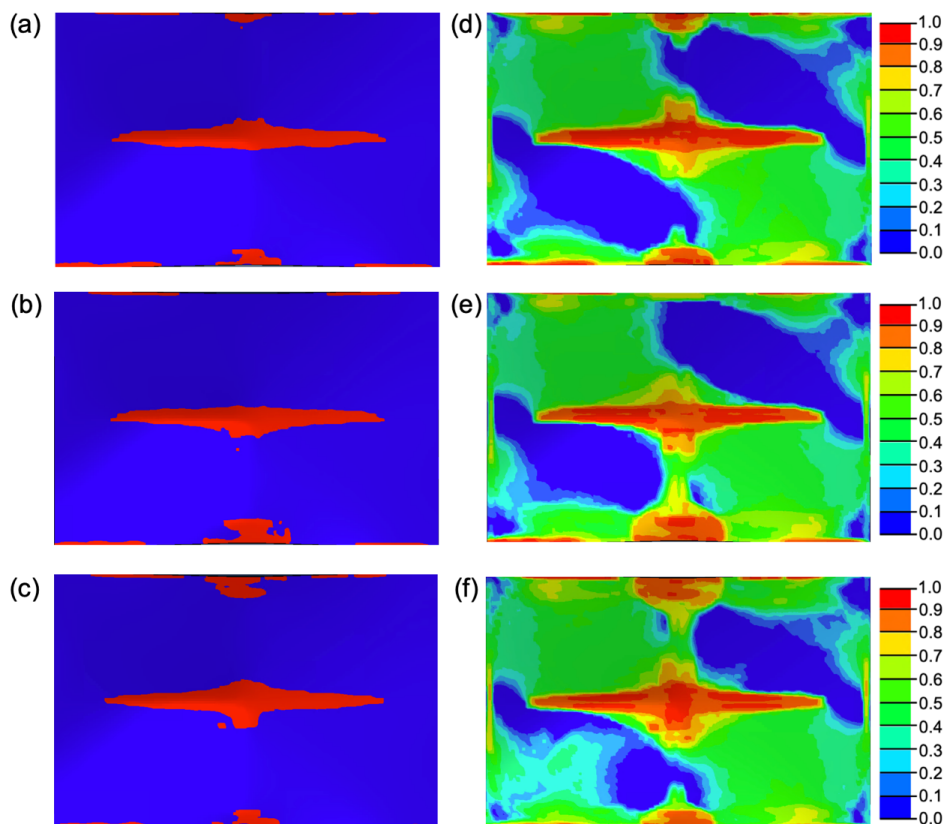
Figure 11-18. Damage maps from 30 J impacts using the preliminary model, and $c_{10} = 0.9$, $d_1 = 0.001$ and $c_1 = 0$, with damage variables above 0.85 shown in red for a flat-ended impactor with (a) 1 mm, (b) 1.5 mm, and (c) 2 mm of rubber and with damage variables according to the scale bar on the right for a flat-ended impactor with (d) 1 mm, (e) 1.5 mm, and (f) 2 mm of rubber.

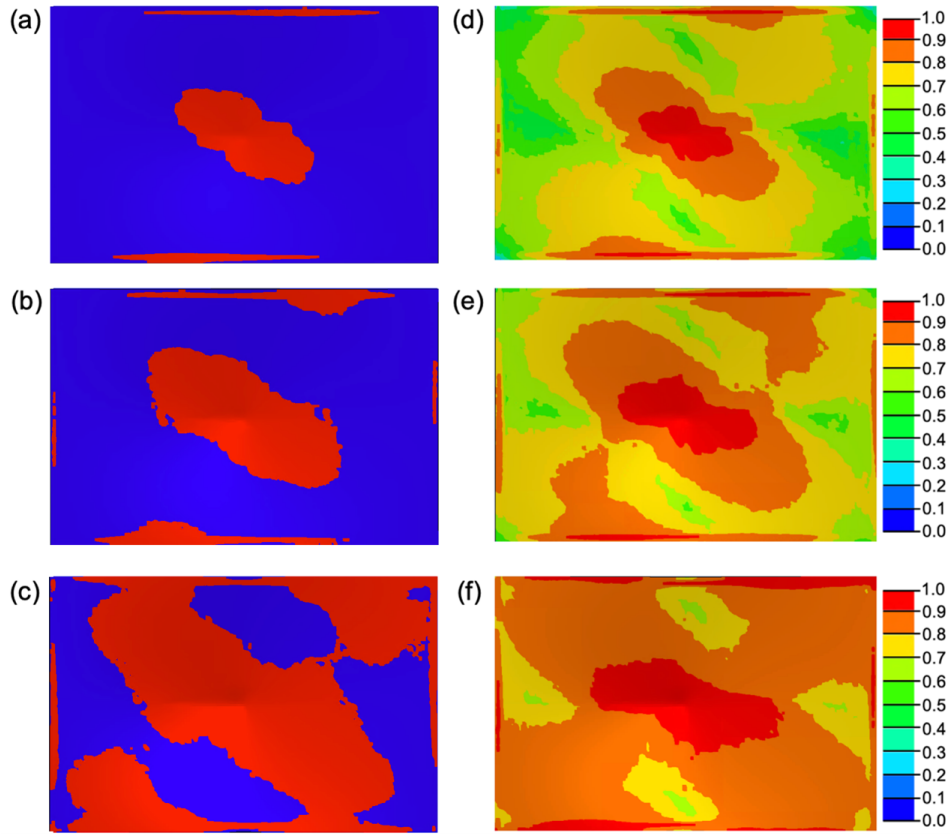
Figure 11-19. Damage maps using the final model with damage variables above 0.85 shown in red for (a) 7.5 J, (b) 15 J, and (c) 30 J and with damage variables according to the scale bar on the right for (d) 7.5 J, (e) 15 J, and (f) 30 J.

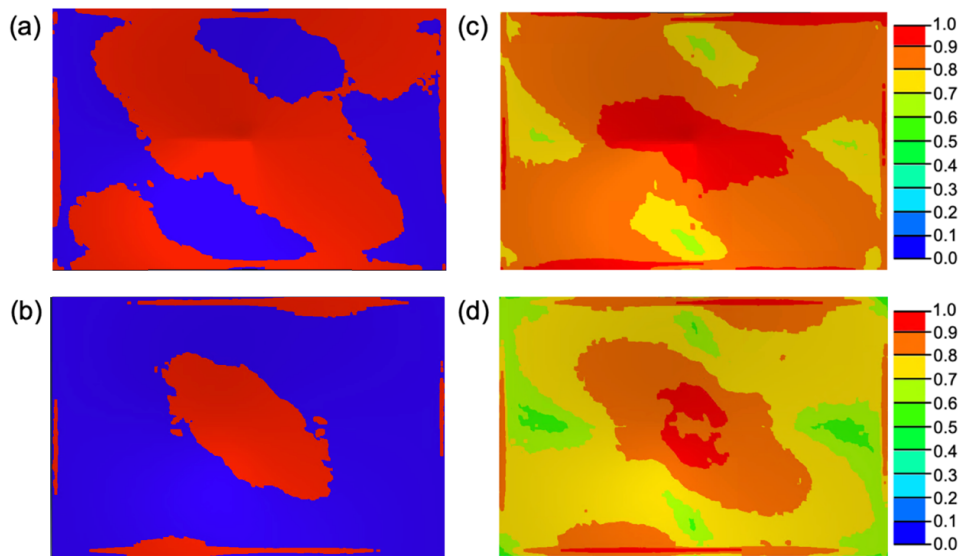
Figure 11-20. Damage maps from 30 J impacts using the final model with damage variables above 0.85 shown in red for (a) round-nosed and (b) flat-ended impactors, and with damage variables according to the scale bar on the right for (c) round-nosed and (d) flat-ended impactors.

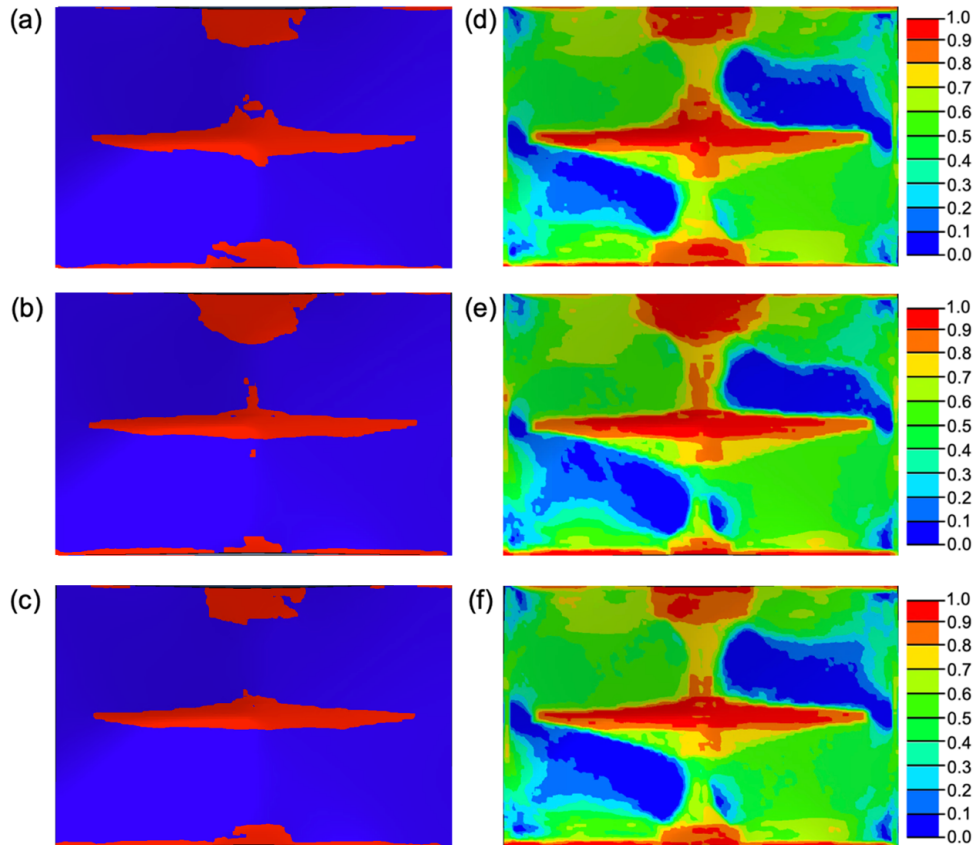
Figure 11-21. Damage maps from 30 J impacts using the final model, and $c_{10} = 0.9$, $d_1 = 0.001$ and $c_1 = 0$, with damage variables above 0.85 shown in red for a flat-ended impactor with (a) 1 mm, (b) 1.5 mm, and (c) 2 mm of rubber and with damage variables according to the scale bar on the right for a flat-ended impactor with (d) 1 mm, (e) 1.5 mm, and (f) 2 mm of rubber.
