TERRESTRIAL LASER SCANNER FOR MONITORING THE DEFORMATIONS AND THE DAMAGES OF BUILDINGS

Three case studies are presented relating to damaged and/or unsafe buildings: Sivillier Castle (Villasor - Sardinia-Italy), the Bell Tower of Mores (Sardinia-Italy) and industrial building (Cagliari - Italy).

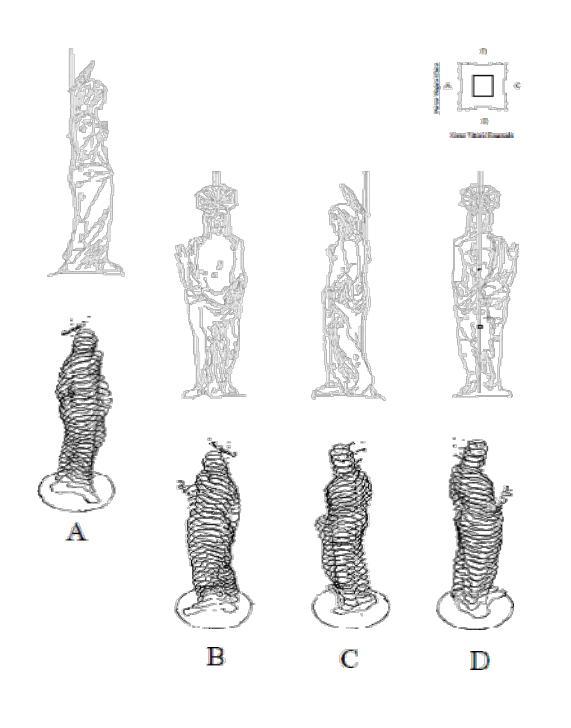
Figure 11: Redeemer statue graphic output

For the graphical reconstruction of the statue of Christ the Redeemer a contour level restitution, with an equidistance equal to 10 cm, was carried out (fig. 11). A classical restitution was also carried out, in which all the cracks and deterioration present in the statues were made evident.

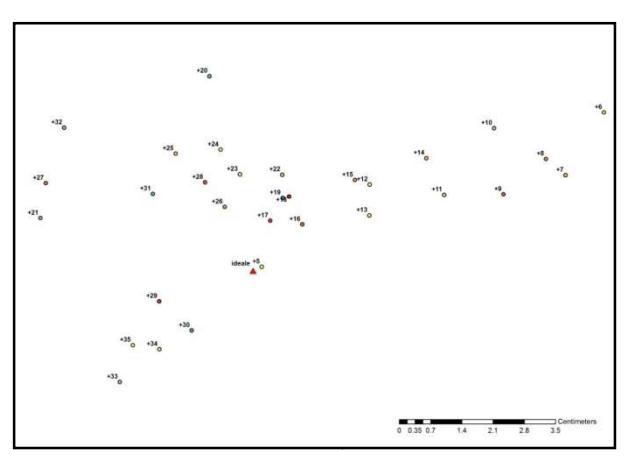
Figura 13: Planimetrical barycentric dispersion

The criterion adopted to assess the out of plumb of the barycentric axis of the bell tower was that of measuring the barycentric displacement of the sections from the vertical axis and passing through to the barycenters of the base [9]. From the 3D model, was extracted one horizontal section for each meter of height, starting from a measurement of 5 m (base section), thus excluding the part of the bell tower that is connected to church of Santa Caterina. The adjective "Ideal" was attributed to all the intersection points of the vertical with the different sections. The pattern of the barycenters of the sections did not diverge very much from that of the vertical, with values of the distance between the ideal point and the real barycenter oscillating between 0.086 m and 0.002 m. Figure 12 shows the pattern overall barycenter curve (in red) with respect to the vertical (in yellow) and figure 13 shows the planimetrical barycentric dispersion of the various sections with respect to the ideal position.

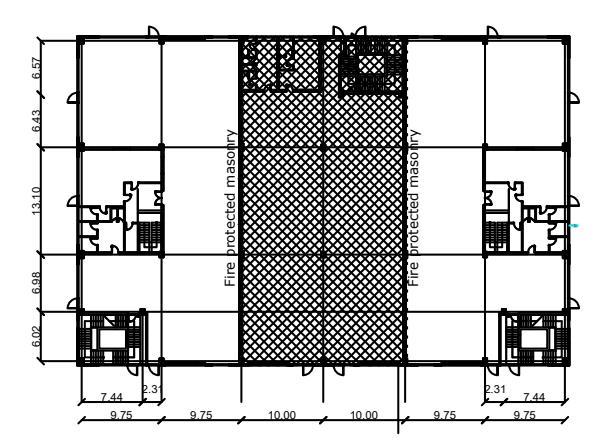
Figure 15: Zone interested by fire at the ground floor

A fire spread over the central part of the ground floor, as shown in Fig. 15, the lateral fire resistant partition walls prevented the fire from spreading to other areas of the building. Indeed, the main damage concerns the central area of the ground floor and the corresponding ceiling. For this reason the laser scanner survey was focused on these parts.

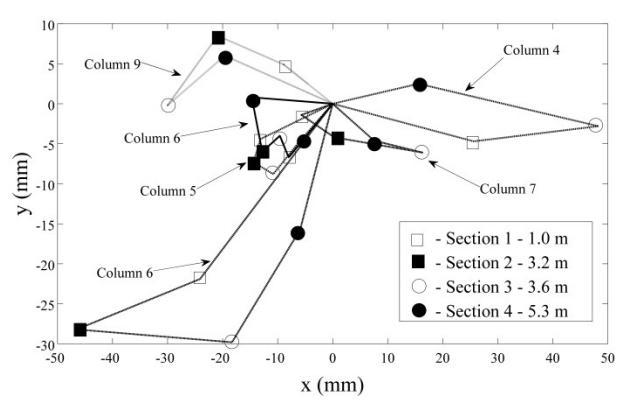
The variation of the centre of gravity position through the column height is reported in fig. 18. Looking at this picture, it is clear that the variations of the centre of gravity position are localized in the central part of the column (Section 2 and Section 3), this confirms the hypothesis of the each column having a constrained end. Some lateral columns, like Column 6, were dramatically dug during the fire and present important cross section reduction on the fire exposed side; instead, the other side presents negligible damage. The central Column 5 and Column 8, exposed on the whole perimeter, present very few centre of gravity positional variations: less than 10 mm in the latter case and less than 5 in the former.

Figure 18: Centre of gravity position of columns cross section at different heights

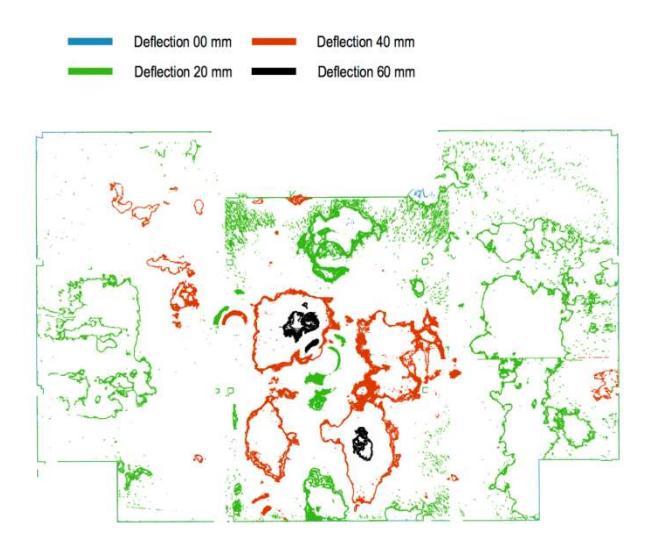
Figure 20: First floor slab deflection

The first floor slab deflection was also investigated by means of Laser Scanner and the result is reported in figure 20. In order to assess the deflections caused by the fire, the Reconstructor software was utilized, which generated a horizontal plan passing through an attachment point between the beam and the column not deformed by the fire and, from this, was calculated the deflections with respect to the multitude of points scanned by the laser scanner. Successively, the level curves of the deflections were generated. The maximum recorded deflection was 60 mm. It is located on the left side and in the bottom part of the fired zone. Visible cracks are not present in the extrados, and the unique sign of the fire is the floor discolouration.
