# VI ITALIAN CONFERENCE OF RESEARCHERS IN GEOTECHNICAL ENGINEERING – Geotechnical Engineering in Multidisciplinary Research: from Microscale to Regional Scale, CNRIG2016

# Kinematics of the Maierato landslide (Calabria, Southern Italy)

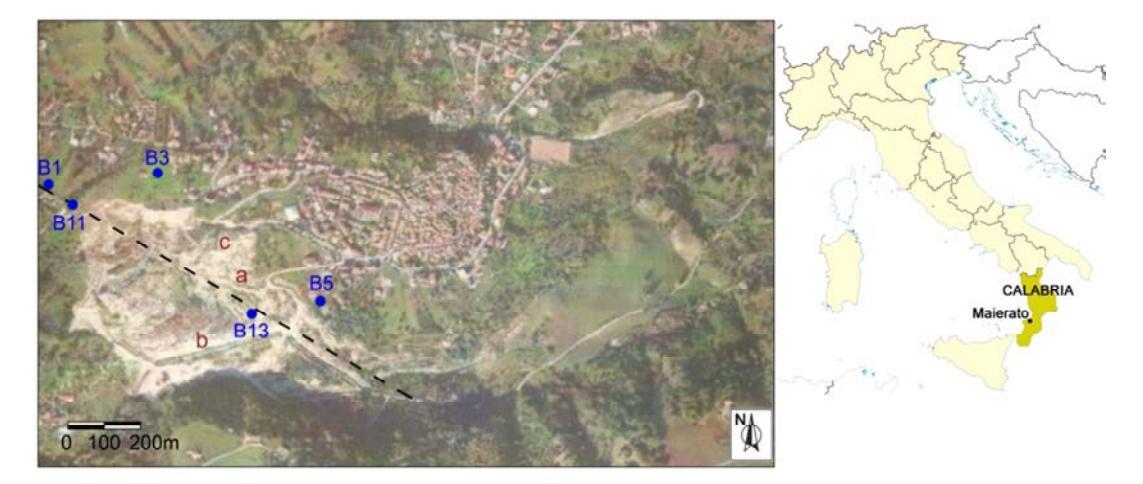
Fig. 1. Aerial view of the 15 February 2010 Maierato landslide and location of the Maierato village (Calabria, Southern Italy). Legend: a, b and c location of the photos in Fig. 2; B1, B3, B5, B11 and B13 location of the boreholes in Fig. 6; ----- trace of section.

The landslide caused the collapse of a bypass road located on the left flank of the landslide body, the destruction of a main road (SP 55) in the lower part of the slope, and the loss of many hectares of farmland. The landslide also moved a building for a distance over 100 m, and caused the formation of a small lake on the right flank of the landslide body. Although the zone was affected by continuous movements especially during the wet seasons, no monitoring system was installed before the occurrence of the 2010 landslide. However, since the landslide was preceded by large deformations affecting mainly the SP 55 road, the area was under observation from some days. Many photos were taken to document the deformation process, and two videos were filmed during the landslide. In addition, a site investigation consisting of boreholes, field and laboratory tests was carried out after the event. Piezometers were also installed in several boreholes to detect the presence of groundwater in the subsoil. All these data are usedto reconstruct the kinematics of the landslide and to define the geotechnical model of the slope.

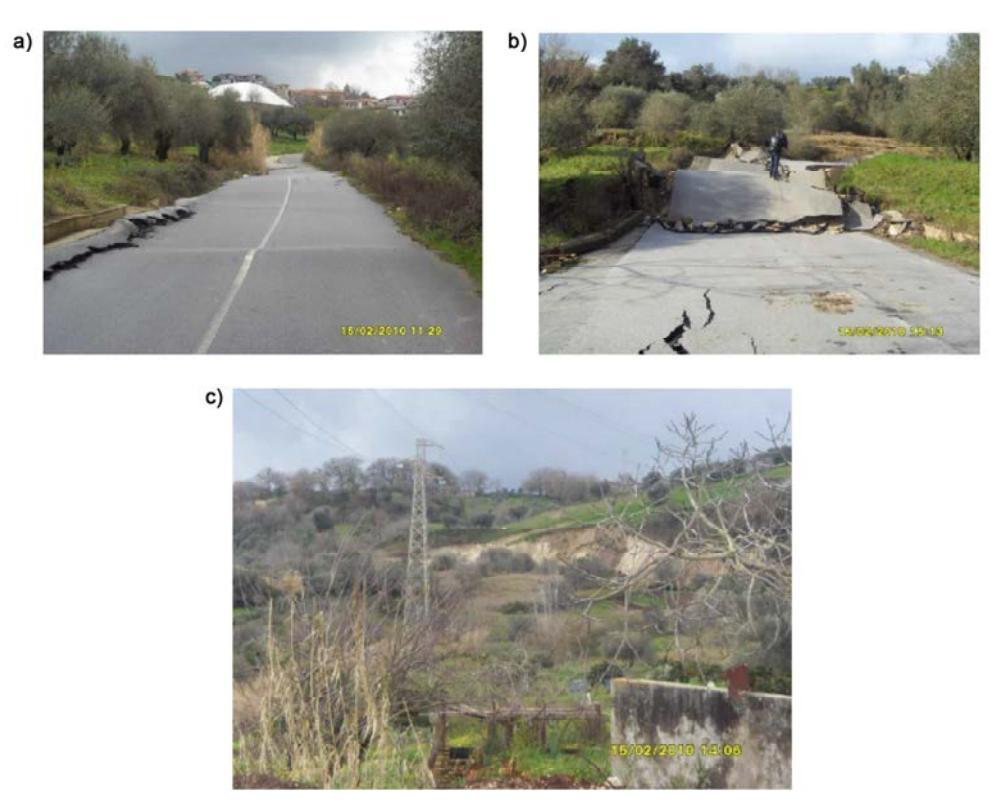
Fig.2. (a,b)cracks and bulges along the SP 55 road; (c)increase in the height of a pre-existing scarp at 270 m a.s.l.(location is indicated in Fig.1).

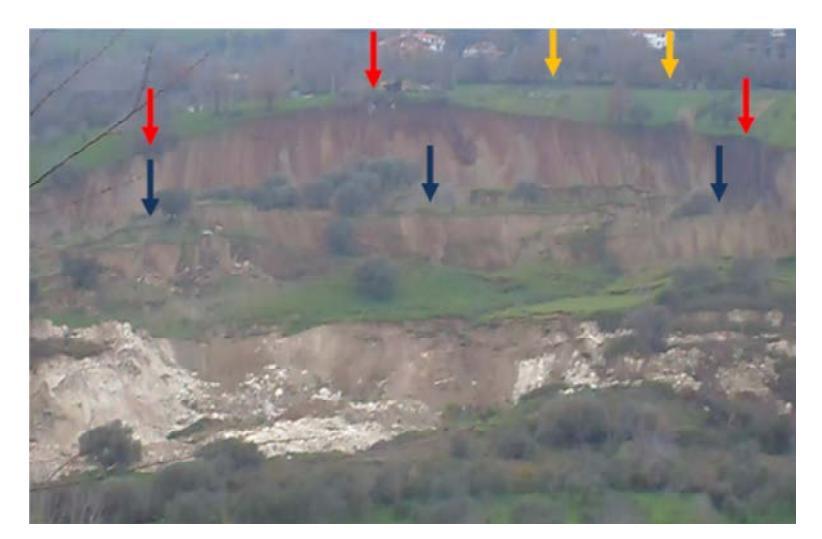
Fig. 3. The 15 February 2010 landslide with an indication of the main slip surfaceat300 m elevation (red arrows) and a second slip surface emerging at285 m elevation (blue arrows). The pre-existing scarp at 305 m a.s.l. (yellow arrows) was not involved by the failure process.

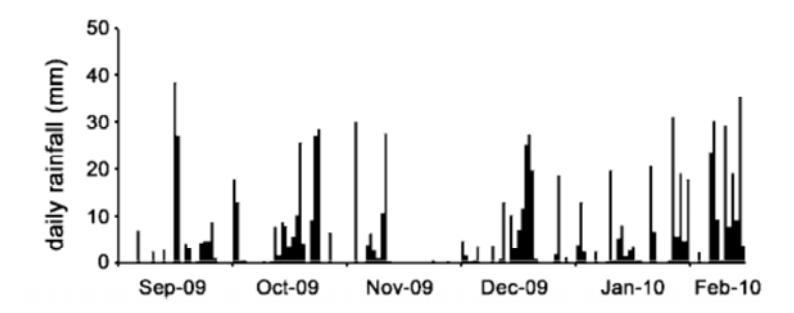
The 15 February 2010 landslide occurred after a long rainy period that also involved the years 2008 and 2009. In particular, from 1 September 2009 to 15 February 2010 (for a total of 168 days), a cumulative rain of about 900 mm was recorded at the rain-gauge station of Vibo Valentia. Daily rainfall recorded in this period is presented in Figure4. As can be seen, although the rain depths are not particularly high (the maximum value is 35.6 mm), precipitation is well distributed over the time period considered. Such a characteristic should in principle favour infiltration (rather than surface flow) and consequently groundwater supply. Figure 5 shows the cumulative rain in the wettest 168 consecutive days of each year of the time series, from 1919 to the date of the landslide. As can be observed, a value of 900 mm was exceeded few times. In addition, two consecutive years with rainfall comparable with that recorded in the years 2009-2010 (black arrow) only occurred in the years 1939-1940 and 1944-1946 (white arrows), i.e. over 60 years before the 2010 landslide, when the land conditions were different from the current ones. In the last decades, in fact, a large area surrounding the landslide site was urbanized.

Fig. 4.Daily rainfall recorded at Vibo Valentia station from 1 September 2009 to 15 February 2010.

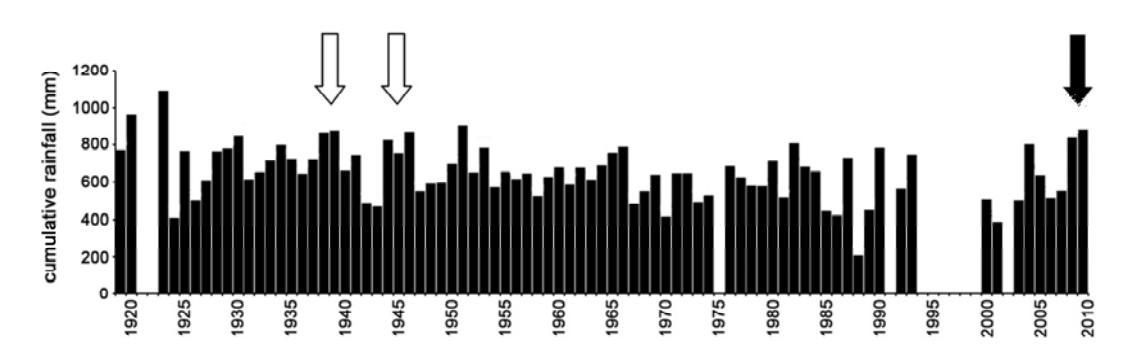
Fig. 5.Cumulative rain in the wettest 168 consecutive days of each yearof the time series, from 1919 to 2010.

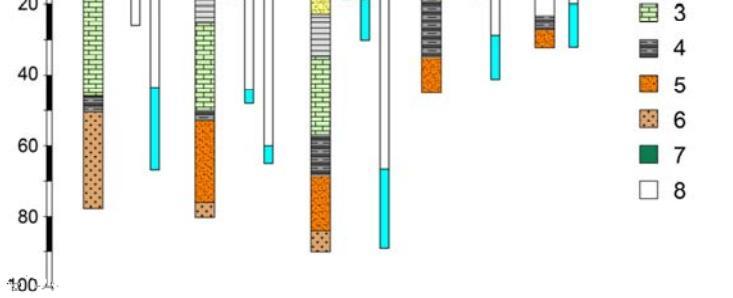
A site investigation consisting of boreholes, laboratory and field tests was performed after the 15 February 2010 landslide. Figure 6 shows the soil profile of some boreholes which were instrumented by piezometers sealed at different depths. The mean piezometric level measured after the landslide, in the period 2011-2012, is also indicated in Fig. 6, for each piezometer considered. As it can be seen, the subsoil consists of the following sequence (from top to bottom) of soils and rocks: (1) Pliocene deposit formed by layers of silty sand and clayey silt. This deposit has a thickness variable from 5 m to 25 m; (2) Miocene evaporitic limestone with a thickness of 25-45 m; (3) Miocene marly clay the thickness of which ranges from a few meters to 20 m; (4) Miocene sandstone, slightly cemented, with a thickness varying from 10 to 40 m; (5) Miocene conglomerate formed by sand and gravel with clasts and blocks

deriving from the underlying formation; (6) Paleozoic basement consisting of gneiss generally with a high degree of weathering. As shown in Fig. 6, a different groundwater, often under pressure, is located in the evaporitic limestone, sandstone and gneiss. Field tests consisting of standard penetration tests (SPT), Ménardpressuremeter tests (MPT) and Lefranc tests were carried out at various depths along some boreholes. In particular, SPTs were performed in the sandy layers of the Pliocene deposit and in the Miocene sandstone. Values of N<sub>SPT</sub> from 19 to 40 blows/30cm were recorded in the Pliocene sand, whereas all the tests performed in the Miocene sandstone yielded a refusal after a penetration of few centimetres. In the evaporitic limestone, both the Ménard modulus, E<sub>M</sub>, and the limit pressure, pLIM, generally increase with depth. In particular, E<sub>M</sub> varies from 12 to 28 MPa, and pLIM from 1.4 to 3.7 MPa. Higher values of these parameters were found in the sandstone and conglomerate. Marchetti Dilatometer Tests (MDT) were also carried out. Average values of the lateral stress index  $K_d=14$  and dilatometer modulus  $E_d=30$  MPa can be attributed to the marly clay. In the evaporitic limestone, both  $K_d$  and Ed have a trend to increase with depth. In particular,  $K_d$  varies approximately from 5 to 10 and  $E_d$  from 30 to 100 MPa. The test conducted in the sandstone was stopped at a depth of about 4.5 m, because of the high mechanical properties of this geological formation. The average values of  $K_d$  and  $E_d$  for this material were 30 and 150 MPa, respectively. Lefranc tests provided the values of the coefficient of permeability, k, indicated in Table 1 [3]. Finally, direct shear tests were conducted to evaluate the soil strength parameters at peak  $(c'_p; \varphi'_p)$  and residual  $(\varphi'_p)$ . On the basis of the experimental data available, the subsoil model shown in Fig. 7 has been reconstructed. The mechanical properties assigned to each soil layer are specified in Table 1, in which  $\gamma$ . E'andy' denote the unit weight, Young's modulus and Poisson's ratio, respectively. The values indicated in Table 1 have been obtained directly from the results of the laboratory tests or using empirical relationships between soil properties and the results from the field tests available [8-10]. Some finite element analyses in which suitable constitutive models are incorporated [11-15], are in progress to interpret the failure mechanism documented by the images and to establish the main factors of triggering of the landslide.

Fig. 6.Soil profiles from some boreholes (location is indicated in Fig. 1) with an indication of the piezometric levels measured after the landslide. Legend: 1) silty sand; 2) clayey silt; 3) evaporitic limestone; 4) marly clay; 5) sandstone; 6) gneiss; 7) cover soil; 8) landslide debris.

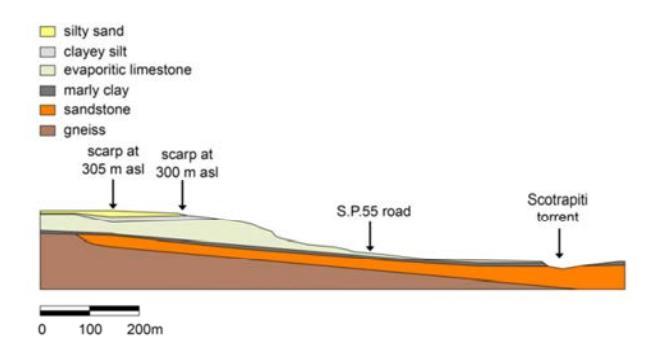
Fig. 7.Geotechnical model of the slope before the 2010 landslide (the trace of this section is indicated in Fig. 1).
