49TH TURBOMACHINERY & 36TH PUMP SYMPOSIA SEPTEMBER 14-17, 2020 | HOUSTON, TX | GEORGE R. BROWN CONVENTION CENTER

Successful 2 planes balancing confirm by rotordynamics calculation

This historical case is focus on the vibration behavior of a generator. After a short circuit issue on the grid, the machine train trip. At this time the level of vibration of the generator was acceptable and well below the level of alarm. However, 10 days after the restart of the unit the level of vibration started to increase. The analysis of the data pointed out an increase of the 1X component. There were no signs of rub or other malfunctions. The analysis of the data concluded on an increase of unbalance or a decrease of the dynamic stiffness. Even if, It is unusual to observe such increase of vibration on a generator, the full inspection of the generator was rejected. In order to operate, even if the root cause was not identified, it was decided to balance the generator. The balancing activity was a success using a modal method. Since the root cause was not determined and in order to be sure that the dynamic behavior of the generator was as expected compare to its design, a lateral analysis was don

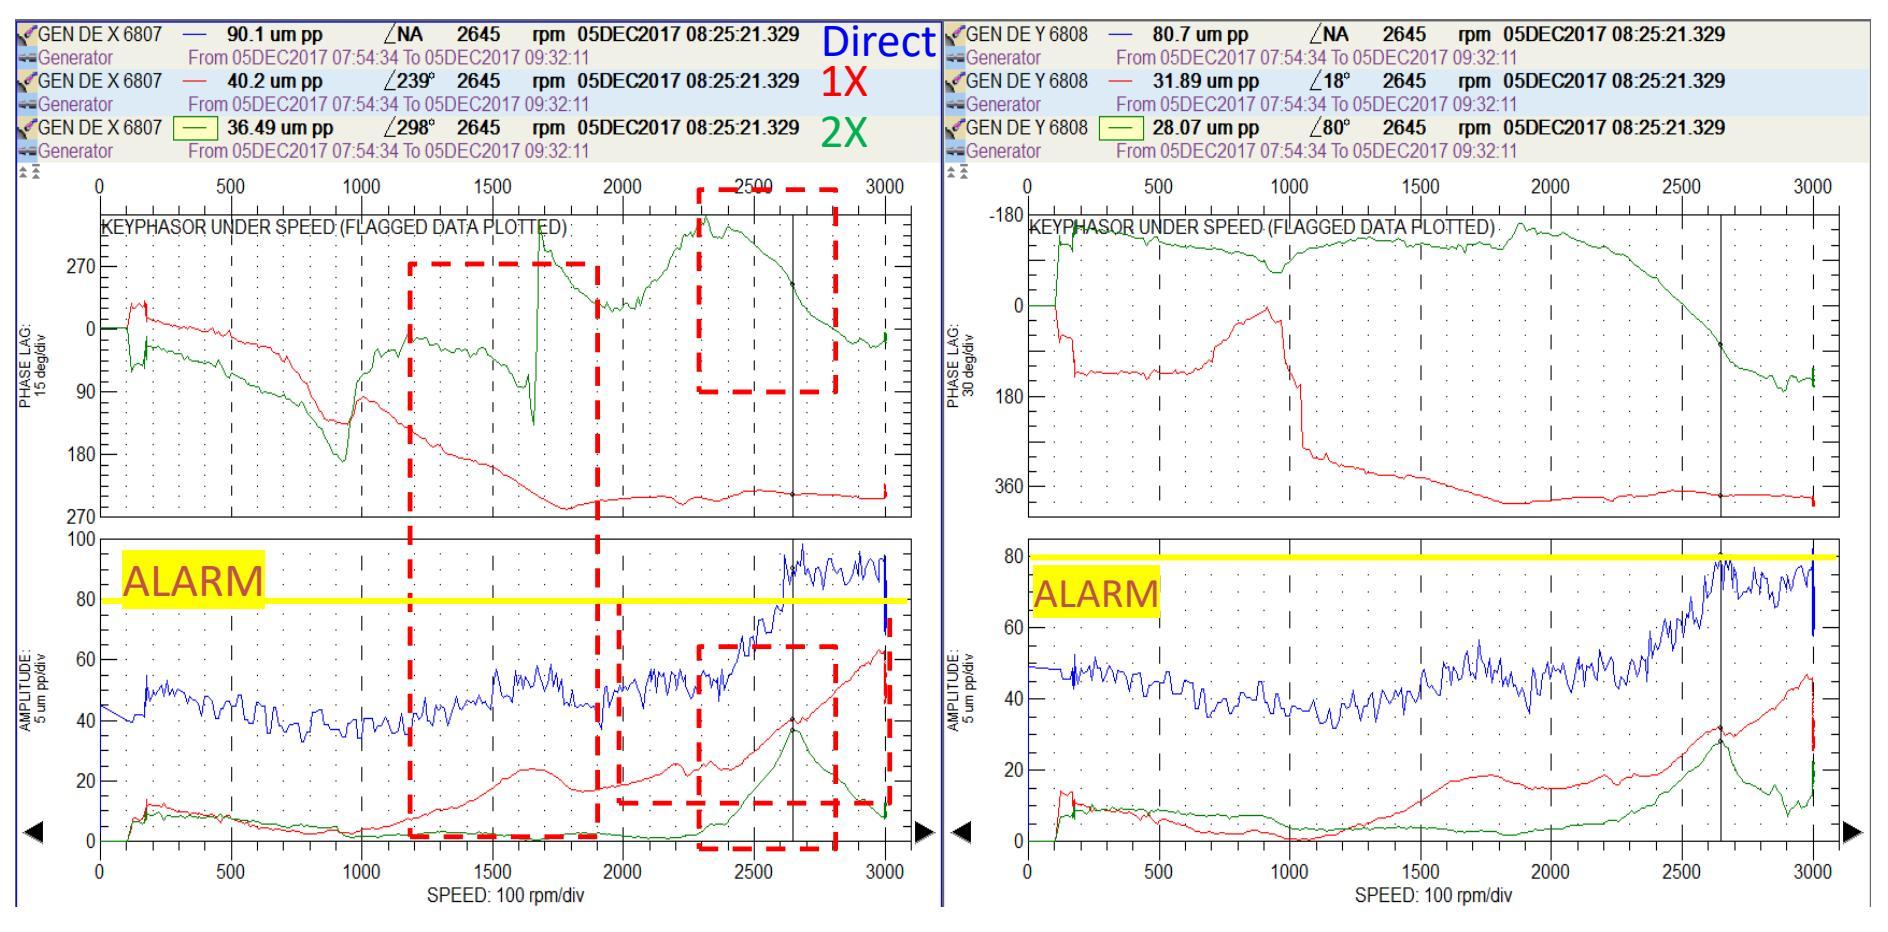
Analysis of one start up / Bode plots

Several run were recorded

- Similar dynamic behavior
- Repeatable behavior
- Thermal transient repeatable
- Shaft movement inside the bearing as expected

Transient information :

- A first critical speed seems to be present around 1700 rpm
- From 2000rpm to 3000rpm the level of 1X increase.
- The 2X response is amplified around 2600rpm indicating that a mode at 5200 cpm may exist.

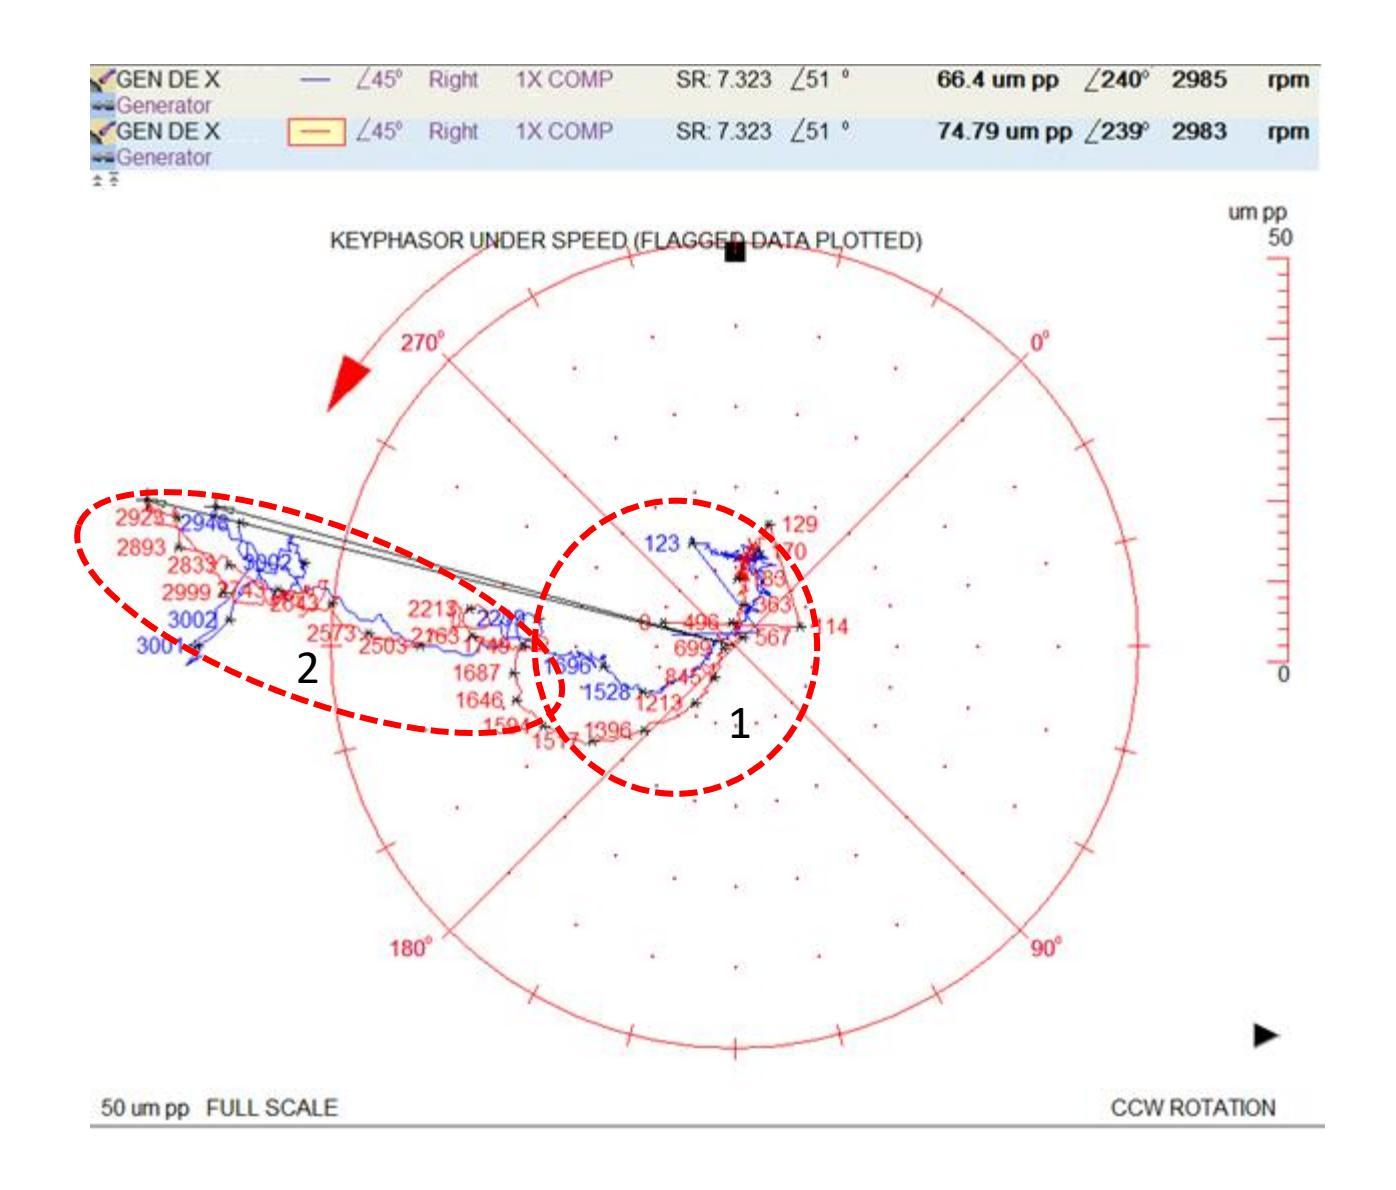
Analysis of a start up & Shutdown

1 - First critical speed

2- Second critical speed ?

- The Vibration are mainly 1X with forward precession
- The orbits are elliptical
- The 1X amplitude increases with the "square" of the speed
- The Dynamic behavior is repeatable from one run to another run
- There is no hysteresis between startup and shutdown
- The 1X vectors of DE and NDE sides are opposite in phase. It most probably due to the influence of a second mode. Balancing plane

The level of vibration is most probably due to an unexpected unbalance.

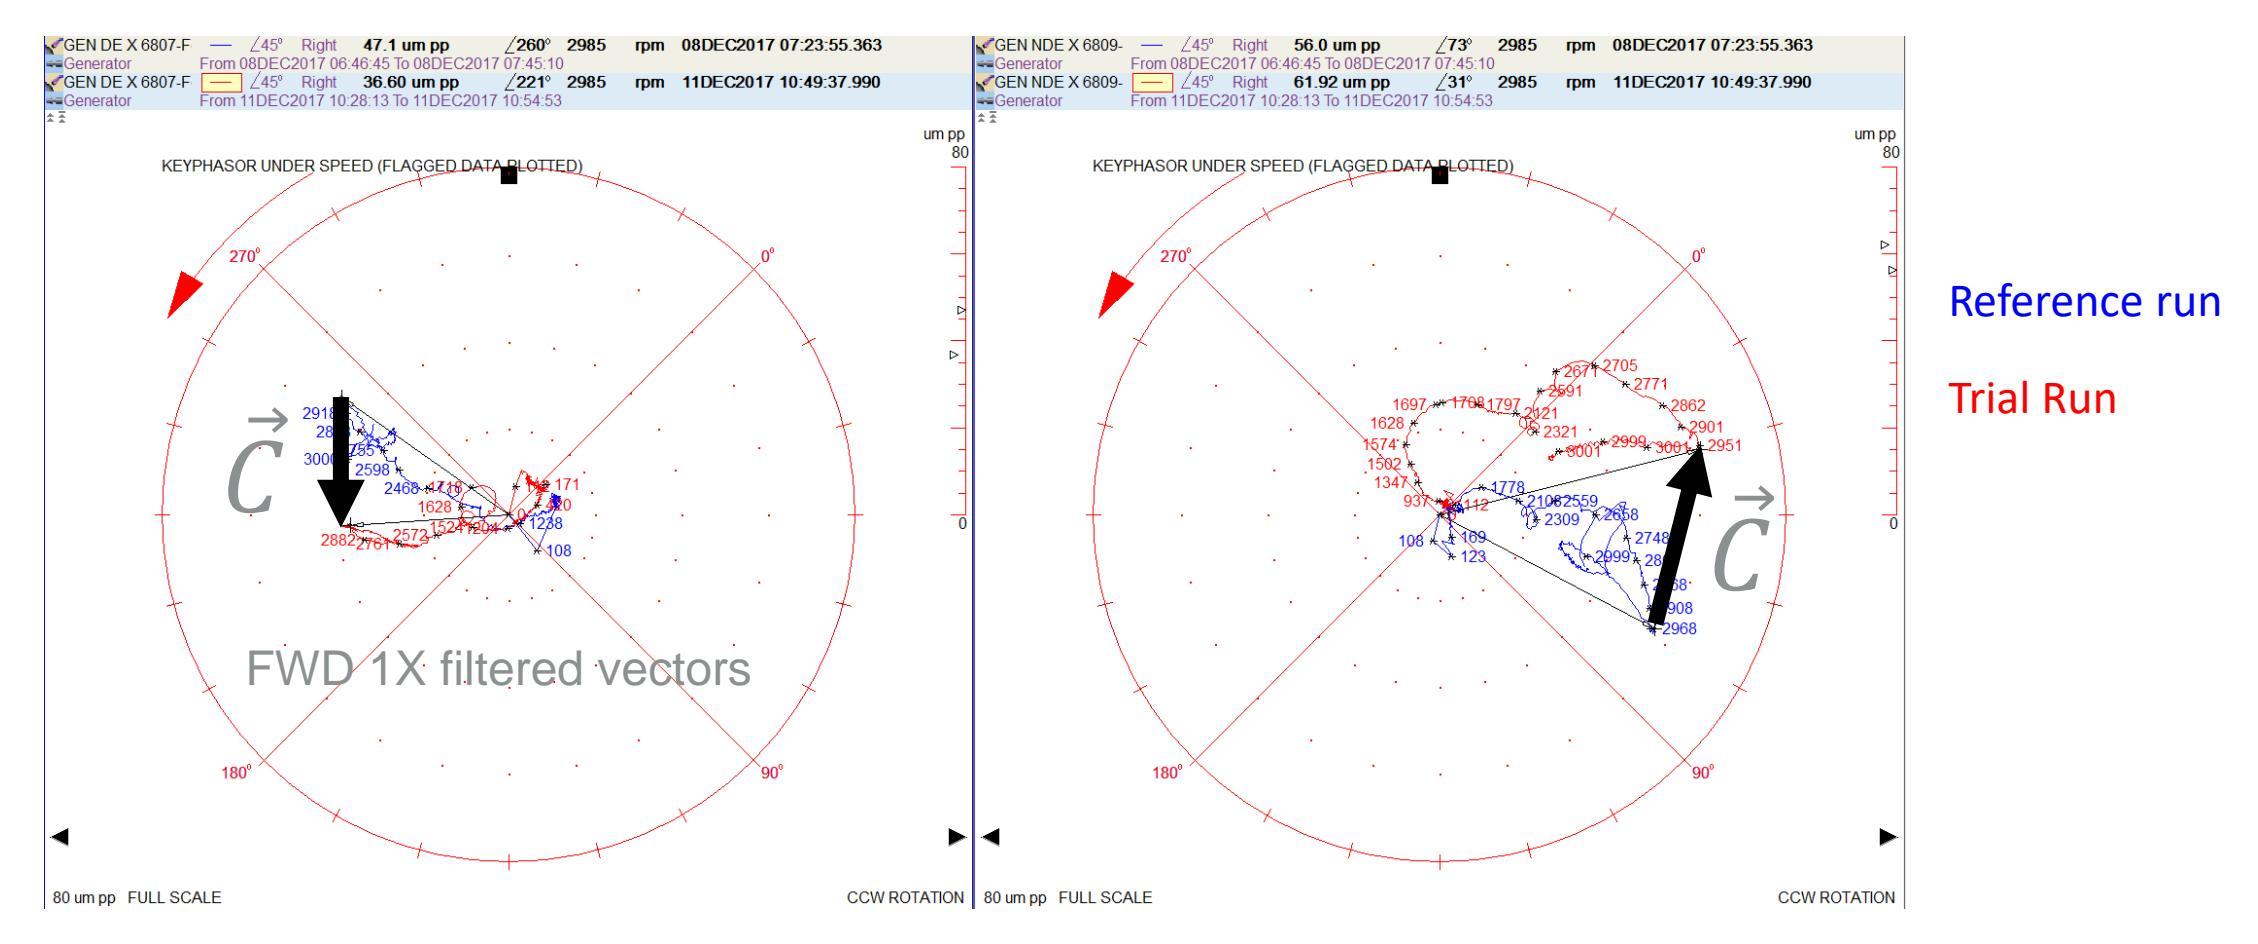
\vec{C} vectors is useable but not oriented as expected. It is not opposed at the original vector \vec{O}

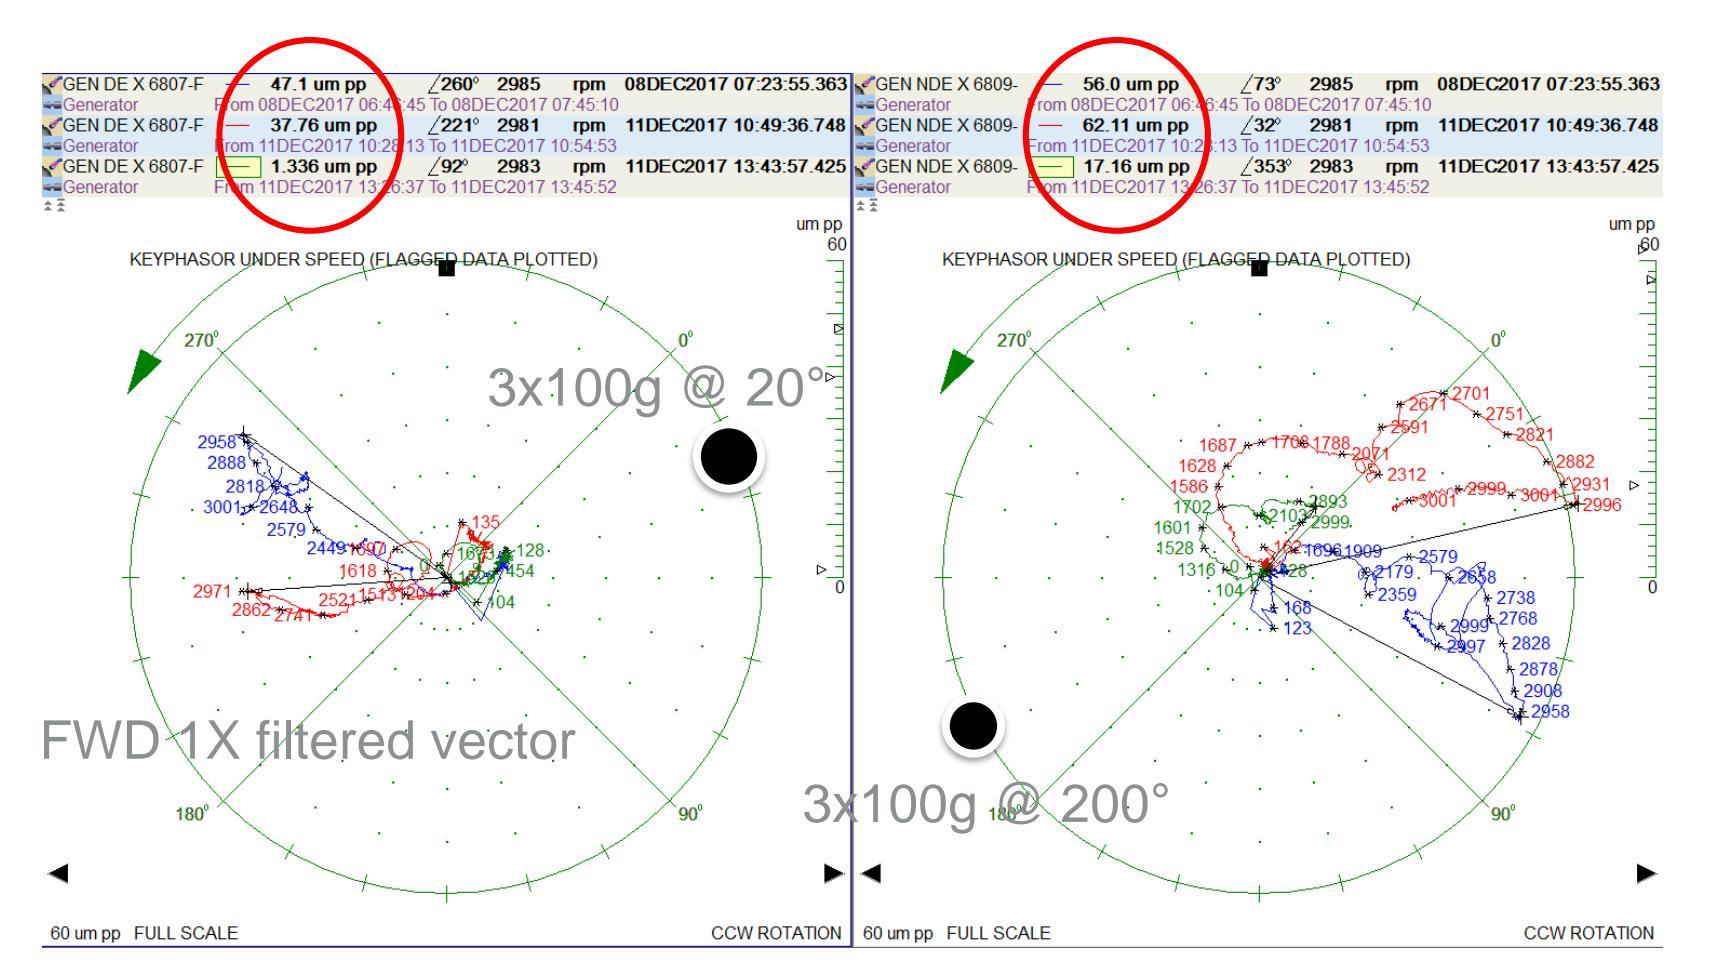
Reference run

Trial Run

Final Run

That's was a success !

1X amplitude decrease by more than 70%

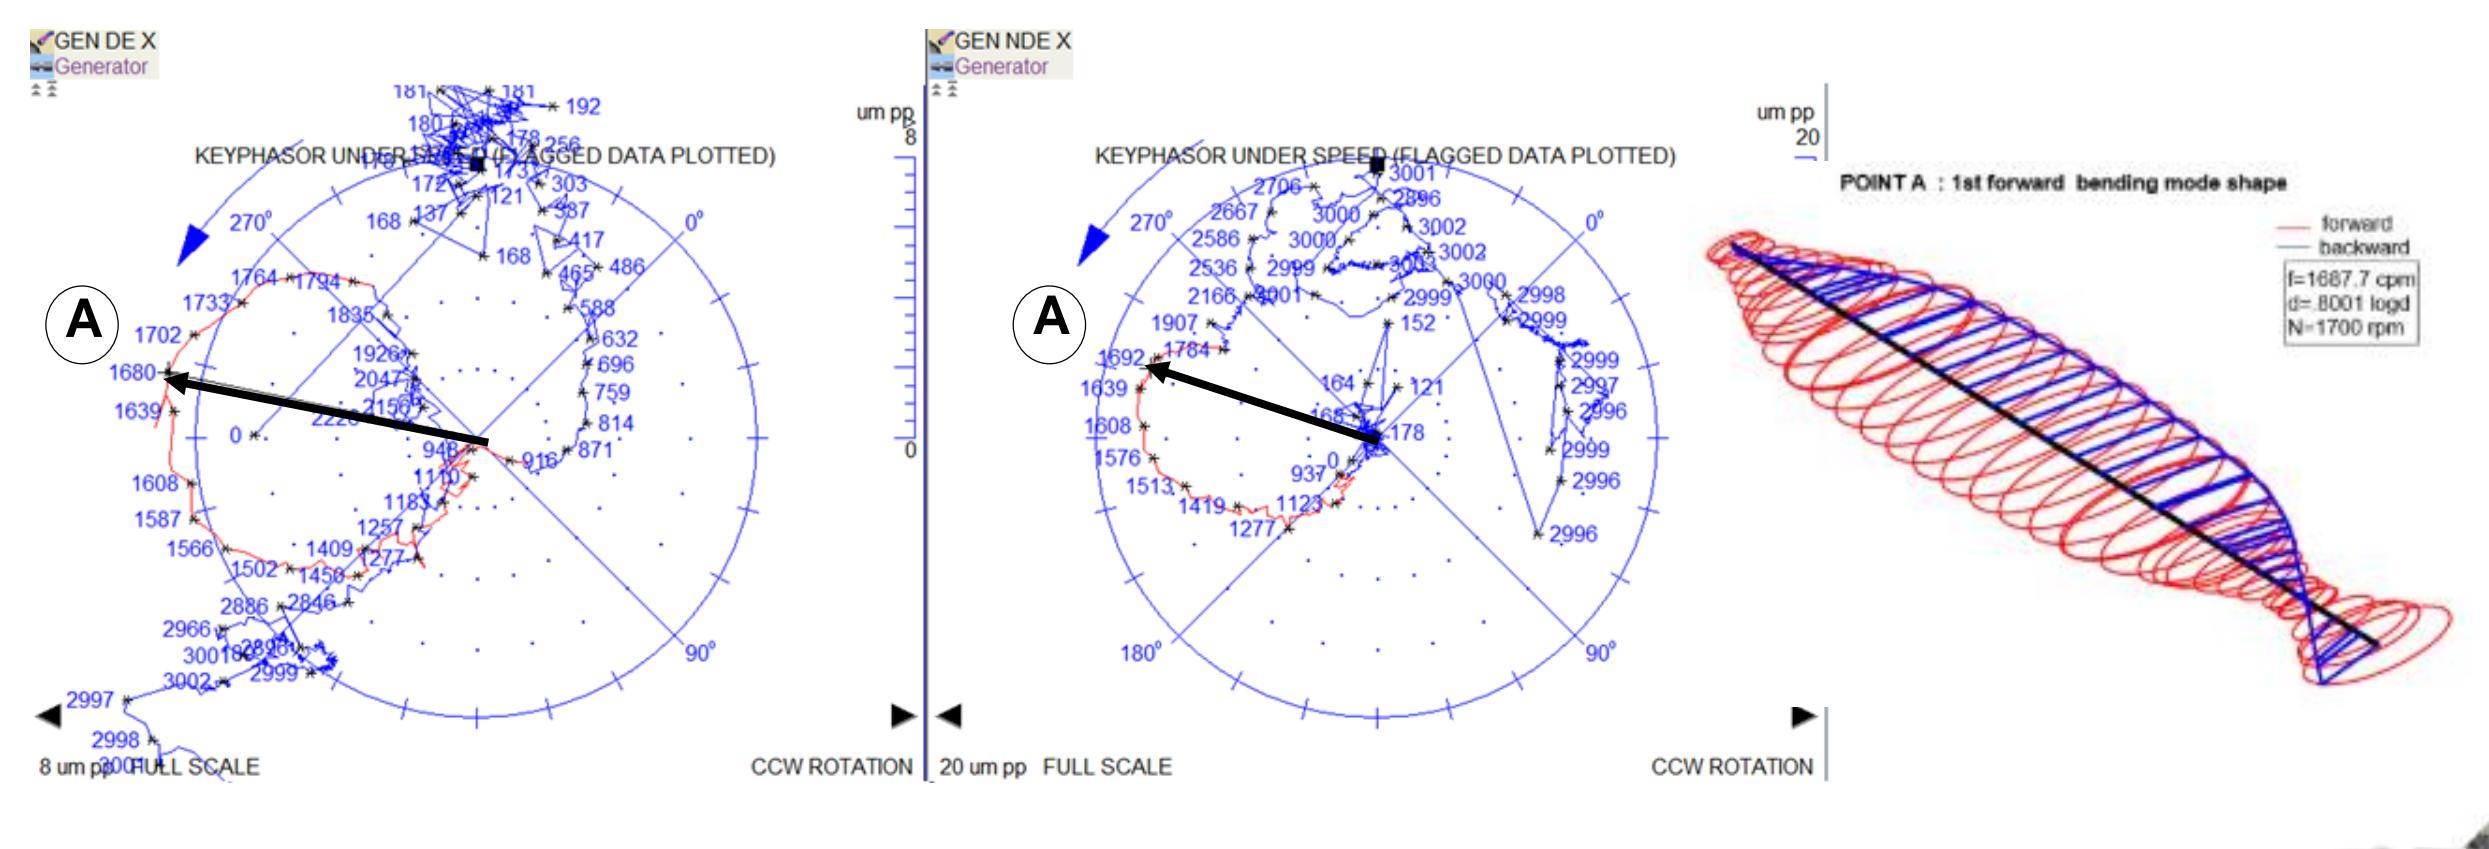
1X FWD polar plots for DE and NDE generator side

1X DE and 1X NDE vectors are in phase and resonance is around 1680rpm, in accordance with calculation

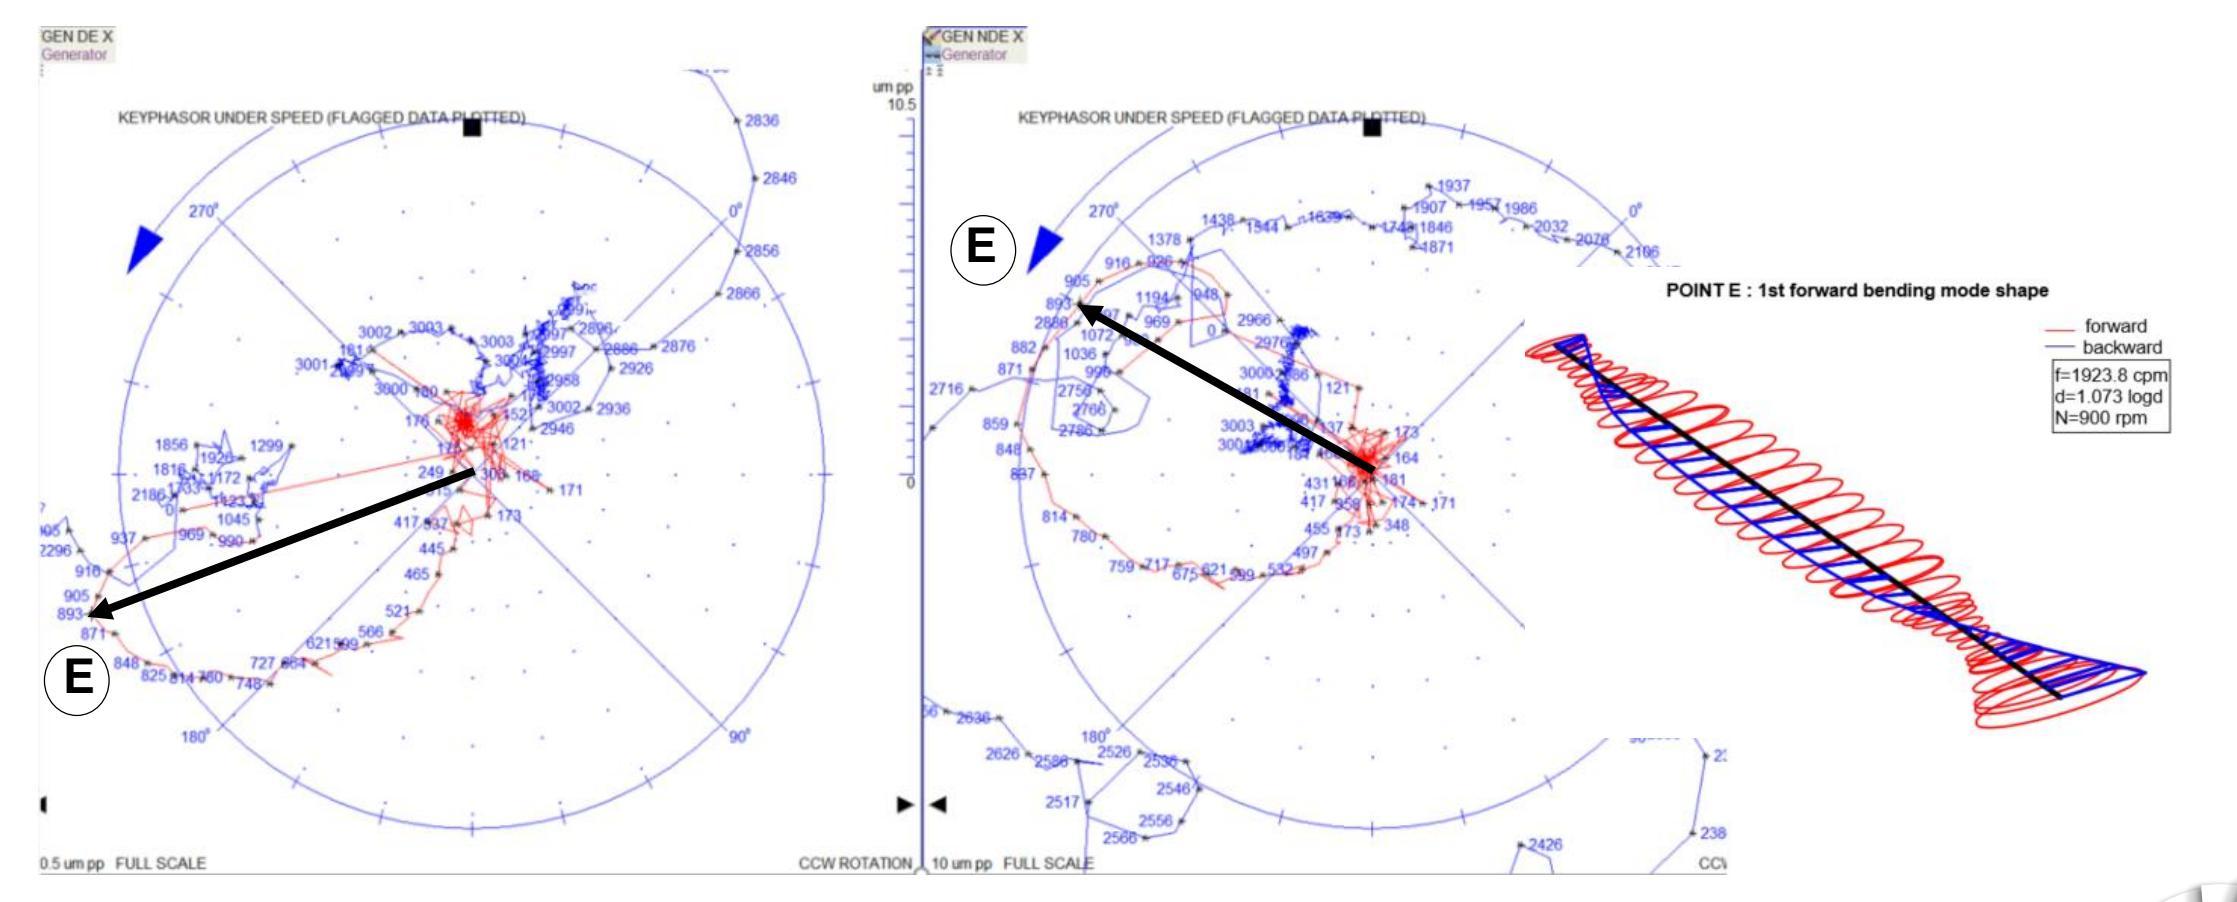
Damped Critical Speed Map 2X FWD polar plot for DE and NDE generator side

2X DE and 2X NDE vectors are almost in phase and resonance is around 900rpm, in accordance with calculation

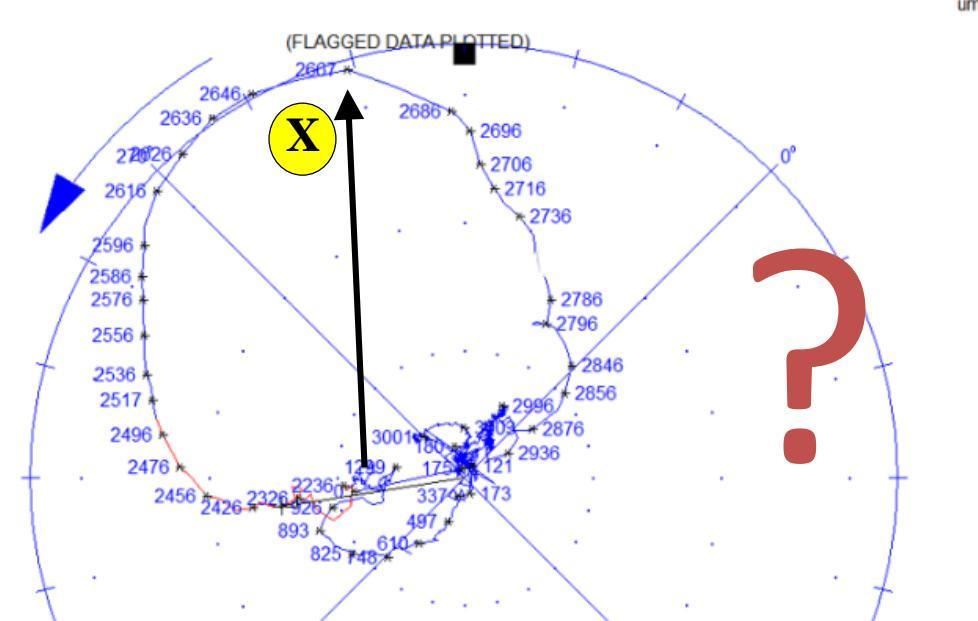
2X FWD polar plot for DE and NDE generator side

DE side probes are located at the nodes so "H" & "G" are not visible. "X" was not on the DCS map ???

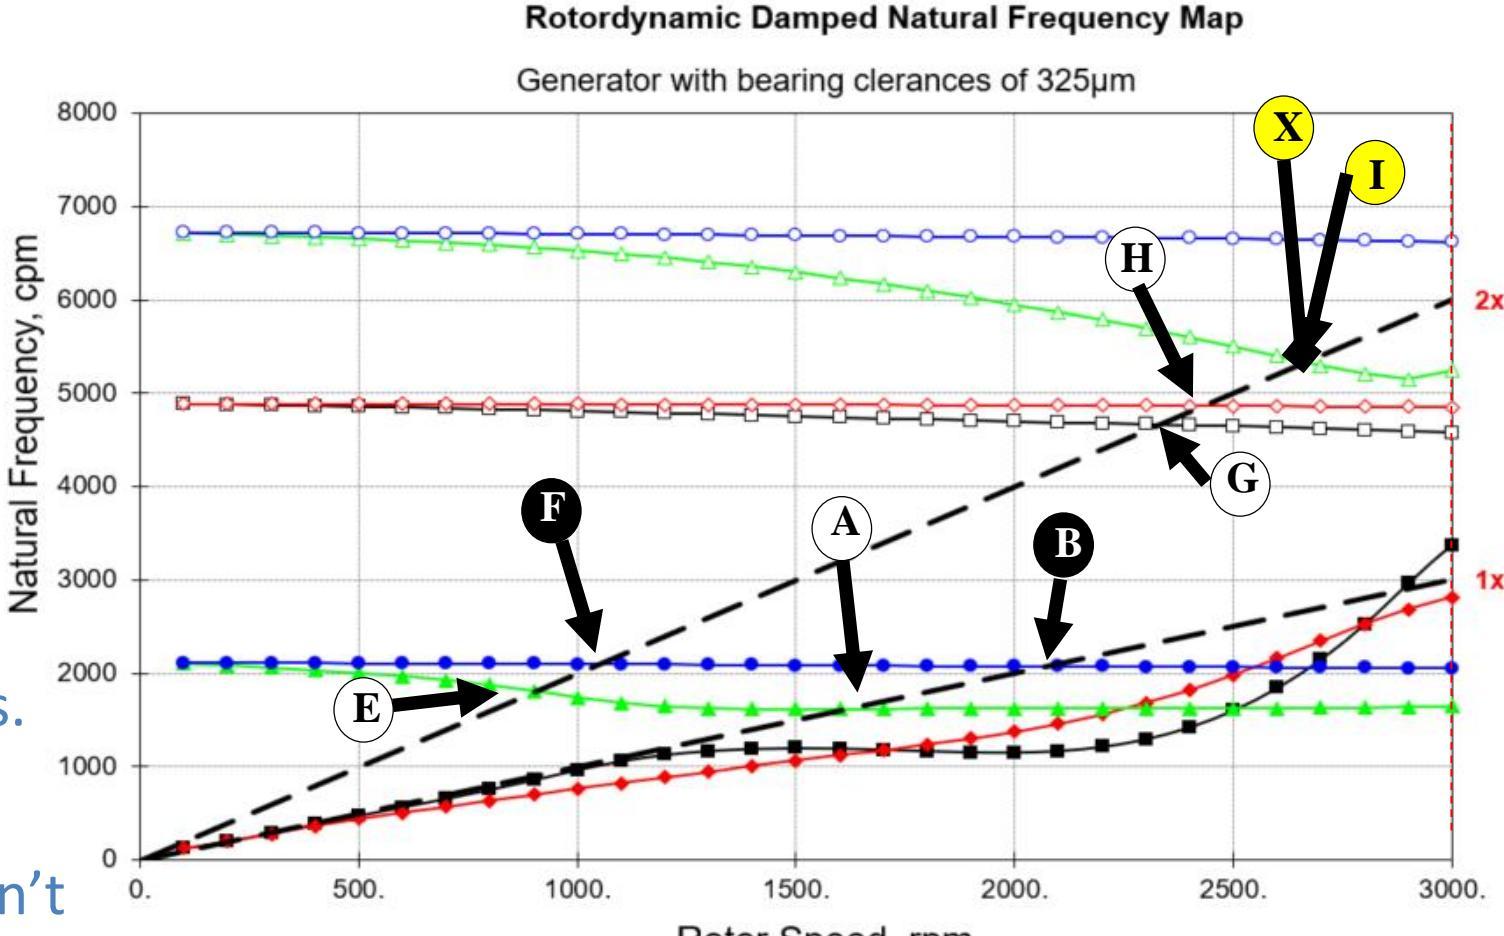
XLTRC² model / Damped Critical Speed Map

- Let's increase bearing clearances from 280µm to 325 µm ?
- X and I points merge
- Given clearances were not correct ? Bearings worn ?
- In any case, the model and measurement match for several points.
- It seems that the increase of vibration after the grid short circuit incident didn't induced major mechanical issue on the generator

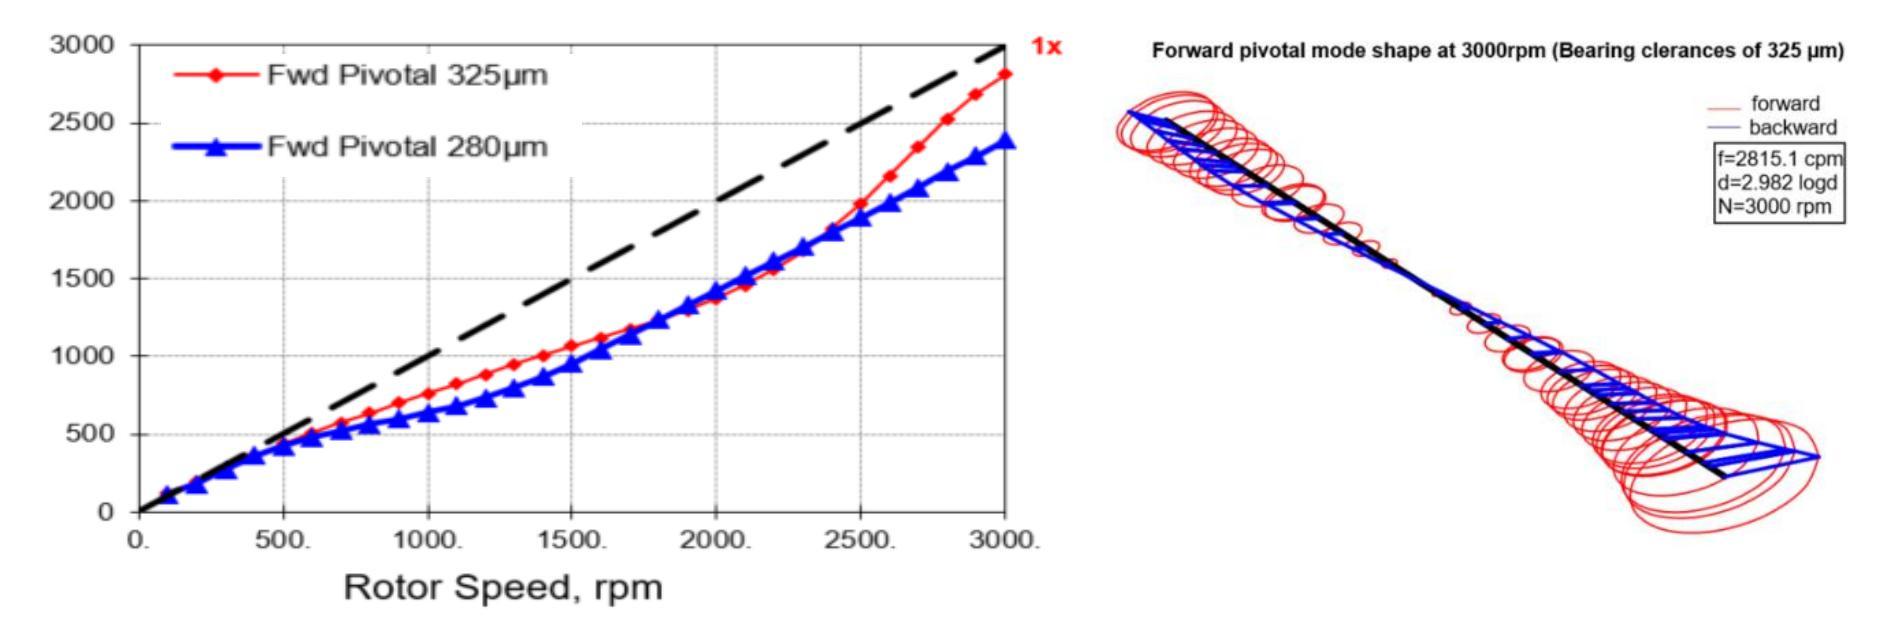
Important trim balance remark : The C vector lags the trial weight by 65°

Theoretically it means that at 3000rpm the generator is running close to a resonance.

The lateral analysis seems to confirm this assumption ! The pivotal mode frequency follow the 1X line and it is really close to 1X line at operating speed (3000rpm).

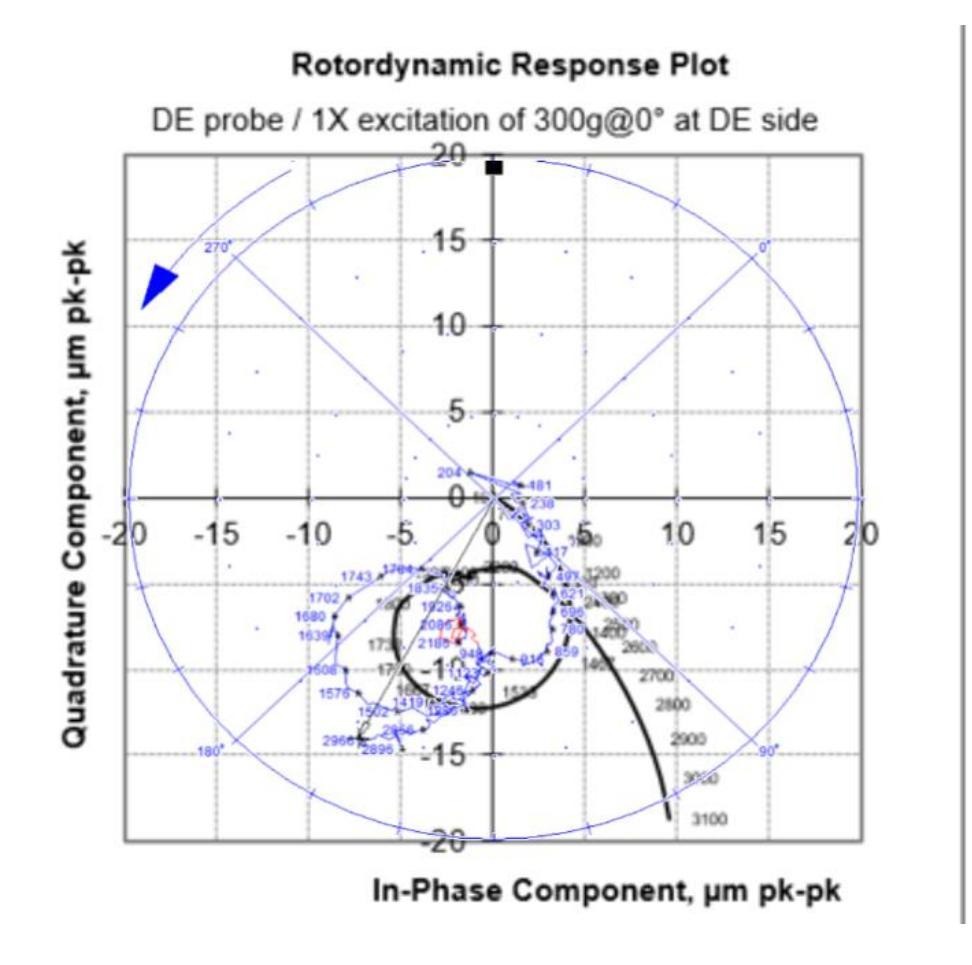
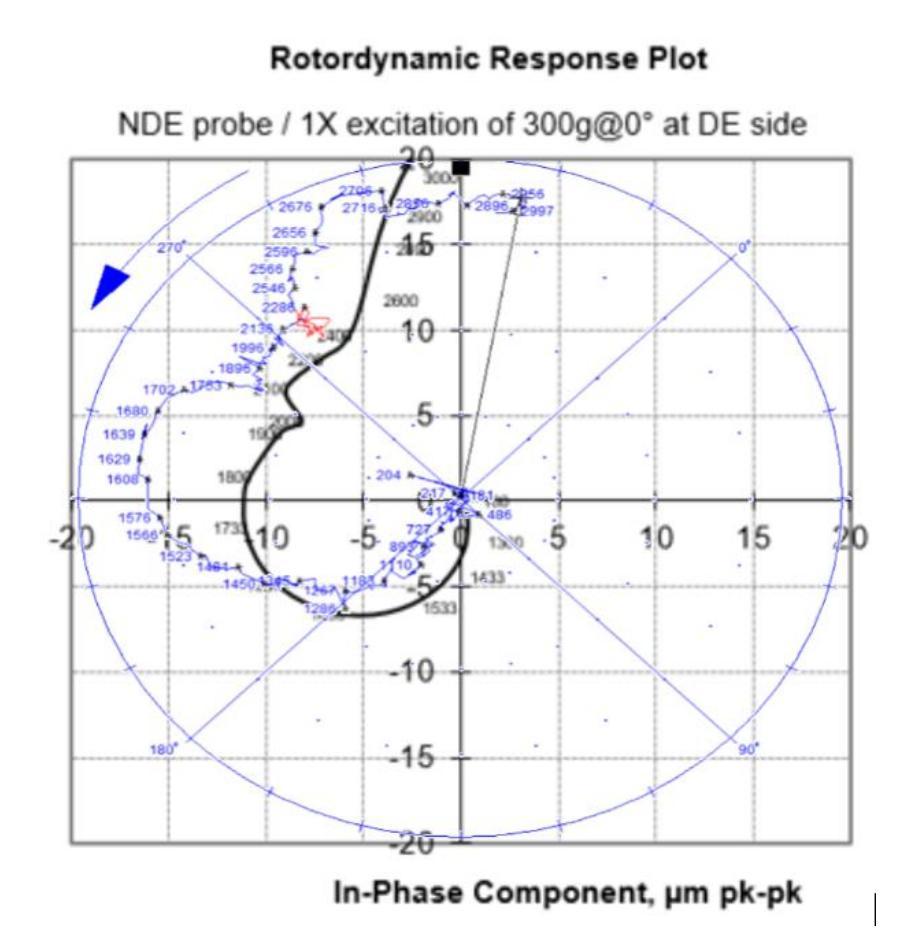
Imbalance response / 300g at DE side

Measurement (BLUE) and calculated 1X response (BLACK) are really close
