Ensuring the seismic resistance of operated CHP buildings

Bellendir E.N.¹, Rubin O.D.², Antonov A.S.^{2,3}, Baklykov I.V.², Zyuzin R.S.⁴

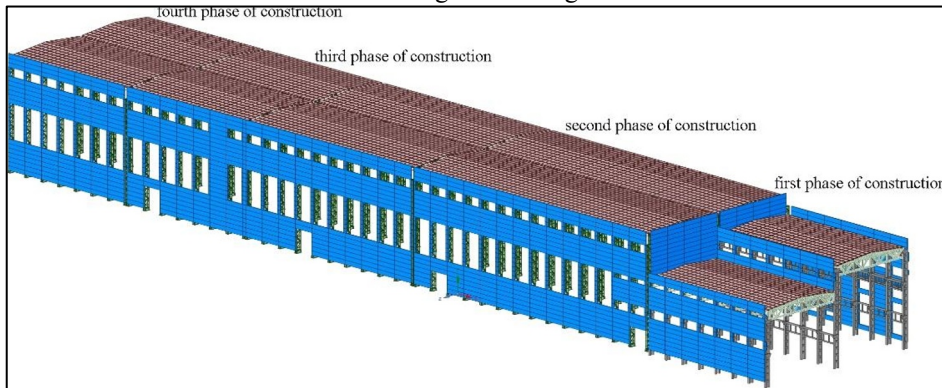
Fig. 1. Spatial model of the building with the order of erection

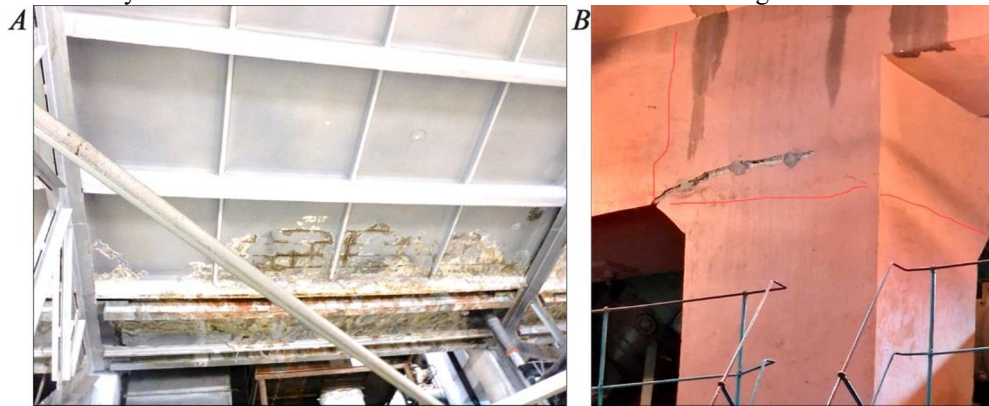
Fig. 2. A - condition of reinforced concrete slabs of the roof of the turbine hall and drainage gutter slabs. B - crack in the structures of the turbine generator foundation at the place of binding the supporting columns with the reinforcing belt.

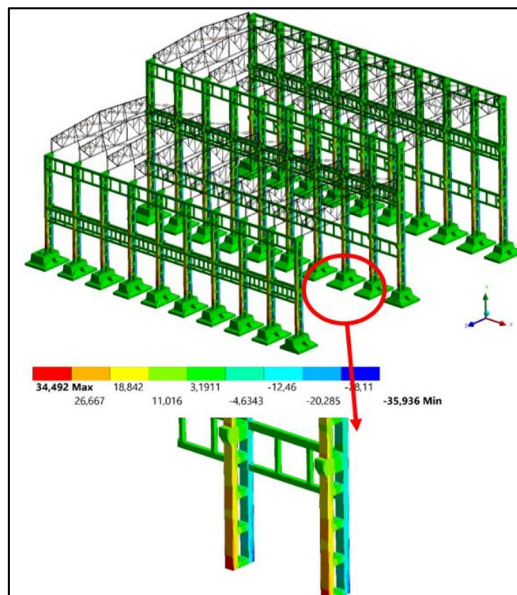
Fig. 4. Seismic impact of 10 points. Vertical stresses, MPa

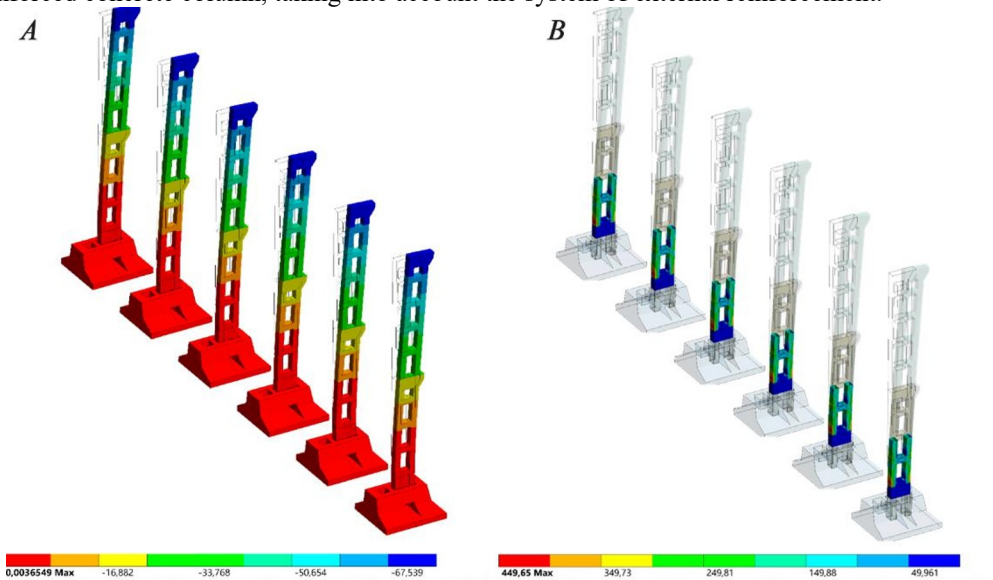
Fig. 5. Seismic impact of 10 points. A- Horizontal displacements, mm B - Equivalent stresses in the carbon tape, MPa

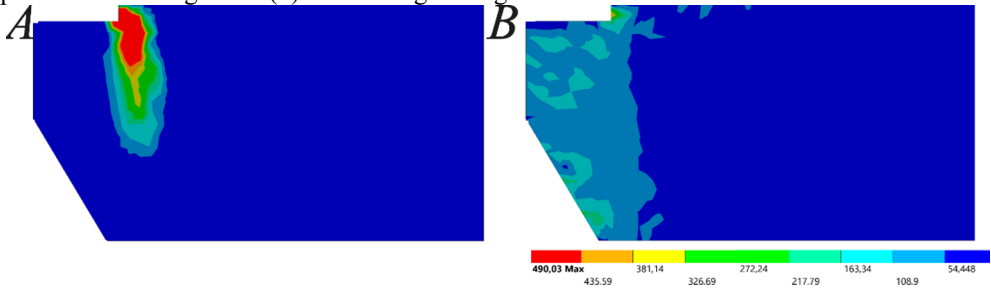
Fig. 6. Seismic impact of 10 points. A - Cracking in the cantilever part of the column, before amplification; B - Stresses in the reinforcement, MPa after strengthening

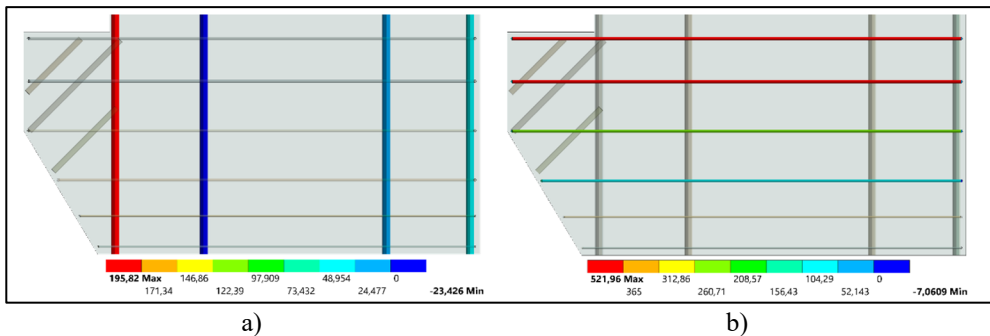
Fig. 7. Seismic impact of 10 points. a) - stresses in the vertical reinforcement of the column $\text{Ø}32 \text{ mm}$; b) - stresses in the horizontal reinforcement of the column $\text{Ø}12 \text{ mm}$
