TVA CCR Disposal Facility Assessment

John S. Montgomery, PE¹, John C. Kammeyer, PE², Alan Casaday², and Michael S. Turnbow²

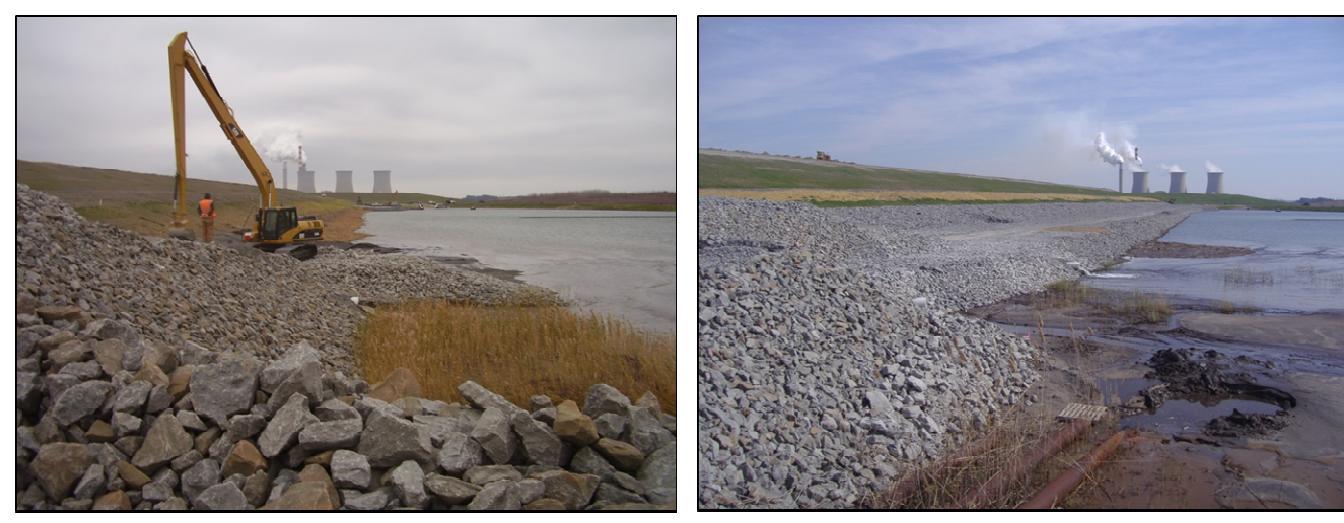
Figure 3 – PAF Gypsum Pond Buttress

Over 100 capital projects and work plans to improve conditions at the facilities are currently in planning, design construction, or completed phases. Figure 2 presents progress made and the implementation schedule for improvements addressing global factors of safety at each respective facility. By September 2011, improvements will be implemented such that all CCP disposal facilities assessed will meet the program minimum global slope stability factor of safety (\geq 1.5). These improvements generally involved rock buttressing, rock armoring, and seepage control blankets. In some cases, operating pools have been lowered, slopes re-graded, and toe drains installed. Figure 3 shows rock buttressing of the gypsum stack at the Paradise Fossil Plant.

East Pond South Slope Buttress - Before East Pond South Slope Buttress - After

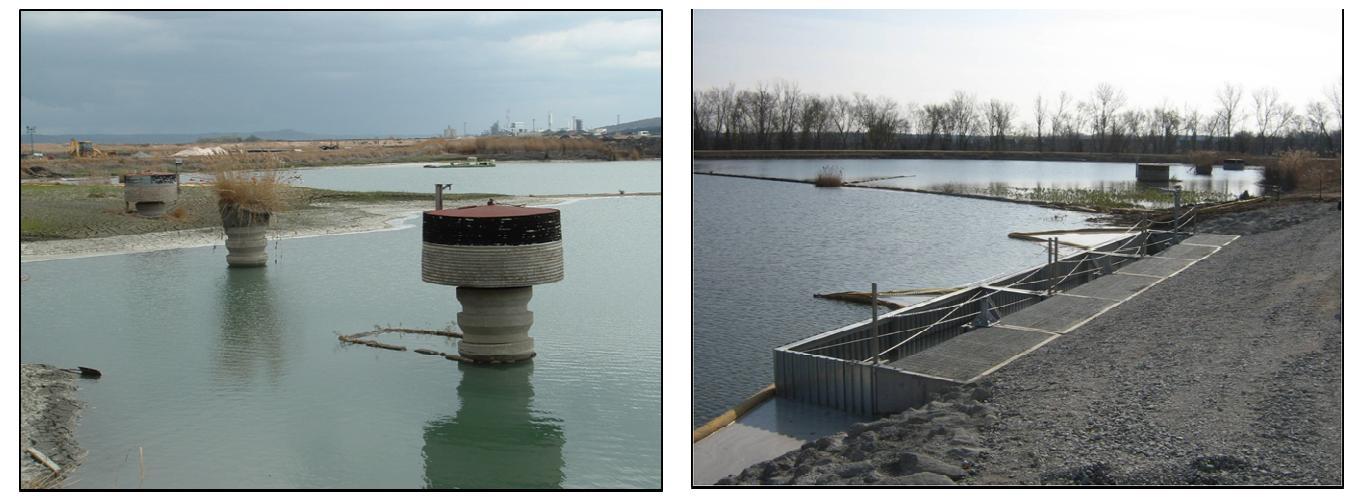
Figure 4 – JOF Spillway Replacement

During Phase 2, an inventory of pipe penetrations was also completed for active CCP impoundments. The inventory focused on spillway location, material, previous problems, and observed conditions. A geographic information system data file and database were developed as tools to allow TVA to track future improvements, modifications and issues. The inventory data is being used to prioritize spillways for replacement or rehabilitation. TVA has spillway replacement and abandonment projects underway or completed at 5 impoundments. Photographs representing a typical replacement project are presented as Figure 4. Abandoned spillways are grouted full and seepage diaphragms are constructed at the downstream end.

South Spillway Inlets - Before

South Spillway Inlets - After
