Scott I. Goodall for the degree of Master of Science in Civil Engineering and Wood Science presented on March 8, 2010.

Title: Optimizing the Performance of Gypsum Wall Board in Wood Frame Shear Walls

OPTIMIZING THE PERFORMANCE OF GYPSUM WALL BOARD IN WOOD
FRAME SHEAR WALLS

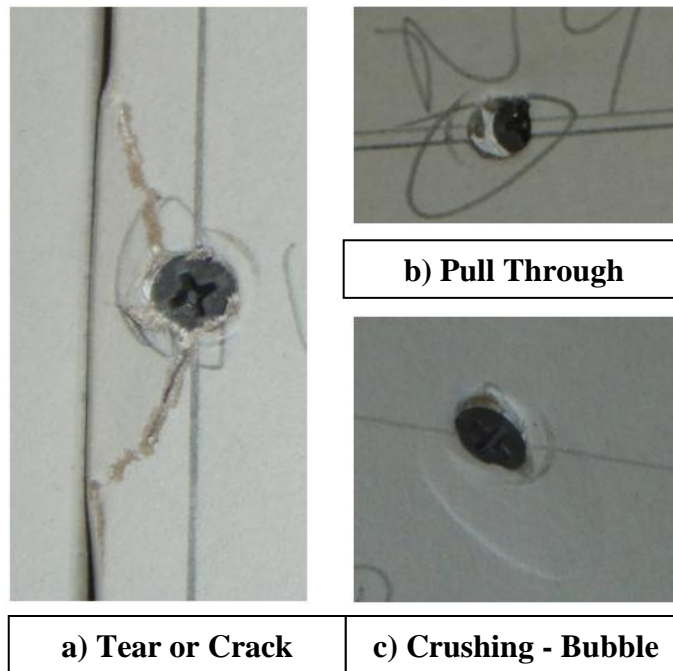
Figure 10. GWB Failure Modes

- 1) Tearing or cracking of the GWB near or around a screw connection (Figure 10a).
- 2) Pull-through of the screw into the back of the GWB by at least 2 mm (Figure 10b).
- 3) Local crushing of the GWB indicated by a visible bubble around the screw connection (Figure 10c).

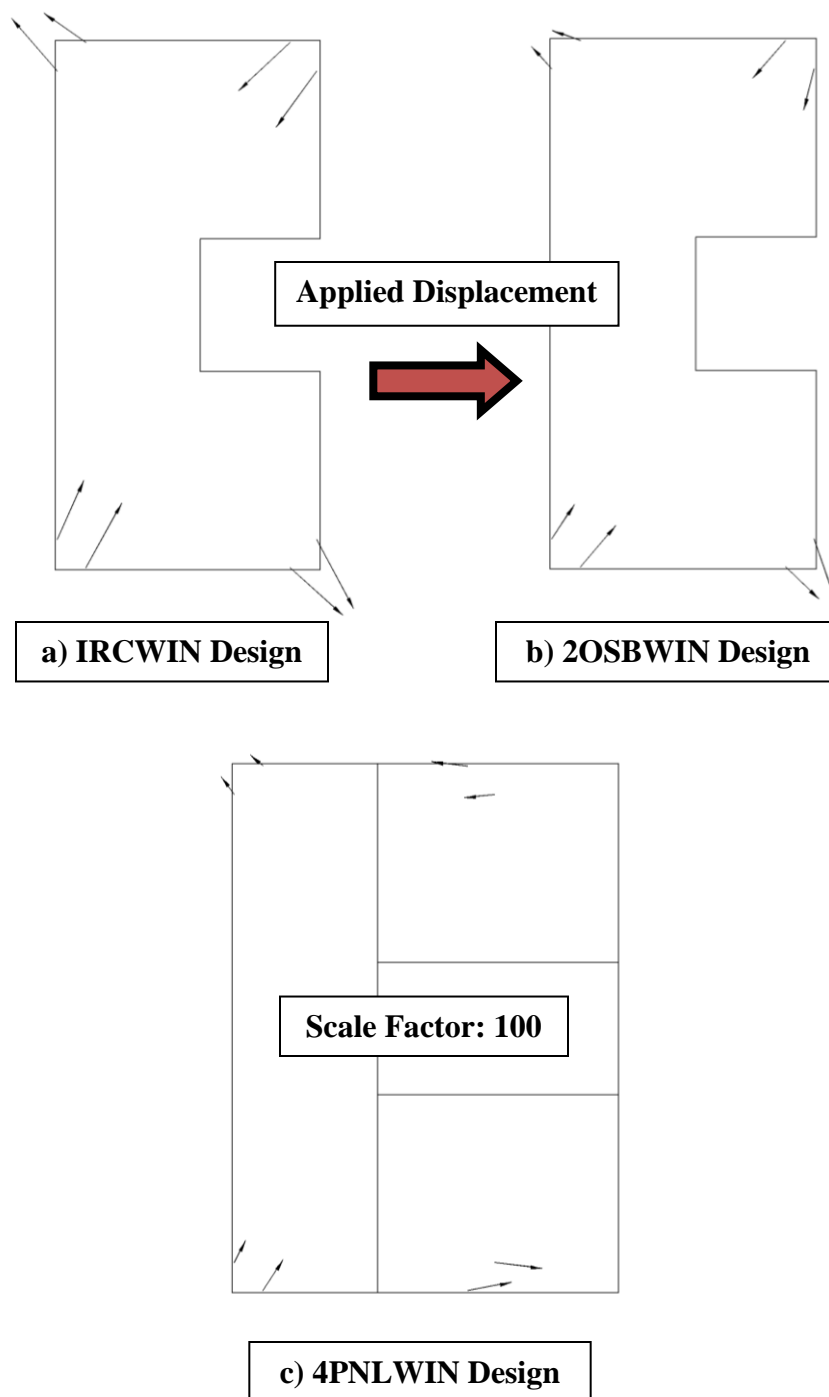
Figure H4. GWB Relative Displacement Vectors at 1% Drift for Shear Walls with Openings

For shear walls with openings, calculated relative displacement vectors for IRCWIN and 2OSBWIN, shown in Figure H4a and H4b, both qualitatively compare to the classical wood frame deflection and GWB rotation model. However, the 4PNLWIN design had a much different GWB attachment than other designs. The four panels attached above, below and to the sides of the window opening rotated

independently of each other until they begin racking against each other which was observed after 1% drift. This four panel flexible GWB attachment moved (absolutely) much more than the more rigid two panel attachment. Because the flexible wood framed moved (absolutely) similar to the GWB panels, the difference between the two absolute movements was small. This small relative displacement is shown in Figure H4. The end stud and plate vectors were consistent with other designs, but those on the middle stud and plate were much different. While the sensors in 4PNLWIN were attached to the same location in the wood frame as all other walls, the sensors were attached to the middle of the GWB panel in 4PNLWIN and the corner of the panel in all other designs. This different location explains the difference in vector direction. Assuming a linear change in relative displacement vector angle between the corners of a panel, the classical model predicts the horizontal angle shown on the top and bottom plates as observed in 4PNLWIN. The horizontal angle is approximately half of the minimum angle change between the corners of the panel predicted by the classical model.

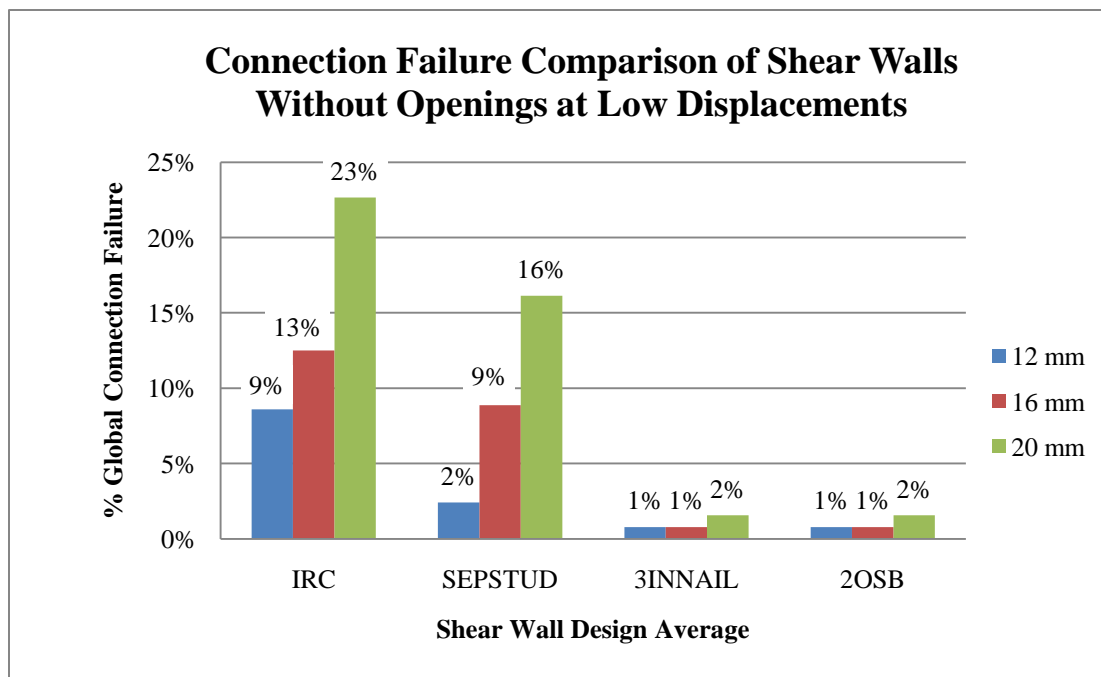
Figure I1: Connection Failure Comparison of Shear Walls without Openings at Low Displacements

A visual comparison between shear walls without openings is shown at low displacements in Figure I1. As can be seen from Figure I1, even small shear wall displacements can cause substantial fastener failure. At low global displacement levels of 12, 16 and 20 mm, the IRC and SEPSTUD designs both exhibited noticeable connection failures. At 20 mm global displacement the IRC and SEPSTUD designs had 23% and 16% respective global connection failures. The 3INNAIL and 2OSB designs had almost no global connection failures for this displacement range. However, all innovative shear wall designs outperformed the control design (IRC) at all of these low displacements.

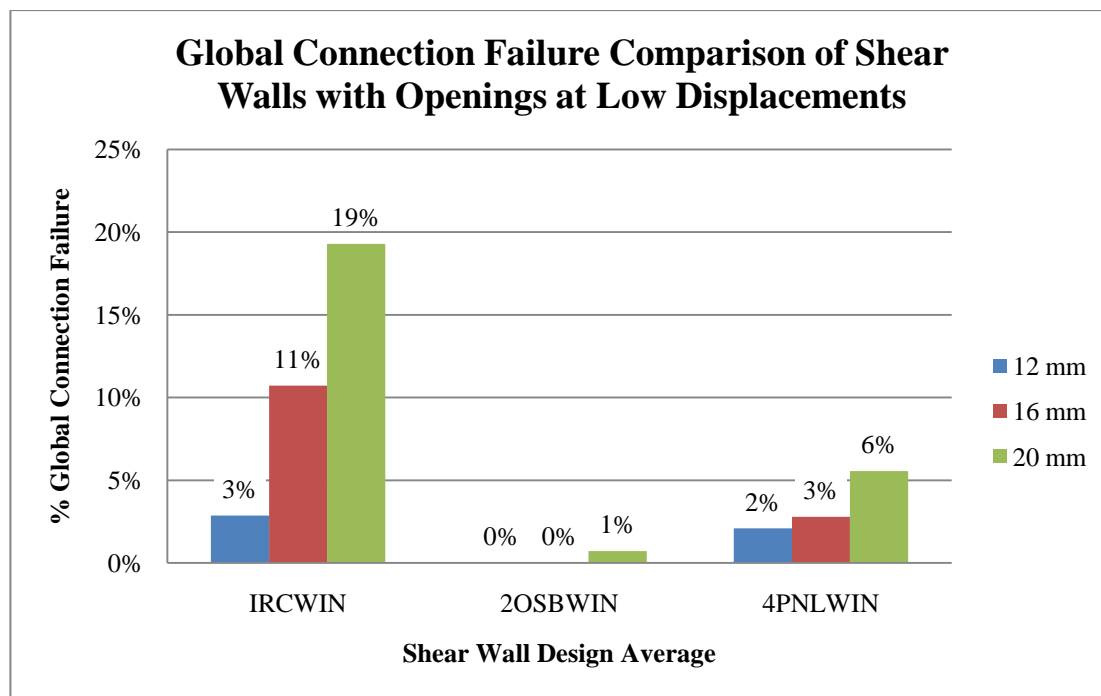
Figure I2: Connection Failure Comparison of Shear Walls with Openings at Low Displacements

A visual comparison between shear walls with openings is shown at low displacements in Figure I2. At the low displacements of 12, 16 and 20 mm, the IRCWIN design exhibited a noticeable connection failure of 19% at 20 mm. The other designs, 2OSBWIN and 4PNLWIN, exhibited lower connection failures of 1% and 6% at 20 mm, respectively. Like shear walls without openings, both innovative designs performed better at all displacements than the control, the IRCWIN design.
