# Analysis of Artifacts and Errors on Intraoral Phosphor Plate Radiographs: A Retrospective Study

Melike Yurttas<sup>1\*</sup>

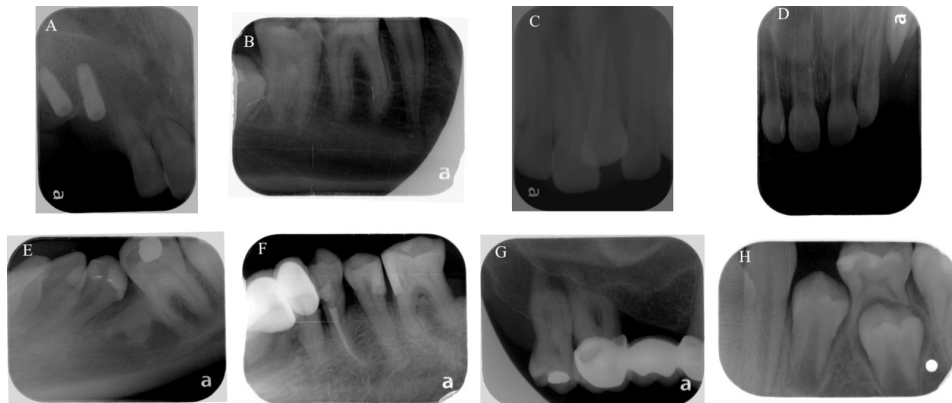
*Technical errors* – angulation errors (vertical-horizontal), incorrect placement of the plate, underexposed-overexposed, elongation/shortening, distortion, motion artifact, plate bending, cone-cut, reversed image (Fig. 1).

**Figure 1.** Technical errors: A) angulation errors (vertical); B) incorrect placement of the plate; C) underexposed image; D) elongation; E) distortion; F) motion artifact; G) cone-cut; H) reversed image.

During imaging, improper vertical and horizontal angulation can lead to image distortion, resulting in the teeth appearing abnormally longer or shorter than their actual size. Due to incorrect positioning of the periapical device, the entire area of the PP does not receive radiation. Cone-cut refers to the radiopaque areas in regions where no X-ray exposure was intended on the periapical image [6]. Numerous studies on artifacts [12, 14, 15] identified cone-cut as the most common artifact of operator or technical errors. In this study, among technical errors, the most common artifact was cone-cut (40.7%), followed by angulation errors (27.1%) and incorrect placement of the plate (12.8%).

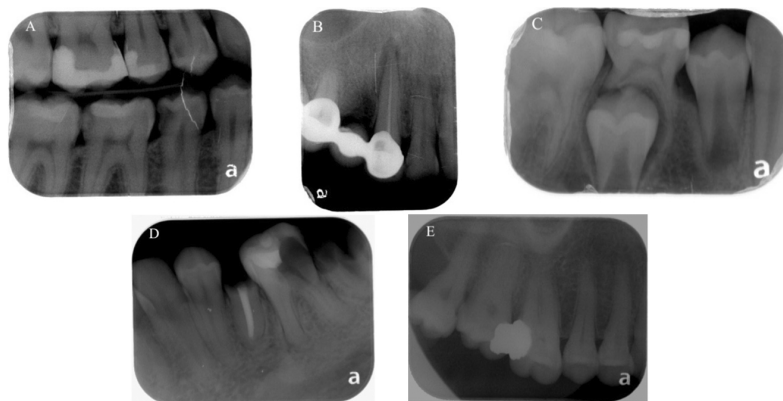
*Plate-related artifacts* – cracks/scratches, bite marks, peeling of the plate, plate contamination (dust, glove powder, fingerprint), crescent-shaped bending (Fig. 2).

**Figure 2.** Plate-related artifacts: A) crack; B) scratches; C) peeling of the plate; D) plate contamination; E) crescent-shaped bending.

Reusing the plates inevitably damages them. Rough handling, excessive bending, patient biting, and forcefully inserting them into the scanner can damage the PPs. These damages can result in diagnostic loss or misdiagnosis, manifesting as cracks, white lines, or scratches that resemble root canal fillings on the image [5, 10]. Additionally, friction and continuous use can lead the protective and light-stimulating phosphor layer to peel off at the edges of

the plates. The appearance of contamination, such as glove powder or fingerprints, on the plate surface may indicate a lack of proper cleanliness during plate usage [5, 7, 9]. According to Çalışkan & Sumer [10], the most common plate artifact was peeling. They observed peeling on more than half of the plates (53.4%). Elkhateeb *et al.* [14] mentioned that bite marks were the most common plate artifacts (40.3%). In this study, plate-related artifacts were the second most common group of artifacts, and cracks and scratches were the most frequent plate artifacts ( $n=418$ , 48.3%) (Fig. 2A, B). The reason for different results in the studies may be attributed to discrepancies in artifact classification, variations in phosphor plate counts across studies, and variances in the experience levels of individuals utilizing the PPs (interns, experienced radiology technicians, etc.).

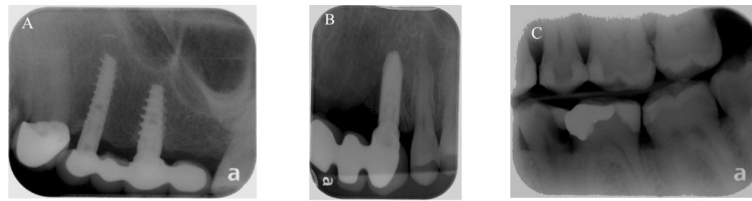
**Figure 3.** Scanner-induced artifacts: A) parallel zigzag radiopaque lines; B) radiolucent lines; C) peeling of the conveyor belt.

lines, erasure artifact, radiolucent lines, peeling of the conveyor belt (Fig. 3).

Short-term variations in laser scanning intensity can cause horizontal white lines to appear on the image. These lines can appear in different regions of scanned plate. Additionally, due to dust particles and dirt along the path of the laser light in the scanner, parallel radiopaque lines (Fig. 3A) can be observed in the scanning direction. These lines consistently appear in the same location on every scanned image. Dust particles and dirt that become trapped in the scanner during the scanning process can produce straight radiopaque lines on the image and the slight movement of these particles can result in the formation of zigzag-shaped radiopaque lines (Fig. 3A) on the image [6, 10]. The radiolucent line (Fig. 3B) observed on the scanned PP has been suggested to be a consequence of electromagnetic interference artifacts. These artifacts can arise from any factors that disrupt, interrupt, decrease, or limit the performance of the scanner. To prevent this artifact, it is necessary to implement appropriate electromagnetic shielding, use the correct voltage source, ensure an uninterrupted power supply, and regularly maintain the scanner [10, 13]. In a study conducted at two different institutes, Tashiro *et al.* [8] determined a browser error rate of 52% in one institute. Additionally, Çalışkan & Sumer [10] stated that approximately 53% of PP artifacts were induced by the scanner. The most frequently detected scanner-induced PP artifacts in their study were straight lines [9]. Furthermore, Elkhateeb *et al.* [14] stated that delayed non-uniform density or bright images were the most common scanning errors (39.9%). Chiu *et al.* [12] detected scanning machine errors in 4.5% of PPs, with horizontal white lines being predominant. In this study, parallel zigzag radiopaque lines were the most common scanner-induced artifacts (98.7%). The variation in devices and artifact classifications across studies may have contributed to the differences in results. It should also be kept in mind that scanner-induced artifacts can generally be resolved by rescanning, whereas most other artifacts required retaking the radiograph.

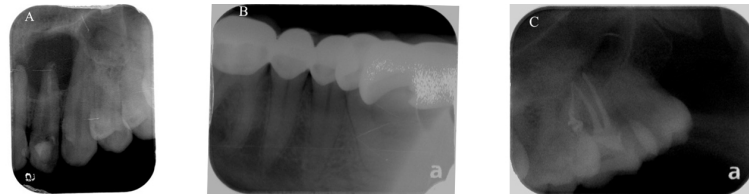
**Figure 4.** Ambient light artifacts: A) fading; B) shinning; C) noisy image.

*Ambient light artifacts* – fading, shinning, non-uniform image density, and noisy image (Fig. 4).

PP artifacts may occur due to exposure to ambient light. Due to prolonged exposure to ambient light when the plate is unsheathed and awaiting scanning, fading may occur along the edges of the scanned plate. Additionally, shining may appear in the center of radiopaque structures or at the edges of the scanned plate due to a complete

loss of the acquired signal in those areas due to excessive spontaneous releasing. Partial exposure of the plate to ambient light typically occurs when plates overlap while unsheathed, resulting in fading in the exposed area. If ambient light has partially affected the plate, a decrease in image density appears in the areas exposed to ambient light. The area protected from ambient light appears with normal density. In this scenario, the image may depict two or more radiographic areas with differing densities for the same structures [6, 10, 15]. According to Çalışkan & Sumer [10], the most common ambient light artifact was fading, accounting for approximately 44.1% of plates. Elkhateeb *et al.* [14] reported delayed scanning artifacts at an approximate rate of 40%. In this study, fading artifacts were detected on half of the plates, followed by shining artifacts (49.3% and 35.9%, respectively). To prevent the formation of artifacts, PPs should be scanned within a maximum of 10 min after exposure in a semi dark room. If scanning cannot be performed immediately, the plates should be stored at room temperature in a light-free environment [16]. Research indicates that the diagnostic quality of the image decreases proportionally with increasing light intensity and exposure time [17].
